GLEN HUNTINGTON BANDSHELL

FINAL DRAFT NOVEMBER 11, 2022

The report documents the history, significance, integrity and existing condition and provides treatment guidance for the resource. It does not evaluate for listing in the National Register of Historic Places. If the resource has been previously listed or evaluated it is referenced and footnoted.

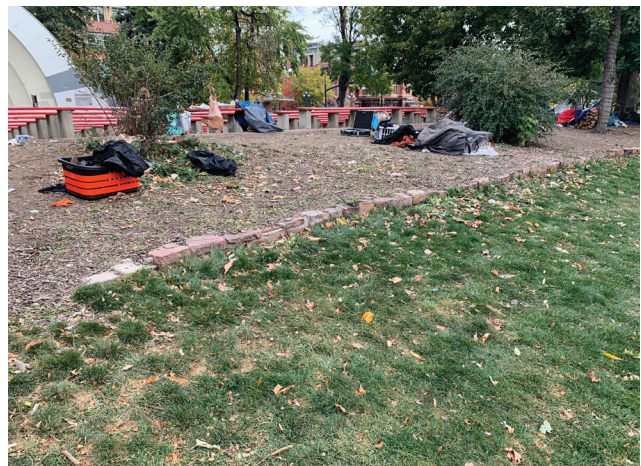
Figure 1-9. Stone Wall, 2020 (source: Mundus Bishop)

- Preserve contributing topography including the landscape berm and sloped amphitheater.
 - Repair the existing stone retaining wall and berm to define the southern edge of the amphitheater.

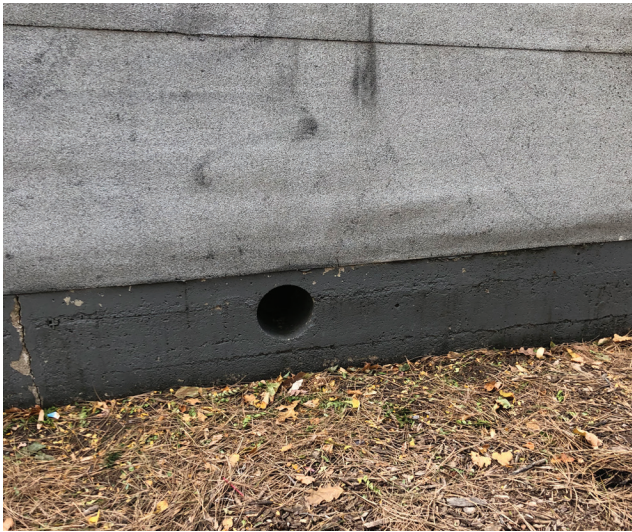
The crawlspace below the stage was inaccessible during field review. Visual inspection of the exterior portions appear to be in good condition. Visible vertical cracks in the foundation and chipped paint were observed on the rear side of the Bandshell.

Figure 1-16. Vertical foundation crack on the east facade, 2020 (source: Ratio and JVA)

Overall, the foundation is in good condition. One vertical crack is in the east foundation wall, which is, likely a naturally formed expansion joint. The west foundation wall is covered in ivy, which can be detrimental to the structure over time. Relatively regularly spaced vertical cracks occur in the in foundation wall along the front of the stage that are likely natural formed expansion joints. The concrete buttresses on both sides of the largest arch have horizontal cracks at the same height. These are likely cold joints from the original concrete pour during construction. Both the vertical expansion joint cracks and horizontal cracks at the cold joints are not of structural concern.

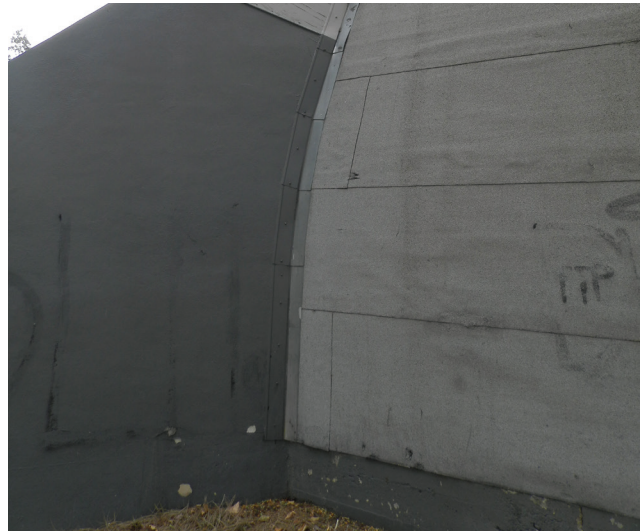
The lower portions of the asphalt roofing extend to the concrete foundations and appear to have been vandalized. The lower portions show signs of blistering and separation from the surface below and are in fair to poor condition. The upper portions of the rolled asphalt roofing appear to be in better condition with minor signs of blistering. On the east end of the roof, one area of the asphalt roofing has been patched with a different material.

Figure 1-17. Rolled asphalt roofing. Note the blistering at the lower portion of the roof, 2020 (source: Ratio)

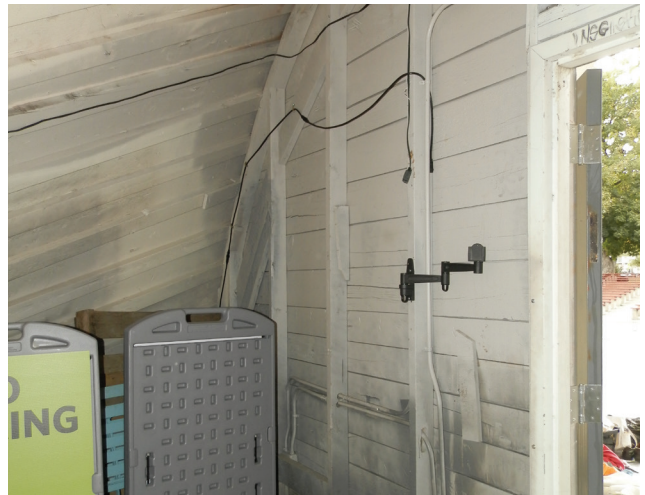
Framing: The majority of the structural wood framing is concealed within exterior finish materials and was unable to be observed. The floor access hatch did not appear to be operable, so stage framing was unable to be observed. The framing within the small storage room at the back of the stage appears to be in good condition. The wood siding is in fair condition with some boards split along the grain.

Figure 1-19. Wood siding, 2020 (source: Ratio)

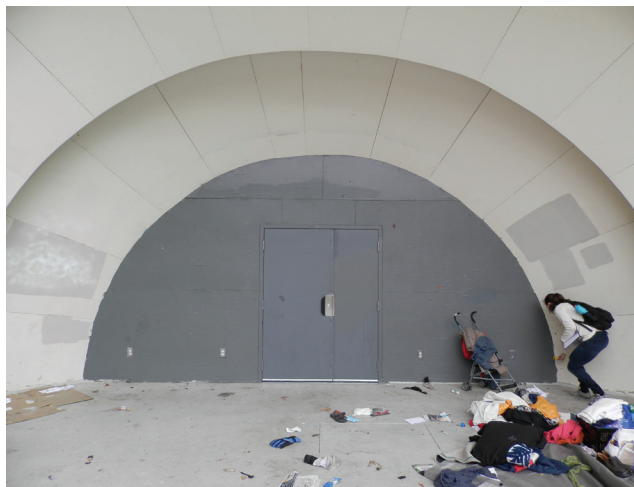
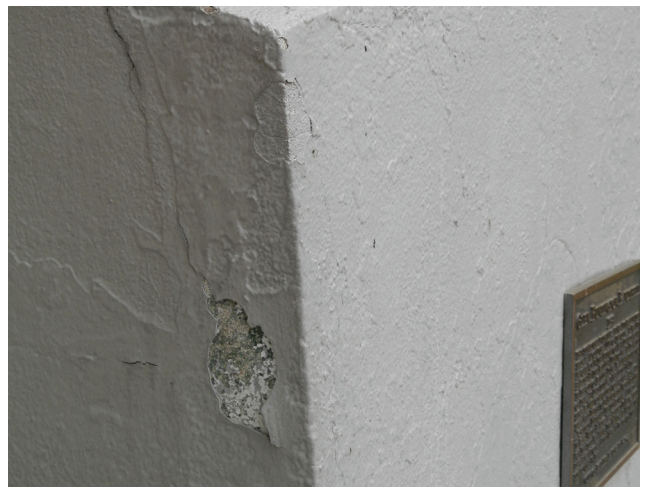
Finish Panels: In general the exterior plywood finish panels appear to be in fair condition. The panels have minor weathering and mostly aesthetic damage due to frequent vandalism. At the topmost proscenium arch, the rear-facing plywood appears to have more significant weathering. The exterior rear wall of the Bandshell has plywood panels covered with ivy. Damage to the wood is likely beneath the vines.

Figure 1-20. Exterior plywood finish panels, 2020 (source: Ratio)

Figure 1-21. Exterior plywood finish panels, 2020 (source: Ratio)

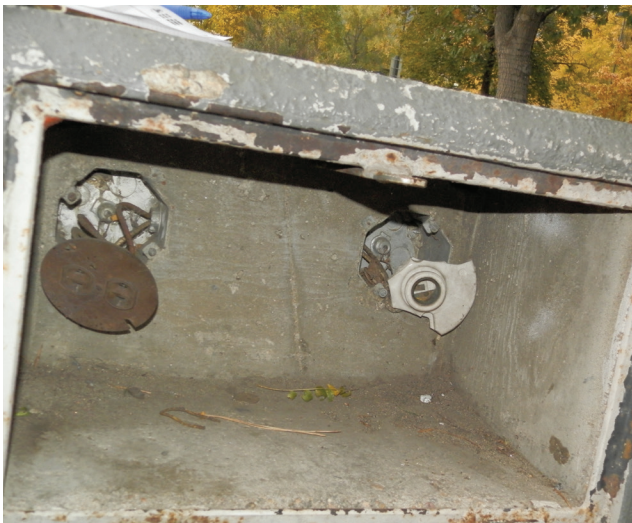
The power and lighting bollards do not show any major cracking or damage. The metal cover plates are either missing or in poor condition with rusted and broken hinges. The receptacles do not appear to be functional and include two 2-pronged outlets with no ground wire. The lighting has been removed and the power boxes exposed.

Figure 1-22. Interior view of lighting and power bollards. Note the cracking concrete forms, rusted and broken cover plates, as well as missing components, 2020 (source: Ratio)

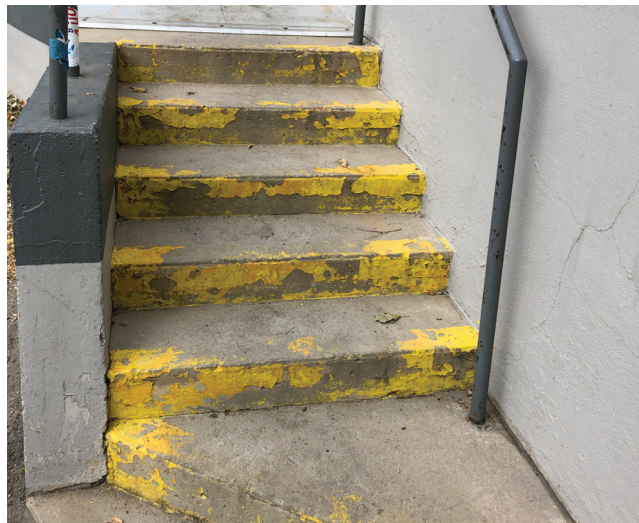
Concrete stairs at both locations appear to be in good condition. The yellow safety nosing paint is in poor condition. The painted steel handrails are in good condition with portions of the painted finish worn off. The handrails do not appear to be in compliance with current accessibility requirements.

Figure 1-23. Concrete stairs. Note the yellow safety nosing paint condition is poor, 2020 (source: Ratio)

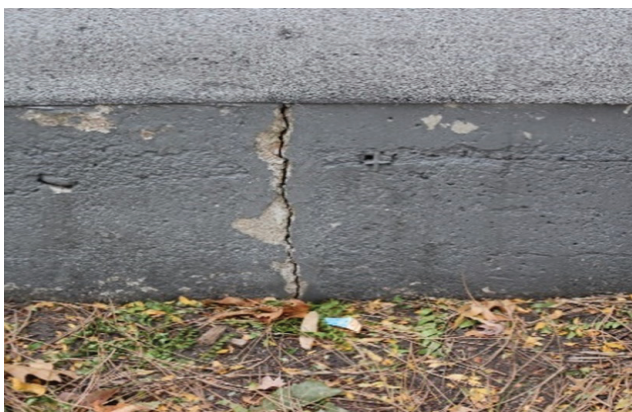
Figure 1-24. Vertical foundation crack on the east side, 2020 (source: Ratio and JVA)

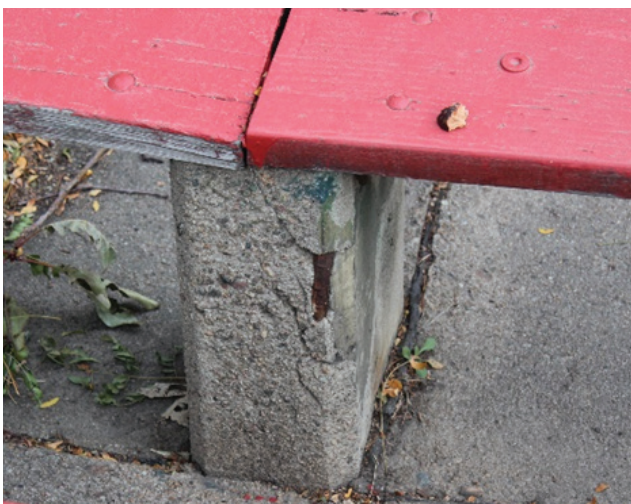
Amphitheater seating faces the Bandshell Stage. The amphitheater consists of a concrete slab that slopes toward the stage and rectangular reinforced concrete pedestals that support wood benches. Steel angle clips connect the wood benches to the concrete. Many concrete pedestals have started to spall. In some spall locations, the exposed rebar appears to only have had 1/4-inch cover. Some pedestals have areas of spider-web cracking and areas where the cement binder has weathered, exposing the larger aggregate. The painted wood bench boards show signs of wear including splitting, warping, and crushing at the connection locations.

Figure 1-26. Spalling at pedestal of Amphitheater Seating, 2020 (source: Ratio)

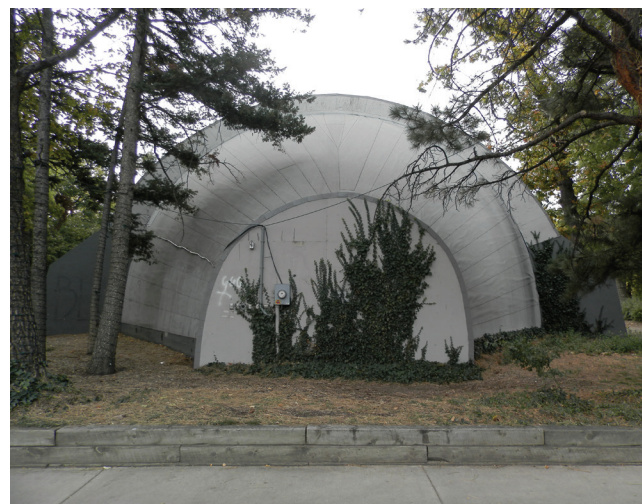
Figure 1-27. Ivy on exterior rear wall, 2020 (source: Ratio)
