HARBECK-BERGHEIM HOUSE

FINAL DRAFT NOVEMBER 11, 2022

The report documents the history, significance, integrity and existing condition and provides treatment guidance for the resource. It does not evaluate for listing in the National Register of Historic Places. If the resource has been previously listed or evaluated it is referenced and footnoted.

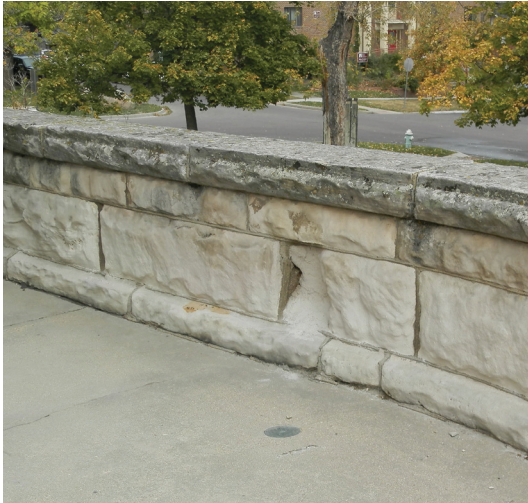
Front Porch: The walls surrounding the porch appear to be made of the same stone as the main building. Overall the stone is in fair shape, with a few areas in poor condition. The primary areas of concern are on the interior faces of the wall on the north side, and around the main entry stair to the north. Significant wear to the stone and mortar is evident and large amounts of both have been weathered away, mostly likely from use of salts and chemical deicers. Graffiti and its removal have caused damage to the stone at both the porch and the main building walls.

Figure 1-10. Stone damage at the interior porch wall, 2020 (source: Ratio)

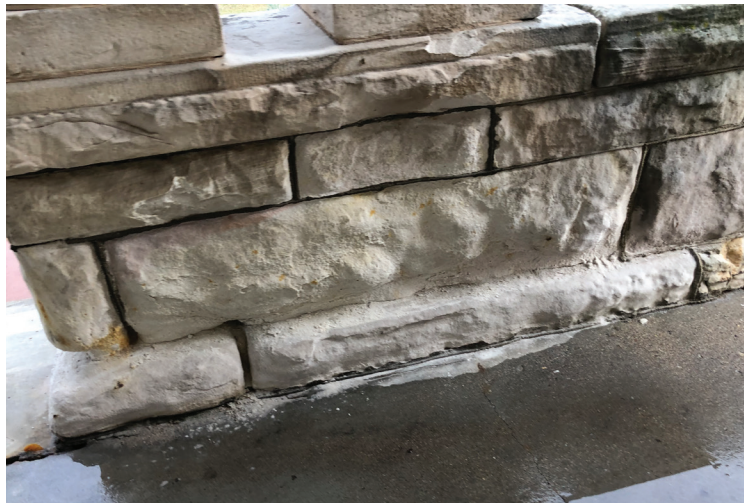
Wrap-around porch walls appear to be a different type of stone, which is in fair condition. Several cap stones are covered with lichens. The entry steps to the porch were noted as Lyons sandstone in previous building evaluations, and appear to be in good condition with some uneven gaps due to ground settling. Four large stone columns support the porch roof and the stone appears to be in good condition. The mortar is in fair to poor condition and in need of repointing.

Figure 1-11. Porch stone walls near the main entry steps, 2020 (source: Ratio)

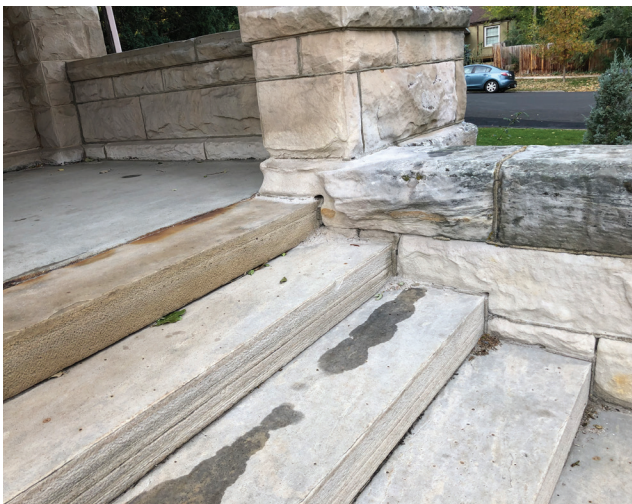
Figure 1-12. Main entry steps, 2020 (source: Ratio)

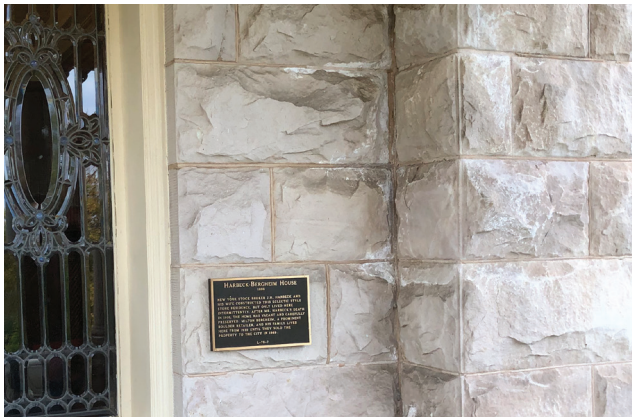
North Facade: In general, the stone masonry on the north side of the building appears to be in good condition. Some visible damage is on the stone just west of the main entry door. One of the headers over the bay windows just east of the main entry has a large crack.

Figure 1-14. Efflorescence west of main entry, 2020 (source: Ratio)

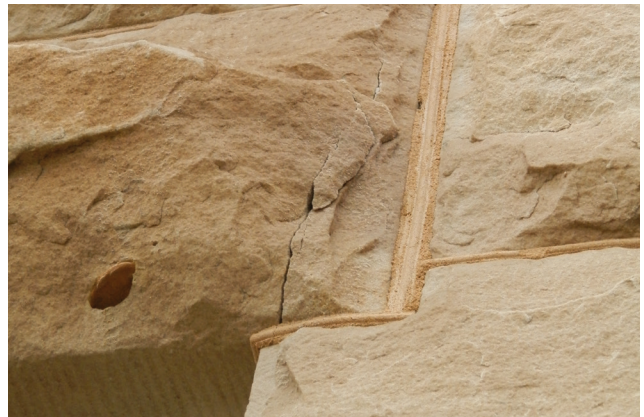
Figure 1-15. Cracked header, 2020 (source: Ratio)

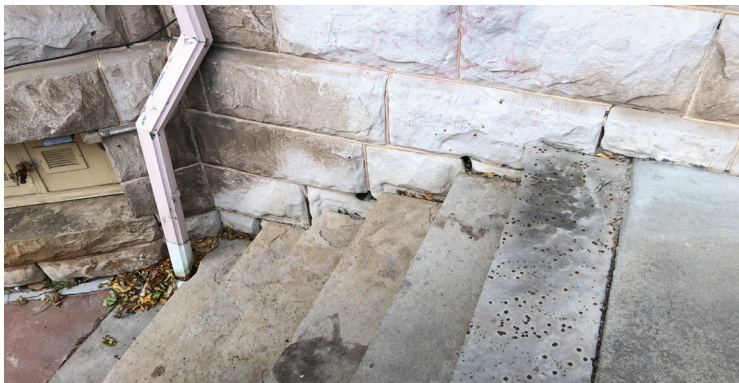
Figure 1-16. Stone damage at stair, 2020 (source: Ratio)

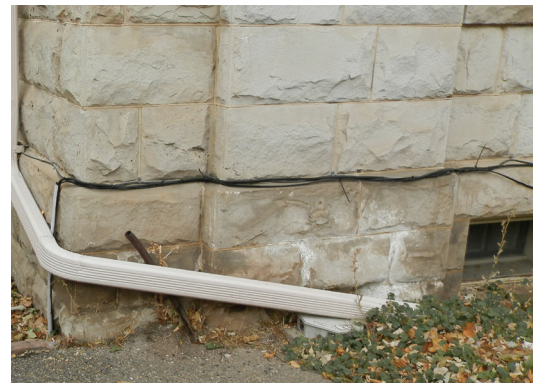
Figure 1-17. Stone damage at gutter, 2020 (source: Ratio)

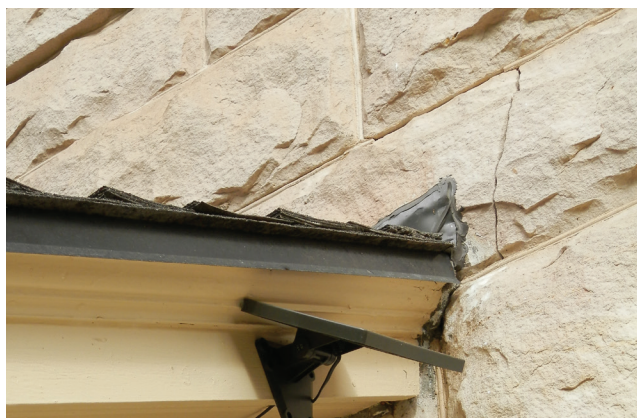
South Facade: The masonry on the south wall is in good condition overall. A cracked stone is above the entry porch addition. The south west building corner has vines growing on the stone, causing potential damage.

Figure 1-18. Cracked stone, 2020 (source: Ratio)

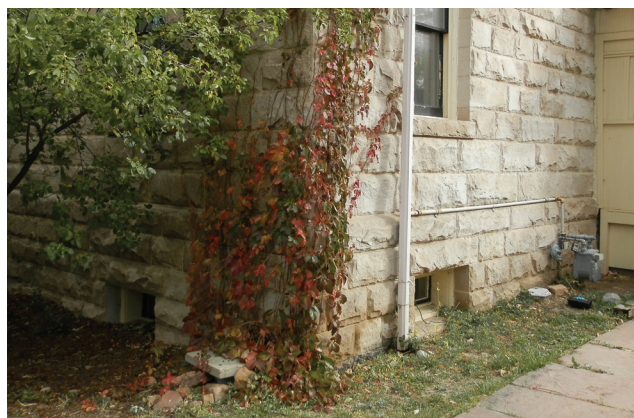
Figure 1-19. Vines on stone masonry, 2020 (source: Ratio)

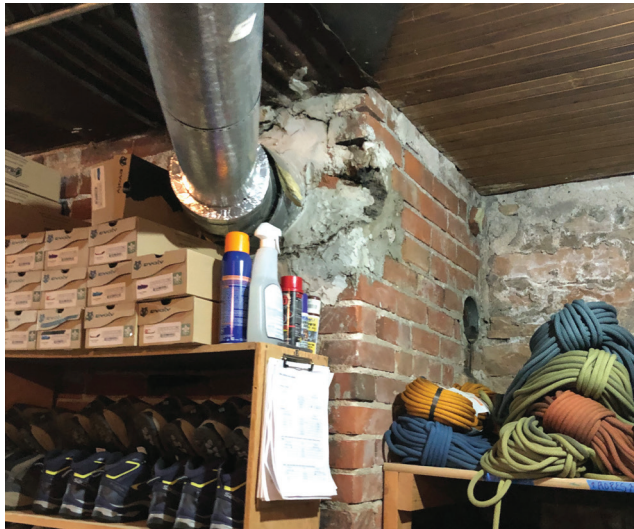
Exposed brick is in the basement and attic. The brick overall appears to be in fair condition. Primary areas of damage are those where ductwork or other penetrations have been made through the brick walls. The resulting openings left holes in the brickwork, and the attempted sealing material between the ducts and the brick has not functioned properly, causing more damage to the surrounding bricks and integrity of the walls in those areas.

Figure 1-24. Basement brick masonry, 2020 (source: Ratio)

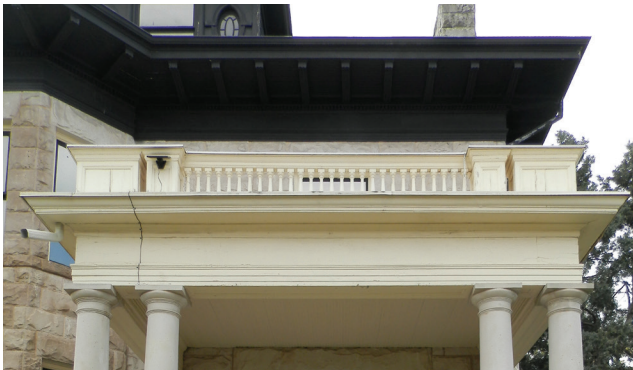
Exterior Porch: As viewed from ground level, the wood porch appears to be in fair condition with evidence of cracking and paint peeling. Below the porch, the wood soffit shows evidence of cracking and warping. During the site visit, a substantial yellowjacket nest was located behind the soffit. The wood railing wraps around the top of the porch and is in poor condition with areas of major splintering, and multiple areas where the bare wood is exposed. An attempt at protecting the top of this wood was made at some point in the past is with the addition of metal caps that cover the tops of the rails. It is unclear what the condition of the wood beneath

Figure 1-28. Porch roof, 2020 (source: Ratio)

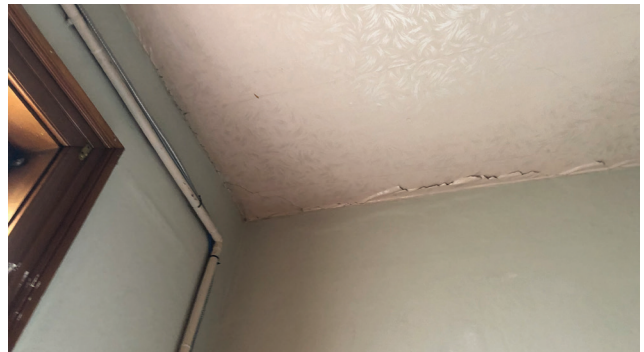
Apart from some detailing on the one of the first-floor ceilings, the interior wall and ceiling finishes are a mix of painted and unpainted wallpaper. Previous attempts to remove the wallpaper were unsuccessful, and the wallpaper was painted over. Most finished surfaces are in good condition. A few areas have peeling wallpaper. A portion of the plaster finish has come off the wall in the second-floor closet.

Figure 1-54. Peeling wallpaper, 2020 (source: Ratio)

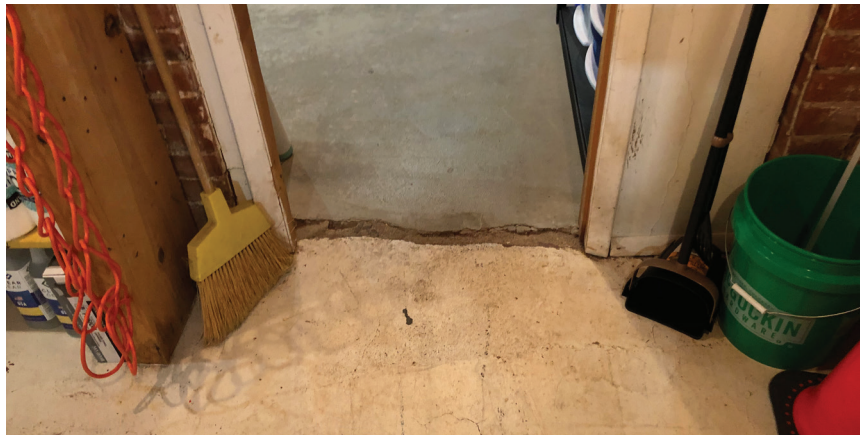
Basement Finishes: The basement kitchen has an acoustical tile ceiling that is in fair condition. Most of the basement flooring is concrete, which appears to be in good condition other than a rough transition between two slabs at one of the doorways. The finished rooms of the basement, other than the kitchen and restroom, have carpeted floors that are in good condition but not original. These same rooms have doors that are not original to the building and appear to be hollow core construction. Exterior windows in the basement appear to be in fair to poor condition with a few locations that have missing or broken hardware. Some windows have been nailed shut.

Figure 1-61. Concrete floor transition, 2020 (source: Ratio)

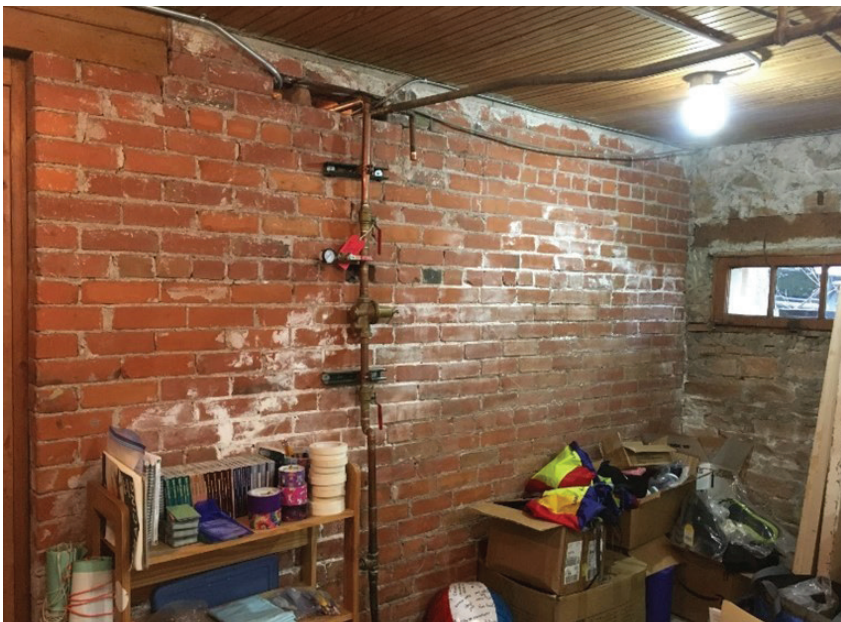
Overall, the foundation is in good condition. Efflorescence was evident at the interior faces of the basement walls that is evidence of past water infiltration (Figure 1-59). An exterior building condition evaluation was prepared by CSC in February 1991. Many of the eroded mortar joints and water infiltration issues identified in the report appear to have been addressed since the report was issued. The basement slab slopes near the southeast corner of the building, however this was likely intentional to allow the slab to drain and is not indicative of structural settlement.

Figure 1-64. Efflorescence on basement walls, 2020
(source: JVA)

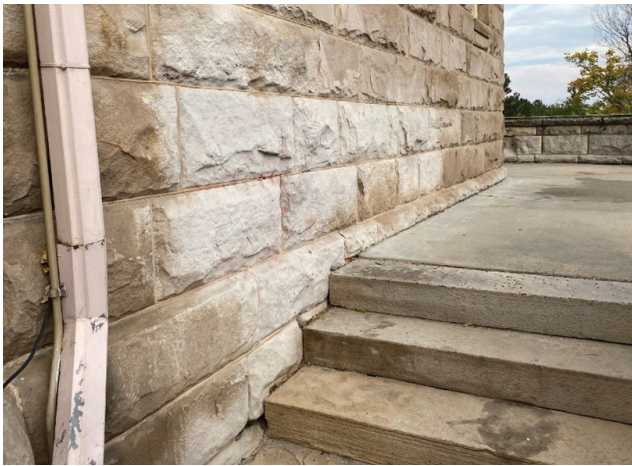
The exterior stone of the house is in overall good condition with the exception of typical weather-related deterioration (erosion) of the sandstone units in Boulder's freeze-thaw climate. The deterioration is more pronounced at the walls near grade at the porch and entry stair (Figure 1-61 and 1-64). There are isolated cracks including thermal movement related cracking of mortar joints at the porch and cracked ashlar units near the front entry door jamb (Figure 1-63). Many of the eroded mortar joints and water infiltration issues identified in the 1991 report appear to have been addressed since the report was issued. Lichen growth is present on the coping stones of the porch however it does not appear to be causing material damage of structural concern to the ashlar units.

Figure 1-65. Erosion of stone at locations of graffiti removal, 2020 (source: JVA)

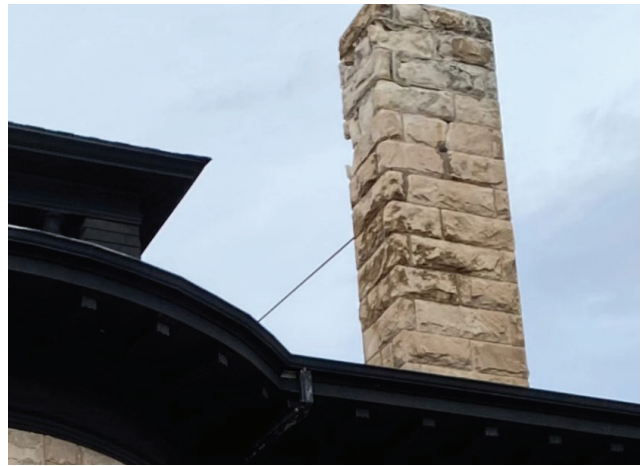
Chimneys: The stonework on the chimneys appears to be in fair to poor condition. Many stones are very worn and weathered with portions of the stones missing, and significant mortar missing. Of the three chimneys, one, in the north east corner, appears to be in the worst condition.

The site includes three stone chimneys, two on the east and one the west side of the house. The porch railing and stair are constructed of a stone similar to that used for the building. The weather-related erosion of stone units and mortar joints in the chimneys has progressed to the point that the stones above the eroded units may become unstable and fall from the chimney (Figure 1-62).

Figure 1-66. Deteriorated and loose stone at chimney

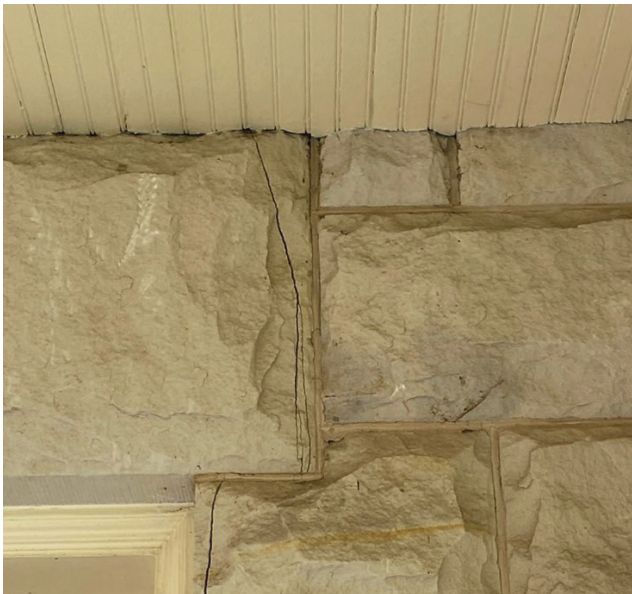
Figure 1-67. Thermal related cracking at door jamb, 2020 (source: JVA)

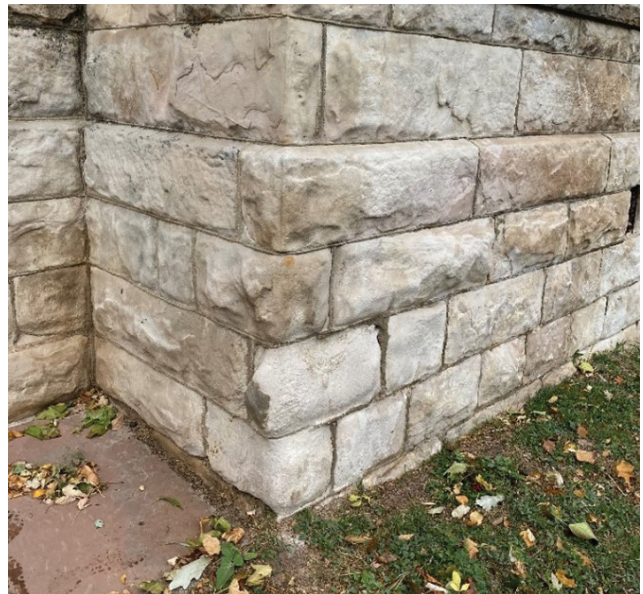
Figure 1-68. Erosion of stone near grade and lichen growth at coping, 2020 (source: JVA)

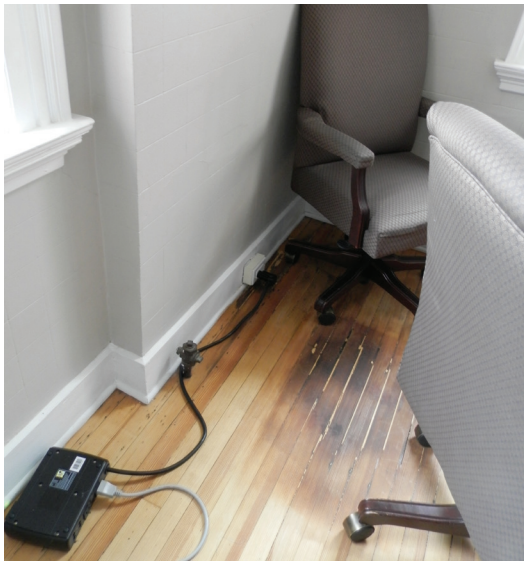
Wood Flooring: Wood flooring throughout the building appears to be in fair condition. A few larger areas of concern showing burn marks or water damage, however most flooring has general wear and scratching. In the attic, wood flooring appears to be in worse condition than the rest of the building with gapping between boards, and noticeable scratching. The flooring does not appear to have the same quality or finish as the rest of the building.

Figure 1-76. Wood floor damage, 2020 (source: Ratio)
