RONNEY FARMHOUSE

FINAL DRAFT NOVEMBER 11, 2022

EXISTING CONDITION

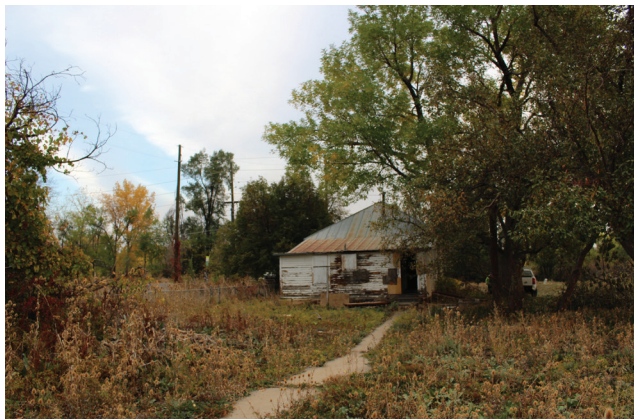
Roney Farmhouse circulation includes deteriorated concrete sidewalks at the front and rear entrances that access the building. Neither are ADA-compliant. The basement is accessed from concrete stairs on the exterior. The abutment walls of its stair are stone.

Figure 1-3. Concrete sidewalk, 2020 (source: Mundus Bishop)

- Consider providing paved parking and an ADA accessible parking space near the front entrance.
- Install a ramp at front or rear entrance to provide for ADA access.
- Remove and replace damaged concrete sidewalks. Provide an accessible path from the parking area to the ramp and entrances.

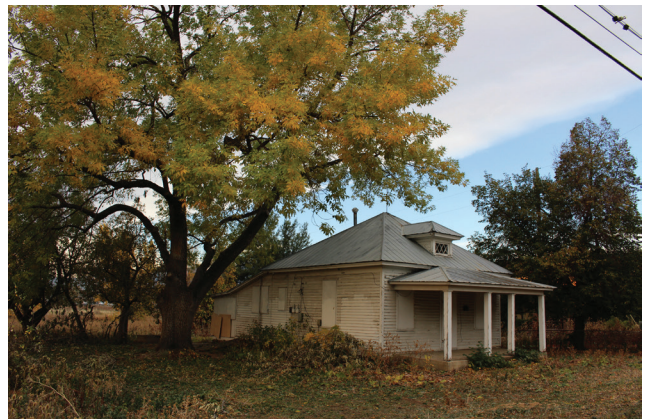
Plantings include deciduous trees on the east and south sides of Roney Farmhouse. One tree could potentially be a Heritage Tree based on its age and association with the Roney farmstead.

Figure 1-4. Potential Heritage Tree, 2020 (source: Mundus Bishop)

- Routinely trim back all vegetation growth within close proximity of the structure.
- Remove debris and broken materials on the exterior including around the site.
- Remove overgrowth of vegetation.
- Maintain potential Heritage Tree at east. Prune to protect roof.
- Provide additional support for soil retainage at the crawlspace access stair.
- Identify Location of original vegetation, shrubs and bushes, plan for rehabilitation into site (at east and south)

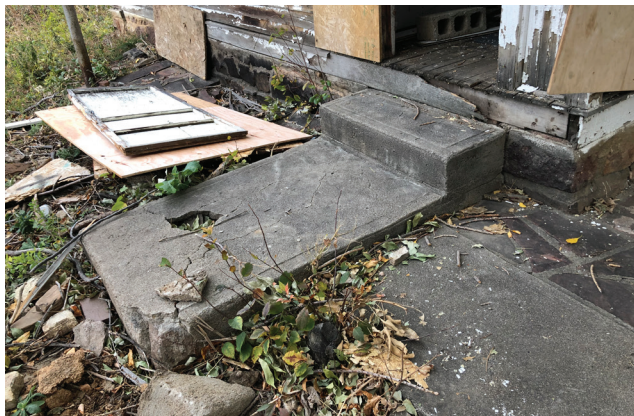
In the rear of the building, a step and short sidewalk extends out from the back door. The step is in good condition, but the sidewalk has a large hole, a corner missing, and is in poor condition.

Figure 1-6. Damaged concrete sidewalk, 2020 (source: Ratio)

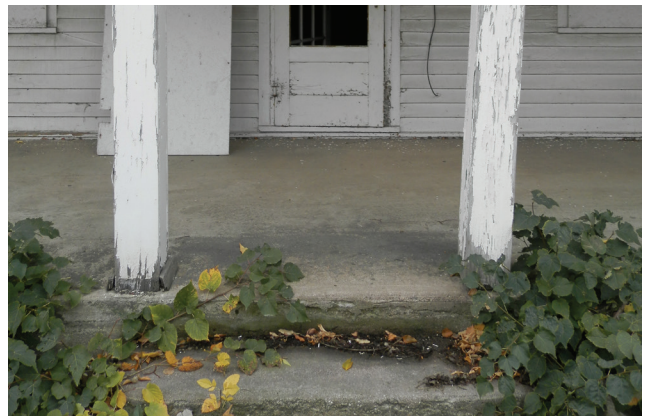
Porch Slabs: The concrete slab of the porch appears to be in good condition. Some damage to the edge of the slab, and the step below, however it seems minimal and primarily with aesthetic.

Figure 1-7. North porch and step, 2020 (source: Ratio)

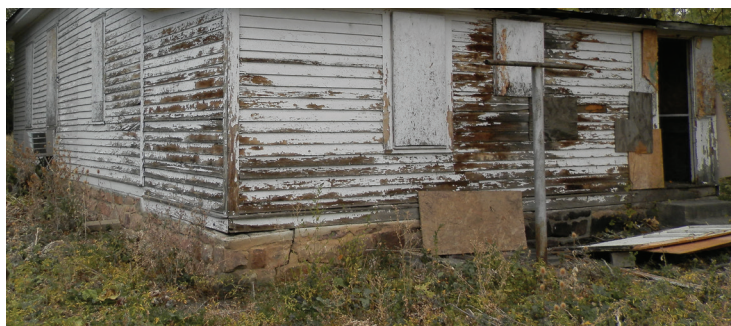
Building foundations and basement walls: Overall, the building foundations are in fair condition. A few areas on the south end require major repairs. The basement walls don't show any major cracks or damage, but the top of the stair wall has a notable crack that extends down half the length of the wall.

Figure 1-8. Cracks at building foundation, 2020 (source: Ratio)

- Foundations - After remediating the roof drainage in the southwest corner of the structure per architectural recommendations, reconstruct the stone masonry foundation in this corner on top of a concrete footing and stem wall set at frost depth; replace missing foundation stones and mortar in place; reconstruct top of displaced cheek wall at exterior entry to the basement; remove vegetation in close proximity to building.

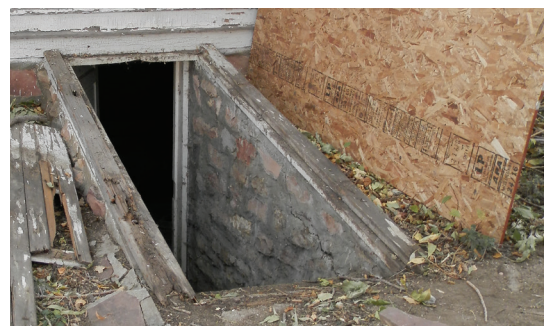
Figure 1-9. Cracks at basement stair, 2020 (source: Ratio)

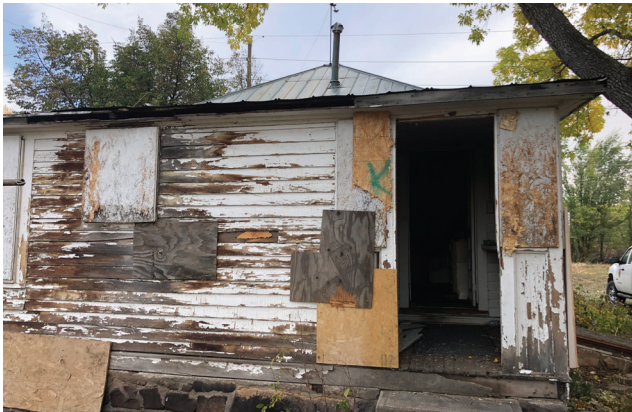
Siding: The existing wood siding varies in condition. On the south end of the building, the wood siding is in poor condition, with a large amount of the paint missing, the boards are worn and weather damaged, and areas are covered with plywood, with greater damage presumed below the plywood panels. The portions of siding contained within the enclosed porch area are in good condition. The remaining exterior siding walls are in poor to fair condition with paint missing and notable wear, but no large areas of concern.

Figure 1-10. South wall siding, 2020 (source: Ratio)

- Walls - When removing deteriorated siding boards on the south elevation, expose rear wall framing to confirm it is not deteriorated. Remove and replace any deteriorated studs and sheathing prior to reinstalling siding; at previously removed original south wall, verify or provide an adequate header below the attic cripple wall.

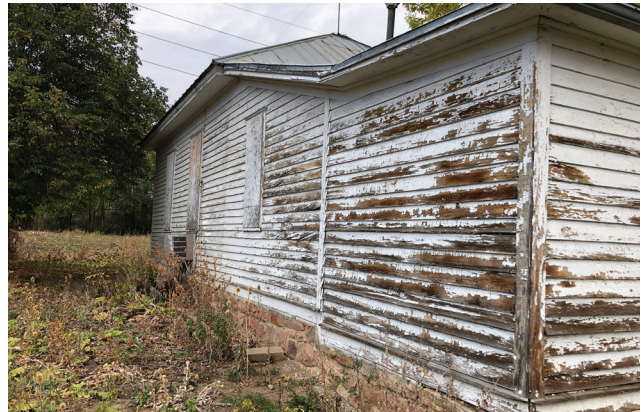
Figure 1-11. West wall siding, 2020 (source: Ratio)

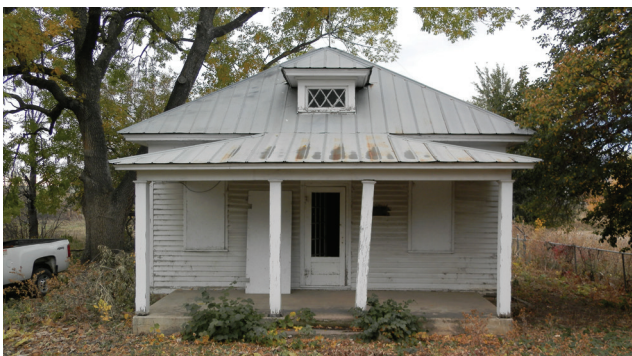
Figure 1-12. North wall siding, 2020 (source: Ratio)

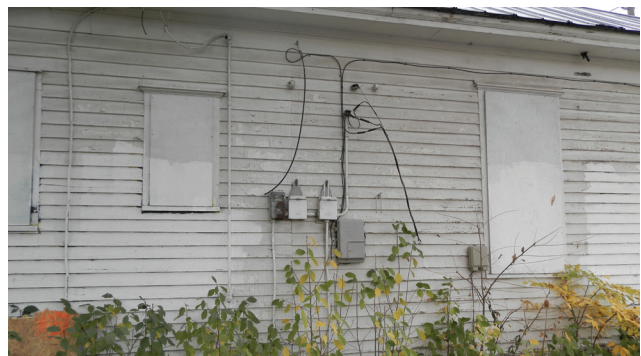
Figure 1-13. East wall siding, 2020 (source: Ratio)

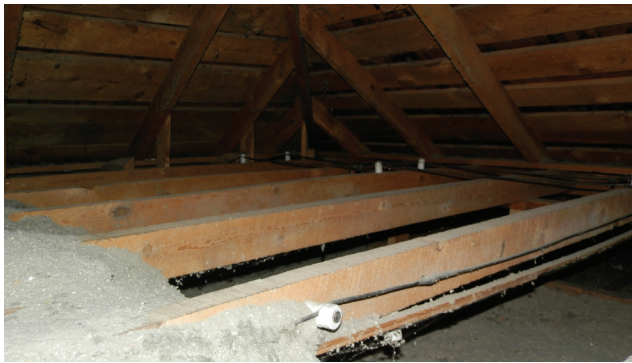
Framing: From what could be seen in both the attic and the basement, the wood framing is in good condition.

Figure 1-14. Roof framing, 2020 (source: Ratio)

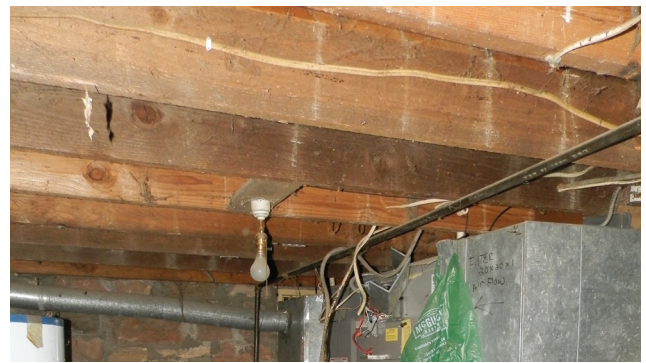
Figure 1-15. Main floor framing from basement, 2020 (source: Ratio)

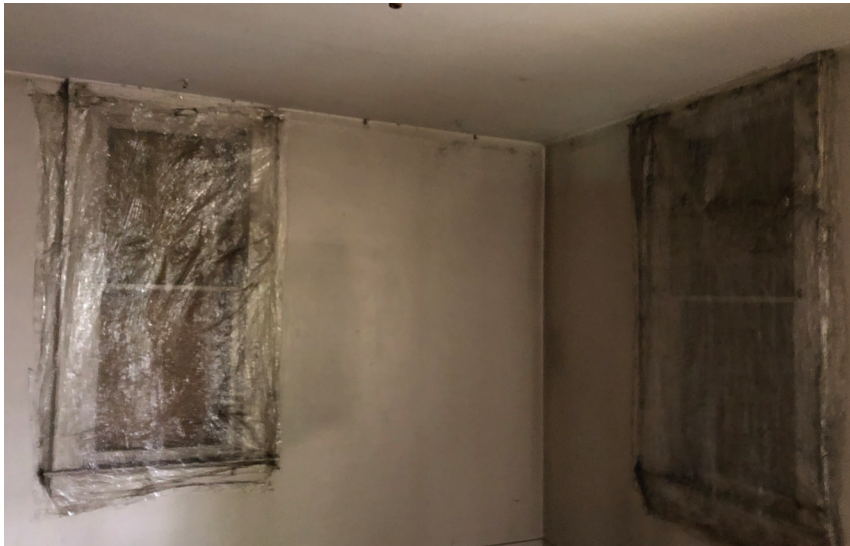
Windows: All window exteriors were boarded up at the time of the site visit, and therefore unable to be verified. The interiors of the wood windows are more visible but covered with a transparent material. From what was observed, the wood windows appear to be in fair condition. Due to the state of the windows, functionality was unable to be tested.

Figure 1-16. Window interiors, 2020 (source: Ratio)

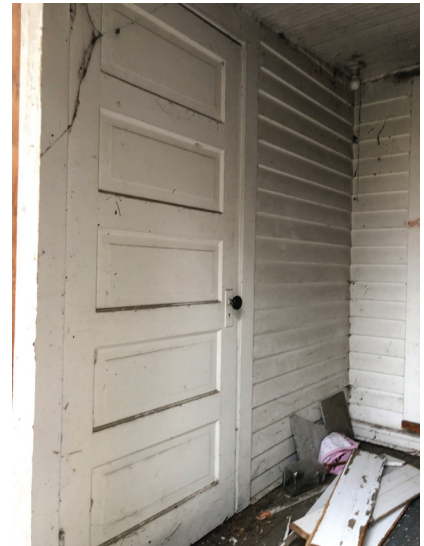
Doors: A majority of the wood doors appear to be original to the farmhouse. The existing doors appear to be in fair condition overall, though many have been vandalized since the building was abandoned.

Figure 1-17. Wood doors, 2020 (source: Ratio)

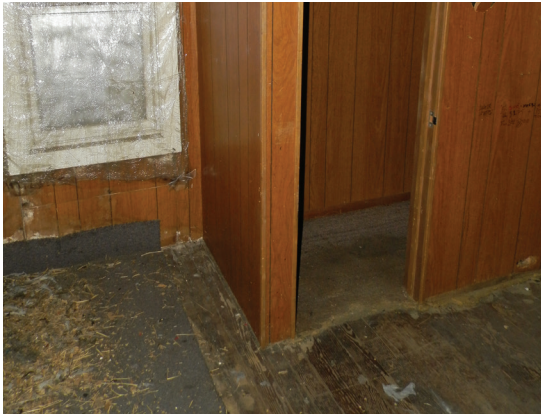
Flooring: The majority of the farmhouse has wood floors, which are overall in fair condition. Some rooms have substantial graffiti damage. The wood flooring in south room addition is in very poor condition.

Wall Paneling: Wood wall paneling is the material of the closet walls of the south room. The wall is in poor condition and has a large hole and a variety of other scratches and scuffs.

Figure 1-18. Wood wall paneling and wood flooring, 2020 (source: Ratio)

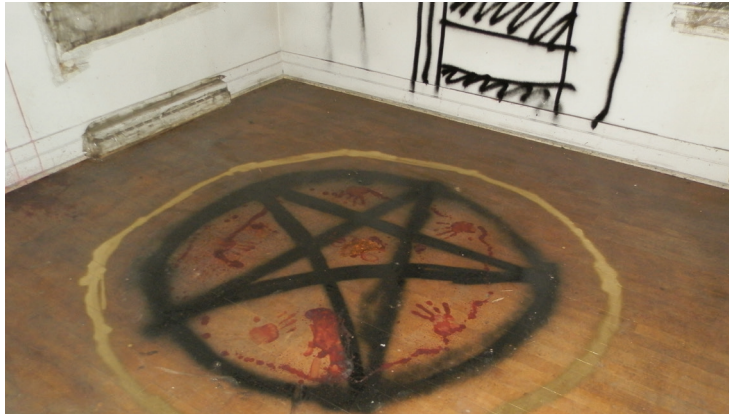
Figure 1-19. Vandalism on wood flooring, 2020 (source: Ratio)

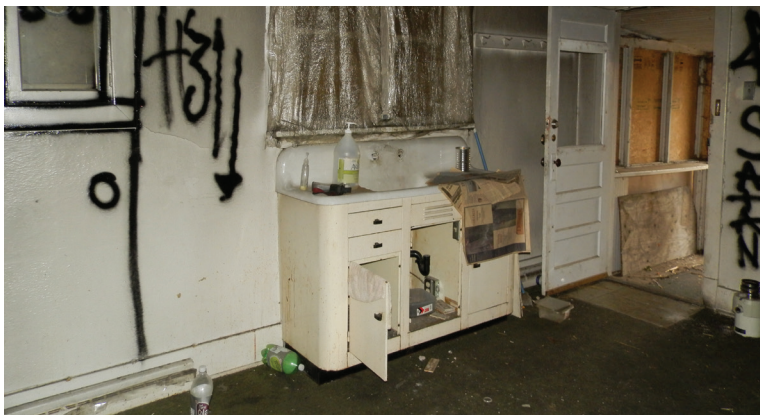
The restroom and kitchen plumbing elements are all in poor condition. As the building is not in use, the functionality was unable to be verified. The restroom fixtures and finishes have been vandalized and show significant damage.

Figure 1-20. Kitchen sink, 2020 (source: Ratio)

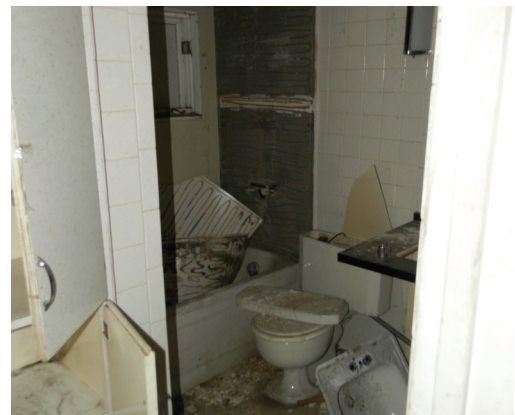
Figure 1-21. Restroom basement, 2020 (source: Ratio)

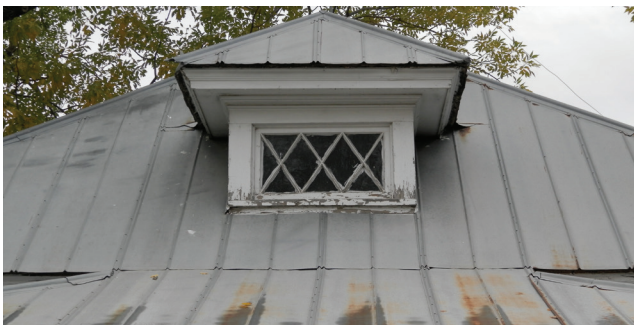
The metal roofing panels appear to be in poor condition. The panels do not show major holes or cracks, but have a large amount of rust. The roof flashing and sealant appears to be minimal or missing. The water tightness of the roof was unable to be verified at the time of the site visit.

Figure 1-22. Roofing, 2020 (source: Ratio)

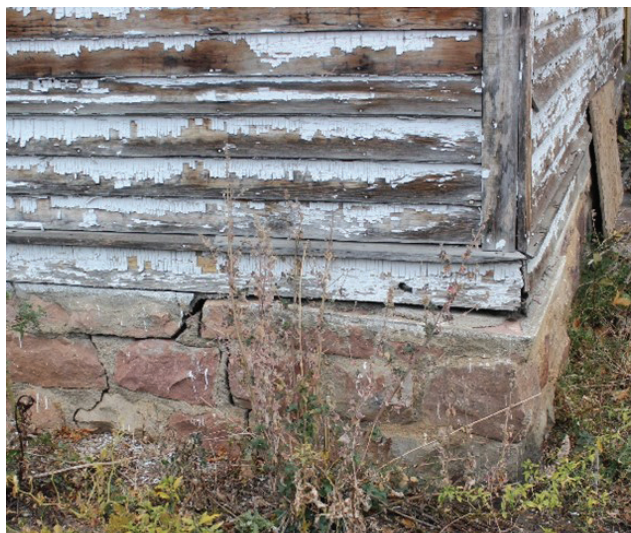
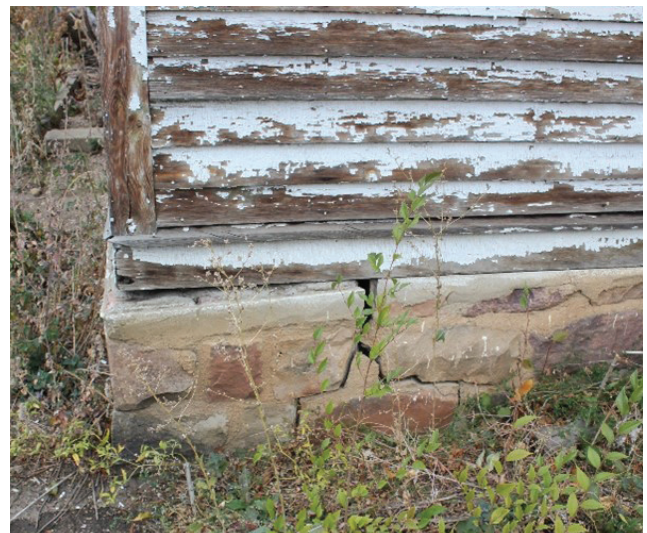
The southwest corner of the building has settled; it is sinking and has cracked and rotated away from the building. At this location, a gutter with no downspout focuses water at this corner, which has likely exacerbated the settlement of the soil in this area due to increased wetting and drying cycles and soil erosion. There are other minor cracks in the foundation caused by thermal expansion, which are not of structural concern. A stone has been removed from the rear foundation wall, compromising its integrity. The basement walls all appear in good condition, however the north retaining wall at the access stair has a large diagonal crack near grade and a vertical crack the length off the wall next to the door opening. The unreinforced stone masonry walls are likely inadequate to retain the soil beyond, causing these cracks. There is also quite a bit of vegetation in close proximity to the structure around the perimeter that can harm the foundation over time.

Figure 1-23. Southwest corner foundation settlement, 2020 (source: JVA)

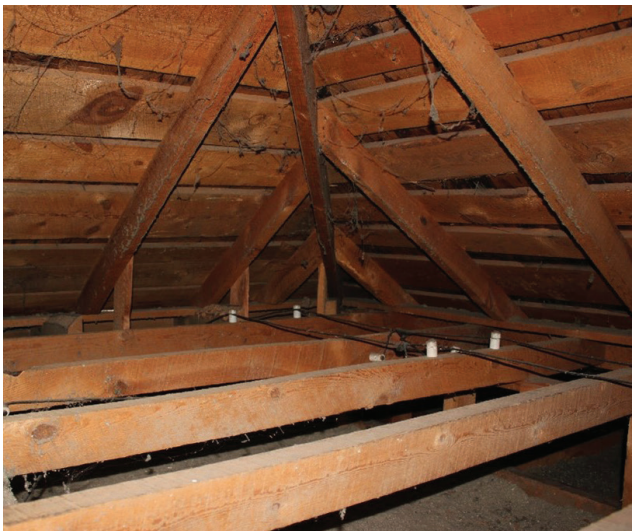
There is no sagging or deflection to indicate structural problems with the roof; however, the second addition roof does not meet current Code requirements. Several of the ends of the roof rafters of the second, southernmost addition have rotted, which are exposed to the elements at the rear of the building where the fascia board is missing. The metal roof has a significant amount of rust, especially on the lower sloped addition and porch roofs. As this worsens, openings can form, allowing moisture to enter the roof and damage the framing.

Figure 1-24. Original house roof framing, 2020 (source: JVA)

- Roof Framing - Reinforce the roof of the second addition by sistering the existing rafters with 5 ½" LVL members; remove deteriorated material from the rafter ends and sister new members eave ends onto the remaining existing rafters. Replace the missing fascia board per architectural recommendations to prevent further damage; while rusted roof is being remediated per architectural recommendations, inspect roof framing for any deteriorated members. Remove deteriorated sheathing or members and replace or sister in kind.
