# PLATT FARMHOUSE

FINAL DRAFT NOVEMBER 11, 2022

| Existing Condition ..... | 6-13 |

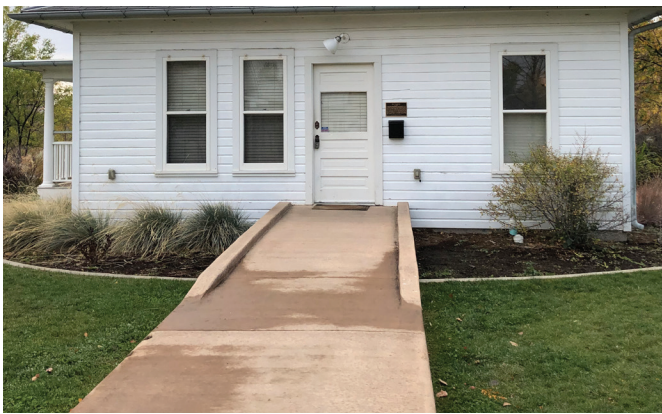
**Sidewalk:** In the current building location, the main entrance is accessed from an accessible concrete ramp. The ramp was added when the building was relocated and rehabilitated and is in good condition. The building entry facing the south irrigation ditch has a concrete pad at the bottom of the stairs that is in good condition.

Figure 1-4. Concrete sidewalk at the accessible entrance, 2020 (source: Ratio)

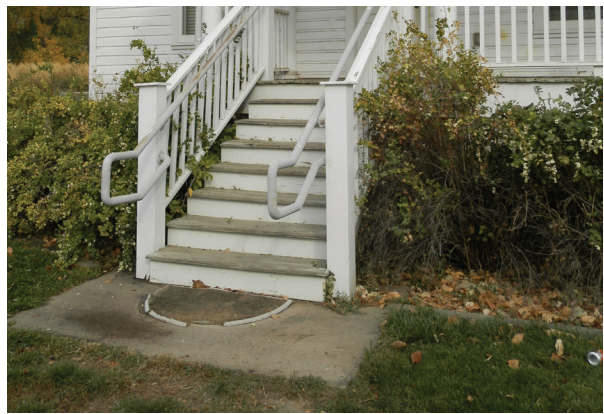
Figure 1-5. Concrete slab at the base of the stairs, 2020 (source: Ratio)

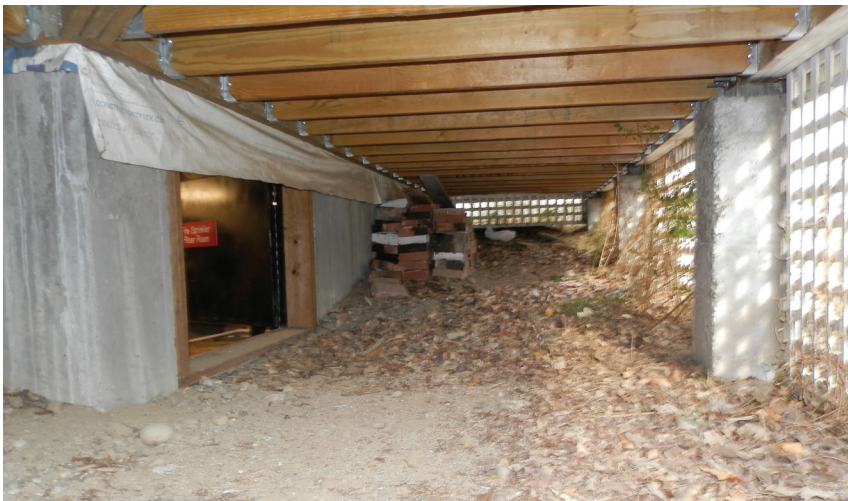
**Building Foundations:** The building and porch appear to have been set on new concrete foundations as part of the relocation and rehabilitation. The concrete appears to be in good condition.

Figure 1-6. Porch and building foundations, 2020 (source: Ratio)

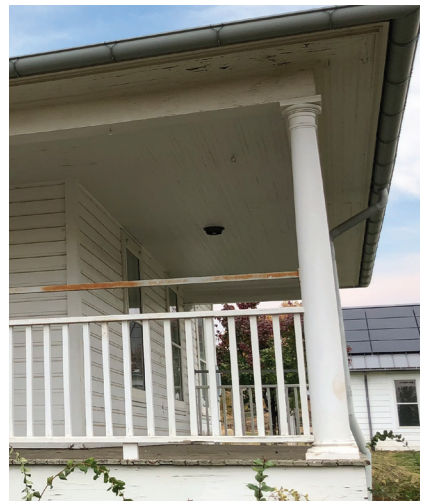
Figure 1-7. Porch columns, 2020 (source: Ratio)

**Porch Columns:** The original wood porch columns were removed during the relocation, and were replaced with new wood columns. It is unclear how closely the new columns match original construction. The columns are in fair condition overall. The paint is peeling slightly at the base of the columns. The wood railing in between the columns appears to be original construction. The rails and posts are in fair condition. The bottoms of the posts are showing signs of cracking and peeling paint. Areas on both the top and bottom rails have peeling paint. To comply with the current code height requirements for guardrails, a metal rail has been added above the wood railings. The metal rail appears to be in fair condition, maintaining its structural integrity but showing large areas of rust.

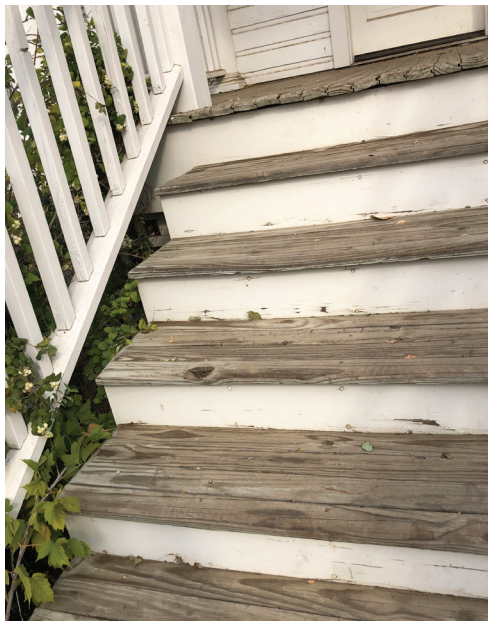
**Porch Flooring:** The wood floor of the porch and the entry stairs are in poor to fair condition. The tongue and groove boards are intact and functional, but are unfinished and showing considerable wear, weathering, and warping.

*Figure 1-8. Wood porch stair, 2020 (source: Ratio)*

- Replace porch and exterior stair wood flooring in its entirety.
- Review original design/plans for the moving, renovation and restoration to determine if there are any outstanding phases of work that weren't completed during the original renovation and restoration project.

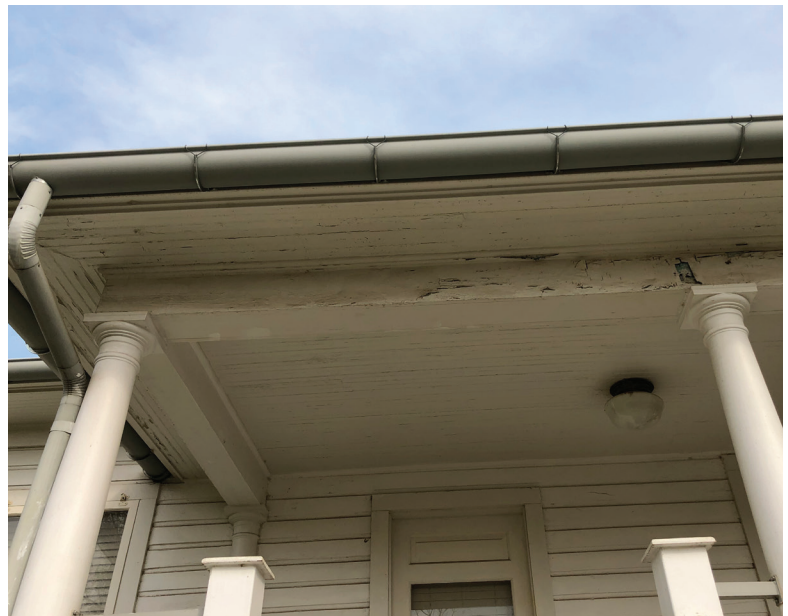
**Porch Framing:** The porch floor framing appears to be in good condition. The porch roof framing and soffit finish are in fair to poor condition. There is considerable wear, weathering, and cracking and peeling paint on both the support beams and the wood soffit material.

*Figure 1-9. Wood porch framing roof supports, 2020 (source: Ratio)*

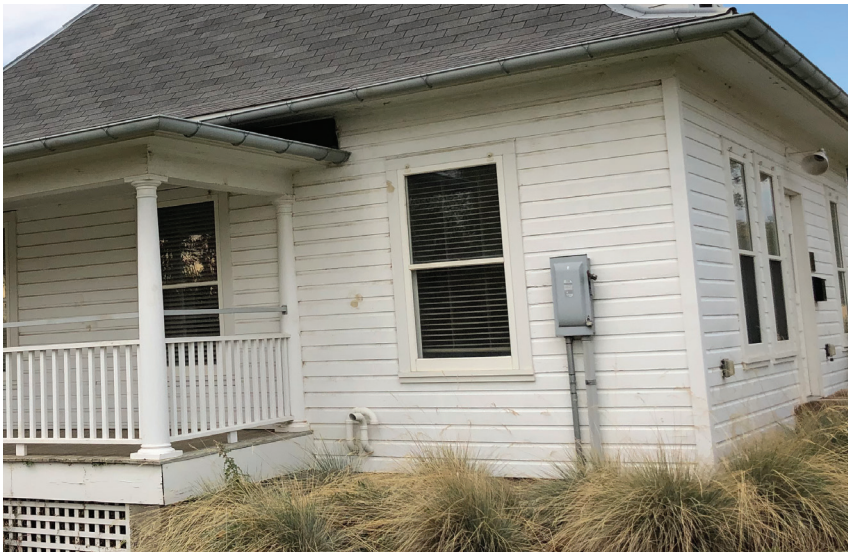
Exterior Siding: In general, the wood siding is in fair condition. Some discoloration is on the siding near the south door that is of an undetermined origin. A few small areas where the siding is damaged, or the paint is missing, occur around the building, and most horizontal joints contain noticeable amounts of dirt.

Figure 1-10. Wood siding, 2020 (source: Ratio)

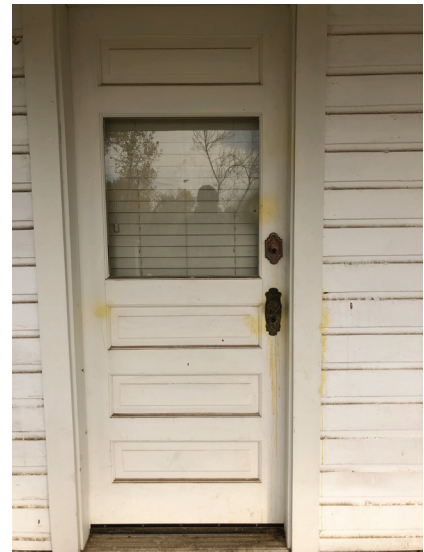
Figure 1-11. South door, 2020 (source: Ratio)

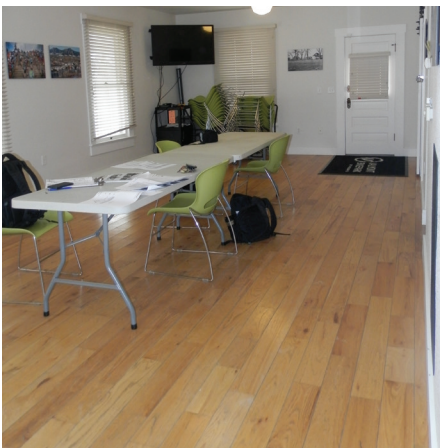
Wood Flooring: Both levels of the interior have wood plank flooring, that appears in good condition. The interior stairs have a wood finish. The stairs appear to be in good condition. The boards that make the nosings of the stairs do not appear to match the wood type of the rest of the stairs, a few nosing boards are loose.

Figure 1-12. Hardwood flooring on the first floor, 2020 (source: Ratio)

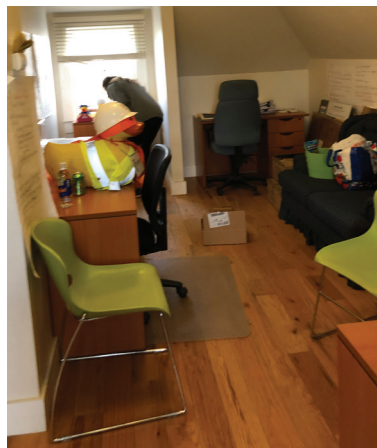
Figure 1-13. Hardwood flooring on the second floor, 2020 (source: Ratio)

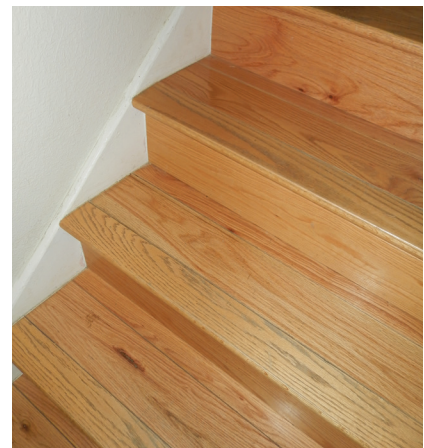
Figure 1-14. Wood treads and nosings, 2020 (source: Ratio)

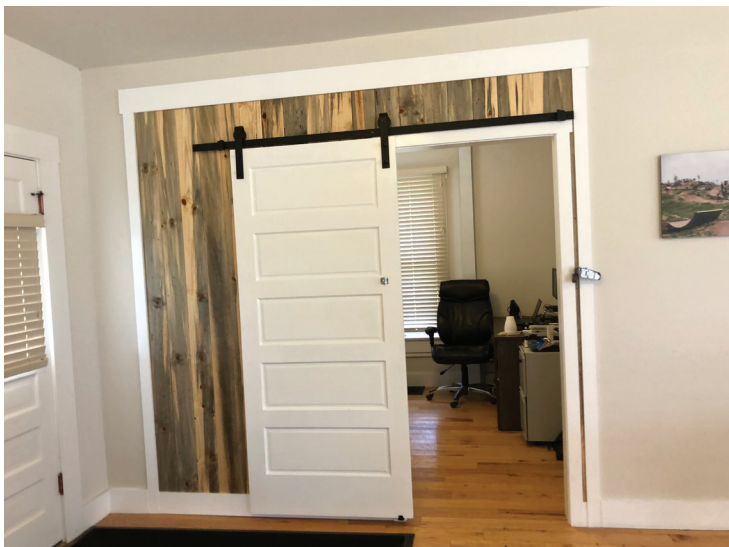
**Windows and Doors:** The windows and doors appear to be in good condition with no obvious signs of wear or damage. Based on the City-provided building drawings of rehabilitation it appears the windows and doors are a mix of both original and replacements. Replacement windows and doors appear to match the design and materials of the original components. Recent work includes the addition of a sliding barn door and wood finish at the first floor office.

*Figure 1-15. Sliding barn door and infill wall, 2020 (source: Ratio)*

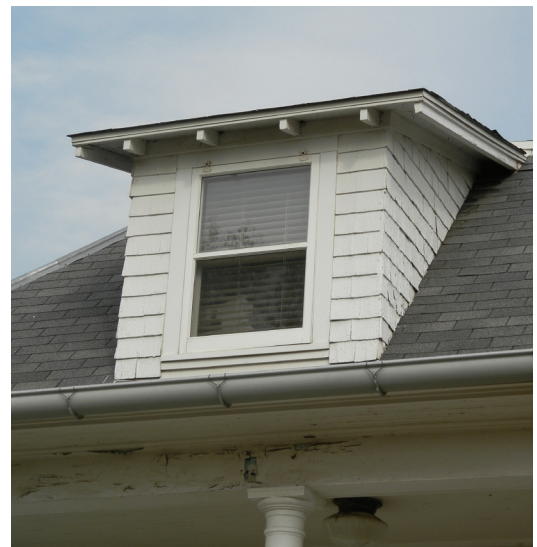
**Shingles:** The main portion of the roof is finished with asphalt shingles, which appear to be in good condition. The upper dormers have an exterior wall finish of painted wood shingles. From ground level observation the shingles appear to be in fair condition.

*Figure 1-16. Wood shingle dormers, 2020 (source: Ratio)*

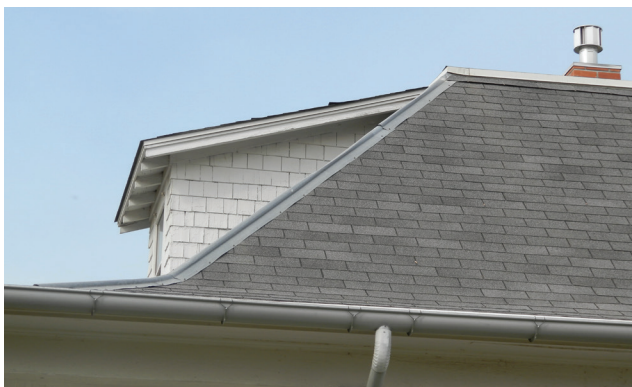
*Figure 1-17. Asphalt shingle roof, 2020 (source: Ratio)*

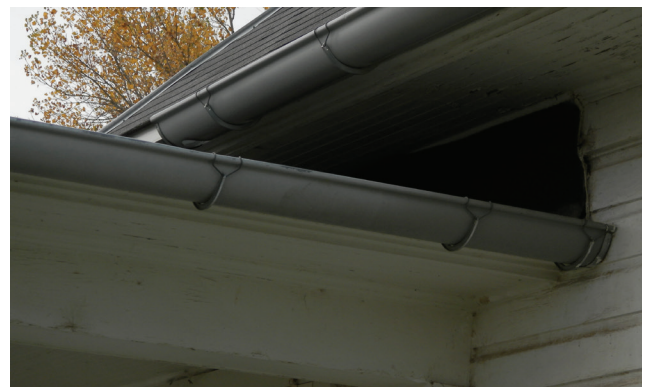
**Gutters:** The gutters and downspouts appear to have been replaced during rehabilitation. The gutter profile is a half-round style, which replicates the gutter shapes in use when the Farmhouse was originally built. Both gutters and downspouts appear to be in good condition.

*Figure 1-18. Half-round gutters, 2020 (source: Ratio)*

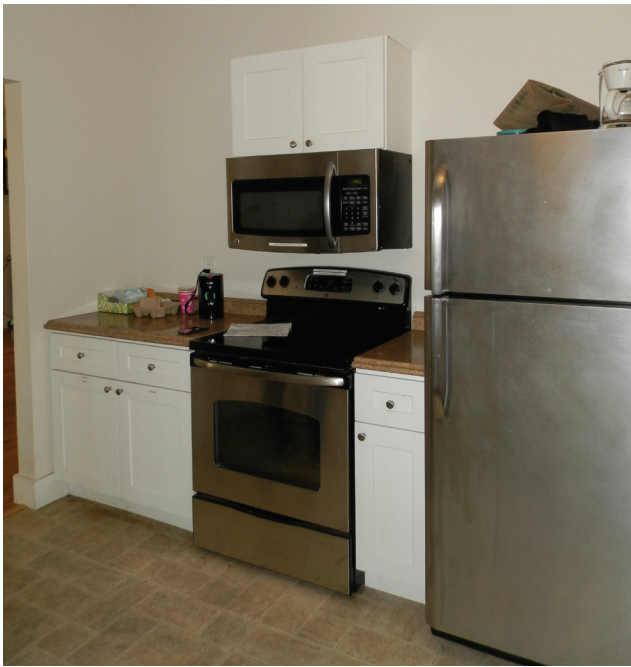
**Tile Floors:** Both the kitchen and the restroom have tile floor finishes, and the restroom has tile wainscot on the wall. The tile work appears to be in good condition.

*Figure 1-19. Kitchen area with tile floor, 2020  
(source: Ratio)*

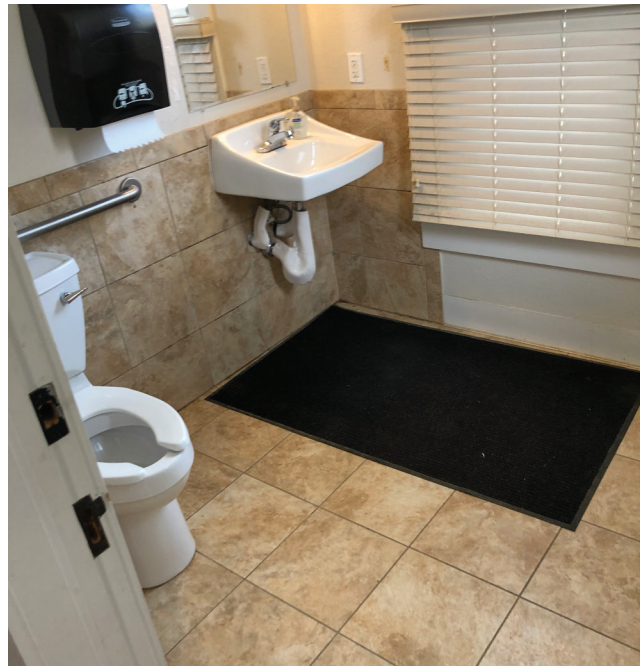
*Figure 1-20. Restroom tile finishes, 2020  
(source: Ratio)*

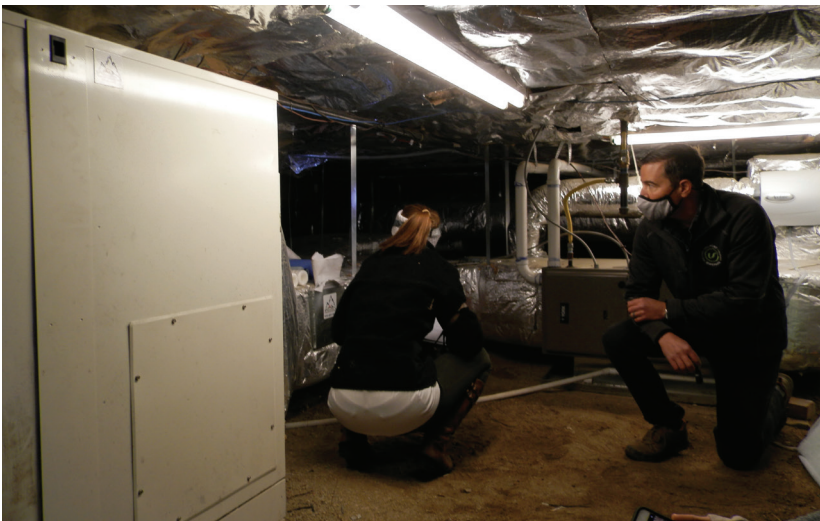
**Mechanical:** The swamp cooler and furnace for the building appear to be in working condition. They are located in the crawl space below the building, that is accessed behind the slatted wood screens below the porch.

*Figure 1-21. Swamp cooler and furnace in the crawl space, 2020  
(source: Ratio)*

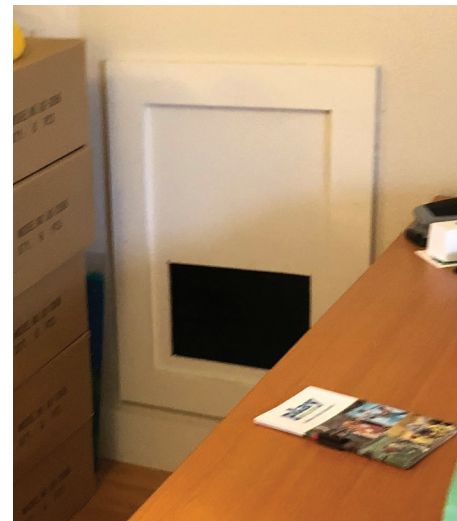
**Attic:** On the upper level there are two wall panels that appear to be the access for the attic space below the eaves of the roof. In both access panels there is a hole cut into them. It is unclear the intent of the holes or if there is an infill panel or grille missing from these locations.

*Figure 1-22. Attic access panel, 2020  
(source: Ratio)*

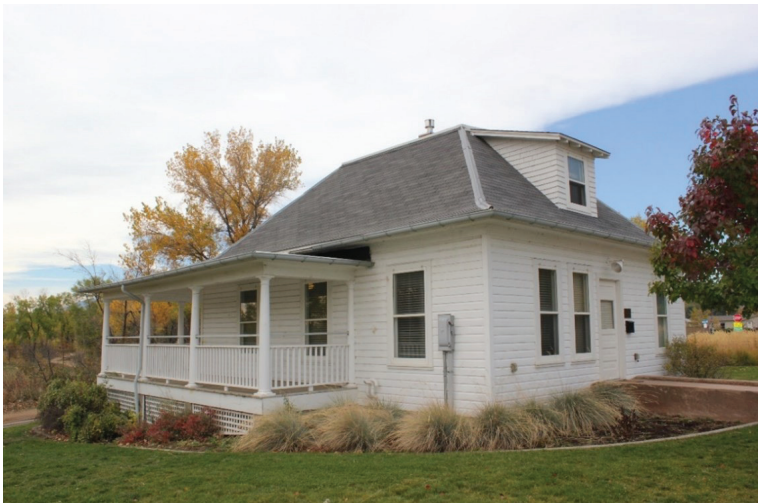
The structure has new concrete foundation stem walls and concrete footings at frost depth. The foundation is in good condition; it is new and is performing as expected. It appears that the new concrete piers at the porch were coated in a finish coat to look like the original piers which had a honeycombed surface.

Figure 1-25. Porch piers wrapped in coating, 2020 (source: JVA)
