HARBECK-BERGHEIM HOUSE

MAY 2023

The report documents the history, significance, integrity and existing condition and provides treatment guidance for the resource. It does not evaluate for listing in the National Register of Historic Places. If the resource has been previously listed or evaluated it is referenced and footnoted.

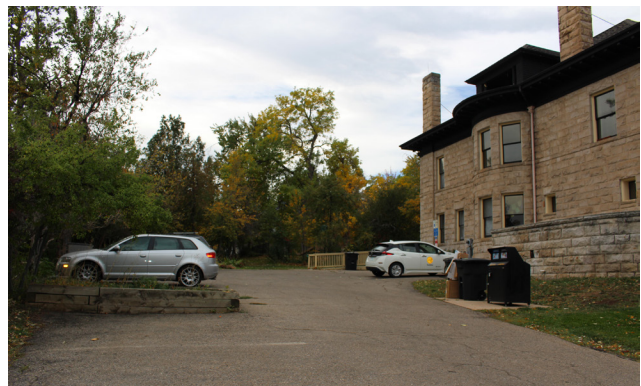
A paved driveway connects the east side of the building with Euclid Avenue and includes a parking area. The driveway alignment is original, but the parking and asphalt paving are contemporary additions. The asphalt paving is crumbling and in poor condition. The parking includes an ADA-compliant parking space and wood ramp (installed in 1991 to provide access to the back entry of the building). The ramp is not ADA-compliant.

Figure 1-4. Driveway and parking, 2020 (source: Mundus Bishop)

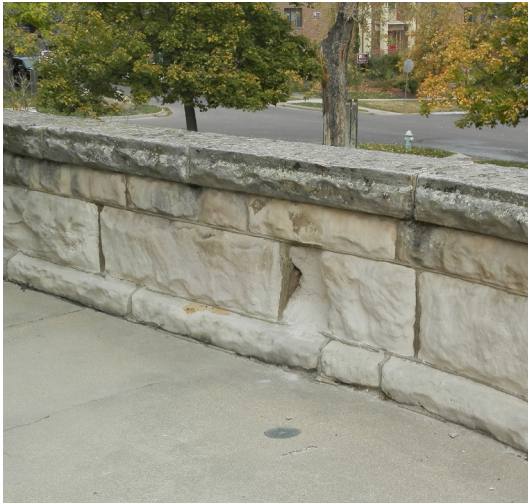
Front Porch: The walls surrounding the porch appear to be made of the same stone as the main building. Overall the stone is in fair shape with a few areas in poor condition. The primary areas of concern are on the interior faces of the wall on the north side, and around the main entry stair to the north. Significant wear to the stone and mortar is evident and large amounts of both weathered away, likely from use of salts and chemical deicers. Graffiti and its removal have damaged the stone at the walls at both the wrap-around porch and main building.

Figure 1-10. Stone damage at the interior porch wall, 2020 (source: Ratio)

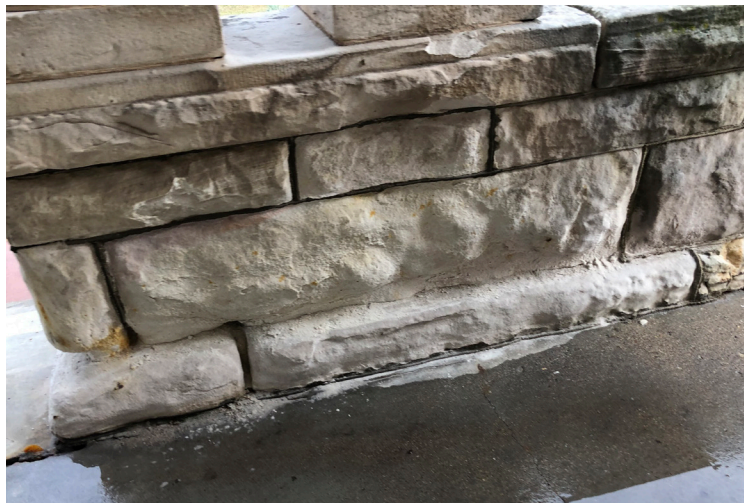
Walls appear to be a different type of stone at the wrap-around porch. This stone is in fair condition. Several capstones are covered with lichen. The entry steps to the porch were noted as Lyons sandstone in previous building evaluations, and appear to be in good condition with some uneven gaps due to ground settling. Four large stone columns support the porch roof and the stone appears to be in good condition. The mortar is in fair to poor condition and in need of repointing.

Figure 1-11. Porch stone walls near the main entry steps, 2020 (source: Ratio)

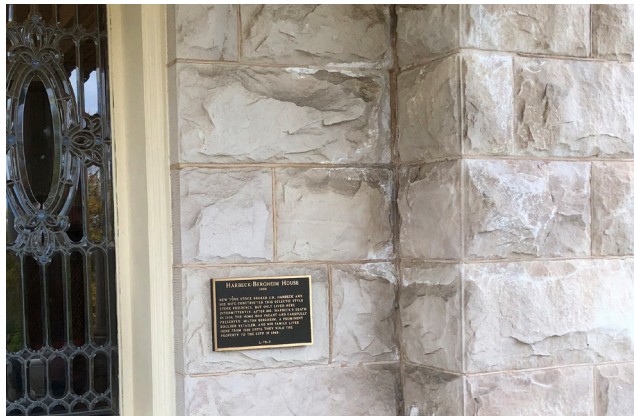
North Facade: In general, the stone masonry on the north side of the building is in good condition. Some visible damage is on the stone just west of the main entry door. One of the headers over the bay windows just east of the main entry has a large crack.

Figure 1-14. Efflorescence west of main entry, 2020 (source: Ratio)

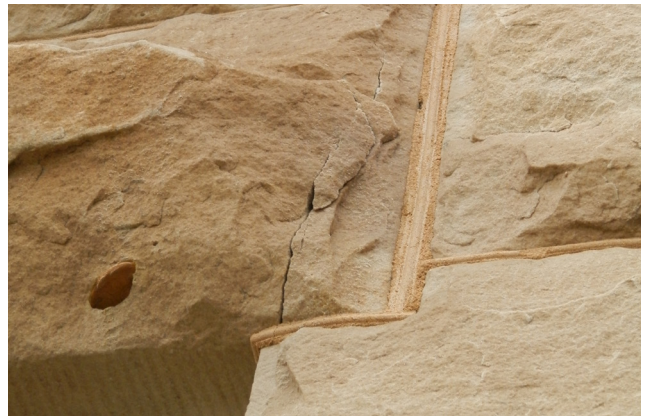
Figure 1-15. Cracked header, 2020 (source: Ratio)

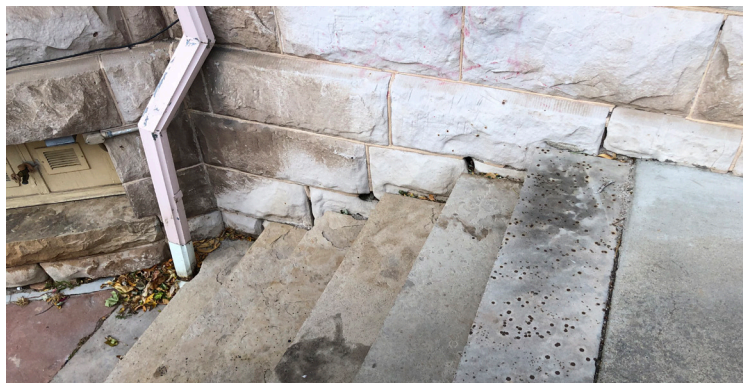
Figure 1-16. Stone damage at stair, 2020 (source: Ratio)

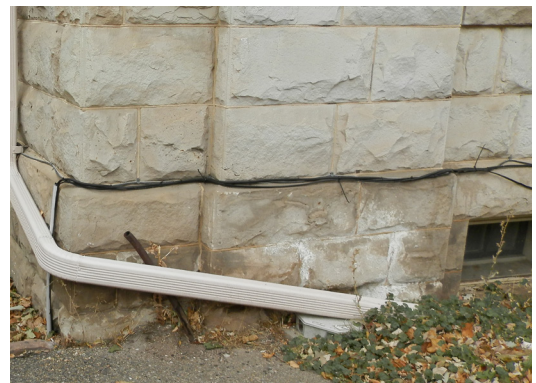
Figure 1-17. Stone damage at gutter, 2020 (source: Ratio)

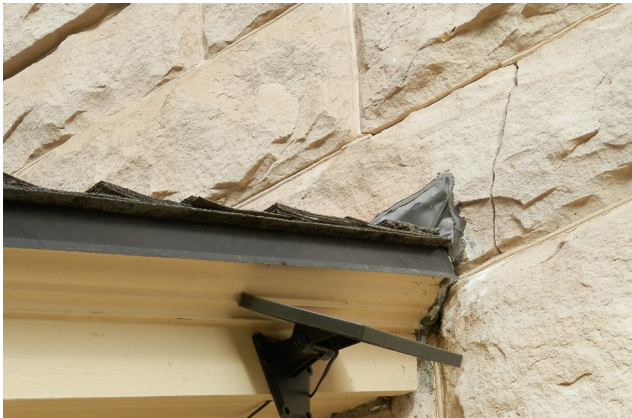
South Facade: The masonry on the south wall is in good condition overall. A cracked stone is above the entry porch addition. The south-west building corner has vines growing on the stone, causing potential damage.

Figure 1-18. Cracked stone, 2020 (source: Ratio)

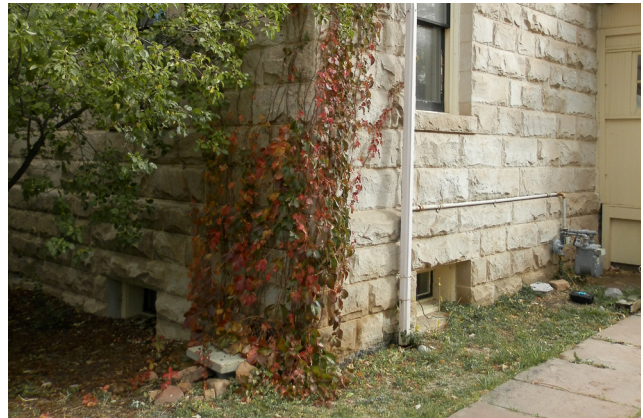
Figure 1-19. Vines on stone masonry, 2020 (source: Ratio)

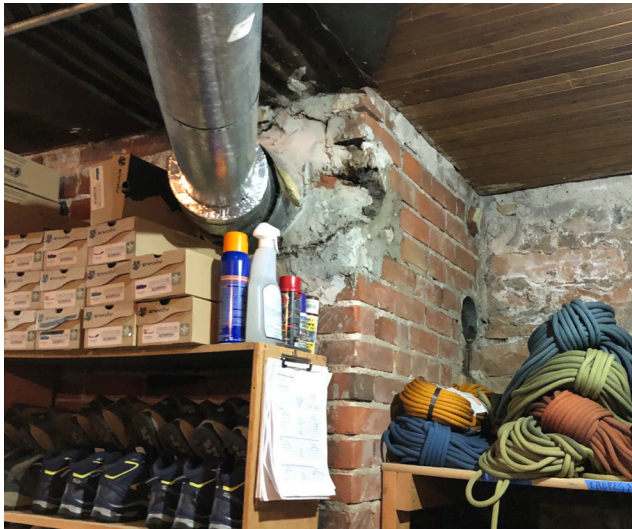
Exposed brick is in the basement and attic. Overall, the brick is in fair condition. Primary areas of damage are those where ductwork or other penetrations have been made through the brick walls. The resulting openings left holes in the brickwork. The attempted sealing material between the ducts and the brick has not functioned properly, causing more damage to the surrounding bricks and impacting the integrity of the walls in those areas.

Figure 1-24. Basement brick masonry, 2020 (source: Ratio)

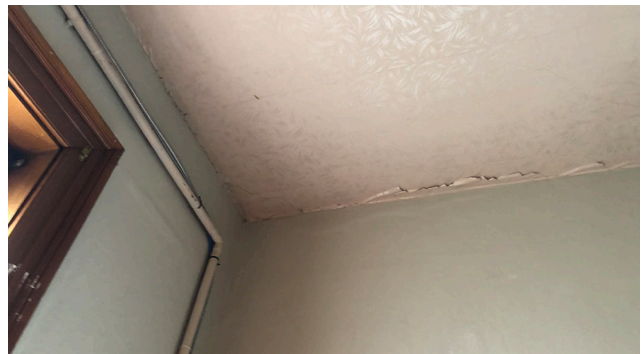
Apart from some detailing on the one of the first-floor ceilings, the interior wall and ceiling finishes are a mix of painted and unpainted wallpaper. Previous attempts to remove the wallpaper were unsuccessful, and the wallpaper was painted over. Most finished surfaces are in good condition. A few areas have peeling wallpaper. A portion of the plaster finish has come off the wall in the second-floor closet.

Figure 1-54. Peeling wallpaper, 2020 (source: Ratio)

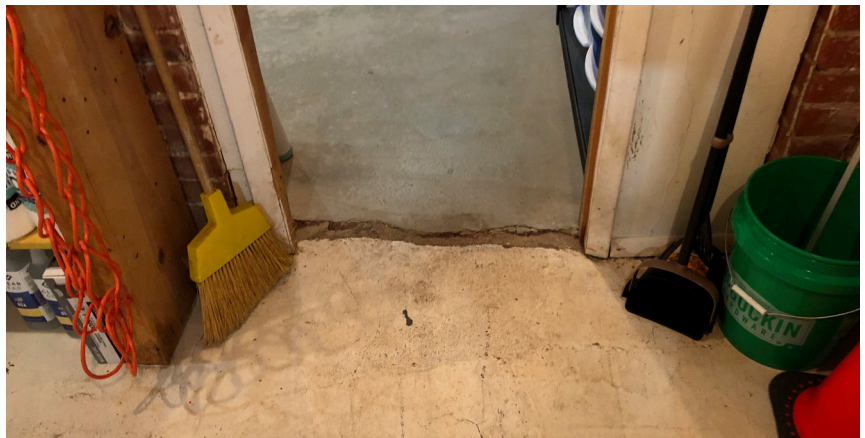
Basement Finishes: The basement kitchen has an acoustical tile ceiling that is in fair condition. Most of the basement flooring is concrete, which is in good condition other than a rough transition between two slabs at one of the doorways. The finished rooms of the basement, other than the kitchen and restroom, have carpeted floors that are in good condition but not original. These same rooms have doors that are not original to the building and appear to be hollow core construction. Exterior windows in the basement are in fair to poor condition with a few locations that have missing or broken hardware. Some windows have been nailed shut.

Figure 1-61. Concrete floor transition, 2020 (source: Ratio)

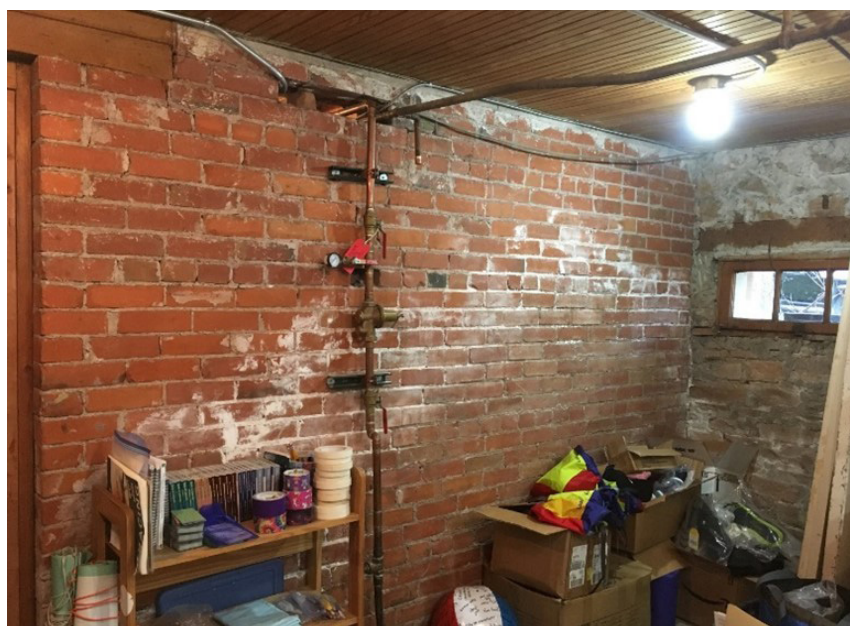
Overall, the foundation is in good condition with no indications of wide-spread settlement such as cracking in the walls above grade. Efflorescence was evident at the interior faces of the basement walls that is evidence of past water infiltration (Figure 1-59). The basement slab slopes near the southeast corner of the building, however this was likely intentional to allow the slab to drain and is not indicative of structural settlement. An exterior building condition evaluation was prepared by CSC in February 1991. Many of the eroded mortar joints and water infiltration issues identified in the report appear to have been addressed since the report was issued.

Figure 1-64. Efflorescence on basement walls, 2020
(source: JVA)

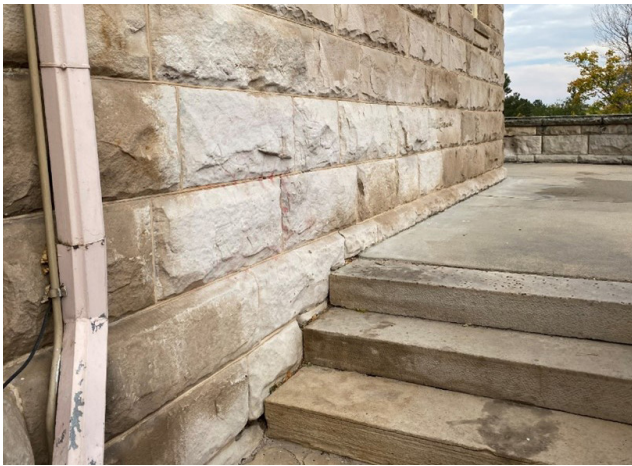
The exterior stone of the house is in overall good condition with the exception of typical weather-related deterioration (erosion) of the sandstone units in Boulder's freeze-thaw climate. The deterioration is more pronounced at the walls near grade at the porch and entry stair. There are isolated cracks including thermal movement-related cracking of mortar joints at the porch and cracked ashlar units near the front entry door jamb. Many of the eroded mortar joints and water infiltration issues identified in the 1991 report appear to have been addressed since the report was issued. Lichen growth is present on the coping stones of the porch however it does not appear to be causing material damage of structural concern to the ashlar units.

Figure 1-65. Erosion of stone at locations of graffiti removal, 2020 (source: JVA)

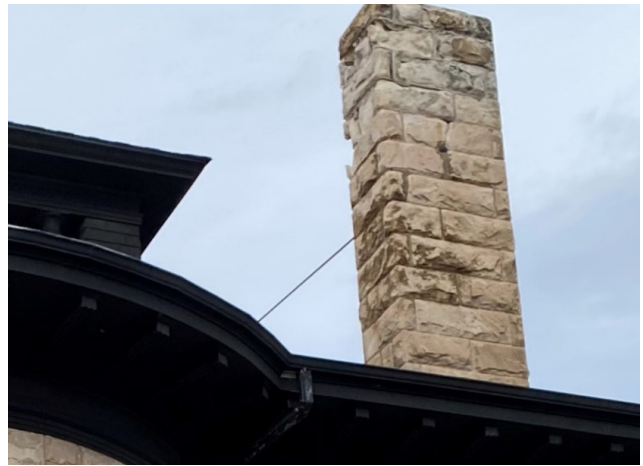
Chimneys: The stonework on the chimneys appears to be in fair to poor condition. Many stones are very worn and weathered with portions of the stones missing, and significant mortar missing. Of the three chimneys, one, in the north east corner, appears to be in the worst condition.

The site includes three stone chimneys, two on the east and one the west side of the house. The porch railing and staircase are constructed of a stone similar to that used for the building. The weather-related erosion of stone units and mortar joints in the chimneys has progressed to the point that some stones appear loose and could dislodge from the chimney.

Figure 1-66. Deteriorated stone at chimney, 2020 (Source: JVA)

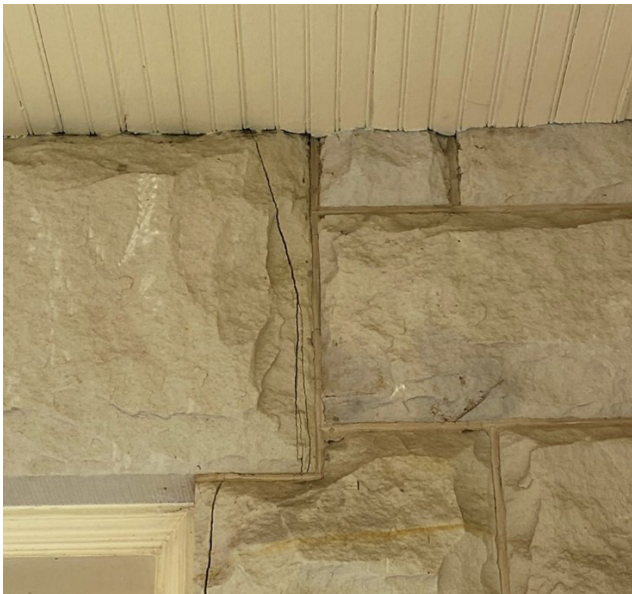
Figure 1-67. Thermal related cracking at header, 2020 (source: JVA)

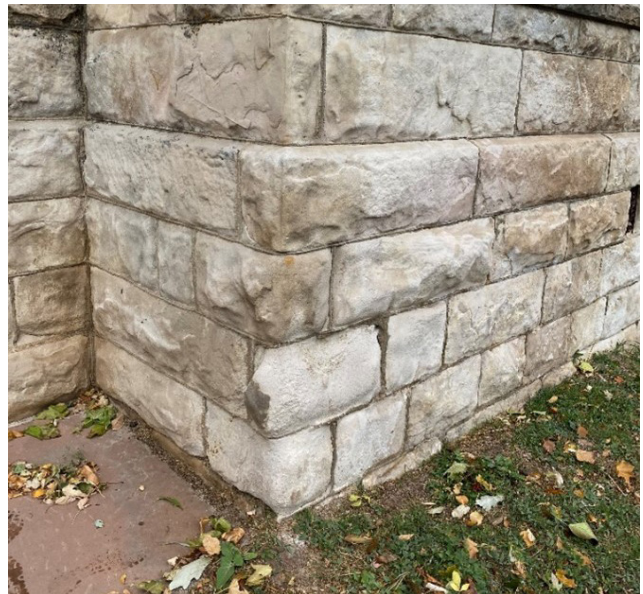
Figure 1-68. Erosion of stone near grade and lichen growth at coping, 2020 (source: JVA)

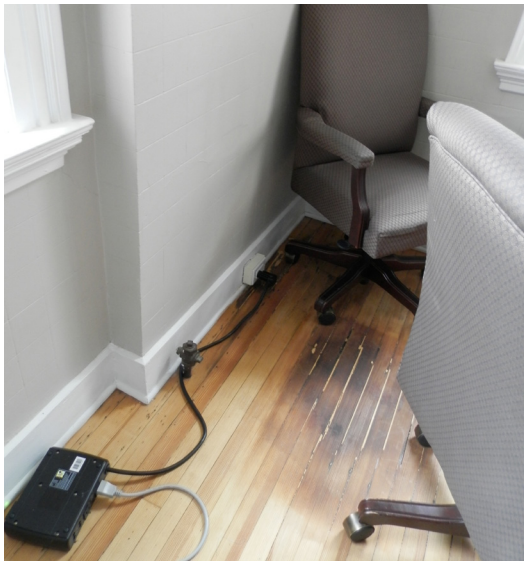
Wood Flooring: Wood flooring throughout the building is in fair condition. Aside from a few areas where there are burn marks and water damage, most of the hardwood flooring has general wear and scratching. In the attic, wood flooring appears to be in worse condition than the rest of the building with gaps between boards, and noticeable scratching. The flooring does not appear to have the same quality or finish as the rest of the building.

Figure 1-76. Second floor wood floor damage, 2020 (source: Ratio)
