BOULDER FIRE STATION NO. 2

MAY 2023

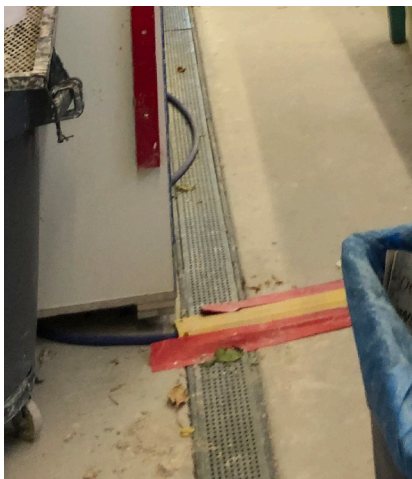
Floor Slab: The lower level floor slab appears to be in good condition. Furniture covers the flooring, however, from what was observed, there was no evidence of major damage. A metal panel inset is in the slab near the lower level restroom. A large trench drain extends north to south through most of the open floor area. These are both in good condition.

Figure 1-4. Linear floor drain, 2020 (source: Ratio)

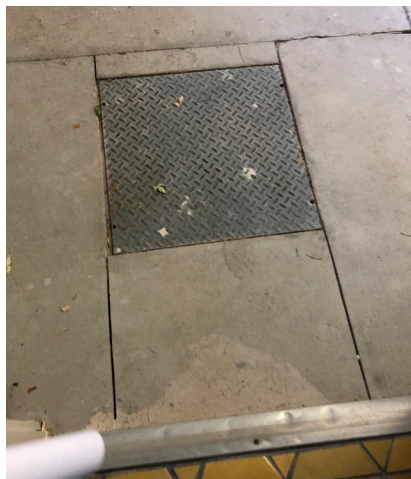
Figure 1-5. Steel panel in building slab, 2020 (source: Ratio)

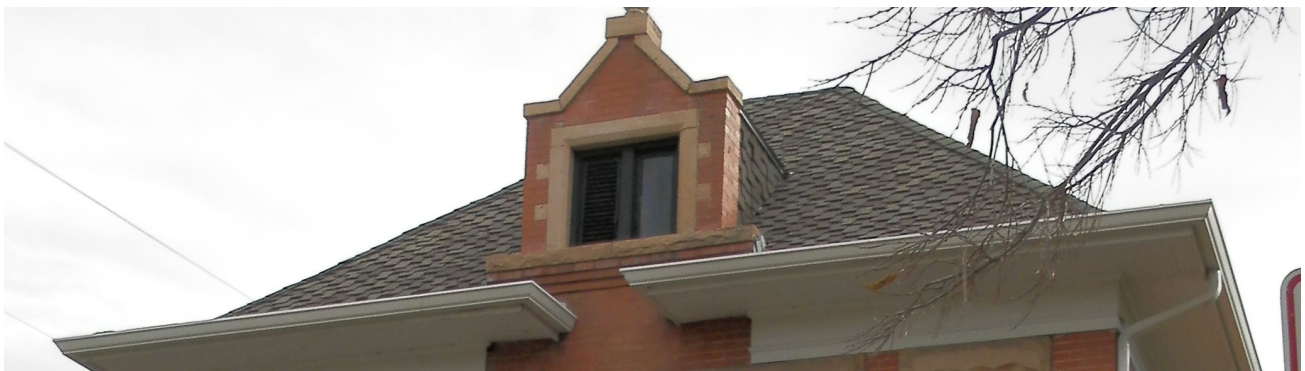
Without roof access, the full conditions of the existing roof were not verified. Of what could be seen from ground level, the existing shingles appear to be in good condition. The roof soffits appear to be in good condition. The gutters and downspouts do not appear to be original to the building but are in good condition.

Figure 1-6. Roof, 2020 (source: Ratio)

- Further investigate the roof and foundation conditions and make repairs based on findings;
 - Remove non-historic coatings on contributing materials.

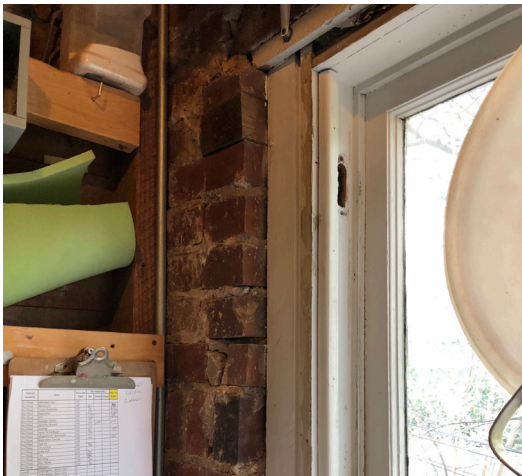
Brick: Overall the existing brick walls are in good condition. Joints appear to have been repointed at some time in the past. Damage near the main entry door on the north end includes brick that appears to have been treated for graffiti removal and is a darker color than the rest of the wall. The interior brick walls are painted and appear in good condition. The center window on the upper level of the south wall is in poor condition and in need of resetting and repointing.

Figure 1-7. Brick at upper window, 2020 (source: Ratio)

- Clean and repoint exterior masonry walls and chimneys as needed using accepted preservation methods detailed by the National Park Service . Replace masonry that is damaged beyond repair;

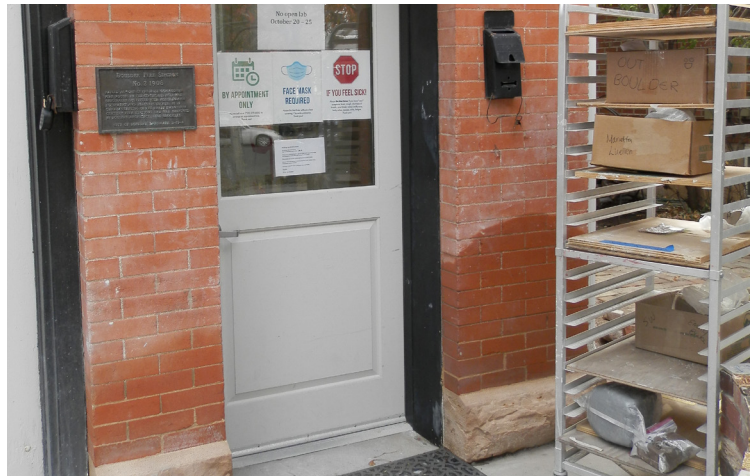
Figure 1-8. Sealant on brick, 2020 (source: Ratio)

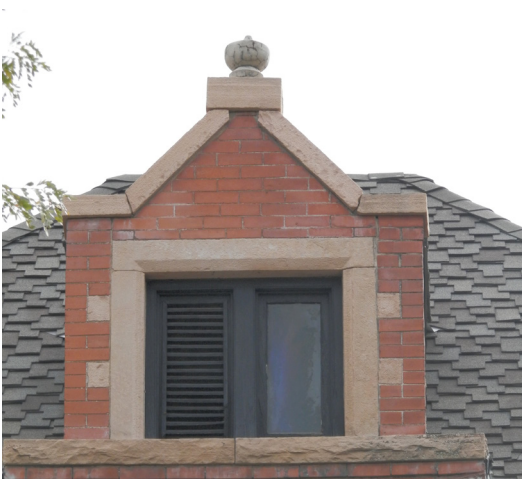
Stone: Stone was used for window lintels, the water table and detailing throughout. The stone shows evidence of weathering, but structurally and functionally are in good condition. One lintel appears to have been replaced with concrete below the exterior staircase

Figure 1-9. Stone detailing, 2020 (source: Ratio)

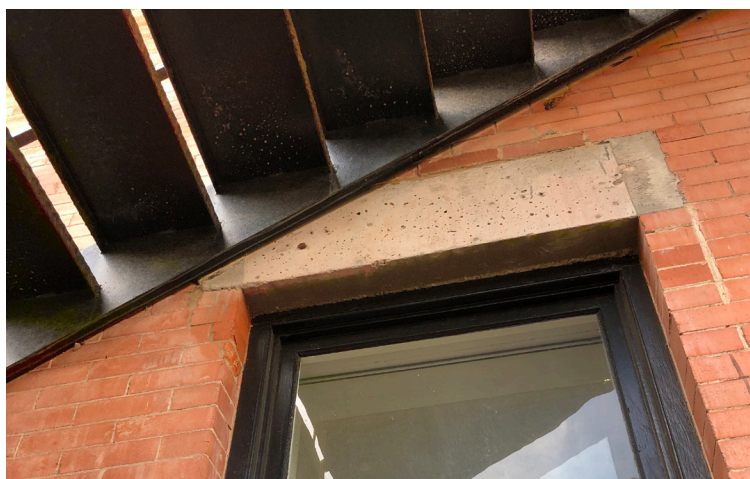
Figure 1-10. Lintel below exterior stair, 2020 (source: Ratio)

- Repair corroding lintels and deteriorating mortar joints in brick masonry.
- Conduct feasibility study for adding an elevator or a lift for accessibility.

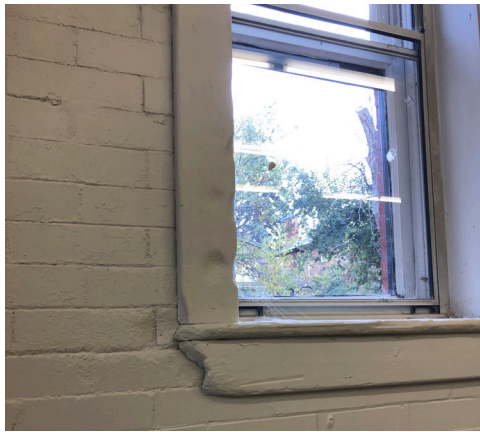
Windows: The window frames are in fair condition. There is considerable damage on the windowsills throughout. Many of the windows have interior storm windows installed. The wood window frames have mostly cosmetic dirt and damage from the ceramic studio use. The lower level windows have been painted. One of the lower level windows has sustained bite marks from where the horses had gnawed on the frame during the time when the stable was still in use.

Figure 1-11. Lower level window with horse damage, 2020 (source: Ratio)

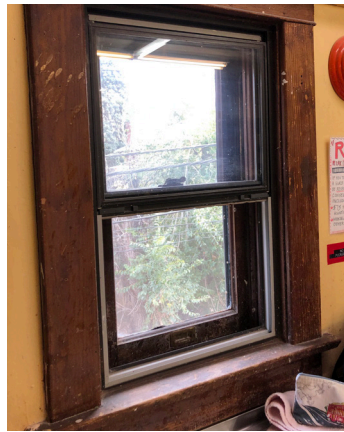
Figure 1-12. Upper level window with interior storm, 2020 (source: Ratio)

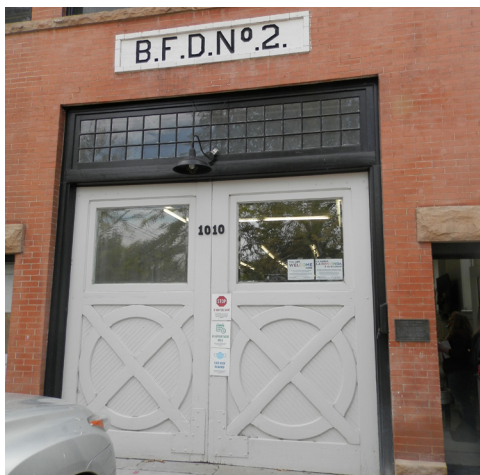
Doors: The main double garage doors at the north end of the building are the original doors. The wood is painted, and the doors are in good condition. The side door on the east wall was cut to create access to the added storage area/loading area. Some upper level doors at the south end appear to be original, and in fair condition. The swing on several of the doors has been reversed. One door appears to have been repurposed to its current location, but the top of the door was cut off to fit the existing frame.

Figure 1-13. Garage doors, 2020 (source: Ratio)

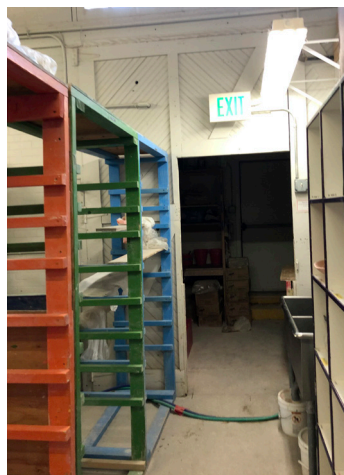
Figure 1-14. Opening cut into original east doors, 2020 (source: Ratio)

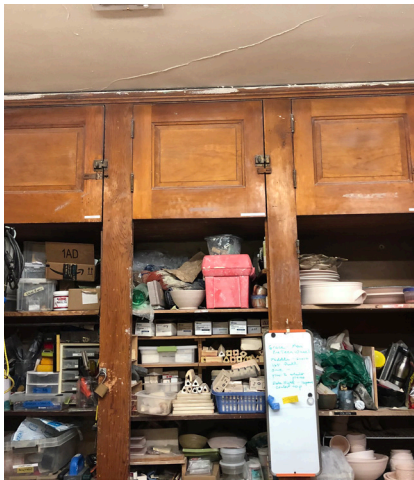
Lockers: The general forms of the original lockers on the upper level are intact, however many of the locker doors have been removed for pottery storage. The smaller doors on top are all in place. The lockers are currently used for storage and are in fair condition.

Figure 1-16. Lockers, 2020 (source: Ratio)

- Consider restoring original wood lockers in their entirety.
 - Future repair of the staircase should be done with in-kind materials.
- Preserve extant structural features in-place.

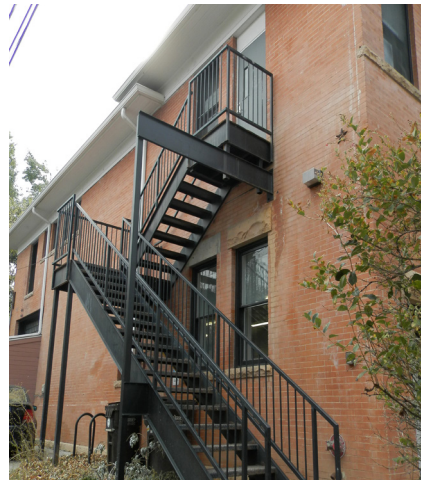
Exterior Stair: The exterior stair is not original to the building. There is evidence that there was a previous exterior staircase to the upper level that was installed in a slightly different location. The exterior stair is in poor condition. It is not well secured to the building and is corroding in multiple areas.

Figure 1-18. Exterior staircase, 2020 (source: Ratio)

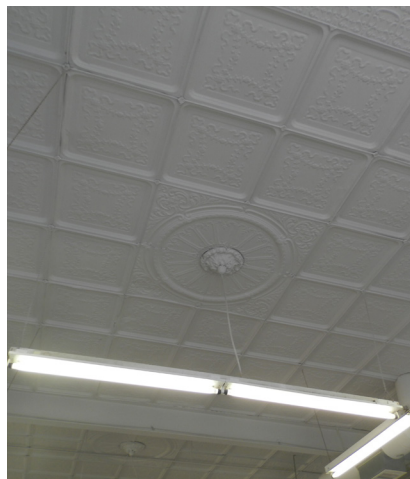
Ceiling Tiles: The painted metal ceiling tiles are not original to the structure and were likely added after the period of significance in order to look historic. They are in good condition. Indication of the fire pole opening is visible from the first and second floors.

Figure 1-20. Lower level ceiling, 2020 (source: Ratio)

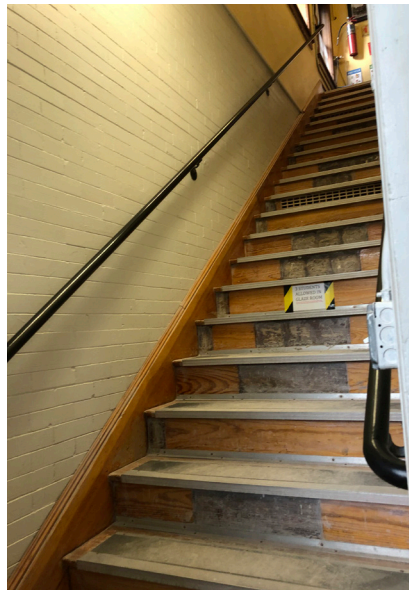
Interior Stair: The bottom steps are concrete with safety painting. Portions of the paint could use retouching, and there is some damage to the corner of the steps. The main portion of the stair is wood, with applied metal treads and nosings added to each step. The metal is worn, but functional. The condition of the wood below the treads is unknown, but the portions of wood that remain exposed are in fair to poor condition.

Figure 1-26. Interior stair, 2020 (source: Ratio)

- Preserve, repair, and replace extant architectural finishes to match in-kind.
 - Replace hardwood stairs.
 - Consider restoring original interior finishes to the best extent possible. Conduct further research for original material and finishes that may have been removed during later modifications.

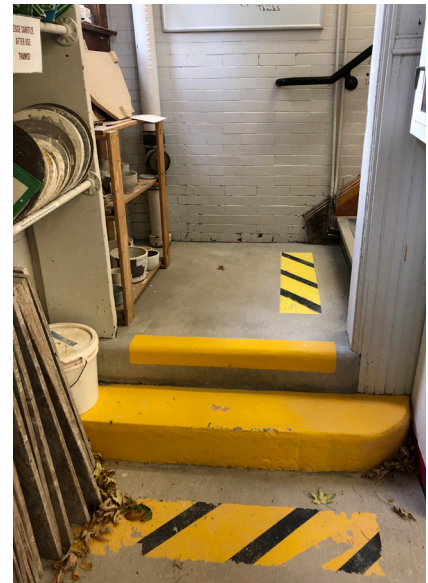
Figure 1-27. Bottom of interior stair, 2020 (source: Ratio)

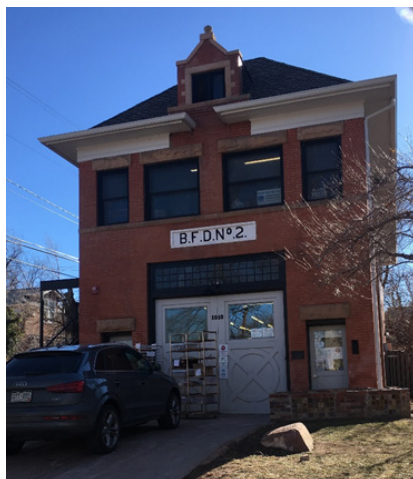
The brick and stone are in overall good condition and exhibit weathering consistent with their age. There are cracks located at brick supported over the large transom window and at the first-floor entry door. The chimney's mortar joints exhibit more weathering than the rest of the building.

Figure 1-28. Front of Fire Station No. 2, 2020 (source: JVA)

- Walls - Rake out deteriorated mortar joints in the walls and chimneys and repoint with a compatible mortar as determined by a mortar analysis of a sample of the original mortar. Note the mortar will require periodic maintenance; Shore the transom window with a steel lintel, slide in a larger bearing plate at either end, pin the masonry near the side of the window, and replace any cracked brick units.

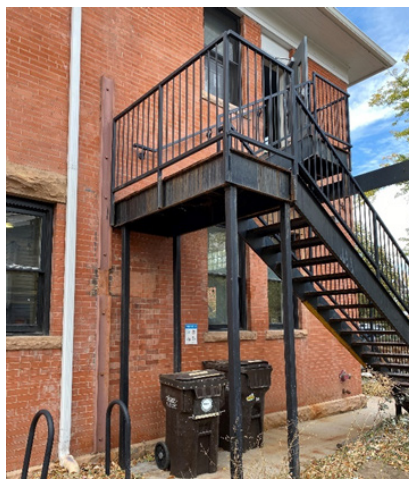
Figure 1-29. Fire escape on east side of building, 2020 (source: JVA)

The fire escape is in poor condition and has significant corrosion at the angles and decks. The chimneys are in good condition showing no signs of structural distress such as displacement.

- Other Structural Elements - Remove any rust from the exterior steel fire escape with a wire brush. Recoat the steel with a zero VOC cold-galvanizing paint. If any members or portions of the deck are corroded beyond structural repair, replace in-kind.

- Further investigate second floor framing and strengthen as necessary.
- Repair exterior steel fire escape.
