PLATT FARMHOUSE

MAY 2023

The report documents the history, significance, integrity and existing condition and provides treatment guidance for the resource. It does not evaluate for listing in the National Register of Historic Places. If the resource has been previously listed or evaluated it is referenced and footnoted.

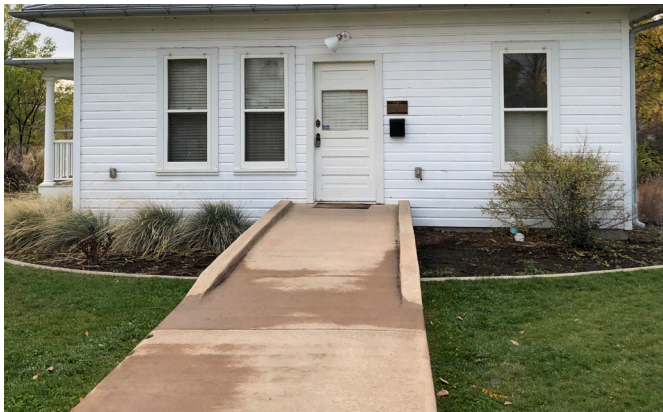
Sidewalk: In the current building location, the rear (north elevation) entrance is accessed from an accessible concrete ramp. The ramp was added when the building was relocated and rehabilitated and is in good condition. The building entry on the south elevation has a concrete pad at the bottom of the stairs that is in good condition.

Figure 1-4. Concrete sidewalk at the accessible entrance, 2020 (source: Ratio)

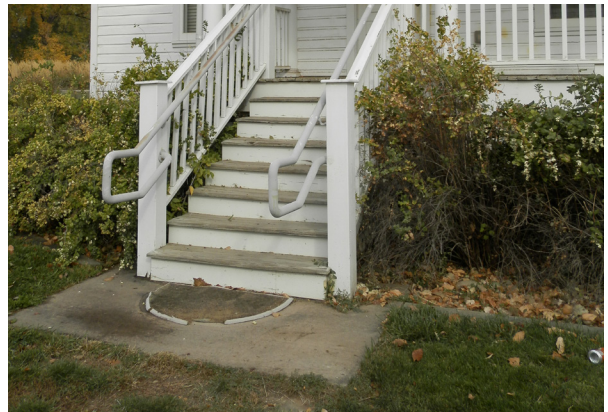
Figure 1-5. Concrete slab at the base of the stairs, 2020 (source: Ratio)

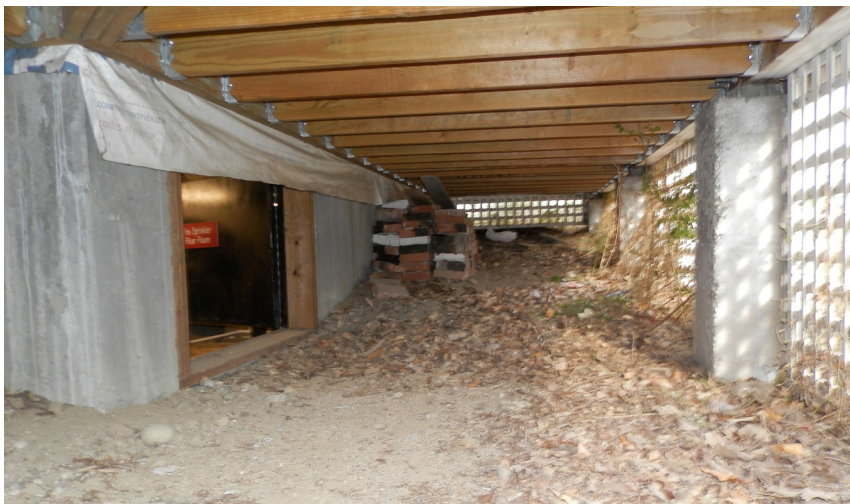
Building Foundations: The building and porch appear to have been set on new concrete foundations as part of the relocation and rehabilitation. The concrete appears to be in good condition. Refer to structural analysis.

Figure 1-6. Porch and building foundations, 2020 (source: Ratio)

The structure has new concrete foundation stem walls and concrete footings at frost depth. The foundation is in good condition. It appears that the new concrete piers at the porch were coated in a finish coat to look like the original piers which had a honeycombed surface.

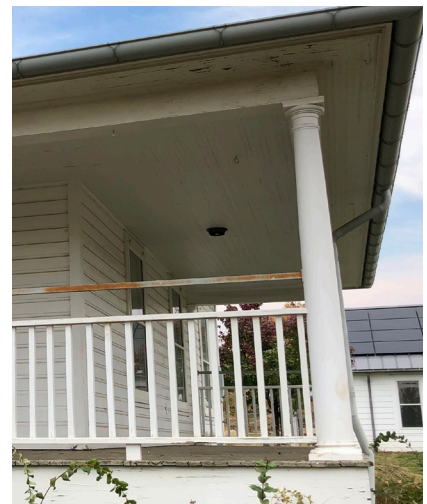
Figure 1-7. Porch columns, 2020 (source: Ratio)

Porch Columns: The original wood porch and stair were reconstructed when relocated. The framing, columns, railing, and stairs were constructed with compatible materials and designed to match the original construction. The columns are in fair condition overall. The paint is peeling slightly at the base of the columns. The rails and posts are in fair condition. The bottoms of the posts are showing signs of cracking and peeling paint. Areas on both the top and bottom rails have peeling paint. To comply with the current code height requirements for guardrails, a metal rail has been added. The metal rail appears to be in fair condition, maintaining its structural integrity but showing large areas of rust.

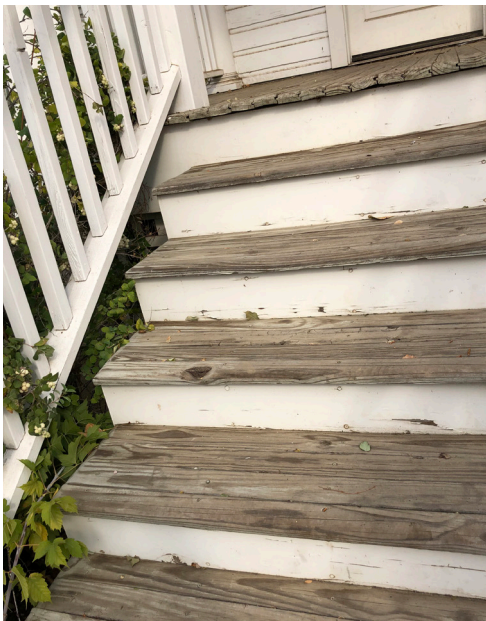
Porch Flooring: The wood floor of the porch and the entry stairs are in poor to fair condition. The tongue and groove boards are intact and functional, but are unfinished and showing considerable wear, weathering, and warping.

Figure 1-8. Wood porch stair, 2020 (source: Ratio)

- 1 - Conduct repairs for the safety and stabilization of Platt Farmhouse.
 - Repair existing porch wood declining and stairs.
 - Install roof and soffit vents and paint soffits.
 - Evaluate exterior paint for routine scheduled maintenance.

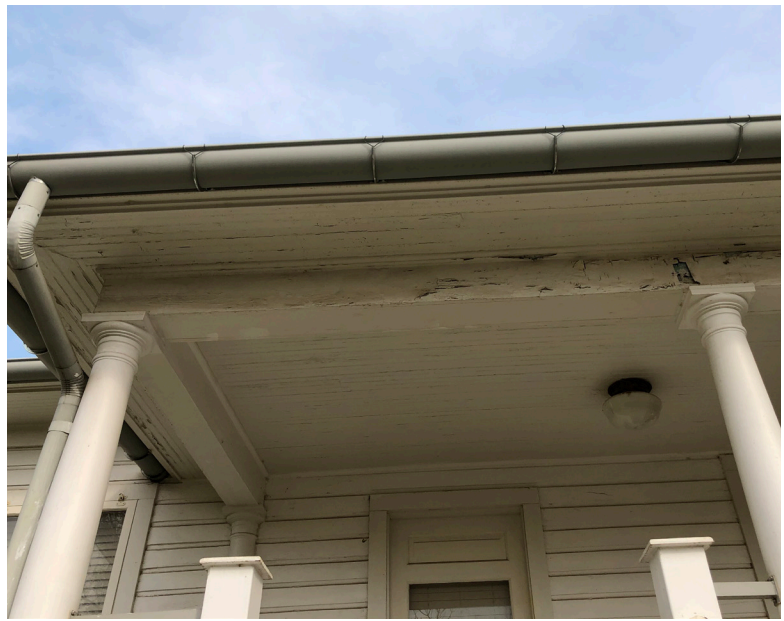
Porch Roof and Soffit: The porch roof is in good condition. The wood soffit is in fair to poor condition. There is considerable wear, weathering, and cracking and peeling paint on both the support beams and the wood soffit material.

Figure 1-9. Wood porch framing roof supports, 2020 (source: Ratio)

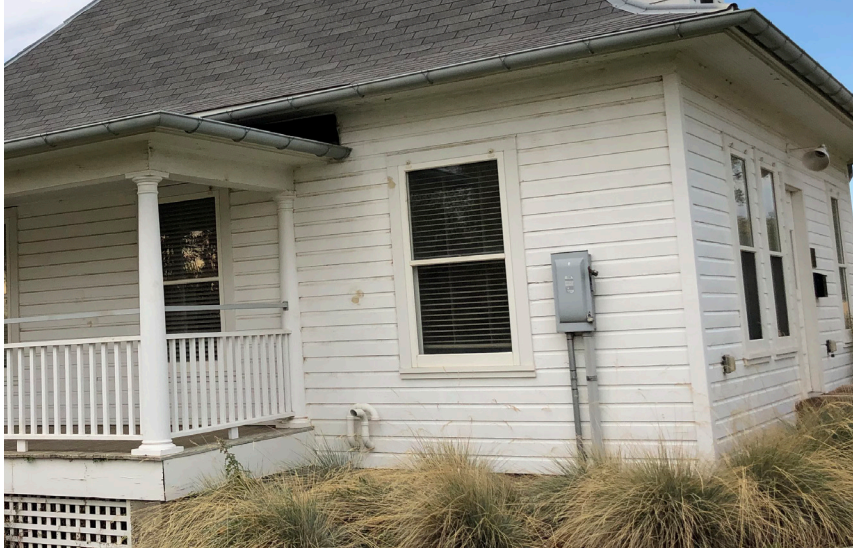
Exterior Siding: In general, the wood siding is in fair condition. Some discoloration is evident on the siding, as well as a few small areas where the siding is damaged or the paint is missing.

Figure 1-10. Wood siding, 2020 (source: Ratio)

- Repair and refinish all painted surfaces.
- Maintain contributing structures and objects through regular maintenance including the following:
 - Touch up all painted surfaces on a routine basis.

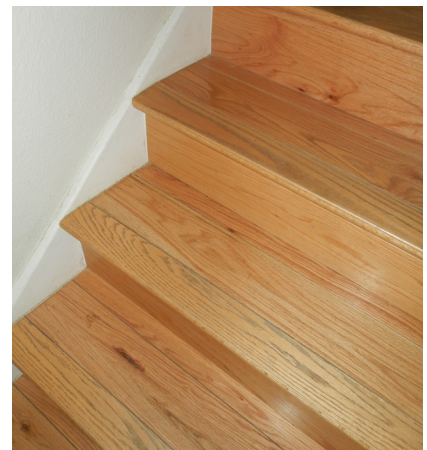
Hardwood Flooring: Both levels of the interior have wood plank flooring, that appears in good condition. The interior stairs have a wood finish. The stairs appear to be in good condition with the exception that a few nosing boards are loose.

Figure 1-14. Wood treads and nosings, 2020 (source: Ratio)

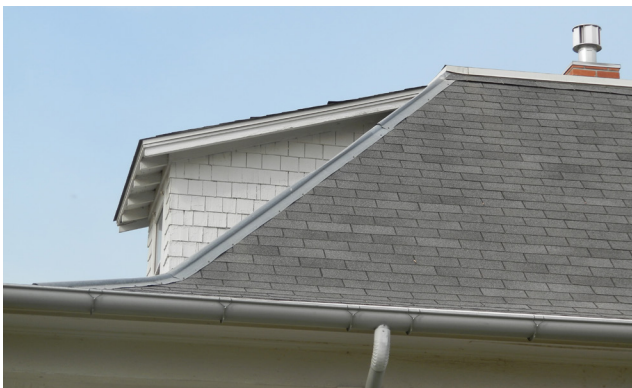
Shingles: The main portion of the roof is finished with asphalt shingles, which appear to be in good condition. The upper dormers have an exterior wall finish of painted wood shingles. From ground level observation the shingles appear to be in fair condition.

Figure 1-17. Asphalt shingle roof, 2020 (source: Ratio)

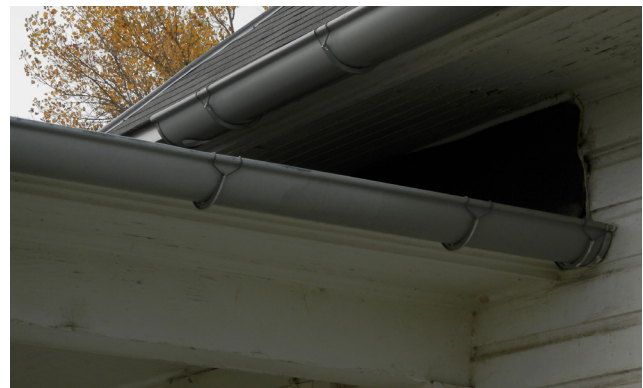
Gutters: The gutters and downspouts appear to have been replaced during rehabilitation. The gutter profile is a half-round style, which replicates the gutter shapes in use when the Farmhouse was originally built. Both gutters and downspouts appear to be in good condition.

Figure 1-18. Half-round gutters, 2020 (source: Ratio)

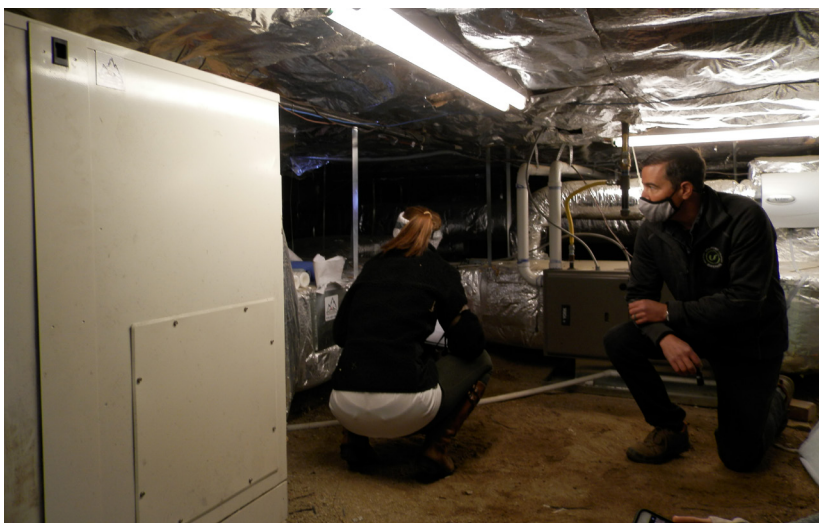
Mechanical: The swamp cooler and furnace for the building appear to be in working condition. They are located in the crawl space below the building, that is accessed behind the slatted wood screens below the porch. A building systems engineer will need to be procured by the city to conduct a thorough analysis to confirm compliance and performance of existing systems.

Figure 1-21. Swamp cooler and furnace in the crawl space, 2020 (source: Ratio)

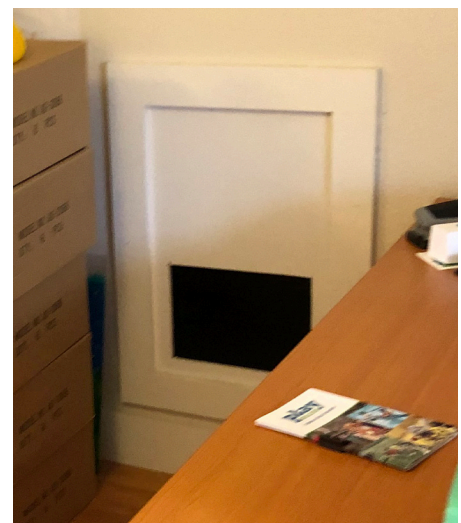
Attic: The attic was partially renovated into an office space, likely at the time of relocation. The rest of the attic remained unfinished and is accessed through access panels on the added partition wall. There are two wall panels that appear to be the access for the unfinished attic space. In both access panels there is a hole cut into them. It is unclear the intent of the holes or if there is a grille missing from these locations. Otherwise the attic spaces are in good condition.

Figure 1-22. Attic access panel, 2020 (source: Ratio)

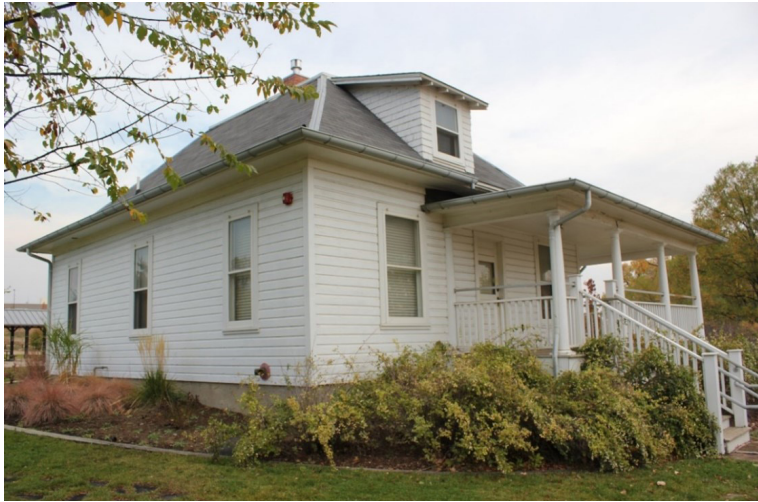
The farmhouse has a wrap-around front porch supported by wood columns. The rear entrance has an ADA-compliant concrete ramp. The porch and ramp are in good condition. The paint on the porch's wood framing elements is failing.

Figure 1-23. Front and west elevation of Platt Farmhouse, 2020
(source: JVA)

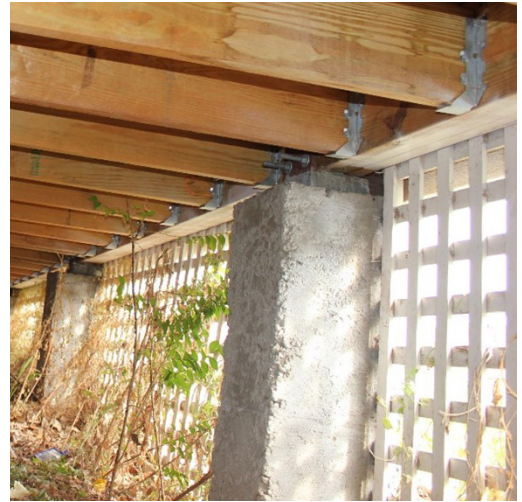
Figure 1-24. Porch piers wrapped in coating, 2020 (source: JVA)
