GLEN HUNTINGTON BANDSHELL

MAY 2023

The report documents the history, significance, integrity and existing condition and provides treatment guidance for the resource. It does not evaluate for listing in the National Register of Historic Places. If the resource has been previously listed or evaluated it is referenced and footnoted.

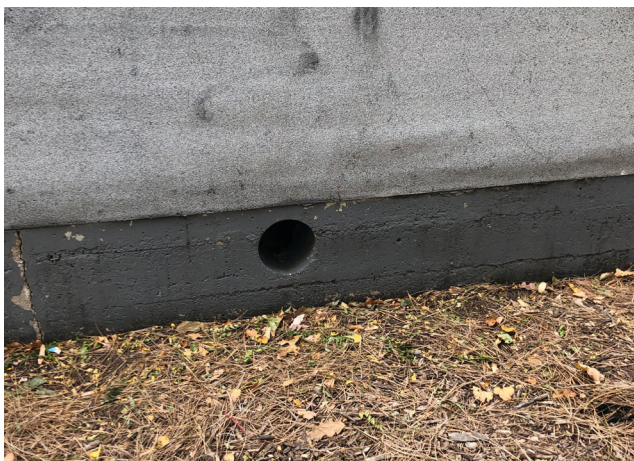
Figure 1-16. Vertical foundation crack on the east facade, 2020 (source: Ratio and JVA)

Overall, the building foundations appear to be in good condition based on the overall system performance. There is one vertical crack in the east foundation wall which is likely a naturally-formed expansion joint. The west foundation wall is covered in ivy, which can be detrimental to the structure over time. Relatively regularly spaced vertical cracks occur in the in foundation wall along the front of the stage that are likely naturally-formed expansion joints. The concrete buttresses on both sides of the largest arch have horizontal cracks at the same height. These are likely cold joints from the original concrete pour during construction. Both the vertical expansion joint cracks and horizontal cracks at the cold joints are not of structural concern. Visible from the crawlspace under the stage, there is a large vertical crack in the 6" thick concrete foundation wall located under the wall at the back of the stage. The crack is located at the center of the stage and is 3/4" wide at the base and 2" wide at the top. Based on photographs taken in 2014 compared to those taken in 2021, the movement does not appear to be active as the crack widths appear to not have changed. This crack is caused by settlement of the east side of the foundation wall. There is no other stark evidence of this movement in the structure above indicating that the redundant wood roof/wall framing is distributing the changes in the load well. Overall, this crack is not of major structural concern. However, it is in the best interest of the resource to monitor the crack and stitch it together to provide continuity at the foundation wall.

- Foundations and Wall Framing - Remove vegetation on and directly adjacent to the building; Stitch crack in interior foundation with helibars. Fill crack with grout. Rout & seal minor cracks with a compatible epoxy.

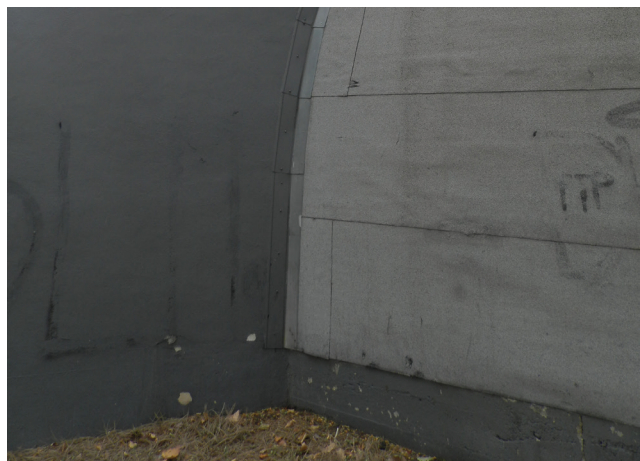
The lower portions of the asphalt roofing extend to the concrete foundations and appear to have been damaged. The lower portions show signs of blistering and separation from the surface below and are in fair to poor condition. The upper portions of the rolled asphalt roofing appear to be in better condition with minor signs of blistering. On the east end of the roof, one area of the asphalt roofing has been patched with a different material.

Figure 1-17. Rolled asphalt roofing. Note the blistering at the lower portion of the roof, 2020 (source: Ratio)

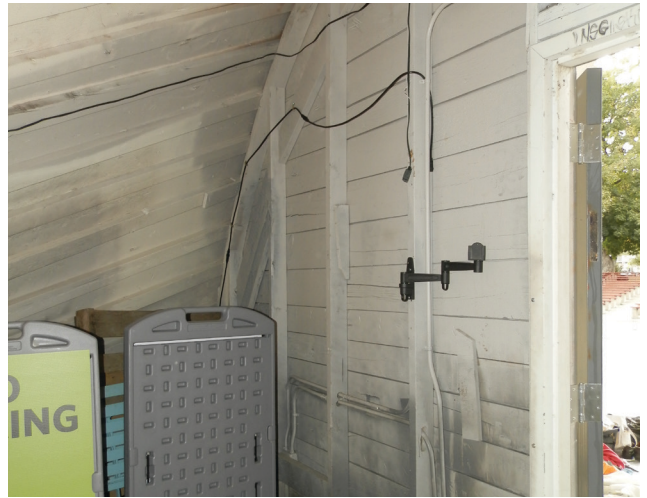
Figure 1-21. Wood siding, 2020 (source: Ratio)

- Repair and refinish extant architectural features to match in-kind including the existing plaster, wood plank siding, epoxy stage flooring, and painted surfaces.

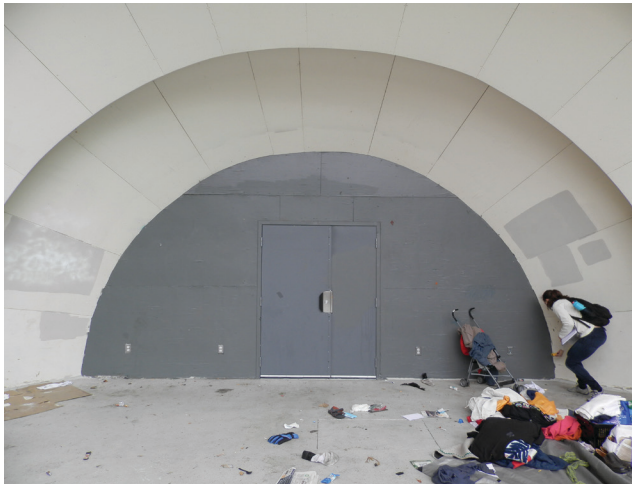
Finish Panels: In general the exterior plywood finish panels are in fair condition. The panels have minor weathering and mostly aesthetic damage due to graffiti. At the topmost proscenium arch, the rear-facing plywood appears to have more significant weathering. The exterior rear wall of the Bandshell has plywood panels covered with ivy. Damage to the wood is likely beneath the vines.

Figure 1-22. Exterior plywood finish panels, 2020 (source: Ratio)

- Replace plywood panels in-kind and finish with paint to match original color scheme. Then apply a marine grade varnish.
- Rewire bollards for power and provide compatible metal cover plates.

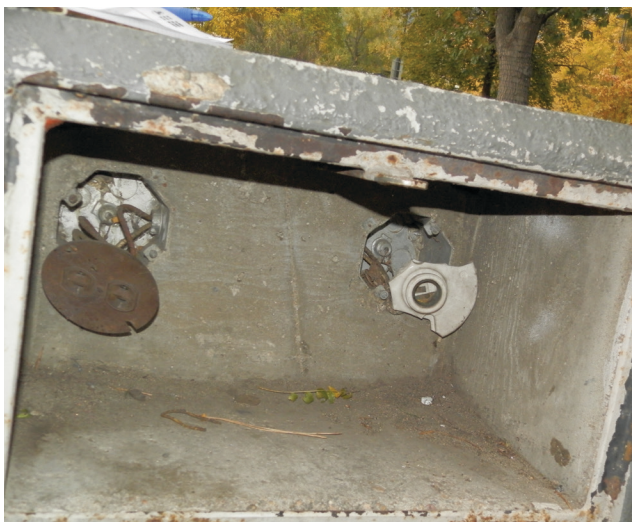
The power and lighting bollards do not show any major cracking or damage. The metal cover plates are either missing or in poor condition with rusted and broken hinges. The receptacles do not appear to be functional and include two 2-pronged outlets with no ground wire. The lighting has been removed and the power boxes exposed.

Figure 1-18. Interior view of lighting and power bollards. Note the cracking concrete forms, rusted and broken cover plates, as well as missing components, 2020 (source: Ratio)

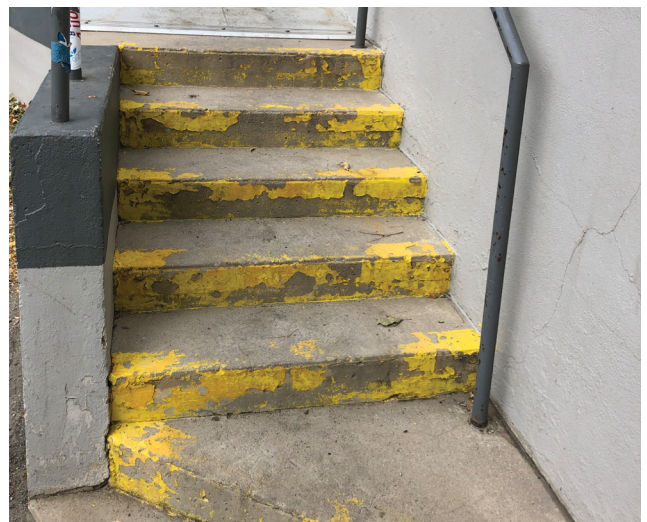
Concrete stairs at both locations appear to be in good condition. The yellow safety nosing paint is in poor condition. The painted steel handrails are in good condition with portions of the painted finish worn off, however, they do not appear to be compliant with current accessibility requirements. There is currently no accessible means to the stage. Both an accessible path and associated features will need to be further studied and considered for future use.

Figure 1-20. Concrete stairs. Note the yellow safety nosing paint condition is poor, 2020 (source: Ratio)

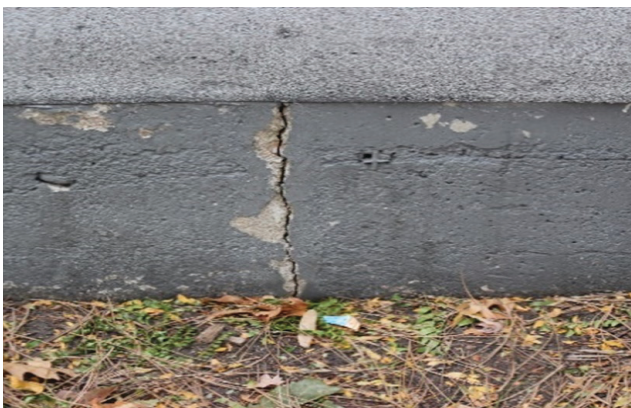
Figure 1-24. Vertical foundation crack on the east side, 2020
(source: Ratio and JVA)

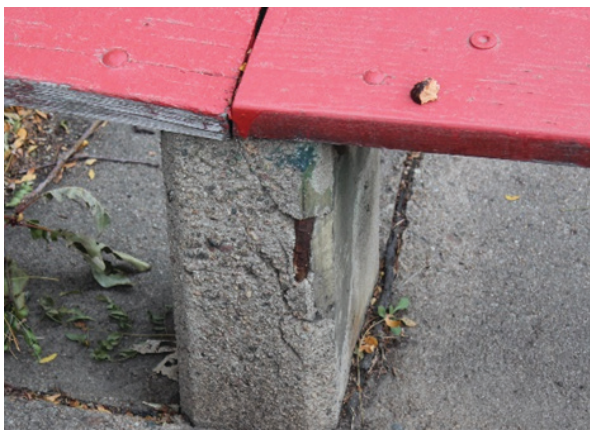
Amphitheater seating faces the Bandshell stage. The amphitheater consists of a concrete slab that slopes toward the stage and rectangular reinforced concrete pedestals that support wood benches. Steel angle clips connect the wood benches to the concrete. Many concrete pedestals have started to spall. In some spall locations, the exposed rebar appears to only have had 1/4-inch cover. Some pedestals have areas of spider-web cracking and areas where the cement binder has weathered, exposing the larger aggregate. The painted wood bench boards show signs of wear including splitting, warping, and crushing at the connection locations.

Figure 1-26. Spalling at pedestal of Amphitheater Seating, 2020 (source: Ratio)

- Seating - At concrete pedestals, remove spalled concrete, remove any rust from reinforcing with wire brush and coat with a low VOC galvanizing paint, and patch with repair mortar; replace deteriorated wood benches in-kind.
