Trail Condition Monitoring Report

2019-2023 Survey

Prepared by Jake Engelman
City of Boulder Open Space and Mountain Parks
August 2024

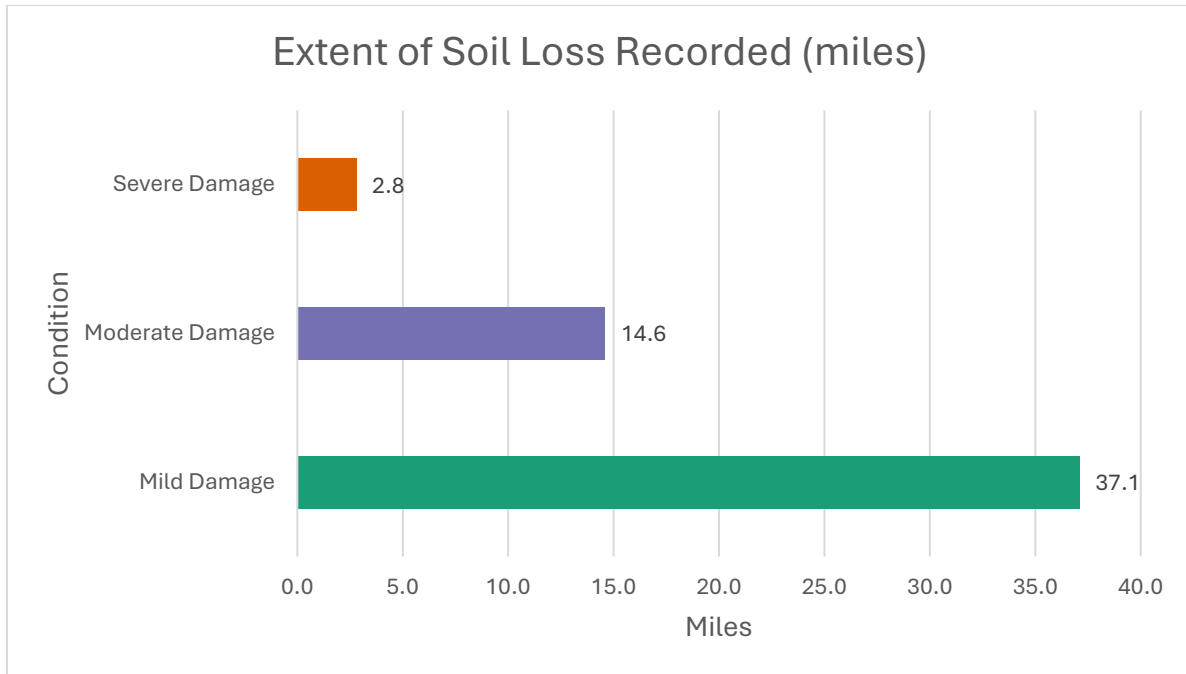
Figure 10: The linear extent of soil loss (erosion) measured during the 2019-23 condition monitoring.

Soil loss was recorded on 54.4 miles of trails throughout the OSMP trail system, accounting for approximately 35% of the total mileage surveyed. Of those 54 miles, 68% of the mileage exhibited mild soil loss, 27% moderate soil loss, and 5% severe soil loss (Figure 10).

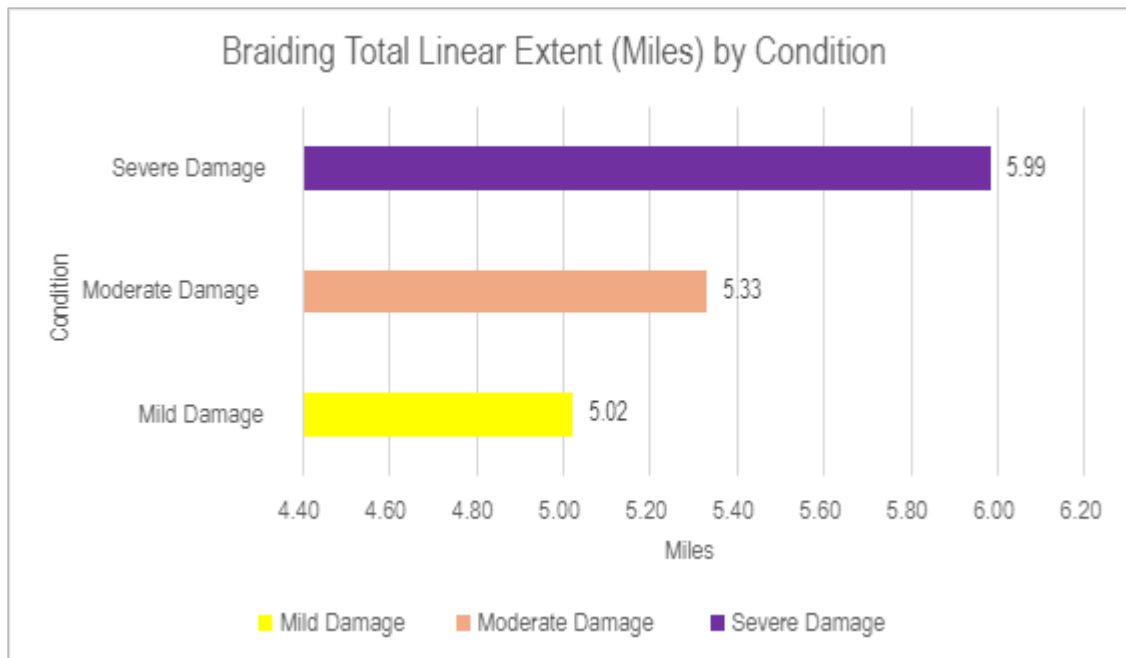
Figure 11: The linear extent of braiding surveyed categorized by condition.

Braiding was recorded on 16.3 miles of trails throughout the OSMP trail system. Of those, 16 miles (31% of the mileage) exhibited mild damage, 32% moderate damage, and 37% severe damage (Figure 11).

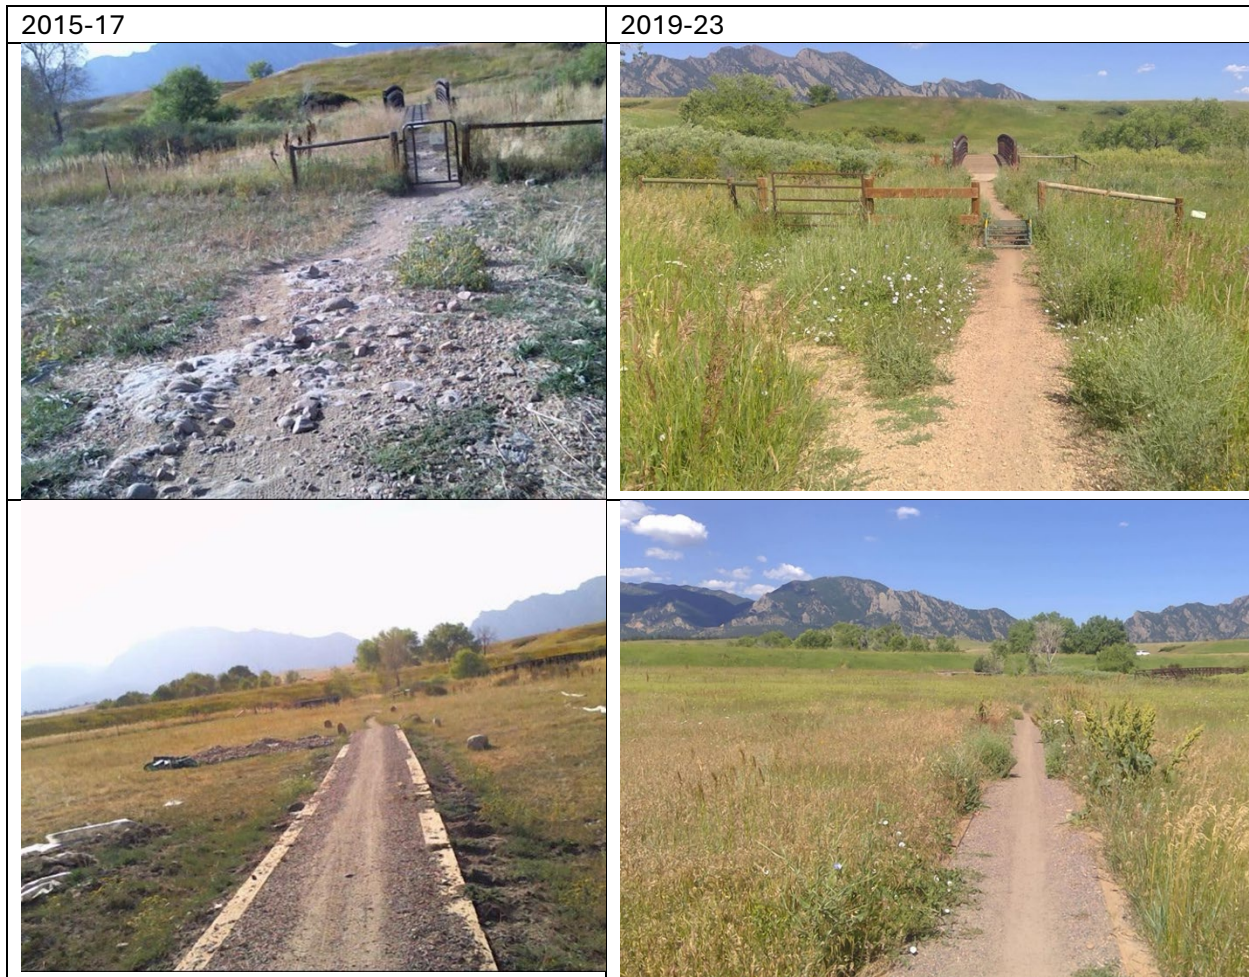
Table 12: Representative photos of how photo point monitoring can provide insight into trail condition changes

The HETAP survey equipment used for trail condition monitoring automatically records a photo at each station (approximately every 14ft). Photo points demonstrate the dynamic nature of trails and surrounding vegetation and are a powerful tool to help evaluate the effectiveness of trail design techniques over time. Table 12 shows examples of how photo points can be used to further understand changes in condition at specific locations around the trail system.

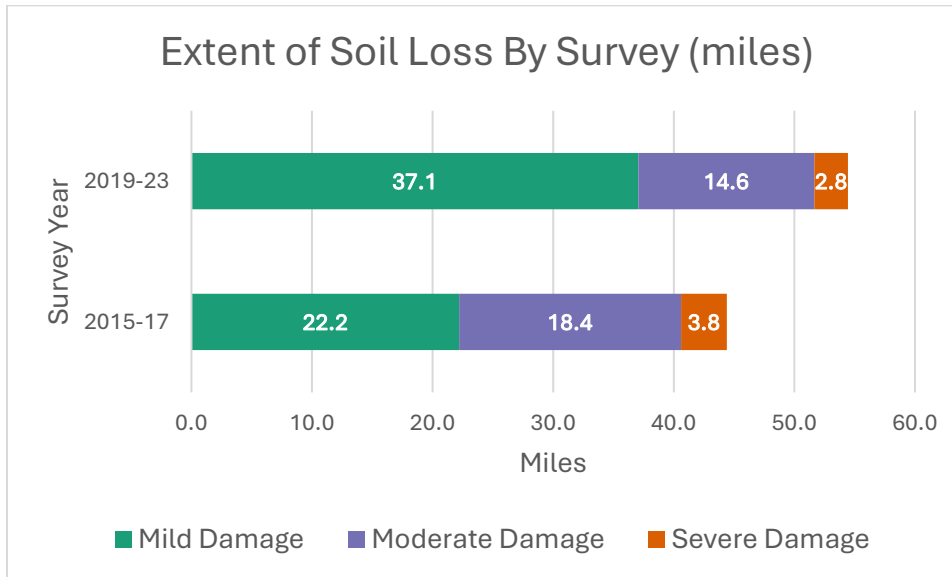
Figure 15: A comparison of soil loss between surveys.

The 2019-23 survey found a decrease in severe and moderate soil loss problems (Figure 15). Some of that decrease can be attributed to significant trail repair projects and trail re-routes. Many trails severely damaged in the 2013 flood were repaired between the 2015-17 survey and the most recent survey. The 2019-23 survey did find a significant increase in mild soil loss damage problems. These areas of mild damage should be considered in routine maintenance sweeps, so they do not develop into moderate or severe damage areas.

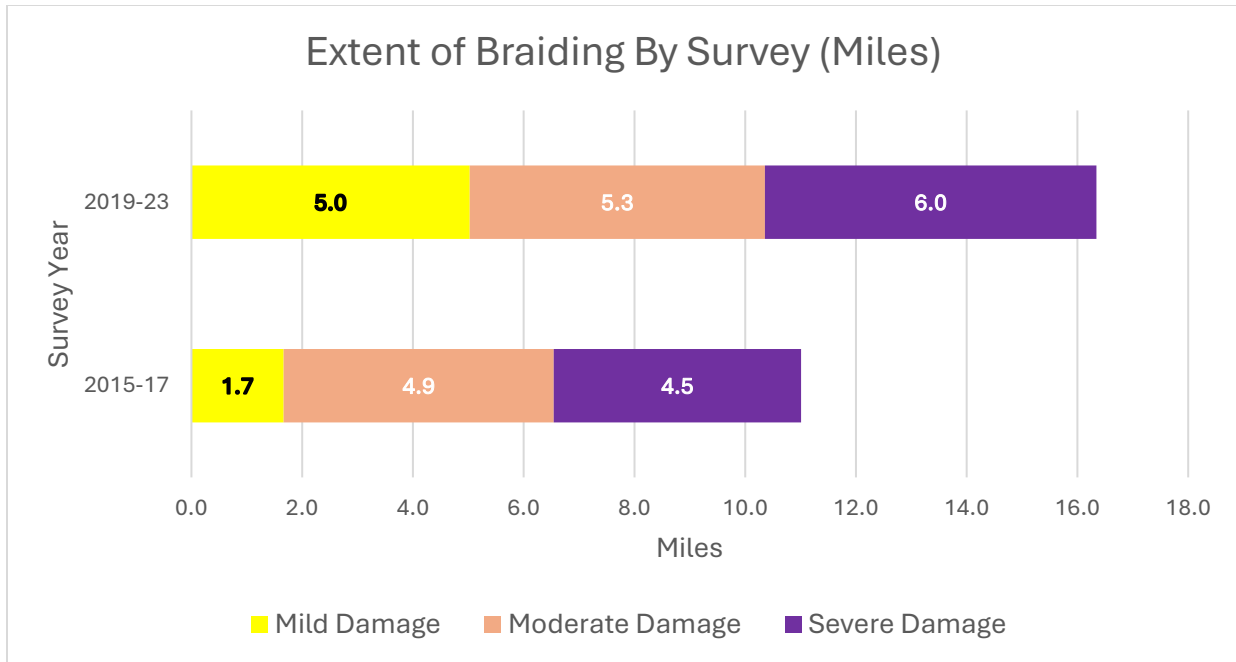
Figure 16: A comparison of the linear extent of braiding between surveys categorized by condition.

The 2019-23 survey recorded more instances of severe, moderate, and mild braiding along trails than the 2015-17 survey (Figure 16). Braiding can indicate other issues, such as drainage issues or erosion, that make the original trail alignment undesirable to travel upon.

The 2007 trail condition monitoring also captured braiding. Despite overall improved conditions from 2015-17 to 2019-23, the 2015-23 surveys saw a significant increase in braiding since 2007. (Table 19). The 2007 survey only recorded problems greater than 30 feet in length, which could account for some of the difference.
