# Trail Condition Monitoring Report

2019-2023 Survey

Prepared by Jake Engelman  
City of Boulder Open Space and Mountain Parks  
August 2024

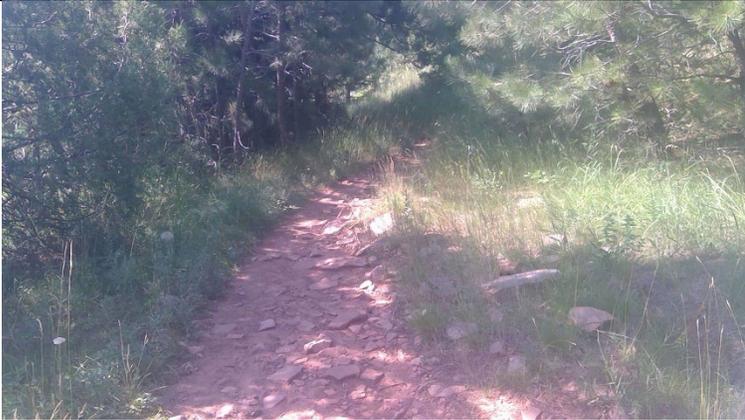
Soil Loss Condition State	Representative Photos
<p>Mild Damage: Trail tread shows minor erosion rills or less soil than adjacent topography but is functional for the managed uses of the trail, and eroded soils do not appear to be significantly impacting adjacent vegetation or water.</p>

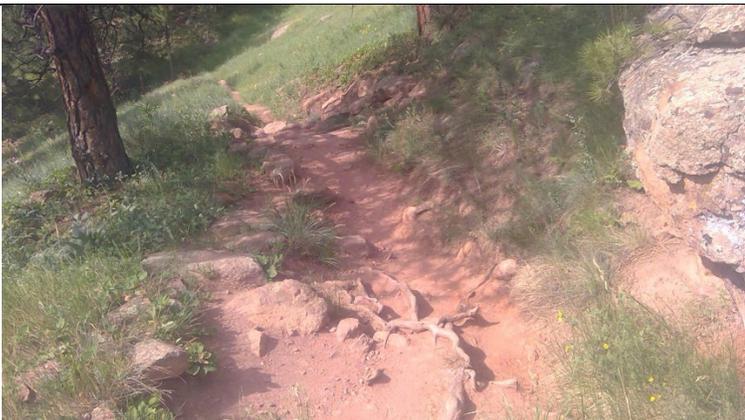
<p>Moderate Damage: Trail tread is gullied, often with exposed roots or loose rocks, and starting to affect travel for managed uses. AND/OR, eroded soils appear to be moderately impacting adjacent vegetation or water.</p>

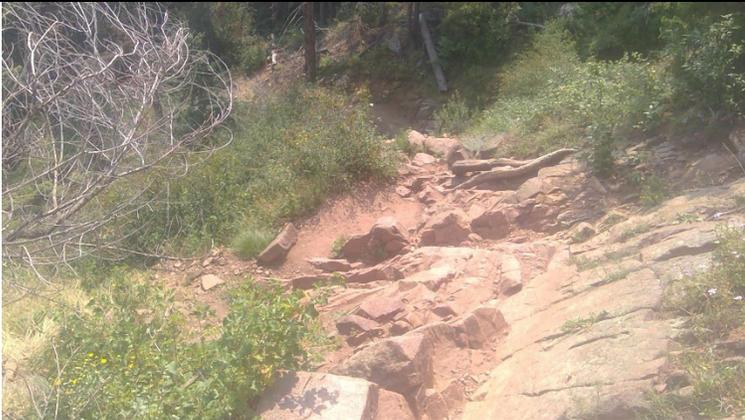
<p>Severe Damage: Trail tread is gullied, often with exposed roots or loose rocks, and preventing travel for managed uses. Original trail tread is not functional and trail impacts such as tread widening or braiding are visible. AND/OR, eroded soils appear to be significantly impacting adjacent vegetation or water.</p>

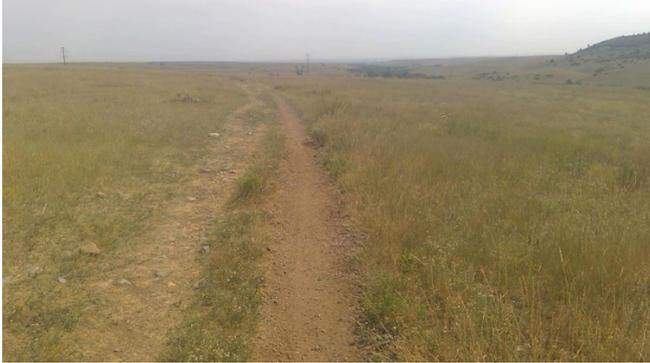
Multiple Tread Condition State	Representative Photo
<p>Mild Damage: Noticeably impeded vegetation growth; some vegetation cover loss; some organic litter pulverized within the tread; some bare soil exposed; tread intact.</p>

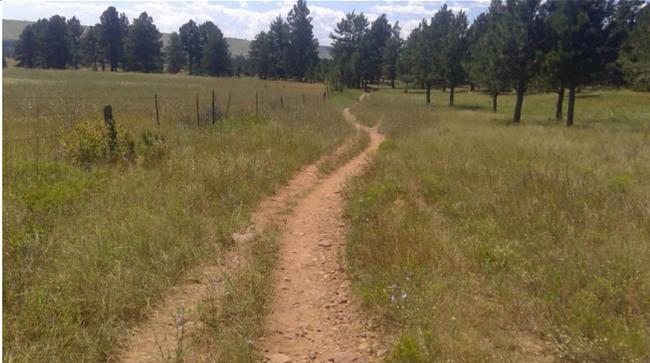
<p>Moderately Damaged: Nearly complete or total loss of vegetation cover; nearly complete or total loss of organic litter within the tread; bare soil widespread; tread mostly intact; some rills evident.</p>

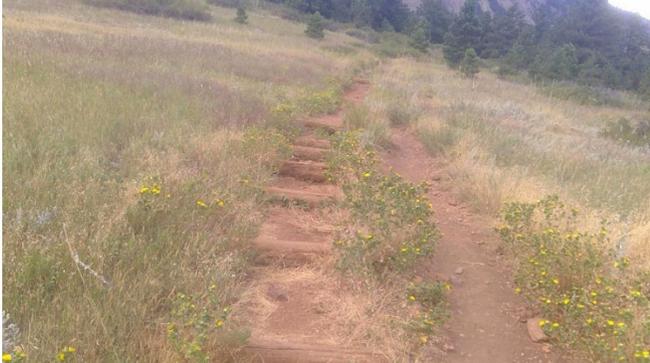
<p>Severely Damaged: Vegetation and organic litter are rare or nonexistent within the tread; active tread erosion evident.</p>

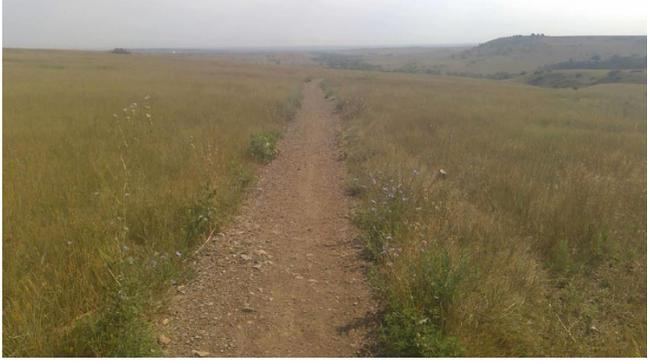
<p>Recovering Damage: Past tread erosion evident; vegetation is reestablishing because tread is no longer usable.</p>

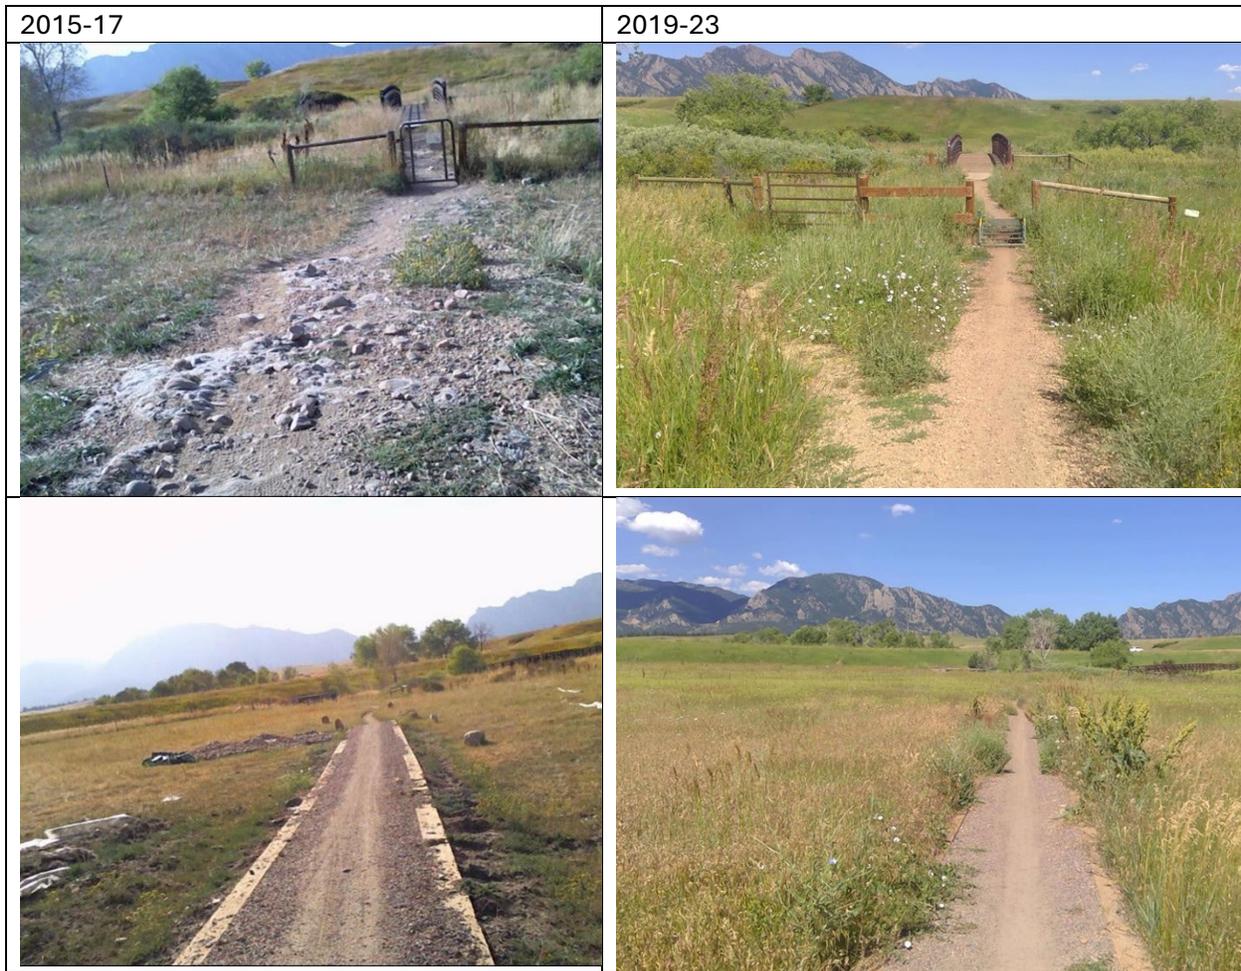
Table 12: Representative photos of how photo point monitoring can provide insight into trail condition changes

The HETAP survey equipment used for trail condition monitoring automatically records a photo at each station (approximately every 14ft). Photo points demonstrate the dynamic nature of trails and surrounding vegetation and are a powerful tool to help evaluate the effectiveness of trail design techniques over time. Table 12 shows examples of how photo points can be used to further understand changes in condition at specific locations around the trail system.
