GLEN HUNTINGTON BANDSHELL

RESOURCE ASSESSMENT REPORT

DRAFT MARCH 2021

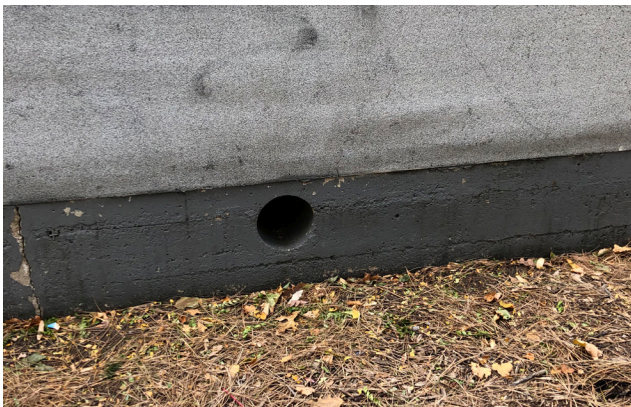
Overall, the foundation is in good condition. There is one vertical crack in the east foundation wall which is likely a naturally formed expansion joint (Figure 1-16) and the west foundation wall is covered in ivy which can be detrimental to the structure over time. There are relatively regularly spaced vertical cracks in foundation wall along the front of the stage that are likely natural formed expansion joints. The concrete buttresses on both sides of the largest arch have horizontal cracks at the same height; these are likely cold joints from the original concrete pour during construction. Both the vertical expansion joint cracks and the horizontal cracks at the cold joints are not of structural concern.

Figure 1-16. Vertical foundation crack on the east side, 2020 (source: Ratio and JVA)

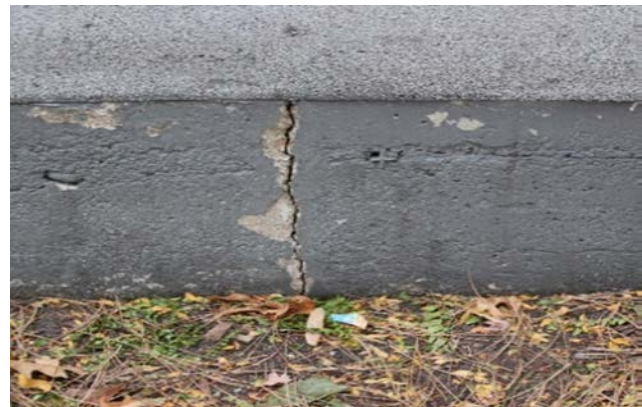
Figure 1-17. Vertical foundation crack on the east side, 2020 (source: Ratio and JVA)

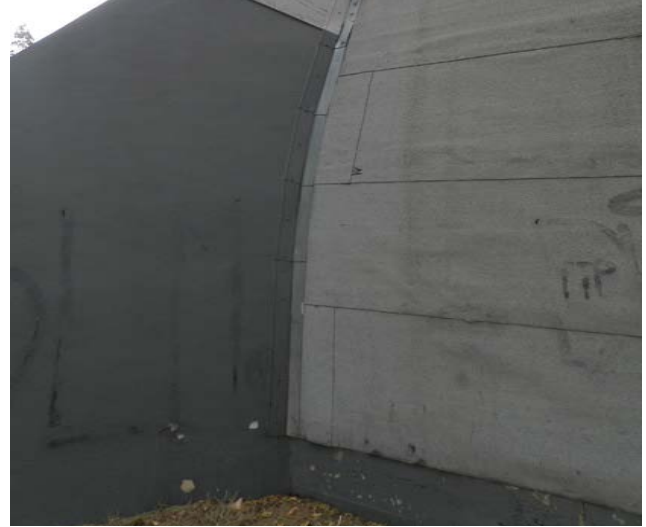
Figure 1-19. View of rolled asphalt roofing. Note the blistering at the lower portion of the roof, 2020 (source: Ratio)

The lower portions of the asphalt roofing extend down to the concrete foundations and appear to have been subject to vandalism. The lower portions also show signs of blistering and separation from the surface below and are in fair to poor condition. The upper portions of the rolled asphalt roofing appear to be in better condition with minor signs of blistering. On the east end of the roof, one area of the asphalt roofing has been patched with a different material.

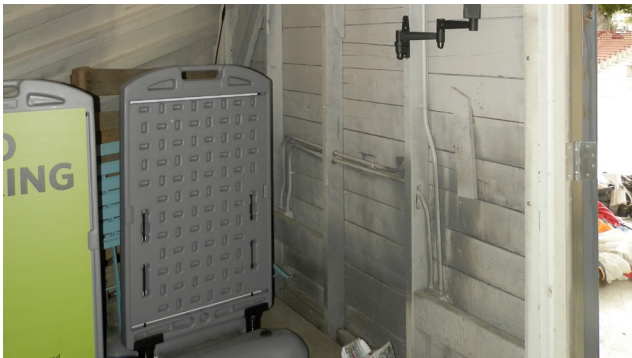
The majority of the structural wood framing is concealed within the exterior finish materials and was unable to be observed. The floor access hatch did not appear to be operable, therefore the stage framing was also unable to be observed. Within the small storage room at the back of the stage the framing appears to be in good condition. The wood siding is in fair condition with some boards split along the grain.

Figure 1-20. View of wood siding, 2020 (source: Ratio)

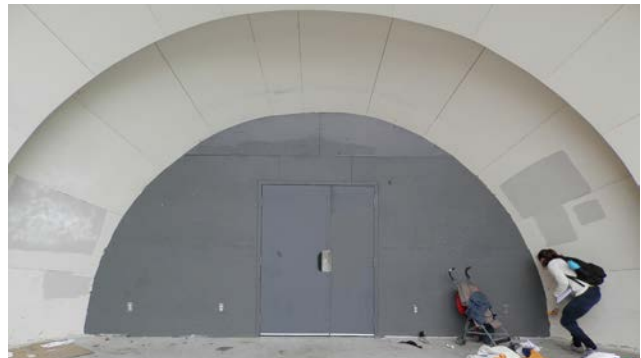
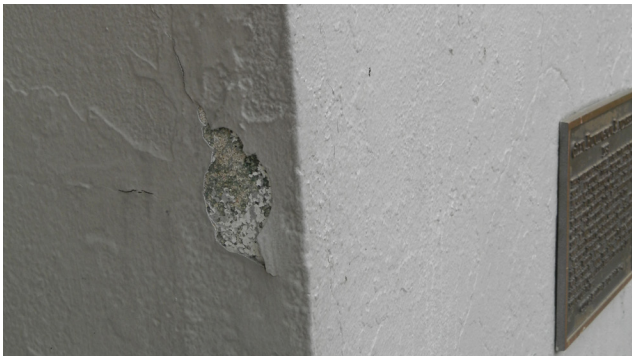
In general the exterior plywood finish panels appear to be in fair condition. The panels have minor weathering and mostly aesthetic damage due to frequent vandalism. At the top most proscenium arch, the rear-facing plywood appears to have more significant weathering. The rear wall of the Bandshell, on the exterior, has plywood panels that are covered with ivy. Damage to the wood is anticipated beneath the vines.

Figure 1-21. View of exterior plywood finish panels, 2020 (source: Ratio)

Figure 1-22. View of exterior plywood finish panels, 2020 (source: Ratio)

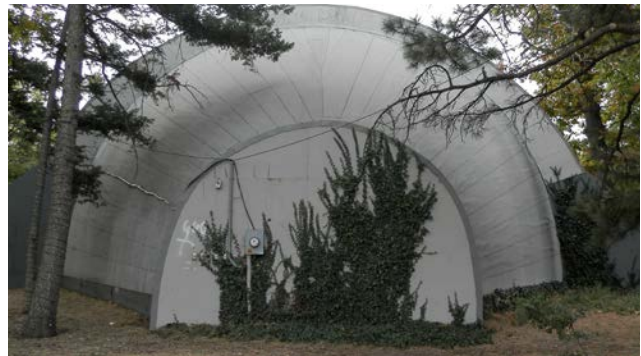
Figure 1-23. View of ivy growing on rear wall, 2020 (source: Ratio)

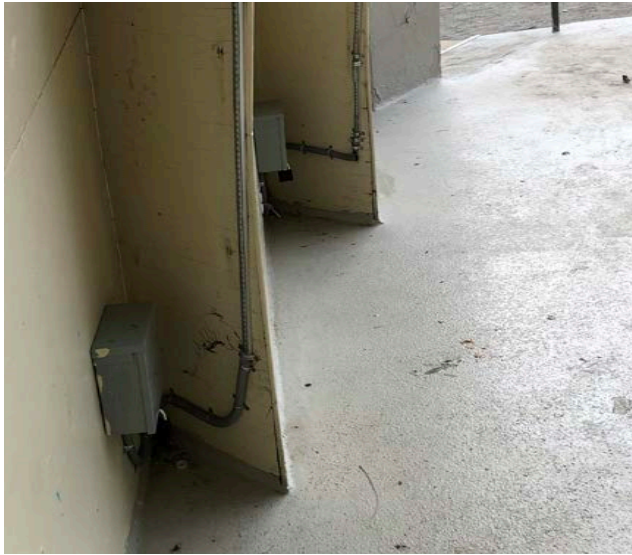
Figure 1-24. View of stage floor, 2020 (source: Ratio)

The stage flooring appears to be finished with a textured underlayment and a liquid polyurethane coating that acts as waterproofing for the floor. The overall surface which is in good condition. There is evidence of previous vandalism damage in one location where the color of the surface does not match the rest of the flooring.

Although the framing was not visible during the observation visit, no major issues such as excessive deflection or signs of deterioration were observed on the floor surface. However, since the Bandshell is an open structure, it will be more prone to moisture damage. This should be further investigated in the next phase of work to determine the current condition of the floor framing.

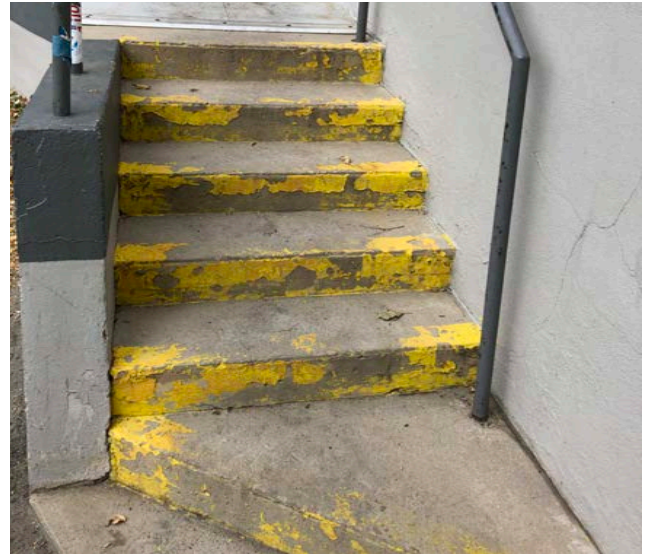
Figure 1-25. View of concrete stairs. Note the yellow safety nosing paint condition is poor, 2020 (source: Ratio)

The concrete at both stairs appears to be in good condition. The yellow safety nosing paint is in poor condition. The painted steel handrails are in good condition, with portions of the painted finish worn off. The handrails do not appear to be in compliance with current accessibility codes.

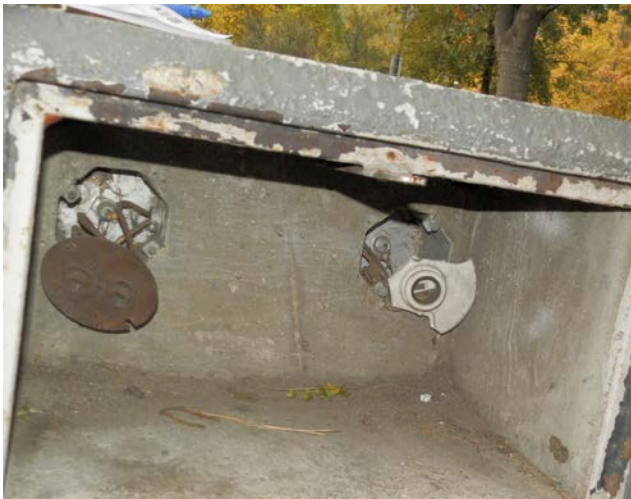
The power and lighting bollards do not show any major cracking or damage. The metal cover plates are either missing or in poor condition with rusted and broken hinges. The receptacles within do not appear to be functional and contain two 2-pronged outlets with no ground wire. The lighting has been removed and the power boxes exposed.

Figure 1-26. Interior view of lighting and power bollards. Note the cracking concrete forms, rusted and broken cover plates, as well as missing components, 2020 (source: Ratio)

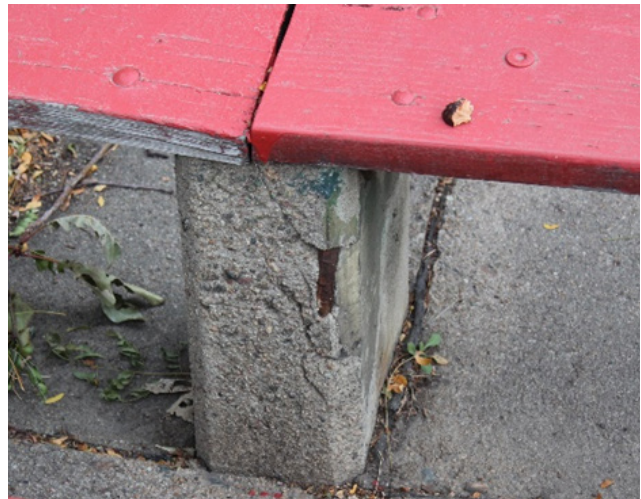
The site includes seating facing the Bandshell stage. The seating consists of a concrete slab that slopes toward the stage and rectangular reinforced concrete pedestals which support wood bleachers. Steel angle clips are used to connect the wood bleachers to the concrete. Many of the concrete pedestals have started to spall (Figure 1-26). In some spall locations, the exposed rebar appears to only have had 1/4-inch cover. Some pedestals have areas of spider-web cracking and areas where the cement binder has weathered, exposing the larger aggregate. The painted wood bleacher boards show signs of wear such as splitting, warping, and crushing at the connection locations.

Figure 1-27. Seating showing spall at pedestal, 2020 (source: Ratio)
