BOYD SMELTER/MILL SITE

RESOURCE ASSESSMENT REPORT

DRAFT MARCH 2021

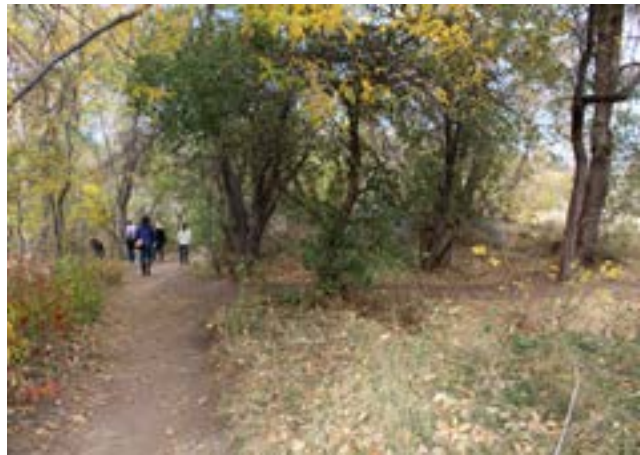
Many remnant extant small-scale features are along the soft surface trail. The soft surface trail varies in width and it rutted in some locations. This trail does not meet ADA accessibility requirements.

Figure 1-4. Soft surface trail adjacent to Boulder Creek, 2020 (source: Mundus Bishop)

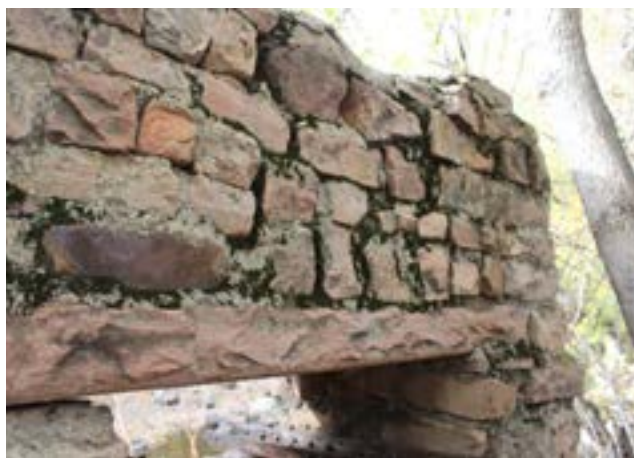
Overall, the masonry pylons are in fair condition. Although there are no signs of major failure or displacement, there are several issues that could be improved to increase the longevity of the pylons. Most of the following were identified at the north pylon due to access, but likely occur at the other pylons as well. Several of the masonry units, primarily the reused concrete, have cracked. Some stones are missing. In some areas, mortar is missing between the stones. Additionally, the mortar is quite hard or cementitious for direct contact with the softer stones (i.e. the sandstone). The parge coat cap atop the masonry pylon is cracked and does not cover all elements. Biogrowth on the masonry is abundant in shady areas of the pylons. The pylons directly adjacent to the banks of Boulder Creek are slightly undercut due to scour from the moving creek water.

Figure 1-12. Biogrowth and areas of missing mortar, 2020 (source: JVA)

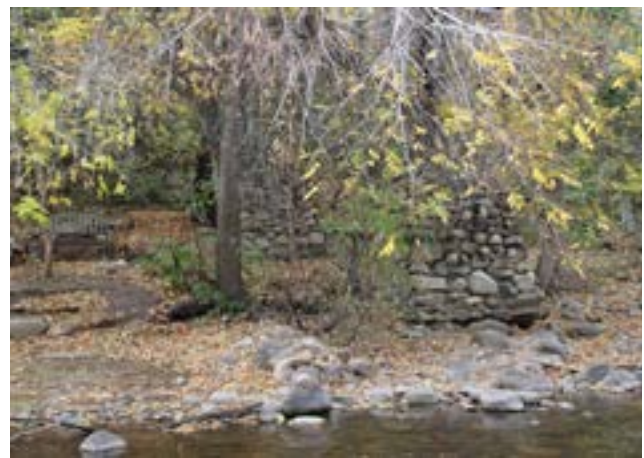
Figure 1-13. Southern pylons on south side of Boulder Creek, 2020 (source: JVA)

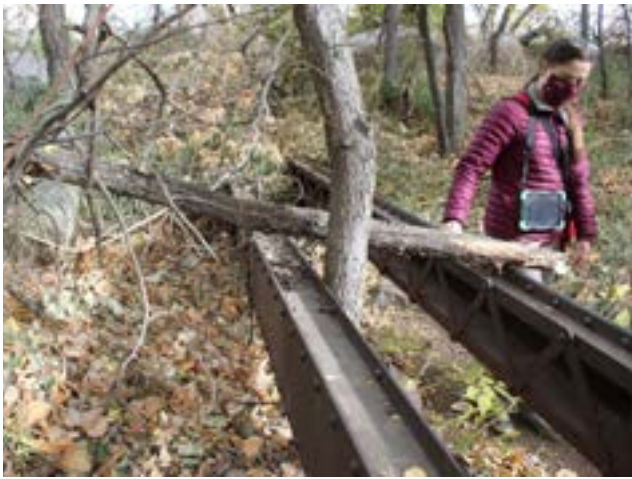
Extending north from the northernmost pylon are two built up girders. These elements consist of a vertical plate riveted to a channel at the top and bottom. The open side is faces with a lattice of thin steel strips. At the south end, they bear on the masonry pylon while at the north end they now bear on grade.

The girders are in fair condition. Although they are structurally stable, the north end of the girders are currently buried in the earth. If there is no substantial foundation element below these ends, the soil could settle and cause the north end of the girders to settle as well. Also, there are areas of the girders where rust has started to form due to exposure to the elements. Lastly, there are trees and other plant growing in close proximity to the steel girders that could cause the steel girders to displace down the road if the plants grow larger.

Figure 1-14. Steel girders extending from northernmost pylon, 2020 (source: Mundus Bishop)

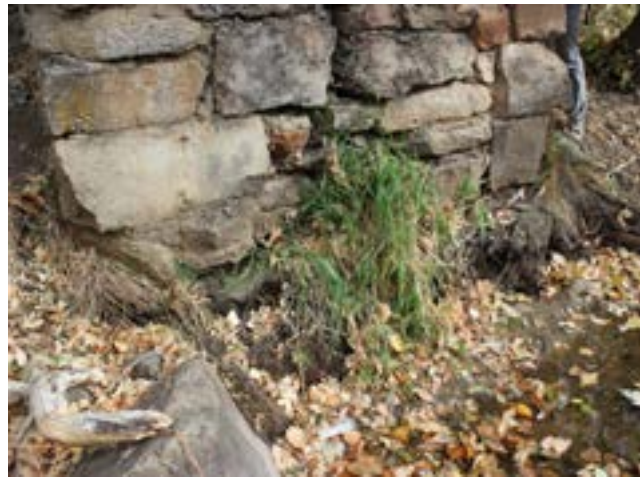
Figure 1-15. Base of north pylon. Note the scour at the creek bank's edge, 2020 (source: JVA)

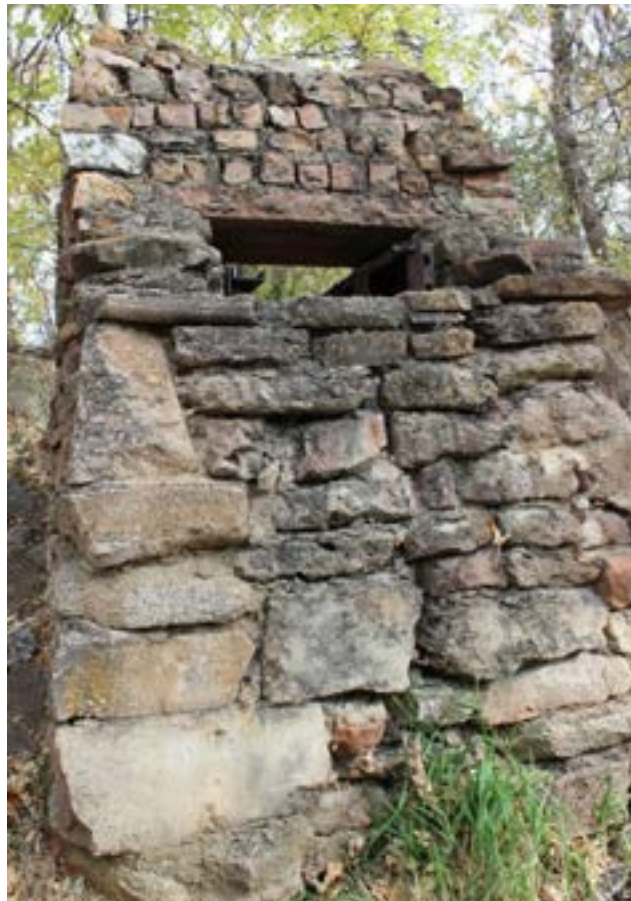
Figure 1-16. South face of north pylon, 2020 (source: JVA)

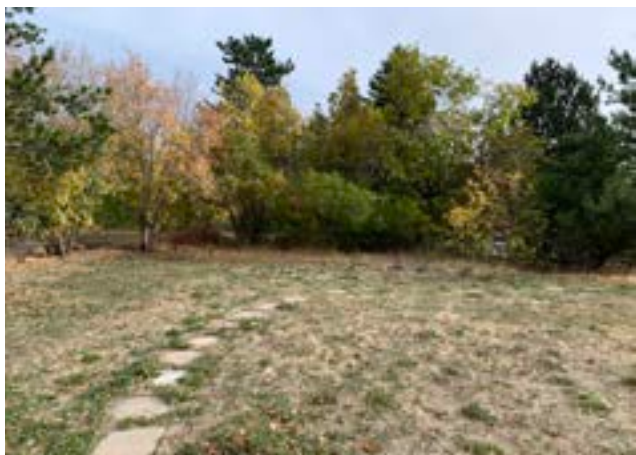
Xeriscape Garden - These pavers were installed after the construction of Boulder Creek Greenway. Little is known about the garden or the stone pavers arranged in three large circles.²³ The feature is in poor condition (Figure 1-17).

Figure 1-17. Pavers from xeriscape garden, 2020 (source: Mundus Bishop)

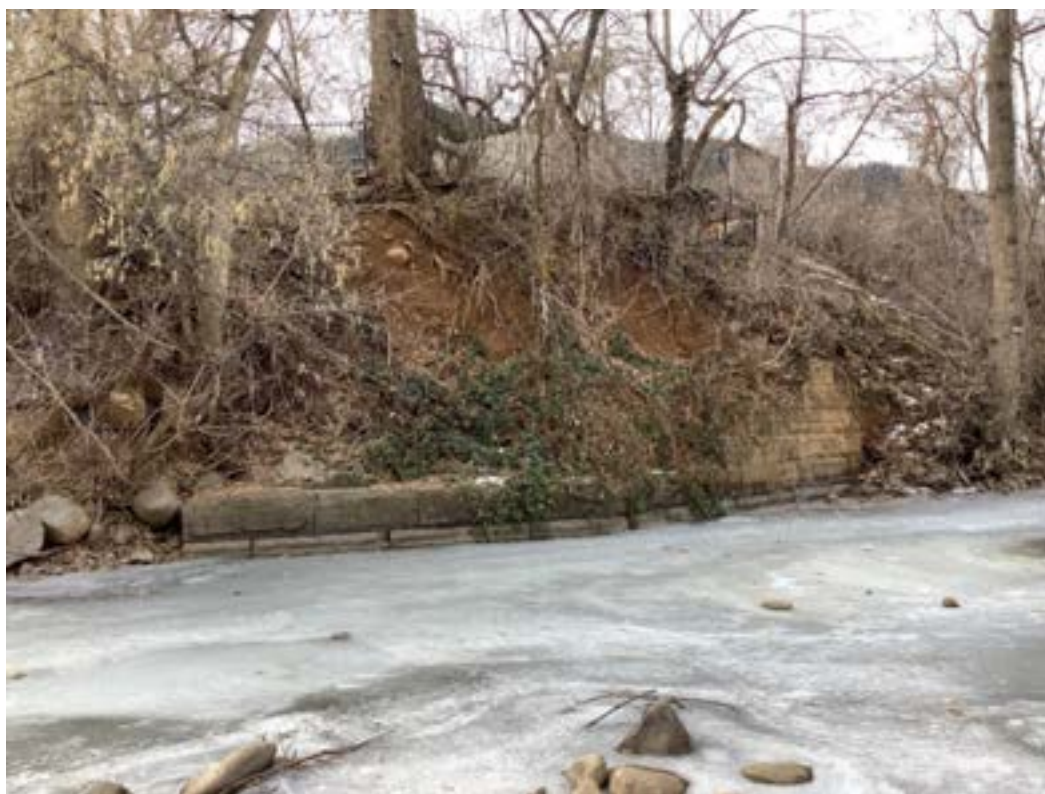
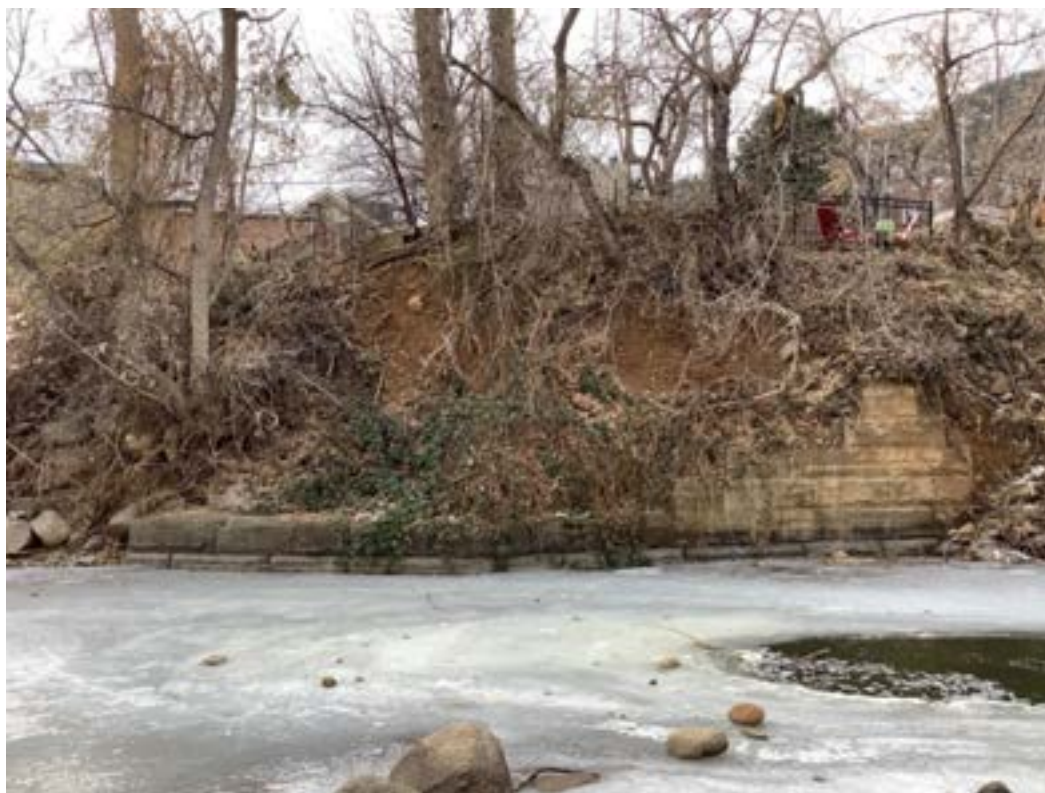
Feature 1: Railroad bridge foundation stones/retaining wall. Located on the south bank of Boulder Creek, F1 comprises a two-course limestone block wall built into the cut bank. This feature doubled as a retaining wall and support structure for the Switzerland Trail railroad (Smith 1998). After this feature was first documented in 1998 (Smith), a modern concrete block retaining wall extension was constructed on top of the west end of F1. In addition, remnants of the north support that Smith observed “scattered along Boulder Creek” are no longer present. Because this feature is bounded by Boulder Creek to the north and private property parcels to the east, south, and west, PaleoWest was unable to access the structure to take detailed measurements. We estimate that the Historic-period portions of F1 measure approximately 30 feet long × 5 feet tall.

Figure 6. 5BL7094, Feature 1, facing southwest. A. Cool, 12/10/2020.

Figure 7. 5BL7094, Feature 1, facing south. A. Cool, 12/10/2020.

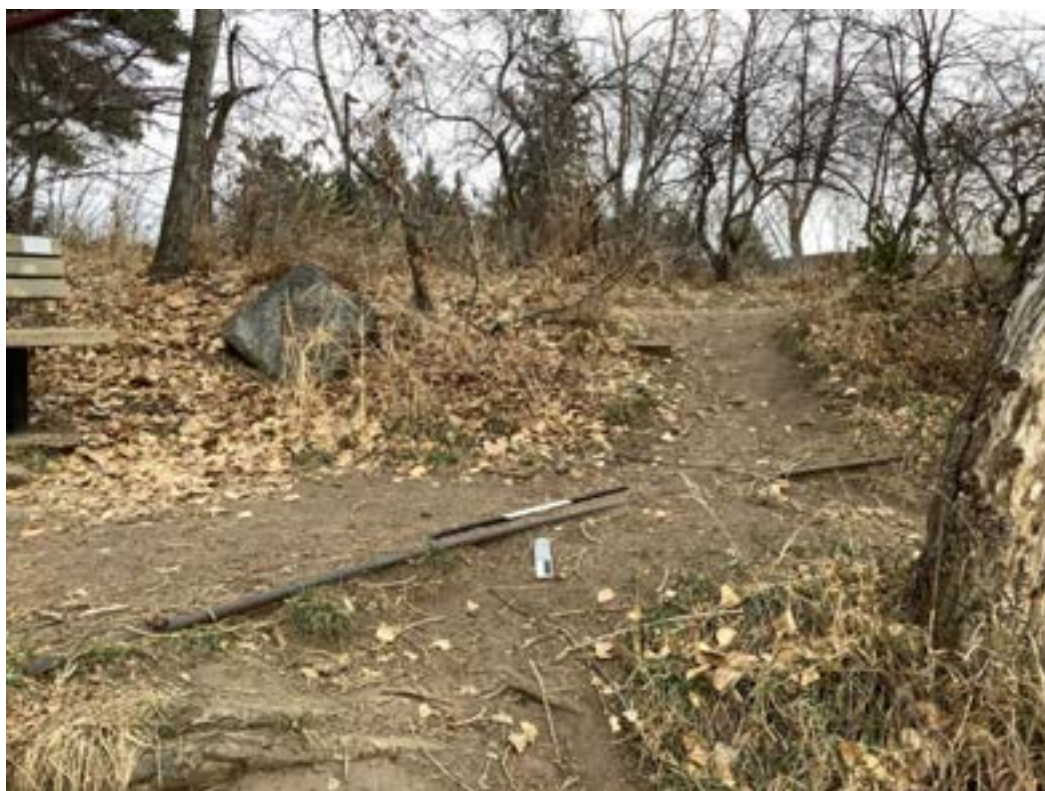
Two artifacts were found in association with F1. A fragment of a railroad tie and a rail segment embedded along the north bank appear to have been repurposed for erosion control. The rail tie measures 2 inches wide × 3.75 inches tall × 14 feet long.

Figure 8. 5BL7094, exposed rail and tie on north bank near Feature 1, facing north. A. Cool, 12/10/2020.

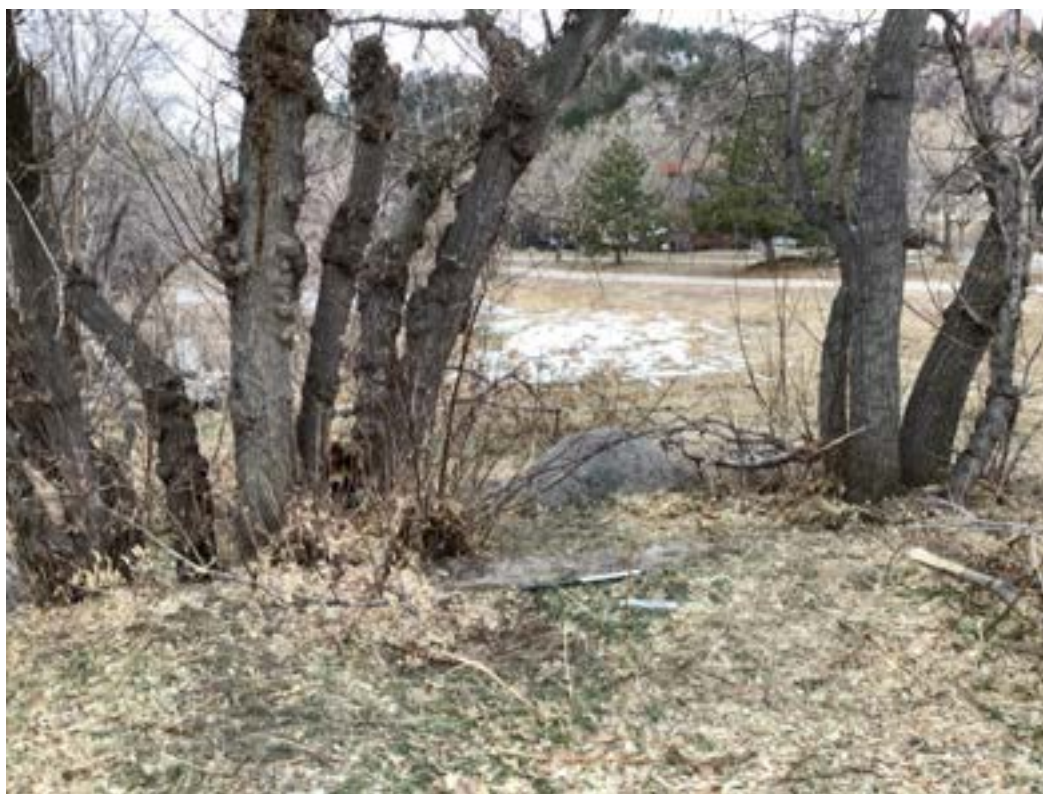
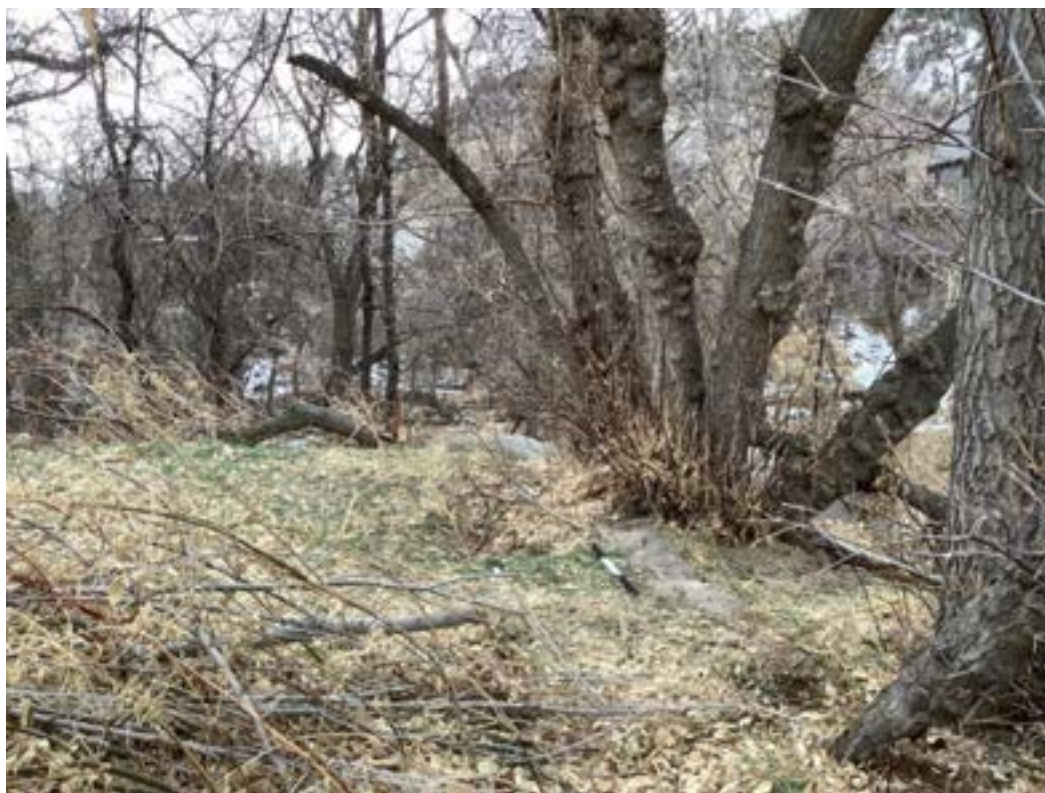
Feature 4: Feature 4 comprises an exposed concrete wall located near the west edge of the F3 west mound. The wall is oriented north-south. Most of the wall is buried within the F3 west mound; only the top of the wall is visible, flush with the ground surface. It measures 1 foot wide × 14 feet long. F4 is likely a foundation wall of the former smelter building.

Figure 26. 5BL7094, Feature 4 exposed wall, facing west. A. Cool, 12/10/2020.

Figure 27. 5BL7094, Feature 4 exposed wall, facing south. A. Cool, 12/10/2020.

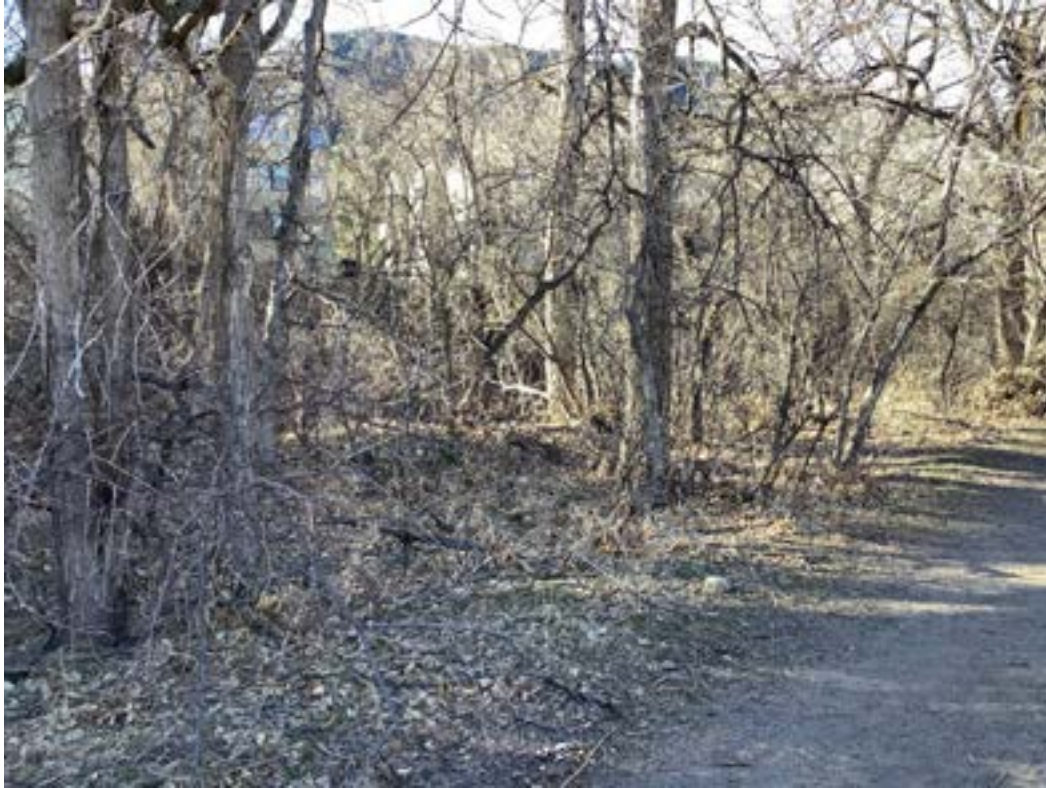
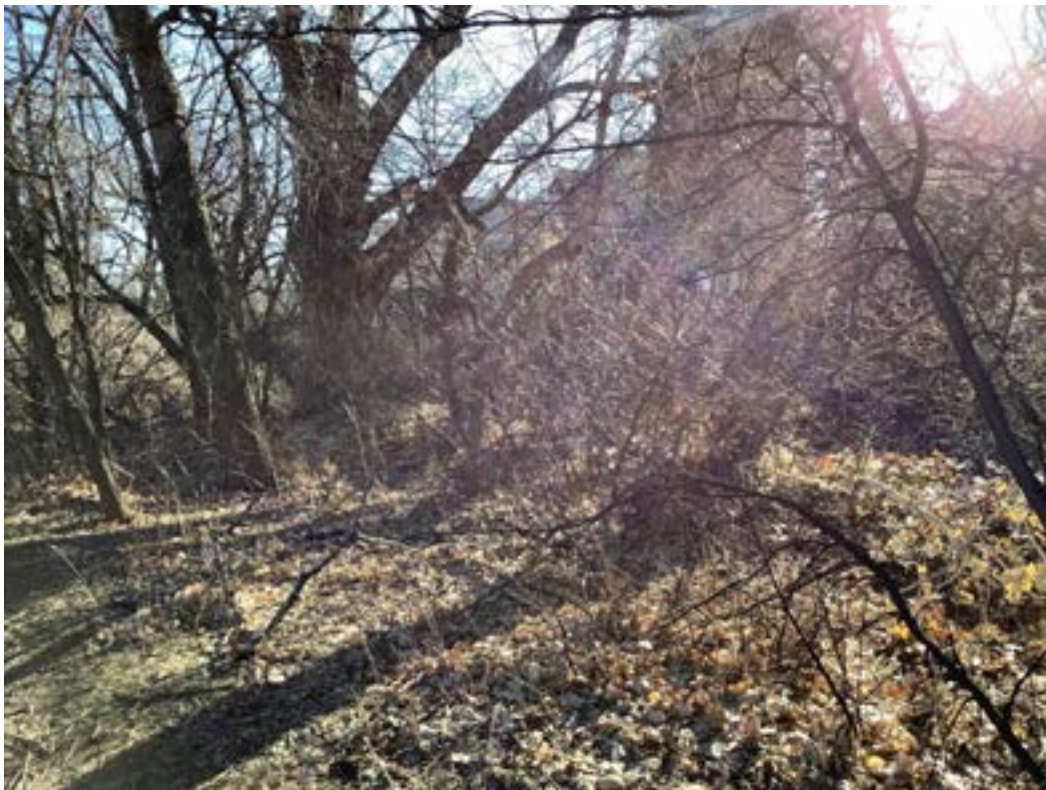
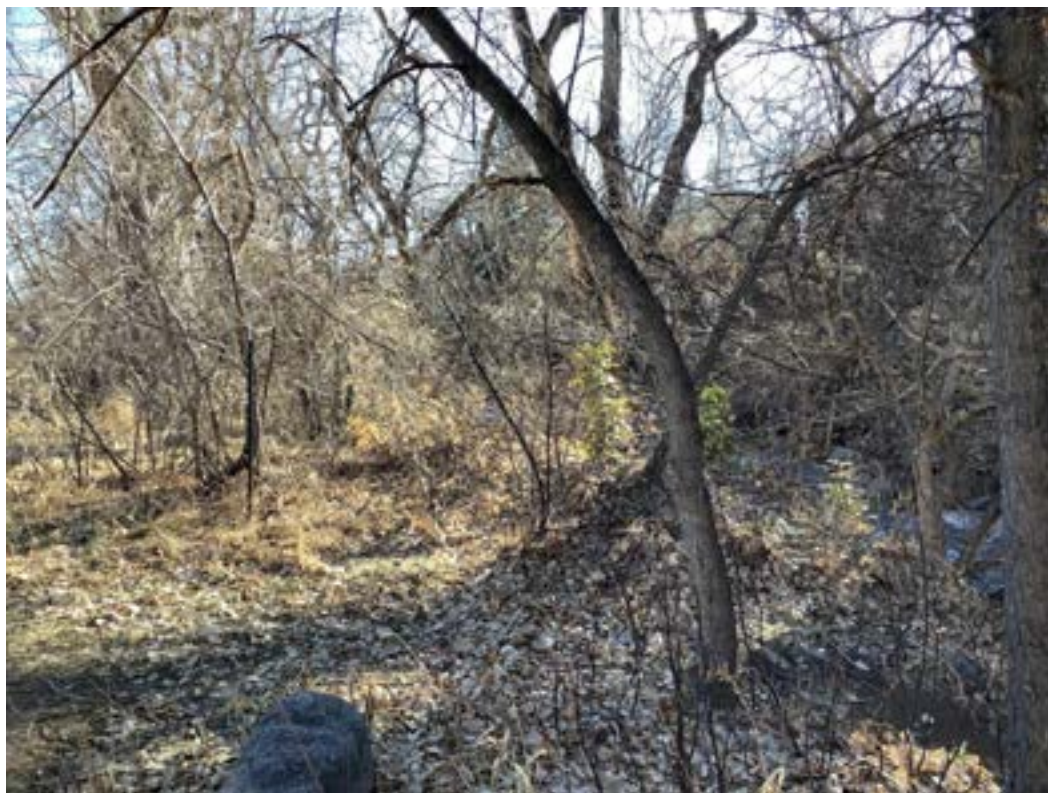
Feature 8: Feature 8 comprises an earthen berm located in the west half of 5BL.7094, between Boulder Creek to the south, F9 to the west, a dirt walking trail to the north, and Sunshine Creek to the east. This irregular berm measures approximately 234 feet long overall. It is broken into three sections measuring (from east to west) 49, 88, and 40 feet long. Each berm segment varies in height and width, averaging 6 feet wide at the base × 3 feet tall. This berm once formed the south retaining wall of the west retaining pond (Smith 1997, 1998). However, F8 was likely modified in recent years during construction of the adjacent walking trails and the catastrophic flood of September 2013. In addition, PaleoWest did not identify the parallel berm formerly located on the north side of the west retaining pond (Smith 1997, 1998); any such feature was likely destroyed during the construction of the Boulder Creek Path.

Figure 37. 5BL7094, Feature 8, east segment, facing southwest. A. Cool, 1/14/2021.

Figure 38. 5BL7094, Feature 8, center segment, facing southeast. A. Cool, 1/14/2021.

Figure 39. 5BL7094, Feature 8, west segment, facing southeast. A. Cool, 1/14/2021.
