CHAUTAUQUA GREEN

RESOURCE ASSESSMENT REPORT

DRAFT MARCH 2021

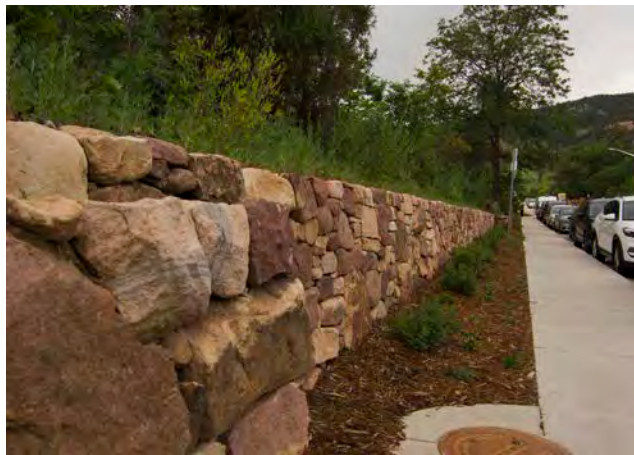
Retaining Walls – The northern edge of the park is lined with several segmented retaining walls parallel to Baseline Road. The walls originally terminated at the Queen's Gate, but five additional sections of wall were built in 2017, extending to the vehicular entrance at Grant Street. At the King's Gates' stone towers, the retaining wall pivot south to form two parallel walls on both sides of the eastern sidewalk (Figure 1-33). The materials of the newer walls are compatible with the rustic character of the site (Figure 1-9).

Figure 1-9. Newer retaining walls built in 2017 (source: Mundus Bishop)

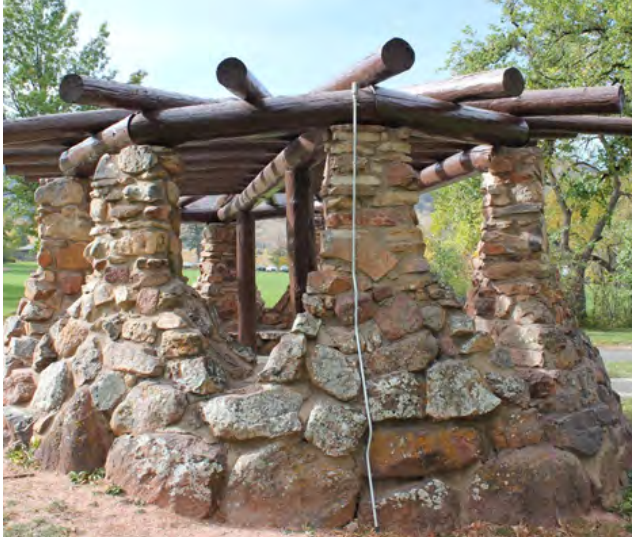
The stone piers are structurally in good condition; however, there are areas of significant mortar erosion, especially around the bases of the piers, and patches of mortar repointing which are not compatible with the original structure. The stones near grade have a significant amount of lichen growth. This does not compromise the structure itself but changes its appearance and is an indication that moisture is prevalent. This indicates that more frequent maintenance of the mortar joints may be necessary. The timber posts have vertical cracks or checks; these are shrinkage cracks and are not of structural concern.

Figure 1-17. The Arbor looking West, note lichen growth and eroded mortar joints, 2020 (source: JVA)

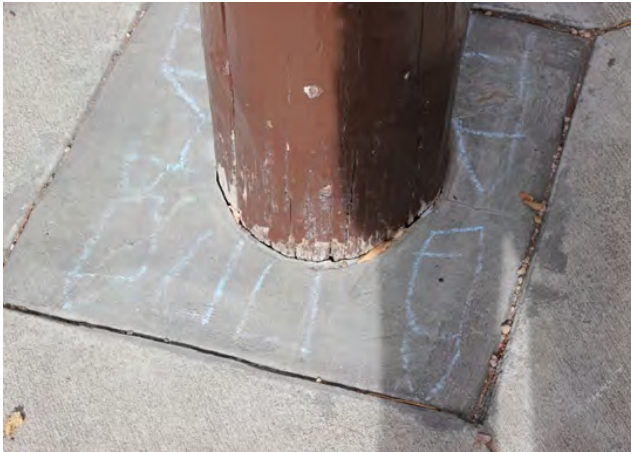
Overall, the foundation of the stone piers is in good condition. There is no evidence of settlement or settlement related cracking. The east timber post shows signs of decay at its base which bears directly on its foundation element and is tightly surrounded by the concrete sidewalk, both of which encourage moisture to remain rather than dry. (Re: Figure 1-19) The west post has new concrete around its base, indicating that it could have been recently replaced; however, this bearing condition could lead to the same moisture related decay pattern in the future.

Figure 1-19. Decay at base of timber post, 2020 (source: JVA)

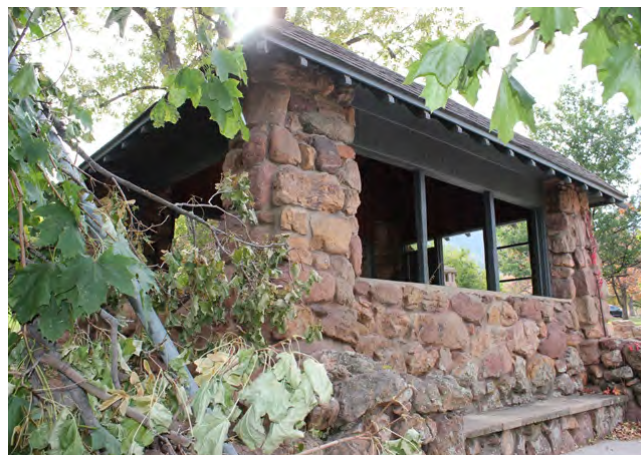
Figure 1-24. North wall of the Shelter House, 2020 (source: JVA)

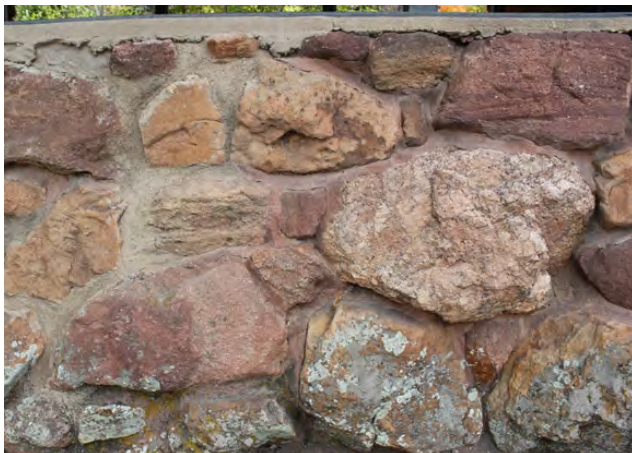
The stone walls are in good condition. There are patches of mortar repointing that are not compatible with the original structure. They are beginning to crack and separate from the stones indicating that the repointing mortar is too strong. Additionally, the repointing is a different color (Re: Figure 1-25). There is a vertical crack through the mortar joints in the northwest buttress that is caused by differential thermal expansion between the buttress and the main wall. (Re: Figure 1-22) Lichen growth is present at the bottom two feet of the north wall.

Figure 1-25. Repair mortar – note red color and separation cracks, 2020 (source: JVA)

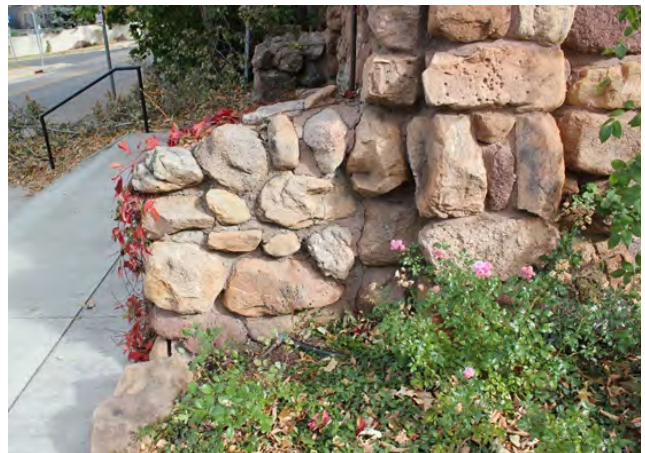
Figure 1-26. Differential settlement crack at northwest buttress, 2020 (source: JVA)

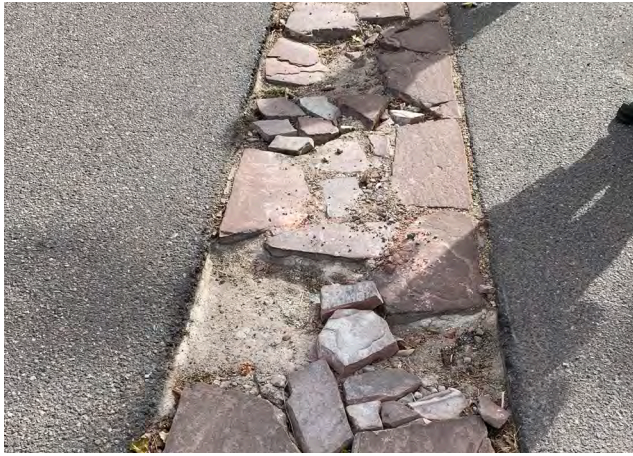
Stone gutters– Rustic stone gutters line portions of Kinnikinic and Sumac Drive. The original gutters were likely built in 1907 when the roadway was graveled. Due to the material choice and seasonal wear, these gutters require heavy maintenance, and many of them are in fair/poor condition. Portions of the gutters have been replaced over time, and it is unclear how many historic gutters remain. In 1987 stone gutters at Sumac Drive were rebuilt when the road was narrowed. These have a steep side slope and are sandstone set in concrete and are non-contributing (Figure 1-39). The City recently replaced a portion of the gutters using compatible materials and these are in good condition (Figure 1-40).

Figure 1-38. Broken stone gutter along main drive, 2020 (source: Mundus Bishop)

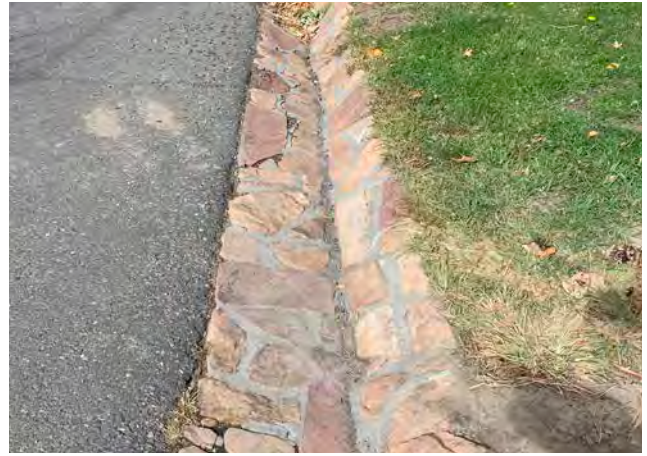
Figure 1-39. Non-contributing gutter along Sumac Drive, 2020 (source: Mundus Bishop)

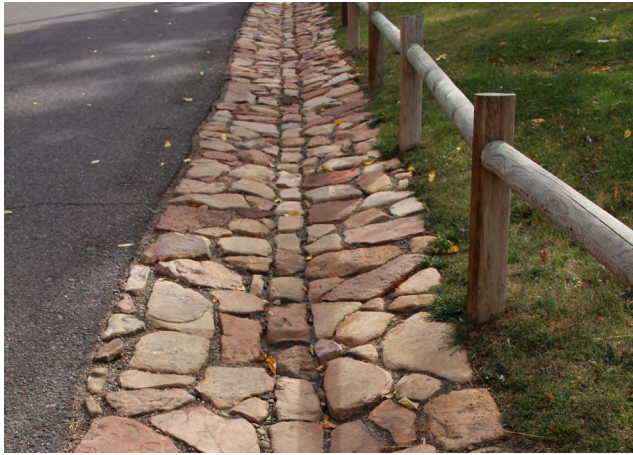
Figure 1-40. Recently installed stone gutters with compatible materials (source: Mundus Bishop)
