BOULDER FIRE STATION NO. 2

RESOURCE ASSESSMENT REPORT

DRAFT MARCH 2021

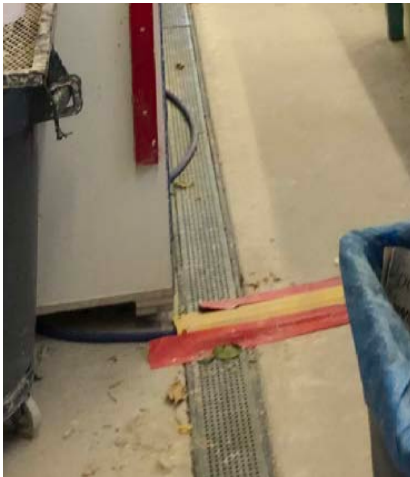
Floor Slab: The lower level floor slab appears to be in good condition. A good deal of furniture covers the flooring, however, from what was able to be observed, there was no evidence of major damage. There is a metal panel inset in the slab near the lower level restroom. A large trench drain runs north to south through most of the open floor area.

Figure 1-4. View of linear floor drain, 2020 (source: Ratio)

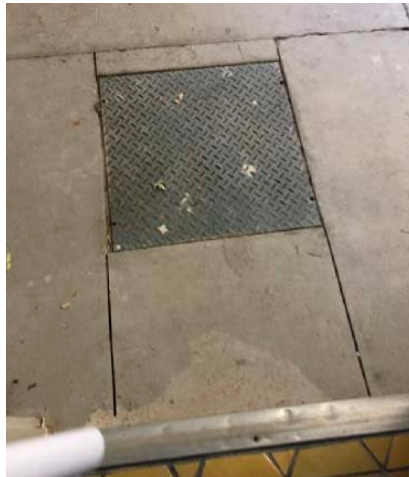
Figure 1-5. View of steel panel in building slab, 2020 (source: Ratio)

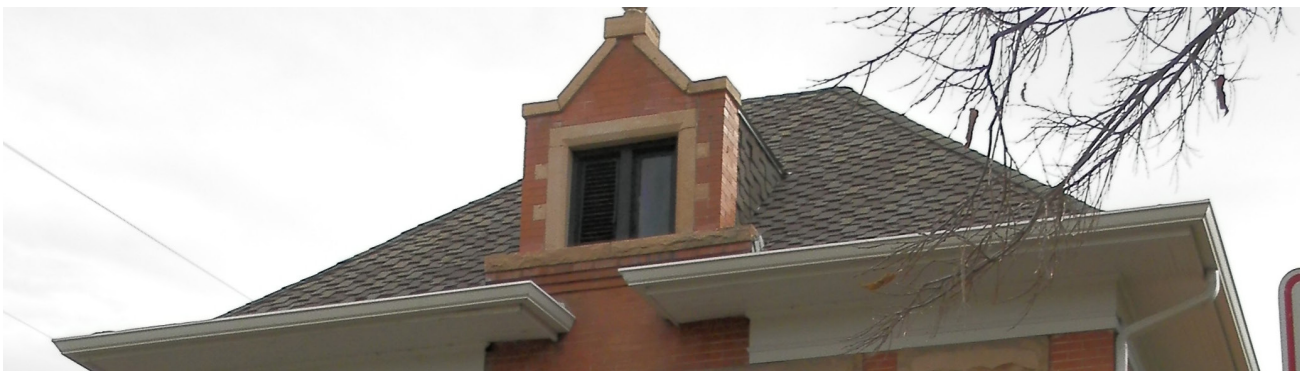
Without roof access, the full conditions of the existing roof were unable to be verified. Of what could be seen from ground level, the existing shingles appear to be in good condition. The roof soffits also appear to be in good condition. The gutters and downspouts do not appear to be original to the building.

Figure 1-6. View of roof, 2020 (source: Ratio)

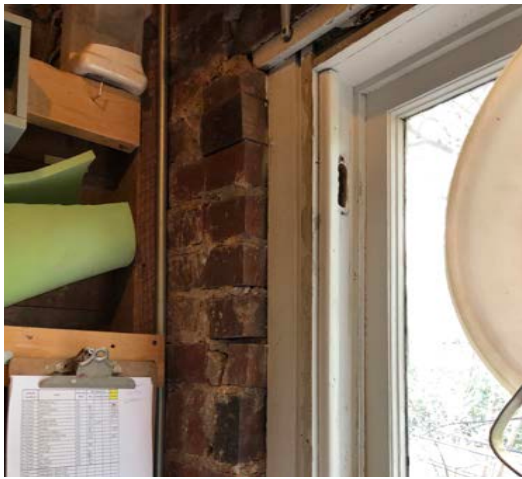
Figure 1-7. View of brick at upper window, 2020 (source: Ratio)

Brick: Overall the existing brick walls appear to be in good condition. There are numerous places where the joints appear to have been repointed at some time in the past. There is also an area of damage near the main entry door on the north end where the brick appears to have been treated for graffiti removal and has a darker color than the rest of the wall. The interior brick walls are painted and appear in good condition. Brick around one window on the upper level is in poor condition, and in need of resetting and repointing.

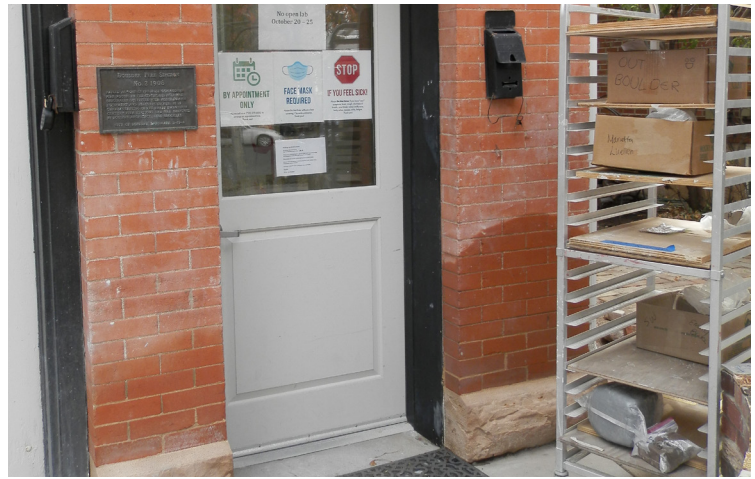
Figure 1-8. View of sealant on brick, 2020 (source: Ratio)

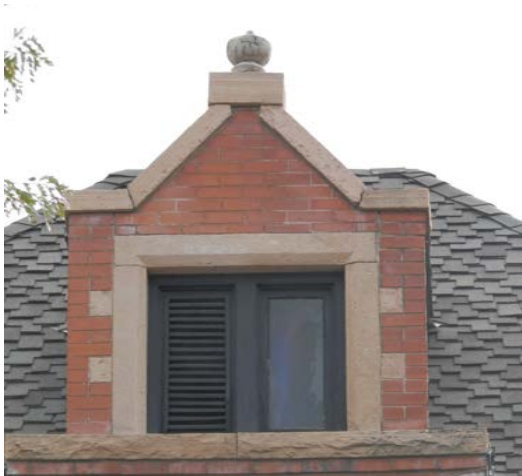
Figure 1-9. View of stone detailing, 2020 (source: Ratio)

Stone: Stone was used for window lintels, the building foundations and additional detailing throughout. The stone show evidence of weathering, but structurally and functionally seems to be in good condition. One lintel appears to have been replaced with concrete to allow for the installation of the exterior staircase.

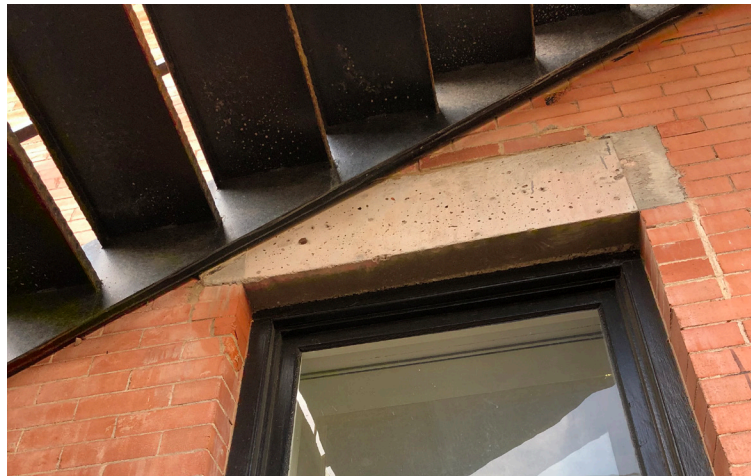
Figure 1-10. View of lintel below exterior stair, 2020 (source: Ratio)

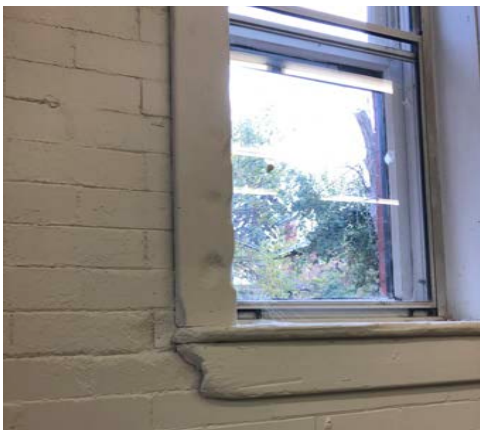
Windows: The window frames appear to be in fair condition. There is considerable damage on the windowsills throughout. Many of the windows have interior storm windows installed. The wood window frames appear to have mostly cosmetic dirt and damage from the ceramic studio use. The lower level windows have been painted. Additionally, on the lower level, one of the wood window frames sustains the damage the frame had originally received from the horse that was stabled there chewing on the wood.

Figure 1-11. (Left) Lower level window with horse damage, 2020 (source: Ratio)

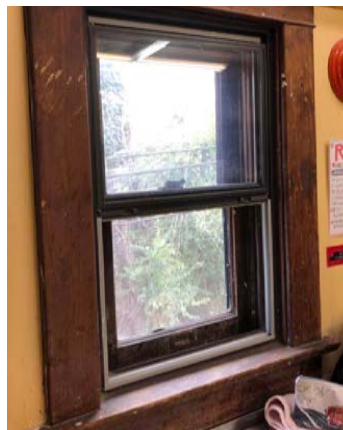
Figure 1-12. (Right) Upper level window with interior storm, 2020 (source: Ratio)

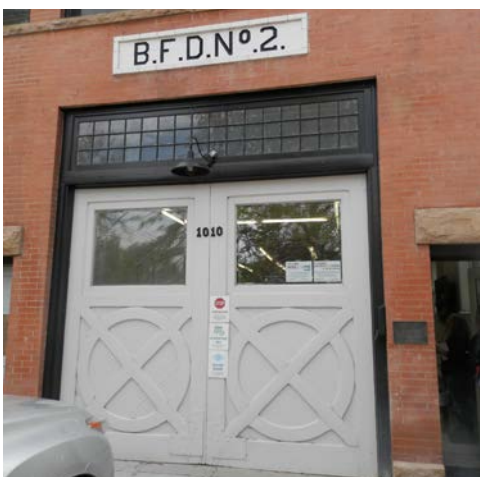
Doors: The main double garage doors at the north end of the building appear to be the original doors. The wood is painted, and the doors appear to be in good condition. The side door on the east wall was cut to create access to the added storage area/loading area. Some of the upper level doors at the south end appear to be original, and in fair condition. The swing on several of the doors has been reversed. One door appears to have been repurposed to its current location and the top of the door cut off to fit the existing frame. The interior function of the rooms on the south end of the upper level has been revised from the original uses.

Figure 1-13. View of garage doors, 2020 (source: Ratio)

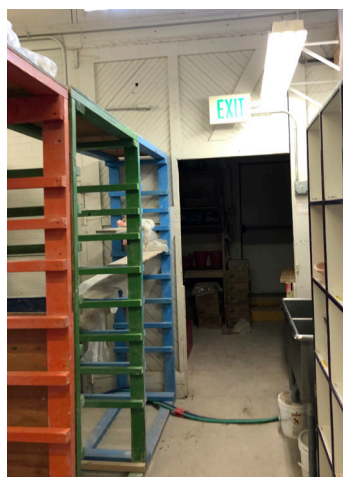
Figure 1-14. View of opening cut into original east doors, 2020 (source: Ratio)

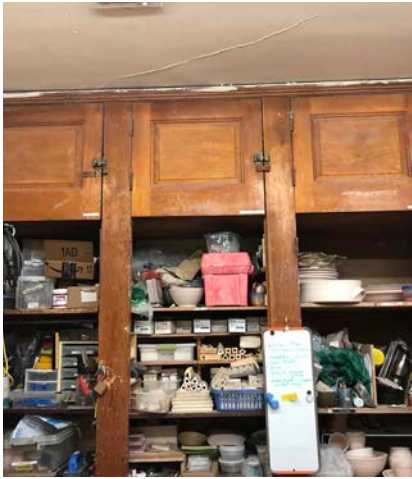
Figure 1-16. View of lockers, 2020 (source: Ratio)

Lockers: The general forms of the original lockers on the upper level are intact, however missing most of the front doors. The smaller doors on top are all in place. The lockers are currently used for storage and appear to be in fair condition.

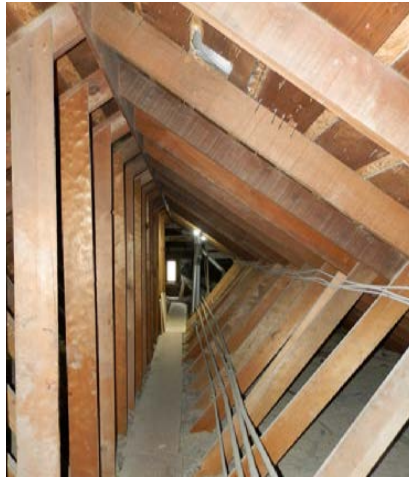
Figure 1-17. View of roof framing in attic, 2020 (source: Ratio)

Roof Framing: Ladder access to the attic is in one of the storage rooms on the south end of the upper level. Existing framing appears to be in good condition.

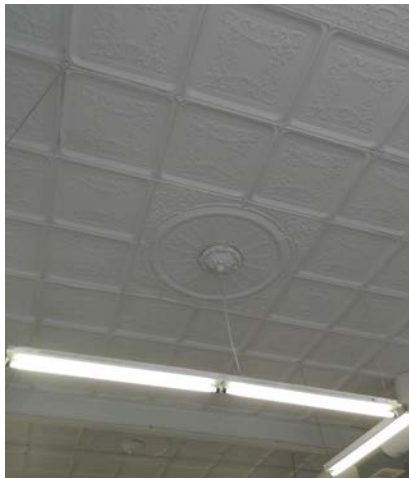
Figure 1-20. View of lower level ceiling, 2020 (source: Ratio)

Ceiling Tiles: Per owner input, the pressed metal ceiling tiles are not the original ceiling finish for the lower level. The panels are painted and appear to be in good condition when observed from eye level. The original opening for the fire pole has been filled in, and the pole removed.

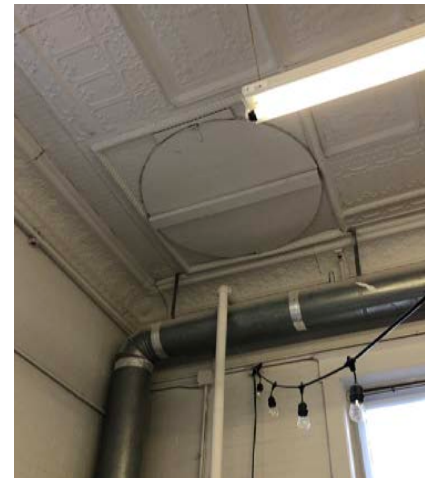
Figure 1-21. View of original fire pole location, 2020 (source: Ratio)

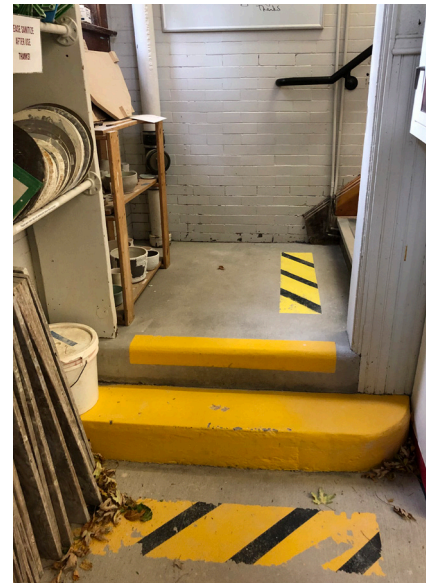
Interior Stair: The bottom steps are concrete and have painted edges in a contrasting color. Portions of the paint could use retouching, and there is some damage to the corner of the steps. The main portion of the stair is wood, with metal panels and nosings added to each step. The metal is worn, but functional. It is unclear the condition of the wood below, but the portions of wood that remain exposed are in fair to poor condition.

Figure 1-27. View of bottom of interior stair, 2020 (source: Ratio)

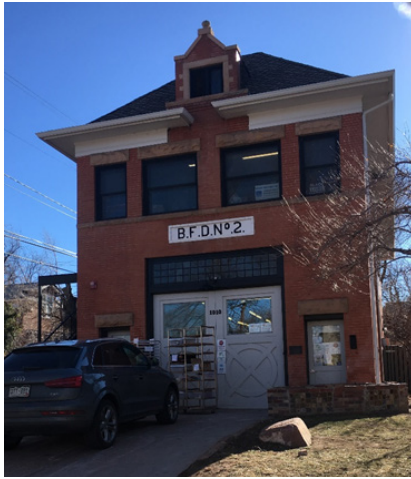
The brick and stone are in overall good condition and exhibit weathering consistent with their age. There are cracks located at brick supported over the large transom window and at the first-floor entry door. The chimney's mortar joints exhibit more weathering than the rest of the building.

Figure 1-28. Front of Fire Station No. 2, 2020 (source: JVA)

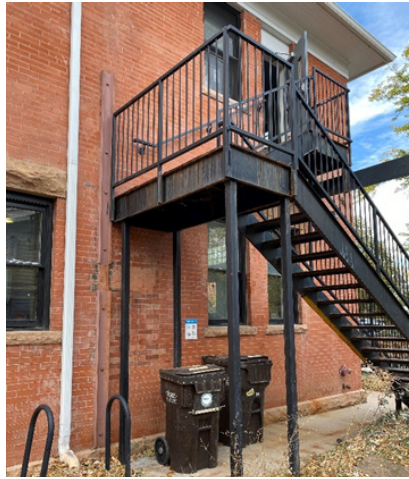
Figure 1-29. Fire escape on east side of building, 2020 (source: JVA)

The fire escape is in poor condition and has significant corrosion at the angles and decks.
