HARBECK-BERGHEIM HOUSE

RESOURCE ASSESSMENT REPORT

DRAFT MARCH 2021

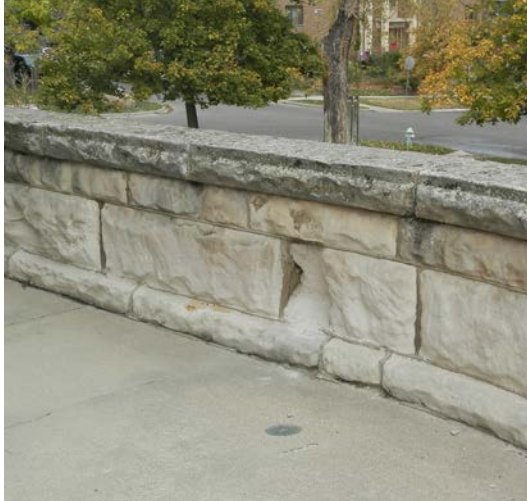
Front Porch: The walls surrounding the porch appear to be made of the same stone as the main building. Overall the stone is in fair shape, with a few areas that are in poor condition. The primary areas of concern are on the interior faces of the wall on the north side, and all around the main entry stair to the north. There is significant wear to the stone and mortar and large amounts of both have been weathered away, mostly likely from salts and chemical deicers. There has also been an issue with graffiti at the building, the removal of which has also caused damage to the stone at both the porch and the main building walls.

Figure 1-5. View of the stone damage at the interior porch wall, 2020 (source: Ratio)

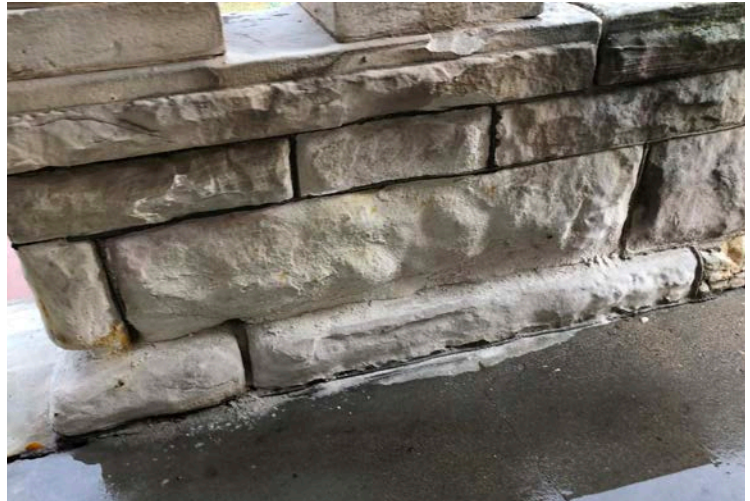
The caps of these walls appear to be a different type of stone which is in fair condition. A large amount of the cap stones are covered with lichens growing on them. The entry steps to the porch were noted as Lyons sandstone in previous building evaluations, and appear to be in good condition, with some uneven gaps due to ground settling. Supporting the porch roof are four large stone columns. The stone appears to be in good condition, though the mortar is in fair to poor condition and appears in need of repointing.

Figure 1-6. View of the porch stone walls near the main entry steps, 2020 (source: Ratio)

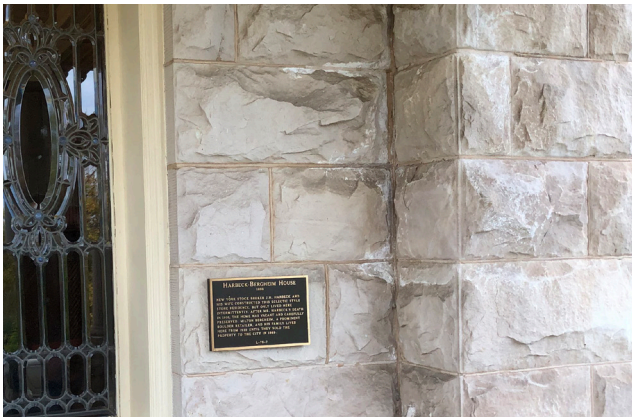
North Facade: In general, the stone masonry making up the north side of the building appears to be in good condition. There is some visible damage on the stone just west of the main entry door. One of the headers over the bay windows just east of the main entry has a large crack.

Figure 1-9. View of efflorescence west of main entry, 2020 (source: Ratio)

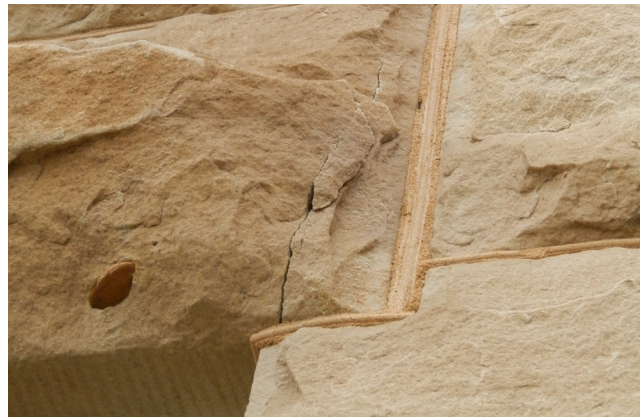
Figure 1-10. View of cracked header, 2020 (source: Ratio)

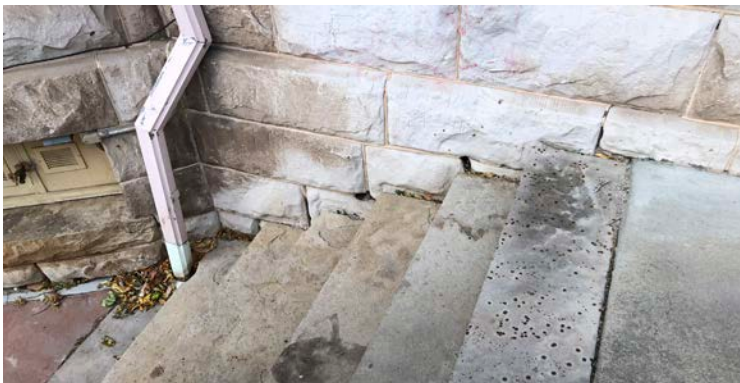
Figure 1-11. View of stone damage at stair, 2020 (source: Ratio)

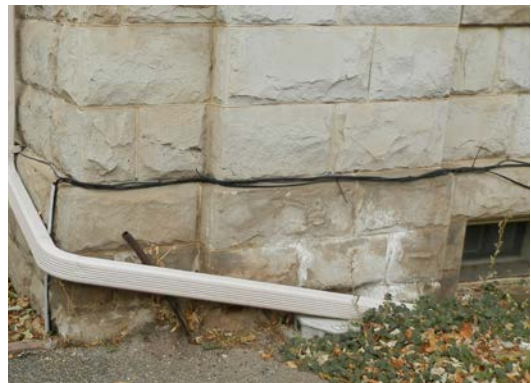
Figure 1-12. View of stone damage at gutter, 2020 (source: Ratio)

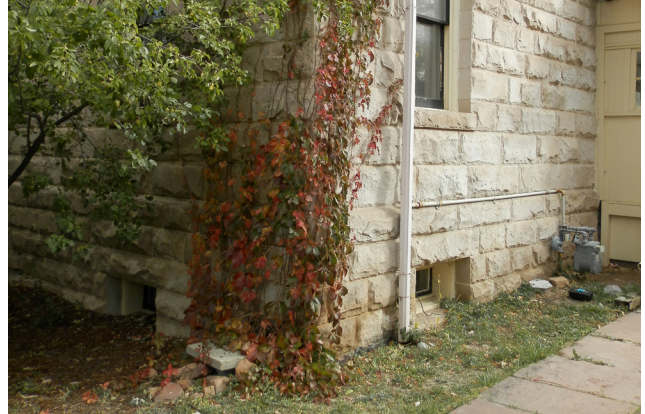
South Facade: The masonry on the south wall is in good condition overall. There is a cracked stone above the entry porch that was added on. And the south west corner of the building has vines growing on the stone, causing potential damage.

Figure 1-14. View of vines on stone masonry, 2020 (source: Ratio)

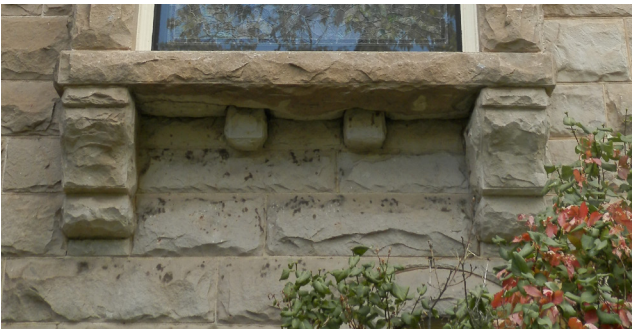
West Facade: Like the other sides of the building, the stone overall appears to be in good condition on the west face. The stone detailing below one of the windows shows some evidence of water damage. Another area toward the bottom of the wall exhibits significant amounts of lichen growing on the stone. There are also a few stones where the face of the stone is damaged or weathered away.

Figure 1-15. View of stone detailing below window, 2020 (source: Ratio)

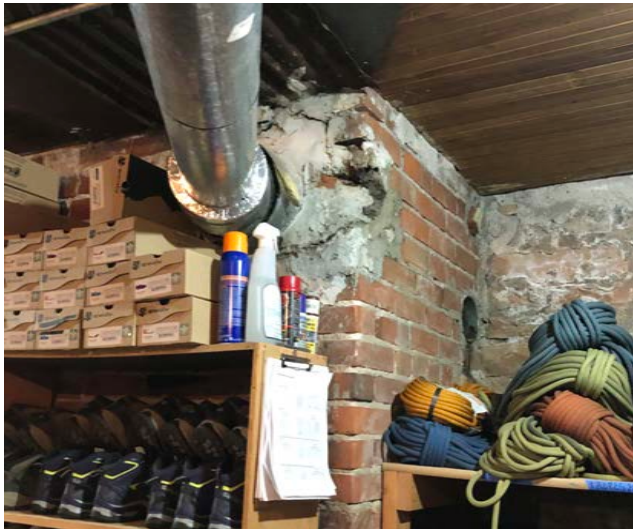
The exposed brick in the building is in the basement and the attic. The brick overall appears to be in fair condition. The primary areas of damage to the brick masonry are those where ductwork or other penetrations have been made through the brick walls. The resulting openings left holes in the brickwork, and the attempted sealing material between the ducts and the brick has not functioned properly causing more damage to the surrounding bricks and the integrity of the walls in those areas.

Figure 1-19. View of basement brick masonry, 2020 (source: Ratio)

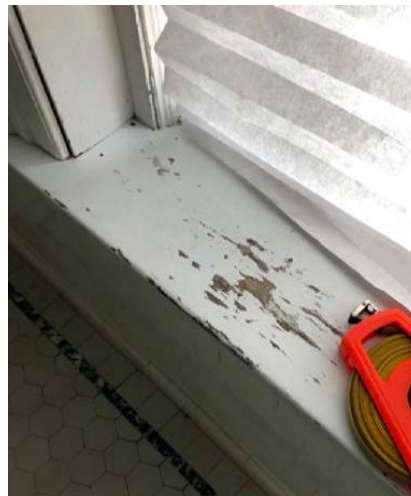
Interior Windows and Doors: The larger window interiors appear to be in good condition overall, however many of the interior windowsills show significant wear, weathering, or water damage. Also, many of the smaller and curved windows have significant cracking in their frames and sashes. In general, the doors appear to be in fair condition. The door construction and materials have maintained their integrity, but around the hardware and other areas of use the finish has become worn, scratched, or scuffed over time. At some of the locations where the doors have been painted, the painted finish is scratched or peeling.

Figure 1-34. View of interior window sill, 2020 (source: Ratio)

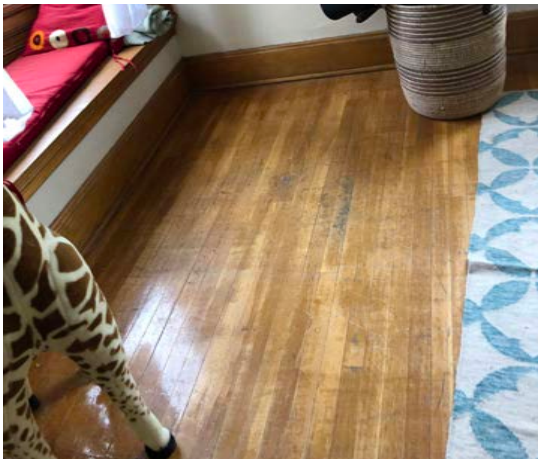
Wood Flooring: The wood flooring throughout the building appears to be in fair condition. There are a few larger areas of concern showing burn marks or water damage, however most of the flooring just has general wear and scratching showing the areas of use. In the attic, the wood flooring appears to be in worse condition than the rest of the building. There is gapping between boards, noticeable scratching, and the flooring does not appear to be of the quality or finish level as the rest of the building.

Figure 1-39. View of wood flooring, 2020
(source: Ratio)

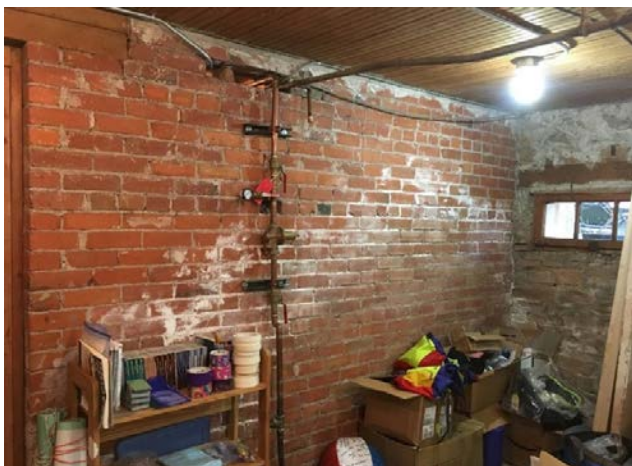
Overall, the foundation is in good condition. There is efflorescence at the interior faces of the basement walls which is evidence of past water infiltration (Figure 1-59). An exterior building condition evaluation was prepared by CSC in February 1991. Many of the eroded mortar joints and water infiltration issues identified in the report appear to have been addressed since the report was issued. Conditions of note include the horizontal bulge in the plaster of the north basement stair wall (Figure 1-60) and the settlement in the far southeast corner of the basement.

Figure 1-59. Efflorescence on basement walls, 2020 (source: JVA)

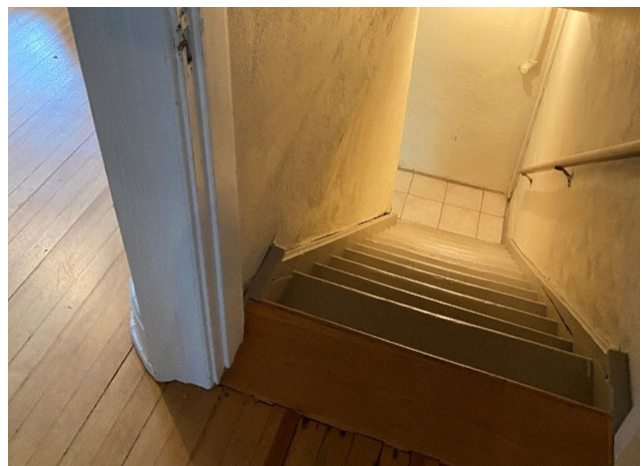
Figure 1-60. Horizontal bulge in basement stair wall, 2020 (source: JVA)

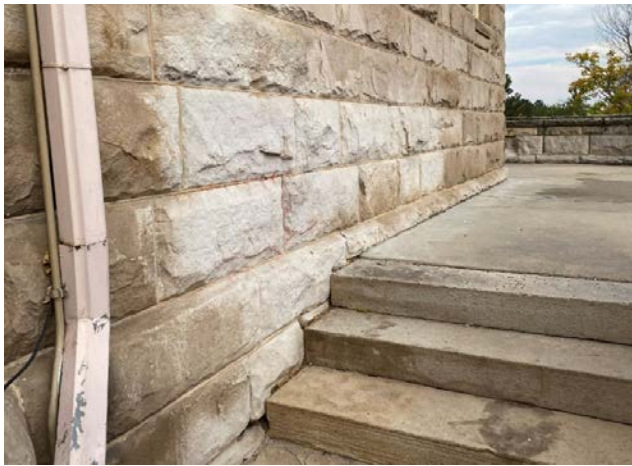
The exterior stone of the house is in overall good condition with the exception of typical weather-related deterioration (erosion) of the sandstone units in Boulder's freeze-thaw climate and is more pronounced at the walls near grade at the porch and entry stair (Figure 1-61 and 1-64). There are isolated cracks including thermal movement related cracking of mortar joints at the porch and cracked ashlar units near the front entry door jamb (Figure 1-63). Many of the eroded mortar joints and water infiltration issues identified in the 1991 report appear to have been addressed since the report was issued. Lichen growth is present on the coping stones of the porch however it does not appear to be causing material damage of structural concern to the ashlar units.

Figure 1-61. Erosion of stone at locations of graffiti removal, 2020 (source: JVA)

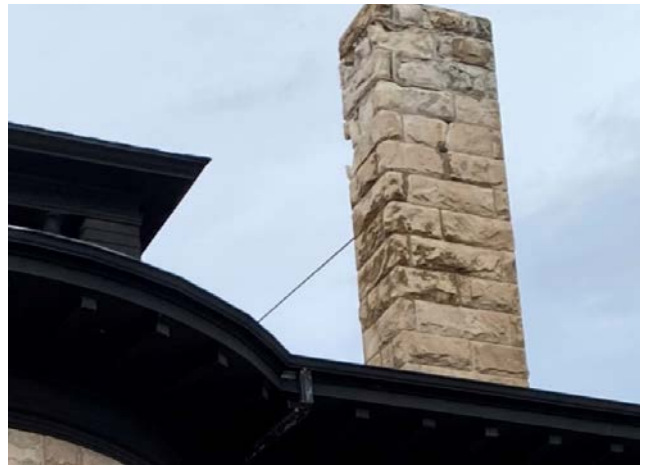
The site includes three stone chimneys, two on the east and one the west side of the house. The porch railing and stair are constructed of a stone similar to that used for the building. The weather-related erosion of stone units and mortar joints in the chimneys has progressed to the point that the stones above the eroded units may become unstable and fall from the chimney (Figure 1-62).

Figure 1-62. Deteriorated and loose stone at chimney

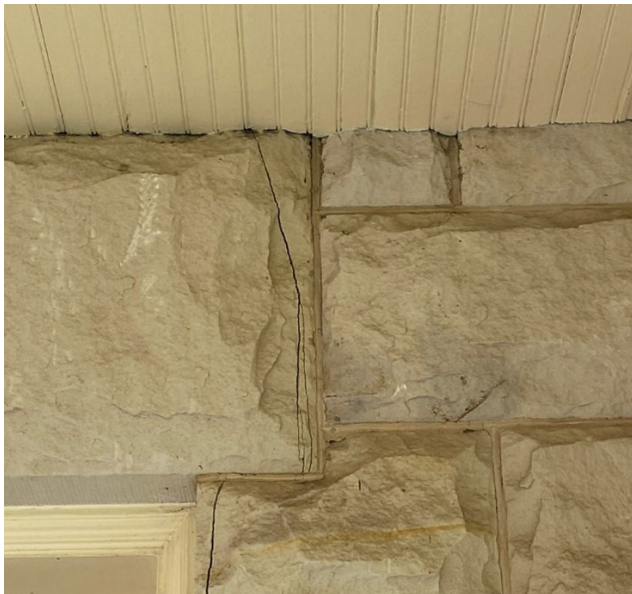
Figure 1-63. Thermal related cracking at door jamb, 2020 (source: JVA)

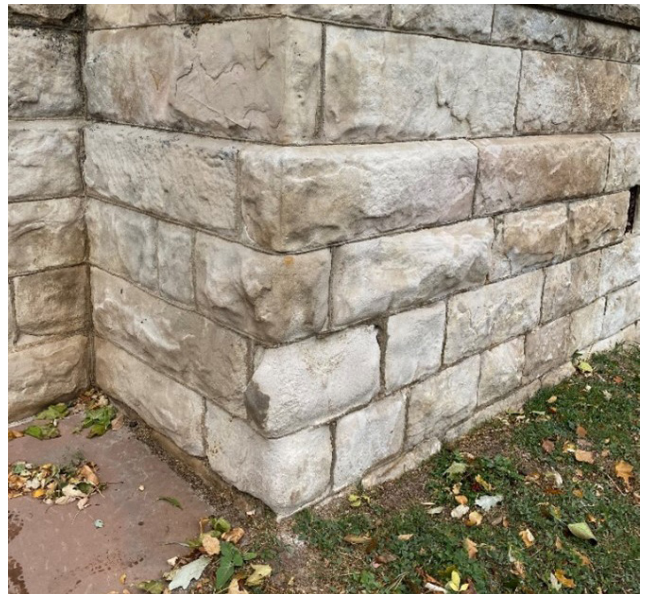
Figure 1-64. Erosion of stone near grade and lichen growth at coping, 2020 (source: JVA)

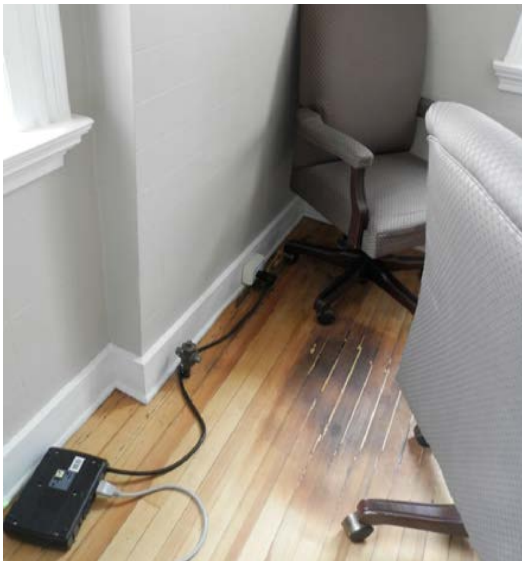
Figure 1-72. View of wood floor damage, 2020 (source: Ratio)
