# PLATT FARMHOUSE

## RESOURCE ASSESSMENT REPORT

DRAFT MARCH 2021

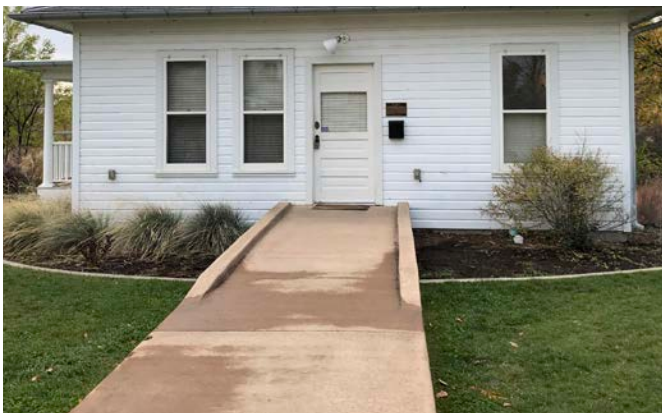
**Sidewalk:** In the current building location, the main entrance is accessed from an accessible concrete ramp. The ramp was added when the building was relocated and renovated and is in good condition. The non-accessible entry facing the south irrigation ditch has a concrete pad at the bottom of the stairs that is also in good condition.

Figure 1-4. View of the concrete sidewalk at the accessible entrance, 2020 (source: Ratio)

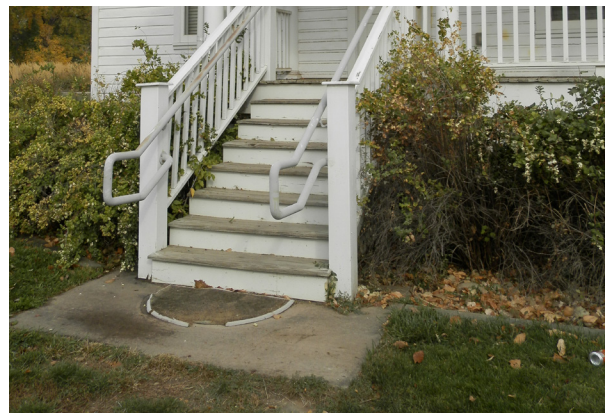
Figure 1-5. View of concrete slab at the base of the stairs, 2020 (source: Ratio)

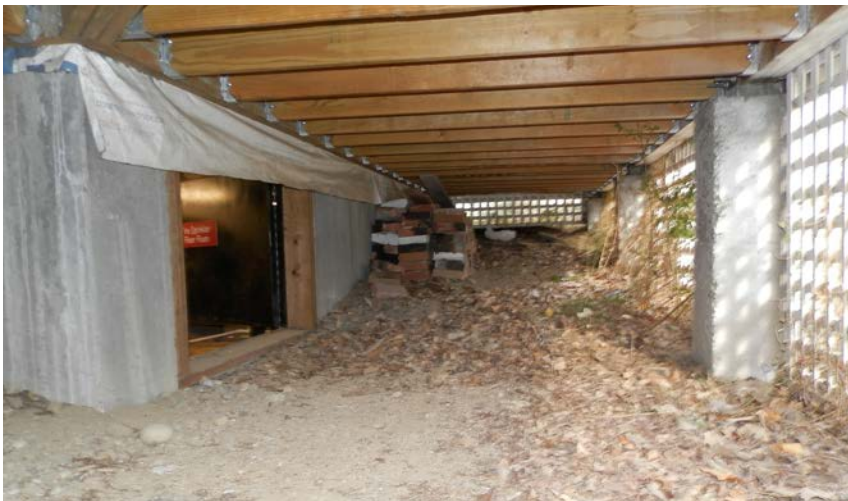
**Building Foundations:** The building and porch appear to have been set on new concrete foundations as part of the recent relocation and renovation. The concrete appears to be in good condition.

Figure 1-6. View of the porch and building foundations, 2020 (source: Ratio)

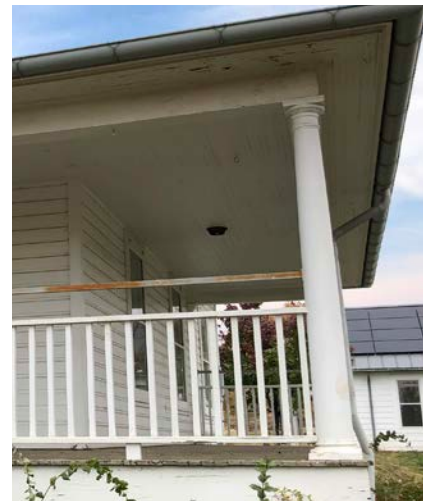
Figure 1-7. View of the porch columns, 2020 (source: Ratio)

**Porch Columns:** The original wood porch columns were removed during the relocation, and in lieu of being refurbished, were replaced with new wood columns. It is unclear how well the columns match the original construction. The columns are in fair condition overall. The paint is peeling slightly at the base of the columns. The wood railing in between the columns appears to be the original construction. The rails and posts are in fair condition. The bottoms of the posts are showing signs of cracking and peeling paint. There are areas on both the top and bottom rails where the paint is peeling. To comply with the current height requirements for guardrails, a metal rail has been added above the wood railings. The metal rail appears to be in fair condition, maintaining its structural integrity but showing large areas of rust.

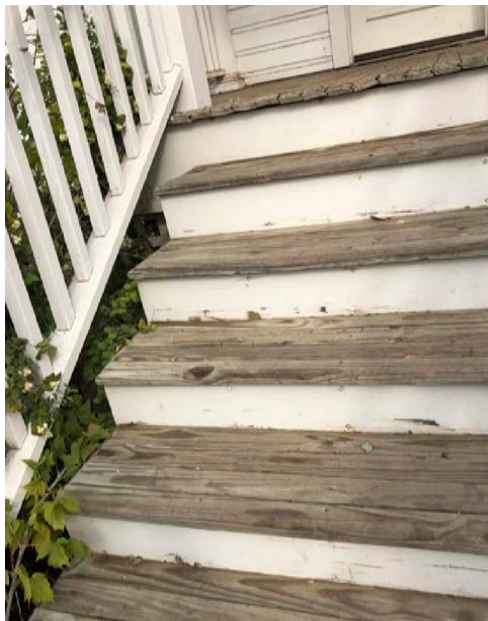
**Porch Flooring:** The wood floor of the porch and the entry stairs are in poor to fair condition. The tongue and groove boards are intact and functional, but are unfinished and showing considerable wear, weathering, and warping.

*Figure 1-8. View of wood porch stair, 2020 (source: Ratio)*

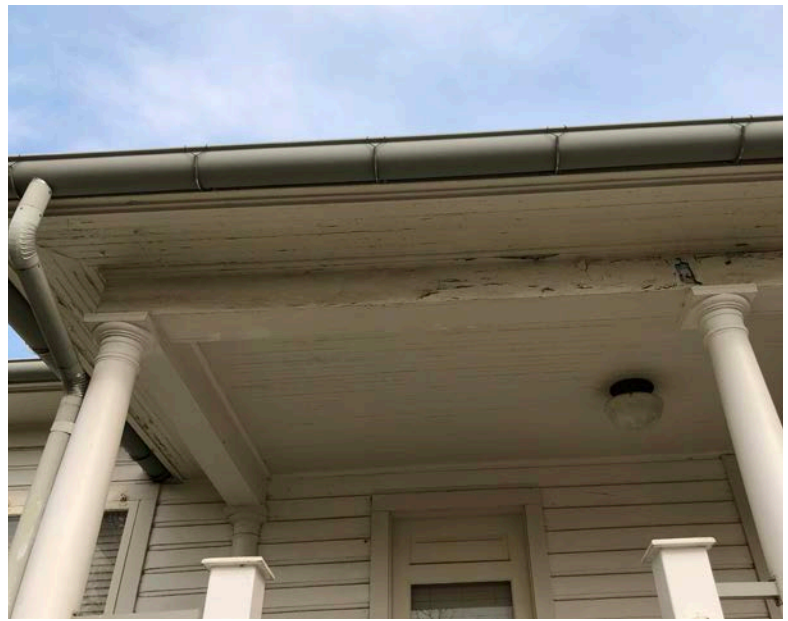
**Porch Framing:** The porch floor framing appears to be in good condition. The porch roof framing and soffit finish are in fair to poor condition. There is considerable wear, weathering, and cracking and peeling paint on both the support beams and the wood soffit material.

*Figure 1-9. View of wood porch framing roof supports, 2020 (source: Ratio)*

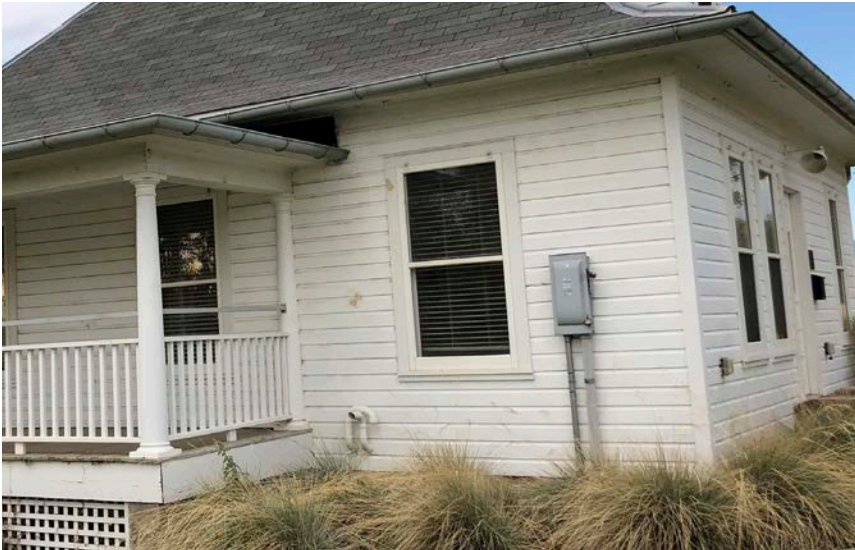
Exterior Siding: In general, the wood building siding is in fair condition. There is some discoloration on the siding near the south door of an undetermined origin. Around the building, there are a few small areas where the siding is damaged, or the paint is missing, and most of the horizontal joints contain noticeable amounts of dirt.

Figure 1-10. View of wood siding, 2020 (source: Ratio)

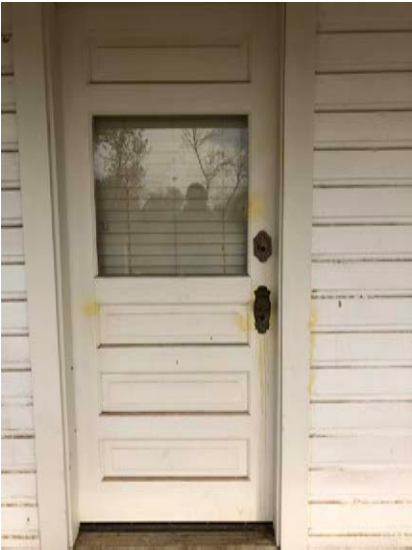
Figure 1-11. View of south door, 2020 (source: Ratio)

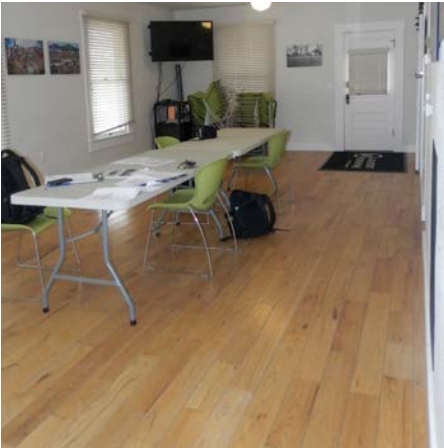
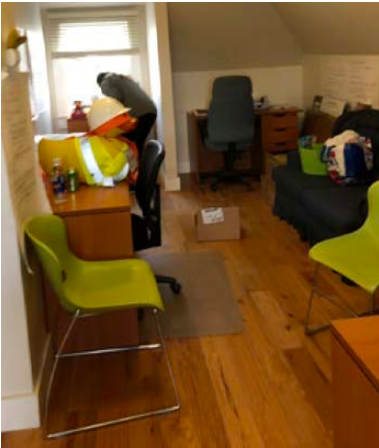
Wood Flooring: Both levels of the interior have wood plank flooring, that appears to be in good condition. The interior stairs also have a wood finish. The stairs appear to be in good condition. The boards that make the nosings of the stairs do not appear to match the wood type of the rest of the stairs. There are also a few locations where the nosing boards are loose.

Figure 1-12. View of hardwood flooring on the first floor, 2020 (source: Ratio)

Figure 1-13. View of hardwood flooring on the second floor, 2020 (source: Ratio)

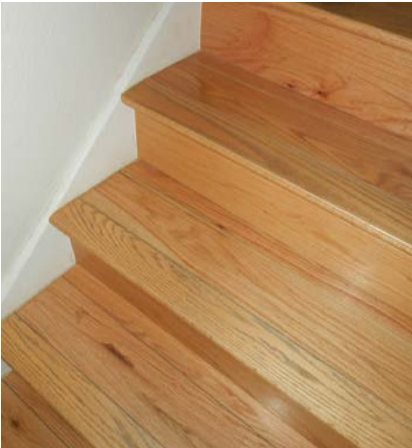
Figure 1-14. View of wood treads and nosings, 2020 (source: Ratio)

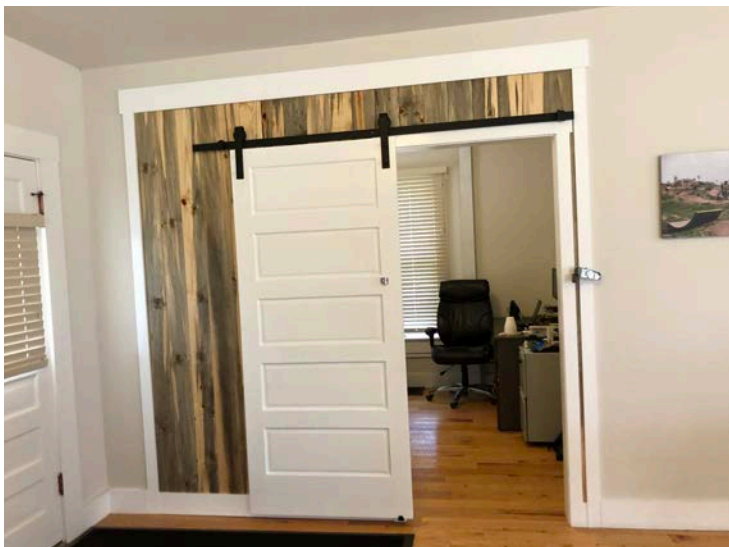
**Windows and Doors:** The windows and doors appear to be in good condition, with no obvious signs of wear or damage. Based on the provided building drawings of the previous renovation it appears that the windows and doors are a mix of both original and replacements. The replacement windows and doors appear to match the design and materials of the original components. The most recent work was the addition of a new sliding barn door and wood finish at the first floor office.

Figure 1-15. View of sliding barn door and infill wall, 2020 (source: Ratio)

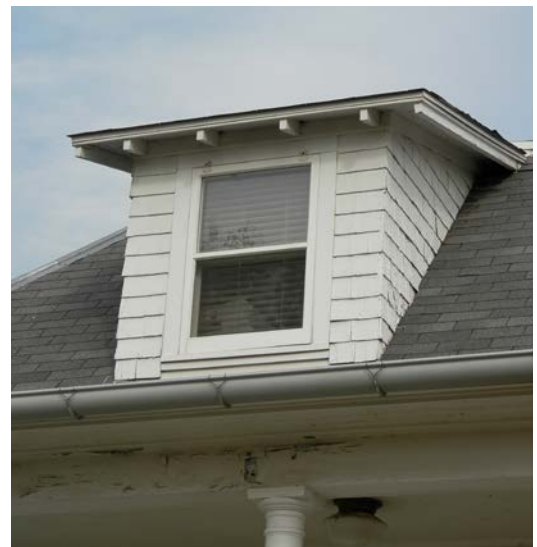
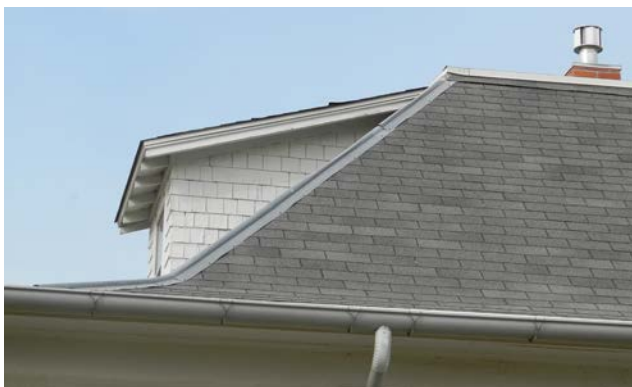
**Shingles:** The main portion of the roof is finished with asphalt shingles, which appear to be in good condition. The upper dormers have an exterior wall finish of painted wood shingles. From ground level observation the shingles appear to be in fair condition.

Figure 1-16. View of the wood shingled dormers, 2020 (source: Ratio)

Figure 1-17. View of the asphalt shingle roof, 2020 (source: Ratio)

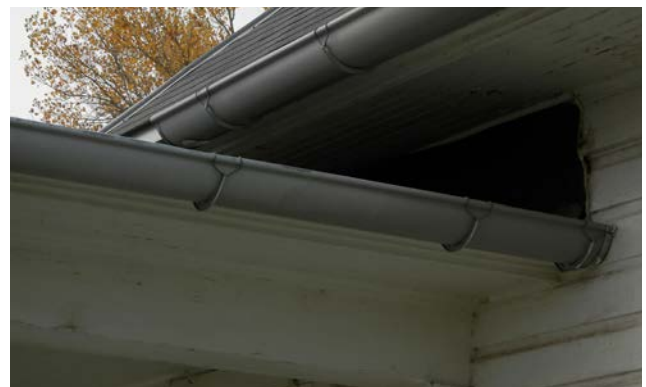
**Gutters:** The gutters and downspouts appear to have been replaced in the previous rehabilitation. The gutter profile is a half-round style which replicates some of the gutter shapes that were in use when the Farmhouse was originally built. Both gutters and downspouts appear to be in good condition.

Figure 1-18. View of half-round gutters, 2020 (source: Ratio)

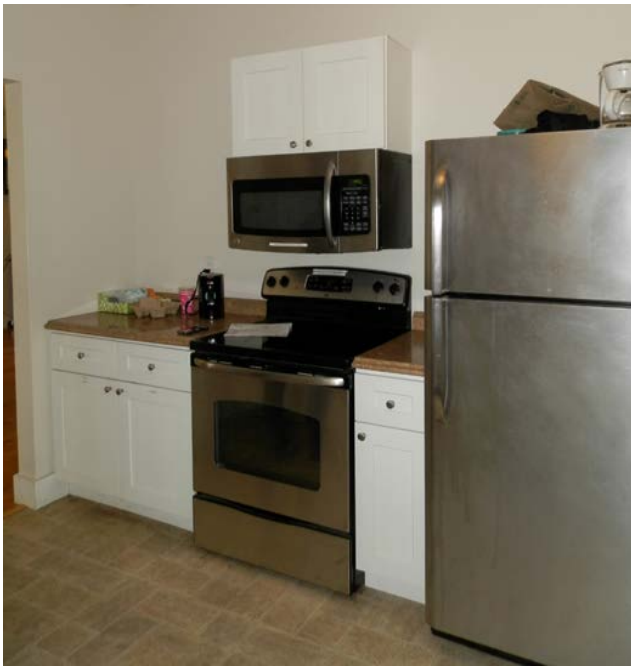
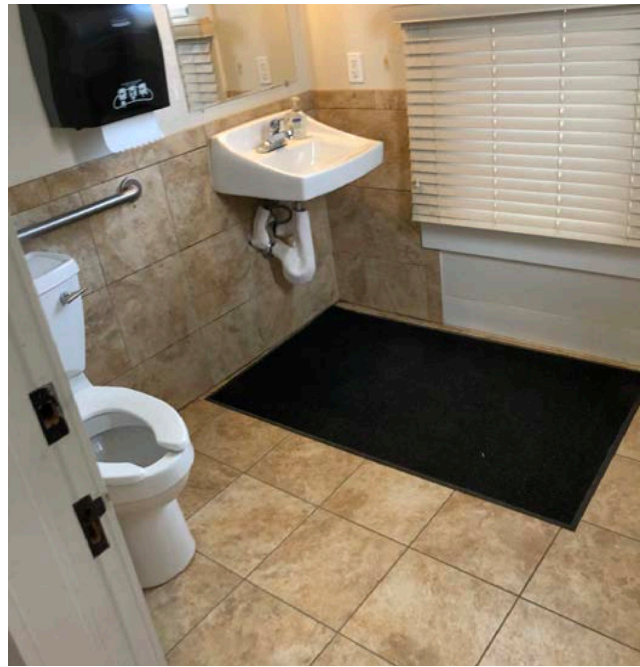
**Tile Floors:** Both the kitchen and the rest room have tile floor finishes, and the rest room has a tile wainscot on the wall. The tile work all appears to be in good condition.

Figure 1-19. View of kitchen area with tile floor, 2020 (source: Ratio)

Figure 1-20. View of restroom tile finishes, 2020 (source: Ratio)

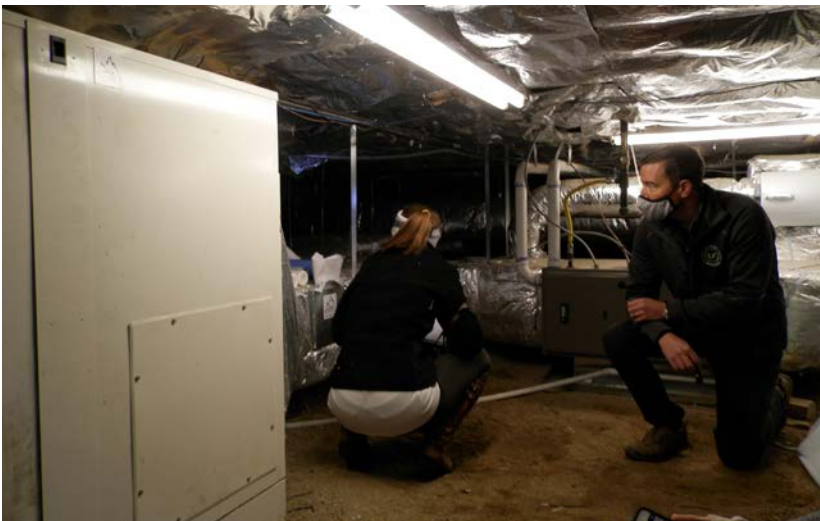
**Mechanical:** The swamp cooler and furnace for the building appear to be in working condition. They are in the crawl space below the building, that is accessed behind the slatted wood screens below the porch.

Figure 1-21. View of swamp cooler and furnace in the crawl space, 2020 (source: Ratio)

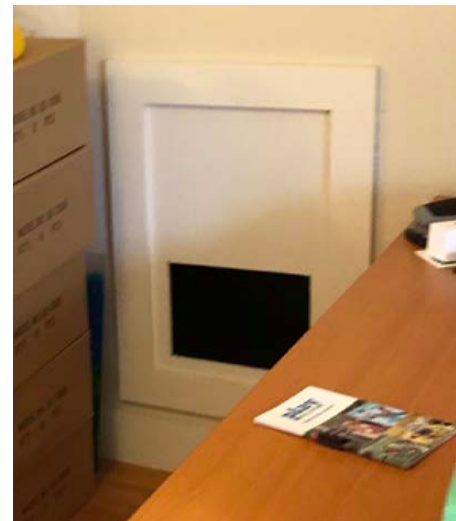
**Attic:** On the upper level there are two wall panels that appear to be the access for the attic space below the eaves of the roof. In both access panels there is a hole cut into them. It is unclear the intent of the holes or if there is an infill panel or grille missing from these locations.

Figure 1-22. View of attic access panel, 2020 (source: Ratio)

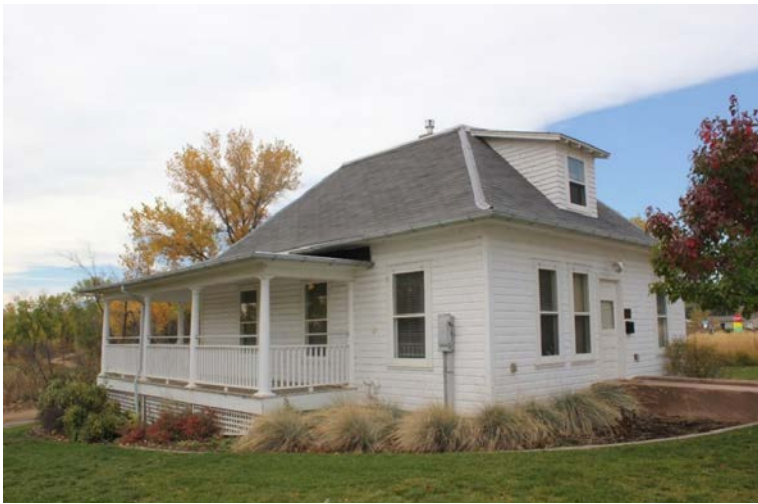
The structure has new concrete foundation stem walls and concrete footings at frost depth. The foundation is in good condition; it is new and is performing as expected. It appears that the new concrete piers at the porch were coated in a finish coat to look like the original piers which had a honeycombed surface.

Figure 1-25. Porch piers wrapped in coating, 2020 (source: JVA)
