RONNEY FARMHOUSE

RESOURCE ASSESSMENT REPORT

DRAFT MARCH 2021

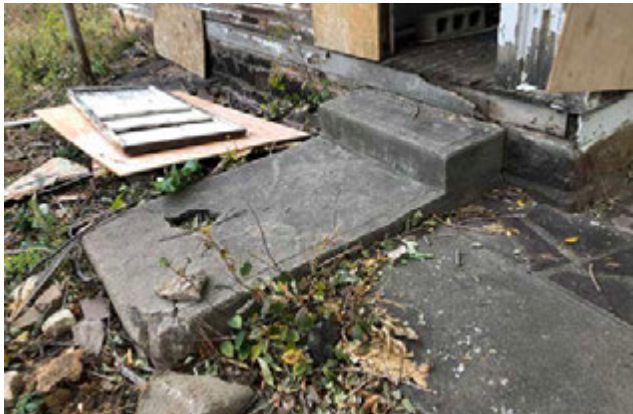
Porch Slabs: The concrete slab of the porch appears to be in good condition. There is some damage to the edge of the slab, and the step below, however it seems minimal and primarily aesthetic. In the rear of the building, there is a step and short sidewalk out from the back door. The step is in good condition, but the sidewalk has a large hole, a corner missing, and is in very poor condition.

Figure 1-4. View of damaged concrete sidewalk, 2020 (source: Ratio)

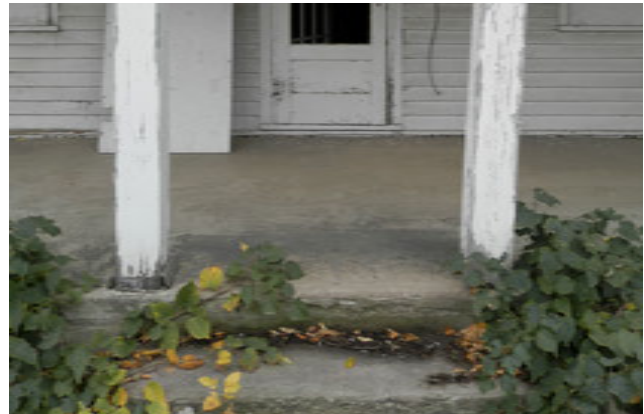
Figure 1-5. View of north porch and step, 2020 (source: Ratio)(source: Ratio)

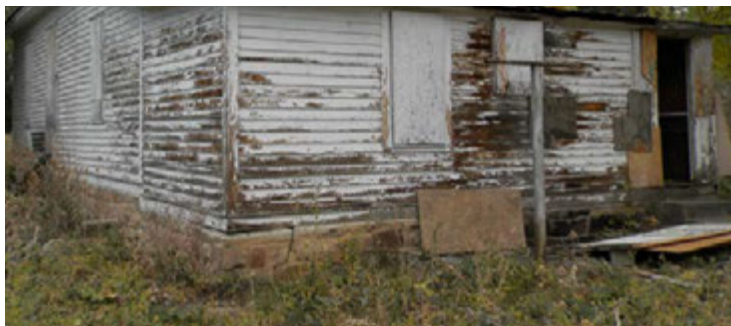
Building foundations and basement walls: Overall, the building foundations are in fair condition. There are a few areas on the south end where major repairs are needed. The basement walls don't show any major cracks or damage, but the top of the stair wall has a notable crack that runs down half the length of the wall.

Figure 1-6. View of cracks at building foundation, 2020 (source: Ratio)

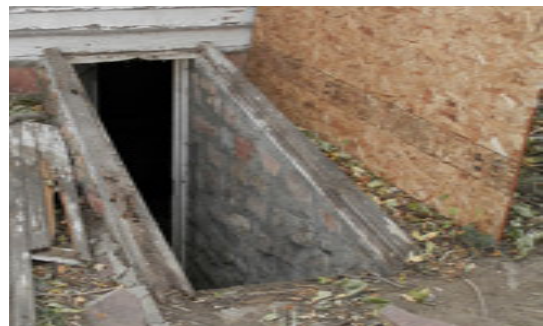
Figure 1-7. View of cracks at basement stair, 2020 (source: Ratio)

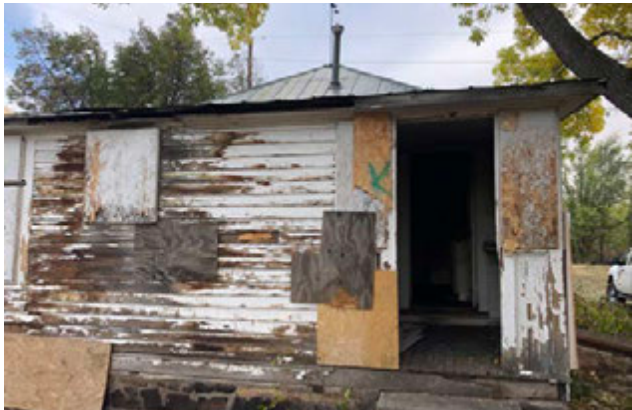
Siding: The existing wood siding is in varying conditions. On the south end of the building, the wood siding is in poor condition, with a large amount of the paint missing, the boards are worn and weather damaged, and there are areas covered with plywood, with greater damage presumed below the plywood panels. However, the portions of siding that are contained within the enclosed porch area are in good condition. The remaining exterior siding walls are in poor to fair shape with paint missing and notable wear, but no large areas of concern.

Figure 1-8. View of south wall siding, 2020 (source: Ratio)

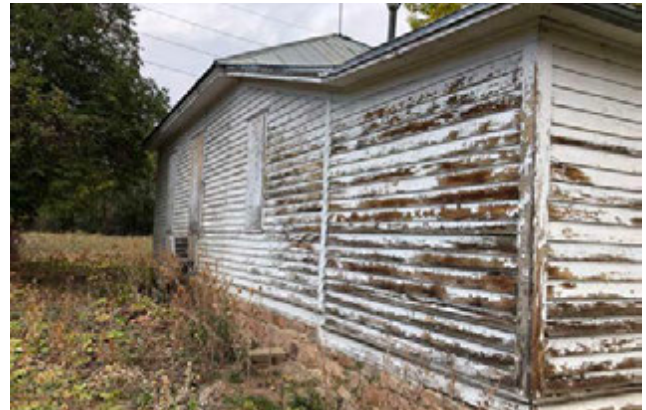
Figure 1-9. View of west wall siding, 2020 (source: Ratio)

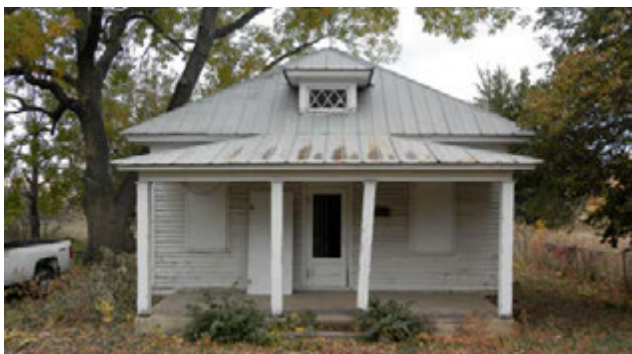
Figure 1-10. View of north wall siding, 2020 (source: Ratio)

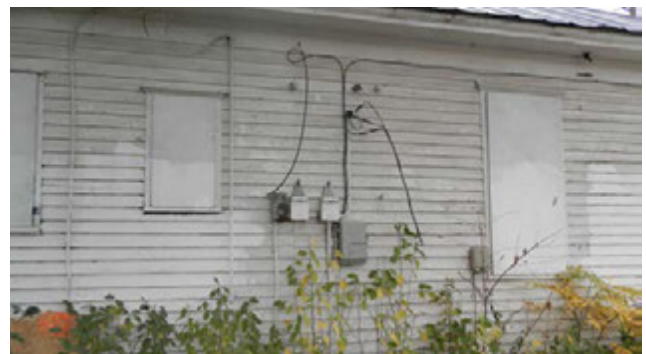
Figure 1-11. View of east wall siding, 2020 (source: Ratio)

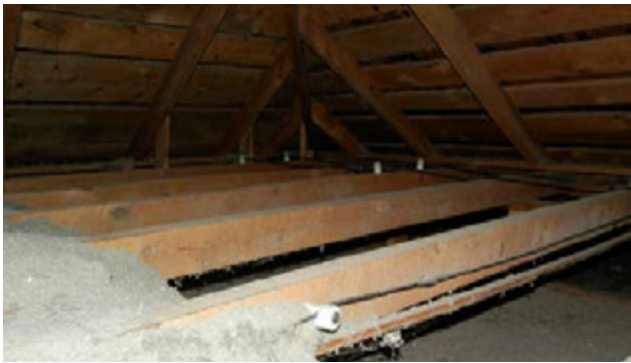
Framing: From what could be seen in both the attic and the basement, the wood framing is in good condition.

Figure 1-12. View of roof framing, 2020 (source: Ratio)

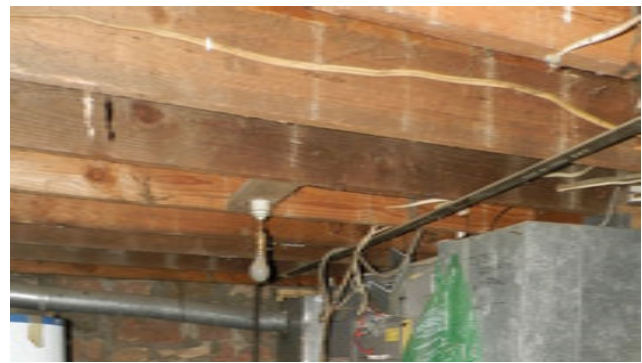
Figure 1-13. View of main floor framing from basement, 2020 (source: Ratio)

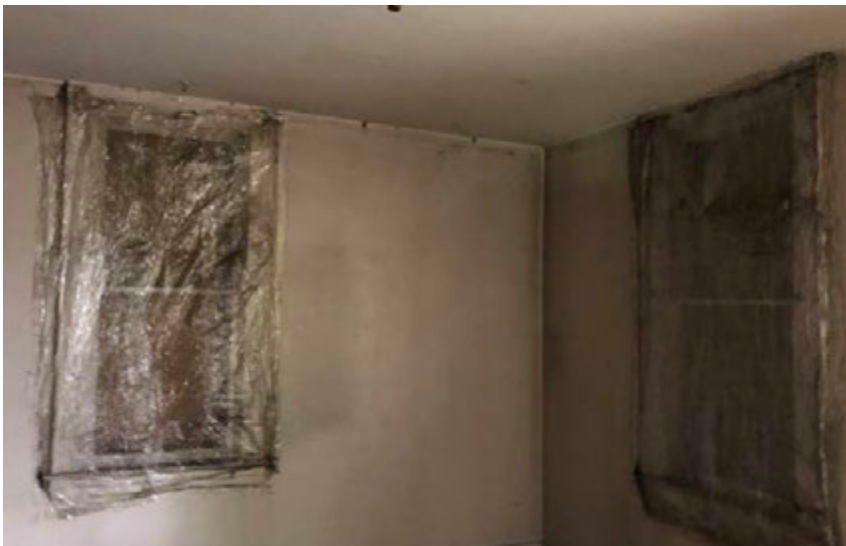
Windows: All of the window exteriors were boarded up at the time of the site visit, and therefore unable to be verified. The interiors of the wood windows are more visible but covered with a transparent material. From what is observable, the wood windows appear to be in fair condition. Due to the state of the windows, functionality was unable to be tested.

Figure 1-14. View of window interiors, 2020 (source: Ratio)

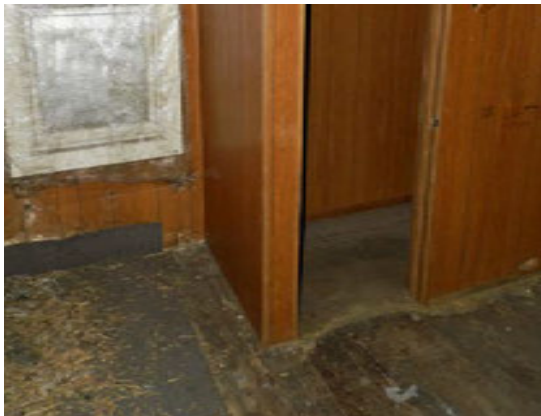
Flooring: The majority of the house has wood floors. Overall they are in fair condition, some rooms with substantial graffiti damage. The wood flooring in south room addition is in very poor condition.

Wall Paneling: There is wood wall paneling as the closet walls of the south room. The wall is in poor condition and has a large hole and a variety of other scratches and scuffs.

Figure 1-16. View of wood wall paneling and wood flooring, 2020 (source: Ratio)

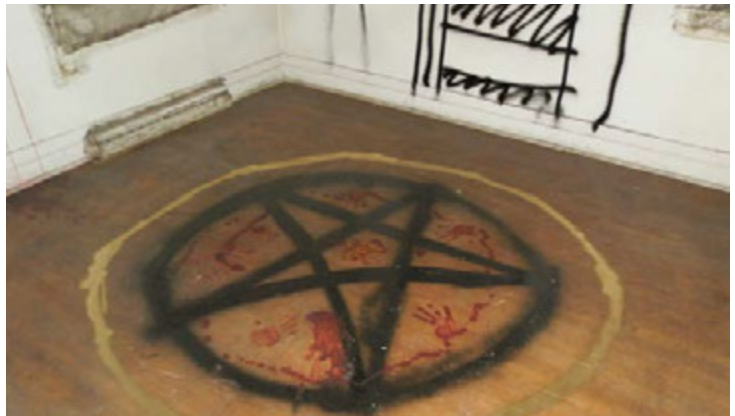
Figure 1-17. View of vandalism on wood flooring, 2020 (source: Ratio)

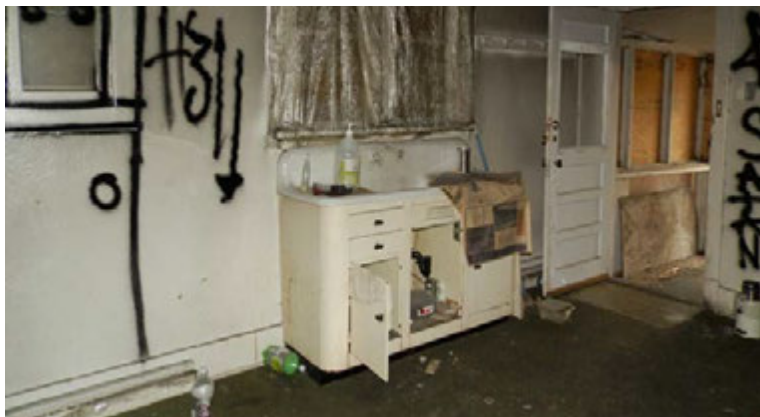
The restroom and kitchen plumbing elements are all in poor condition. As the building is not in use, the functionality was unable to be verified. The restroom fixtures and finishes are in various states of vandalism and show significant damage.

Figure 1-18. View of kitchen sink, 2020 (source: Ratio)

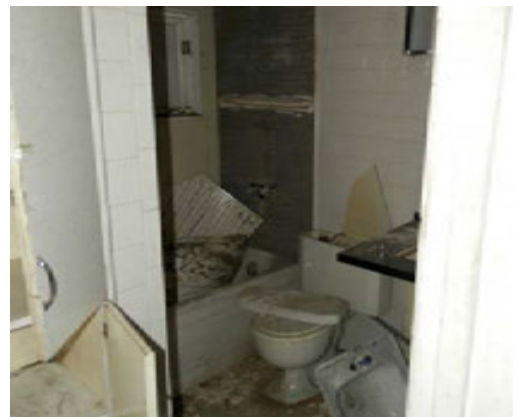
Figure 1-19. View of restroom basement, 2020 (source: Ratio)

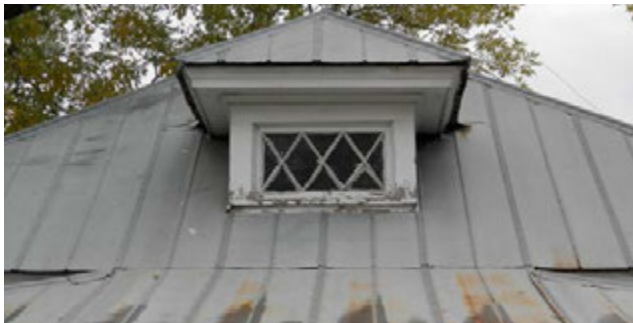
The metal roofing panels appear to be in poor condition. The panels do not show any major holes or cracks, however there is a large amount of rust. The roof flashing and sealant appears to be minimal or missing. The watertightness of the roof was unable to be verified at the time of the site visit.

Figure 1-20. View of roofing, 2020 (source: Ratio)

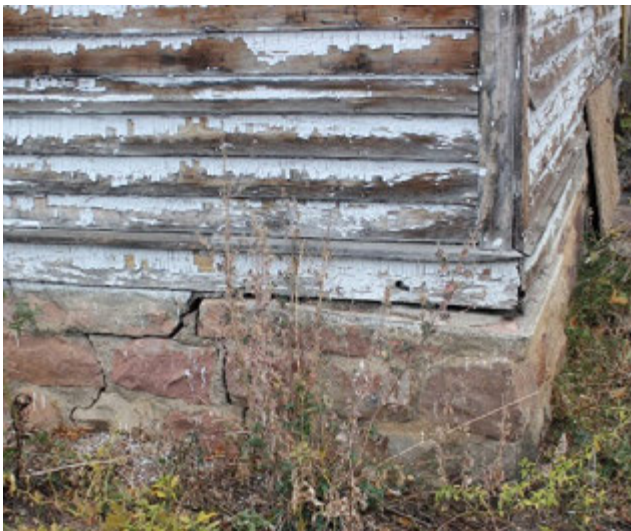
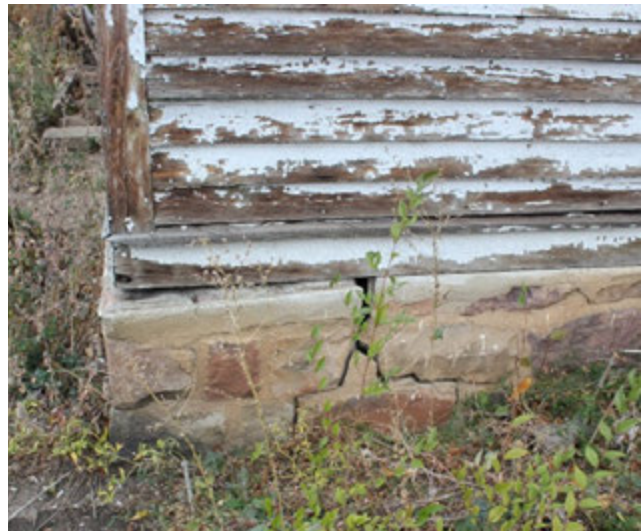
The southwest corner of the building has settled; it is sinking and has cracked and rotated away from the building (Figure 1-21). At this location, a gutter with no downspout focuses water at this corner which has likely exacerbated the settlement of the soil in this area due to increased wetting and drying cycles and soil erosion. There are other minor cracks in the foundation caused by thermal expansion which are not of structural concern. A stone has been removed from the rear foundation wall, compromising its integrity. The basement walls all appear in good condition, however the north retaining wall at the access stair has a large diagonal crack near grade and a vertical crack the length off the wall next to the door opening. The unreinforced stone masonry walls are likely inadequate to retain the soil beyond, causing these cracks.

Figure 1-21. Southwest corner foundation settlement, 2020 (source: JVA)

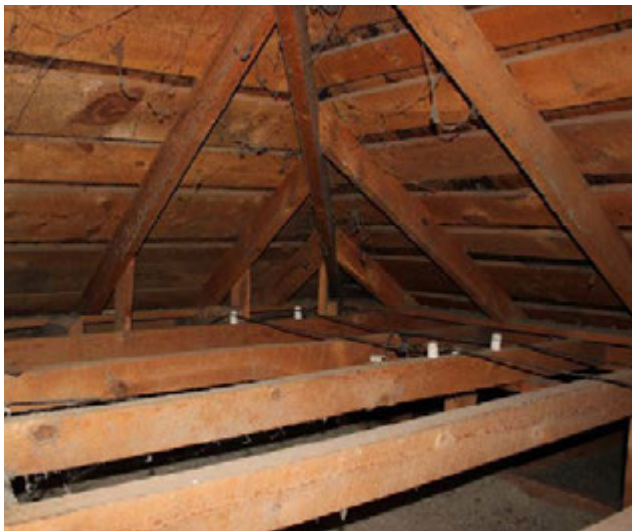
There is no sagging or deflection to indicate structural problems with the roof; however, the second addition roof does not meet current Code requirements. Several of the ends of the roof rafters of the second, southernmost addition have rotted which are exposed to the elements at the rear of the building where the fascia board is missing. The metal roof has a significant amount of rust, especially on the lower sloped addition and porch roofs. As this worsens, openings can form, allowing moisture to enter the roof and damage the framing.

Figure 1-22. Original house roof framing, 2020 (source: JVA)

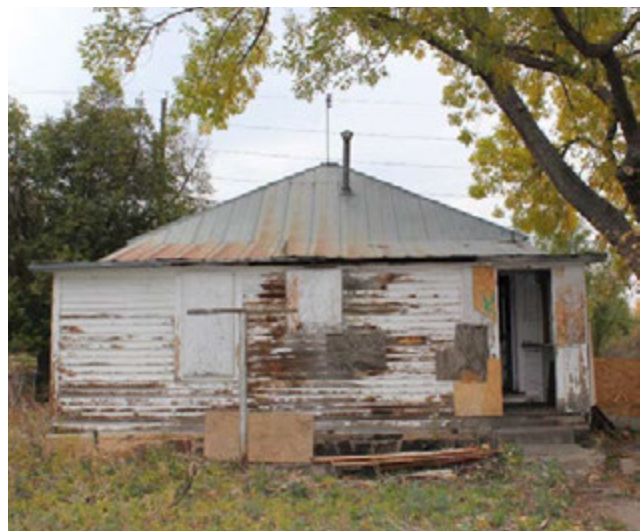
Figure 1-23. Back of Roney House, note rusted metal roof, 2020 (source: JVA)
