# BEAR CANYON CREEK

## FLOOD MITIGATION PLAN

October 17, 2016

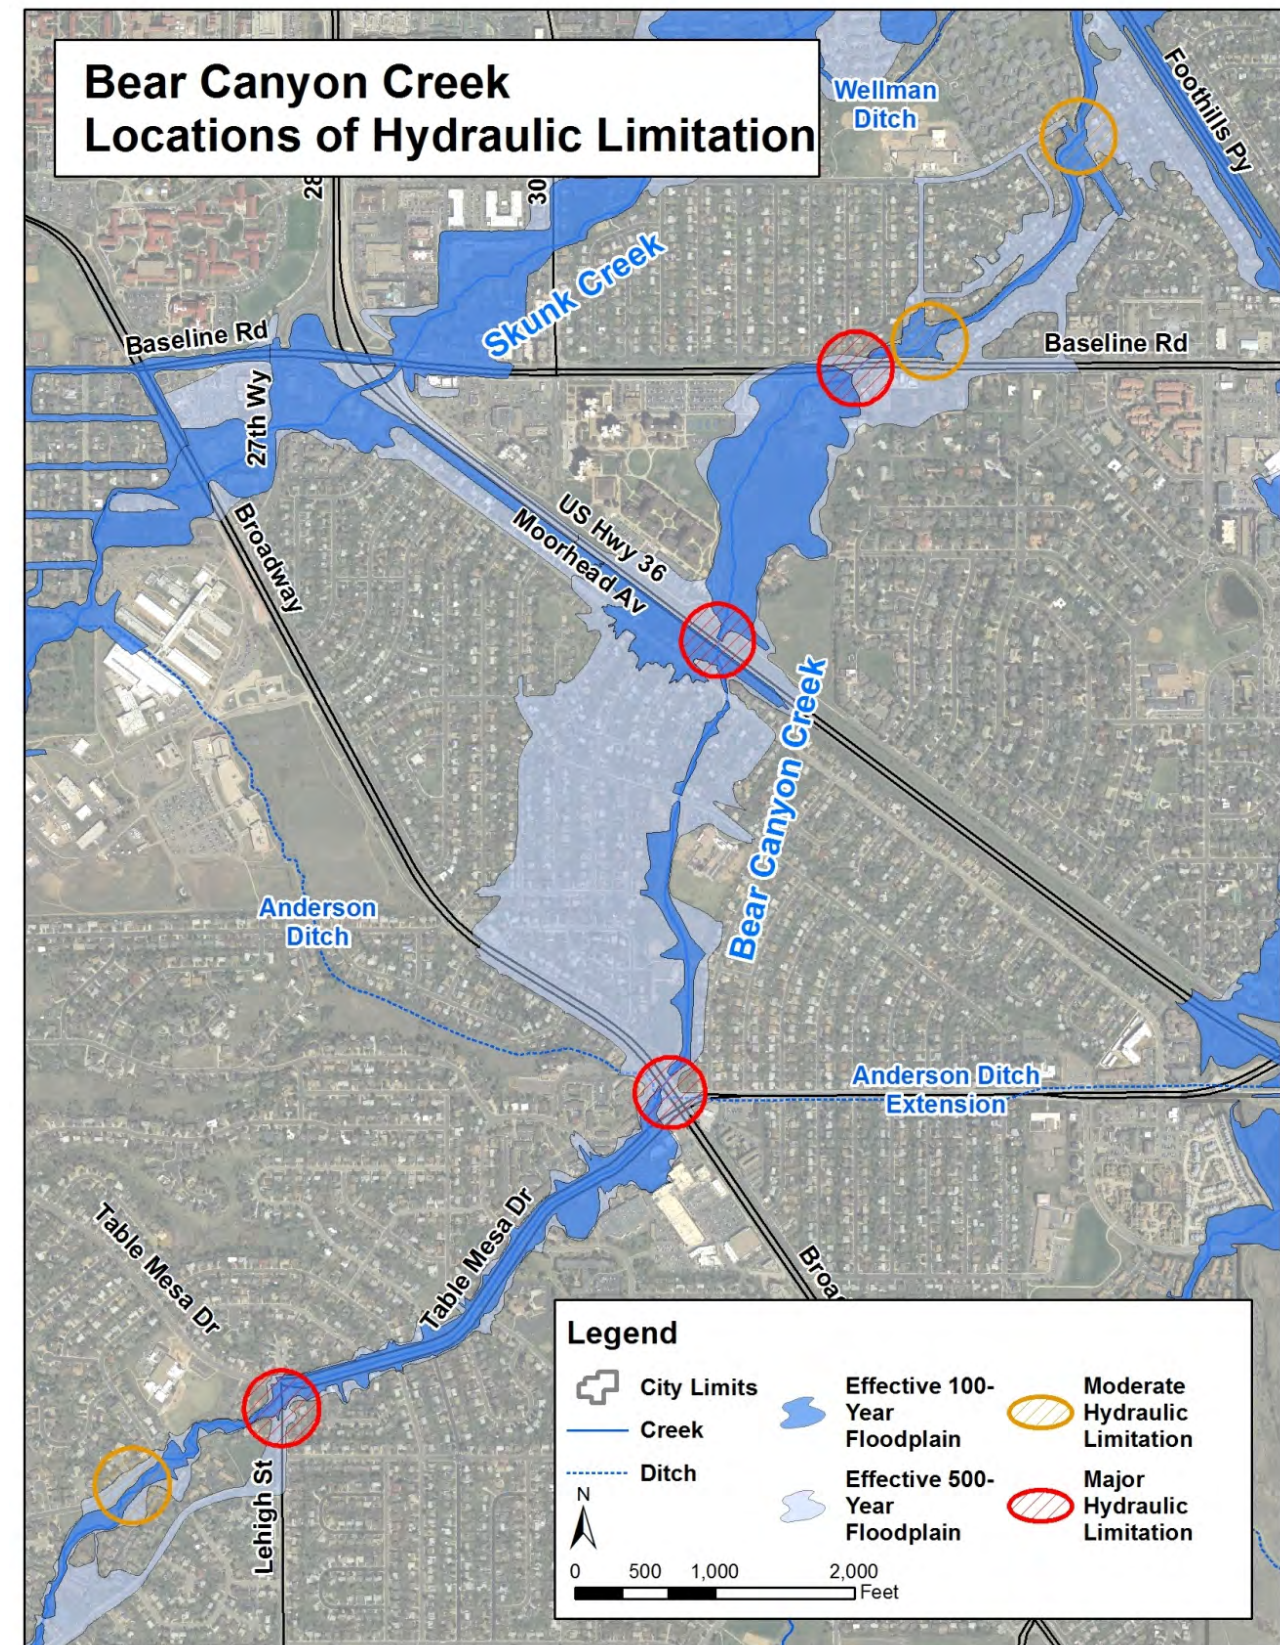
Figure 3: Pinch Point Locations

It is important to note that the improvements downstream of Baseline Road have priority for design and construction. Gilpin Drive is the main pinch point for the entire downstream section. Without increasing capacity at this culvert, any upstream improvements will cause negative downstream impacts, particularly near Mohawk Drive.

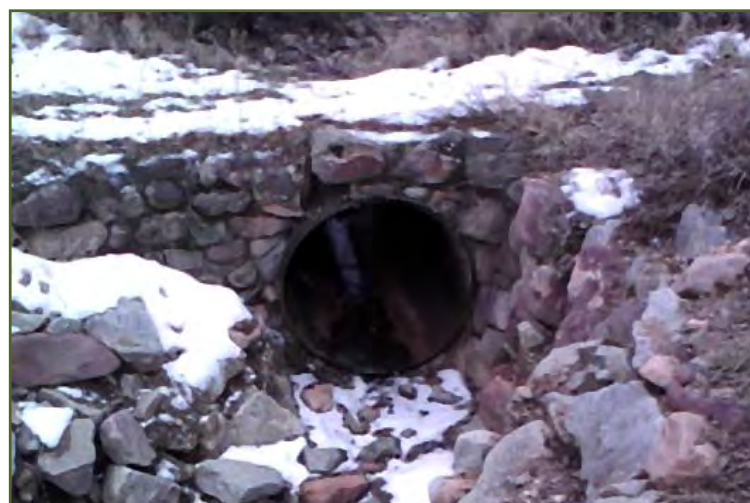
*Culvert R1-2: Ithaca Drive Steel Pipe*

The existing steel pipe was originally used as a farmer’s crossing over the creek. Today, it acts as a social trail for the community. In major storm events, the steel pipe completely clogs with debris and creates high erosion impacts downstream. After the 2013, flood the steel pipe was cleaned and repaired, but the next heavy rain event in the summer of 2014 eroded the repair. The city owns the property where the culvert is located and there are no access issues. A stormwater reconfiguration project is planned for Ithaca Drive and the outfall located upstream of the steel culvert. The steel culvert removal would be more cost effective and cause less disruption to stream and neighborhood activities if completed in conjunction with the Ithaca Drive stormwater project.

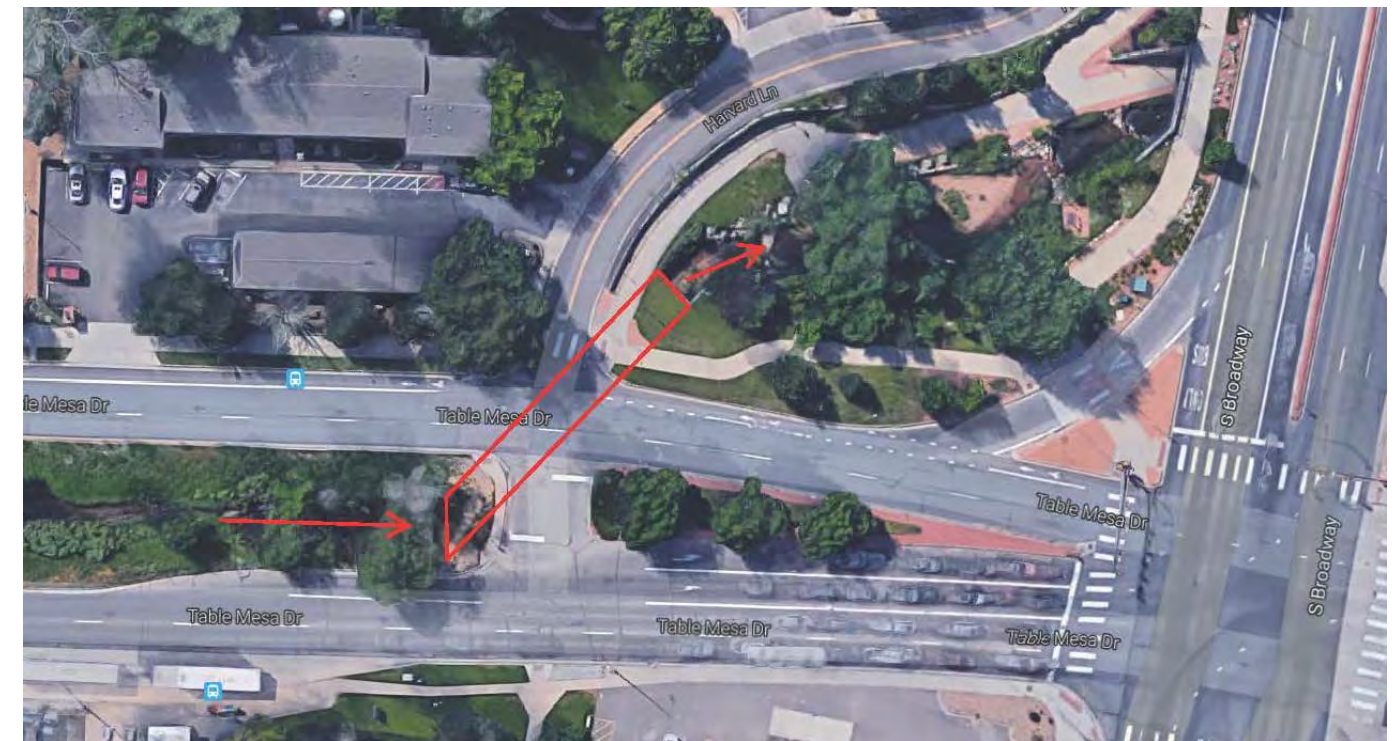
*Harvard Lane Existing Culvert Configuration*

upstream portion of this culvert is on city right of way and the downstream portion is located on city property. There are no access issues.

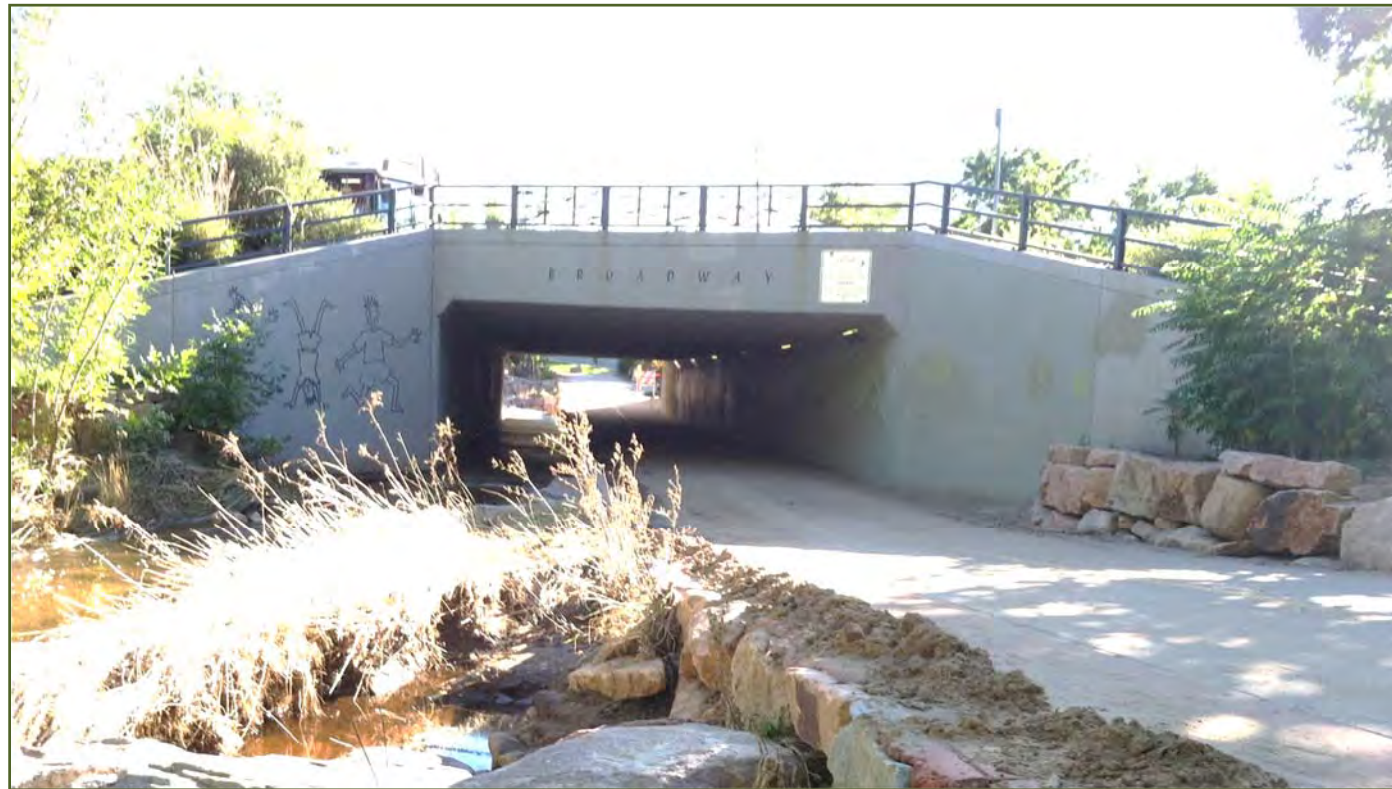
*Culvert R2-7: Broadway Underpass*

Improvement	Size	Width (ft)	Shape	Length (ft)	% of 100-year Storm
Existing	7.5' x 23'	23	Box	83	58%
Reconfigure	Reconfigure inlet	23	Box	83	100%

In order to pass 100-year storm events at Broadway, an additional foot of rise is required in the culvert. This additional rise can be acquired by modifying the existing wingwalls and should be analyzed in greater detail at the time of design. The culvert is located on city owned property and there are no access issues.

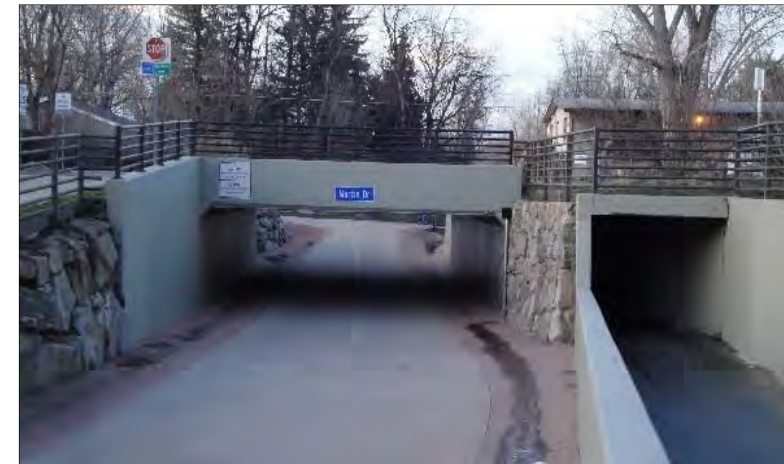
*Culvert R2-8: Martin Drive*

The underpass at Martin Drive was constructed in 1996 and has held up well in previous large-scale storm events such as September 2013. No capacity increases are recommended for this culvert. However, the roadway at Martin Drive directly above the underpass should be noted as having a low topographic point at approximately Martin Drive and 35<sup>th</sup> Street. Surface nuisance drainage flows away from the creek and the street could be re-graded to direct flows back towards the creek and off of street surfaces.

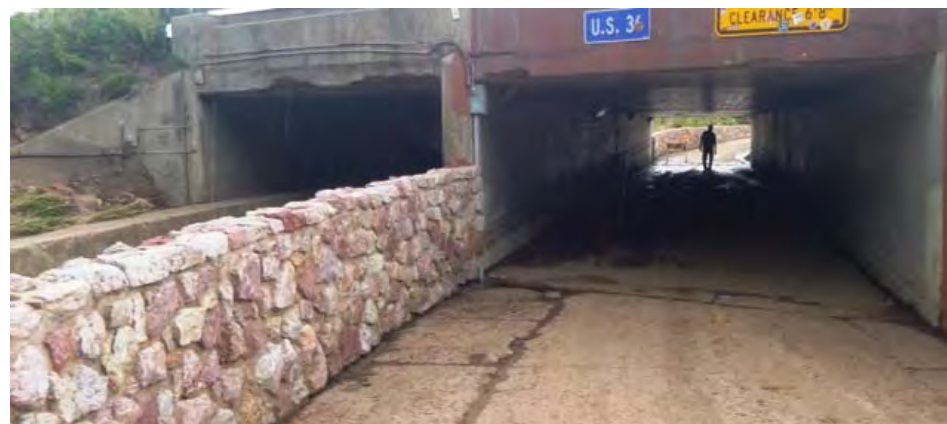
*Culvert R3-2: Underpass at US 36*

At the US 36 culvert, the pedestrian underpass and drainageway are separated upstream and downstream by a rock separator wall (shown in photo below). The separator wall prevents flows from the multi-use path from entering the channel, creates ponding on the path and effectively cuts capacity of this culvert in half. In addition to increasing culvert capacity, removing the pedestrian separator wall and grading the inlet and outlet conditions for the creek and path would allow greater flows to pass through this culvert unencumbered. Pedestrian and creek separation and safety will be addressed during the design phase. It is anticipated that the multi-use path will carry some flow during smaller events such as a 2-year storm. The culvert is located on city right of way and there are no access issues.

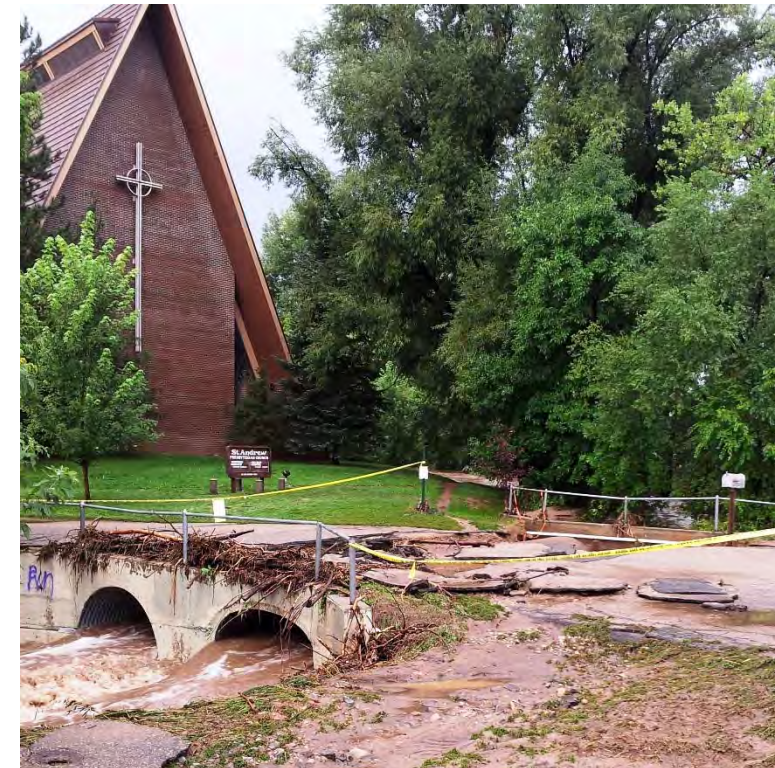
*Culvert R3-3: Saint Andrew Church Driveway*

Improvement	Size	Width (ft)	Shape	Length (ft)	% of 100-year Storm
Existing	(2) 43" x 68"	12.5	Elliptical	40	0%
Replace	Driveway Bridge	40	Bridge	40	100%

The driveway culverts at Saint Andrew Presbyterian Church are undersized and become completely blocked during flood events. During the September 2013 flood event, waters passed over the driveway, peeling away asphalt and blocking main access to the church from Baseline Road. Removing these culverts and replacing with a driveway bridge will alleviate the hydraulic limitation and allow larger storm event flow to pass more easily through this area. The culvert is located on private property and an easement agreement will be needed.

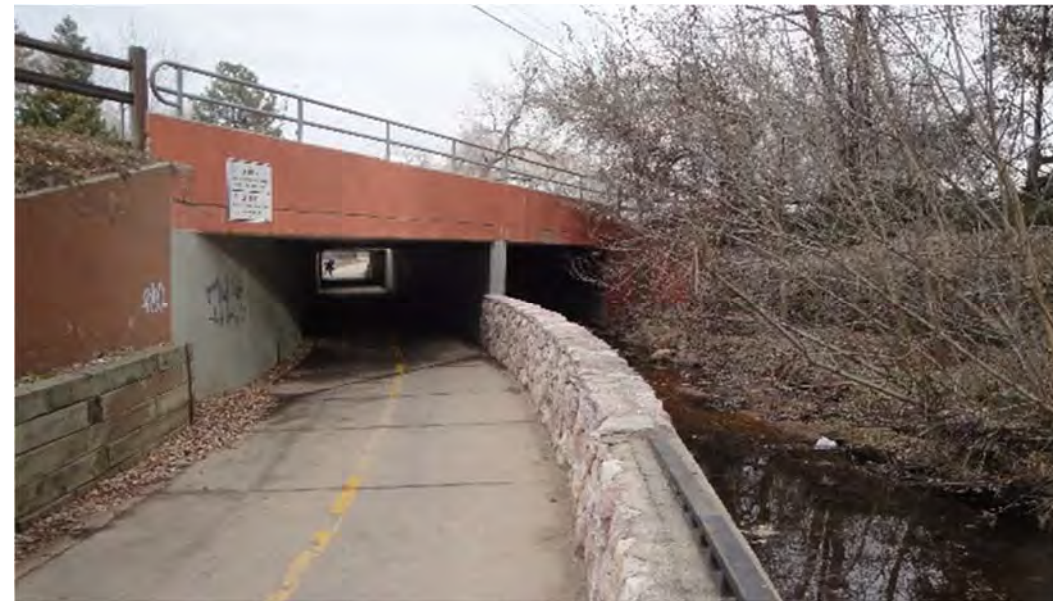
*Culvert R3-4: Underpass at Baseline Road*

Improvement	Size	Width (ft)	Shape	Length (ft)	% of 100-year Storm
Existing	(2) 7' x 12'	25	Box	186	27%
Replace	(2) 7.5' x 28'	56	Box	186	100%

The underpass and culvert at Baseline Road are at an acute angle that can be uncomfortable for multi-use path users and do not pass 100-year storm flows. This culvert should have increased capacity and a wider angle in the path that can provide improved line of sight for users. The culvert is located on city right of way and there are no access issues.
