# COLUMBIA CEMETERY

DRAFT NOVEMBER 11, 2022  
SUBMITTED DECEMBER 16, 2022

The report documents the history, significance, integrity and existing condition and provides treatment guidance for the resource. It does not evaluate for listing in the National Register of Historic Places. If the resource has been previously listed or evaluated it is referenced and footnoted.

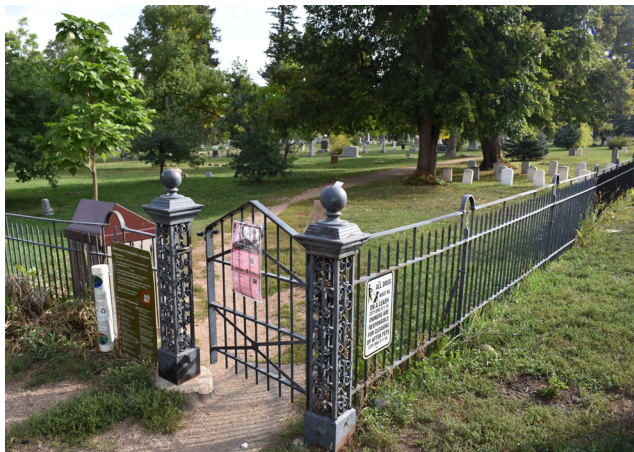
Figure 1-5. Iron fence and gate, 2022 (source: Mundus Bishop)  
8-16

**Iron Fence and Gates** - An iron picket fence with a top rail surrounds the cemetery on three sides. The fence varies in condition but overall is in need of sanding, staining, and portions should be replaced in kind. There is a section on the southwest that appears to have been a recent restoration. Areas of rust, peeling, and damage from vehicles is apparent along 9th Street. The attachment plates and concrete footings are mostly secure and functioning well. Three decorative small iron gates occur along the fenceline, at the southwest, southeast, and north side of the cemetery. They are in need of some sanding, staining, and replacement of parts in kind.

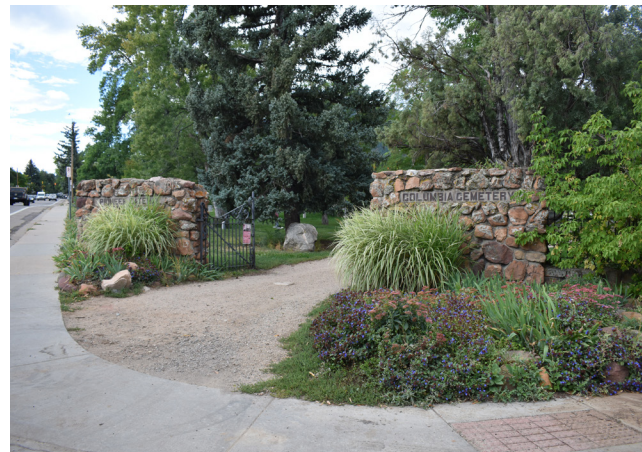
Figure 1-6. Pioneer Gateway with perennial bed in foreground, 2022 (source: Mundus Bishop)

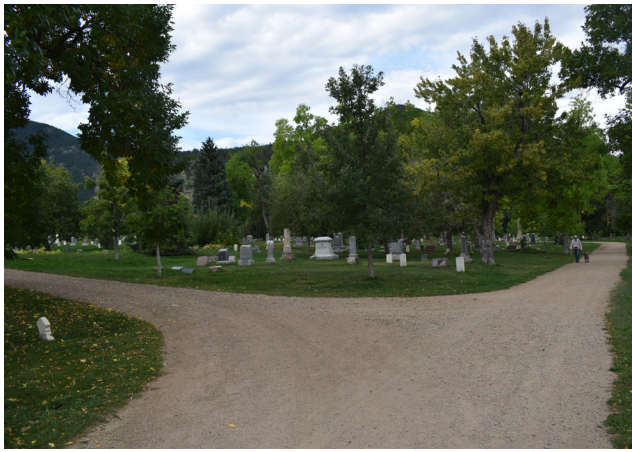
Figure 1-7. Soft-surface roads are the primary circulation routes through the cemetery, 2022 (source: Mundus Bishop)

There is a view to Boulder Canyon along the northern gravel road, although the view is largely blocked by mature trees along Pleasant Street. Views to the Flatirons are present in a few places throughout the cemetery. These views are more like glimpses as the view is often blocked by mature trees. (Figure 1-7).

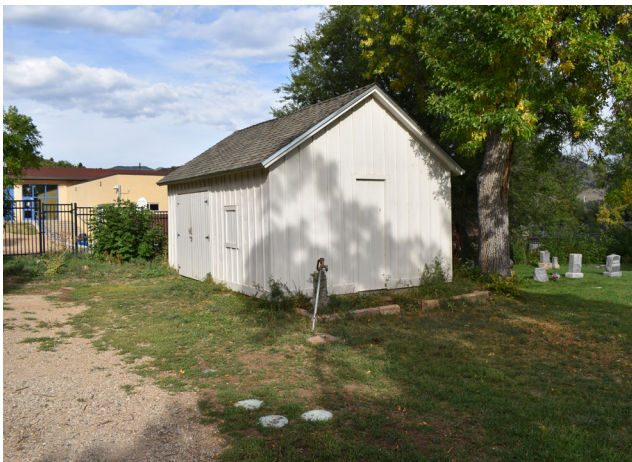
**Maintenance Shed** - This shed is a white, rectangular (15'x20'), wood vertical board and batten structure with an asphalt roof. It was originally constructed circa 1915 and rehabilitated in 2015. There is material storage on the west and north sides. Stone boulders extend from the west side to the north and end at a mature tree. There is overgrown vegetation at the west side along the narrow trench. A low wall occurs near the east side access.

*Figure 1-11. Maintenance Shed, 2022*  
(source: Mundus Bishop)

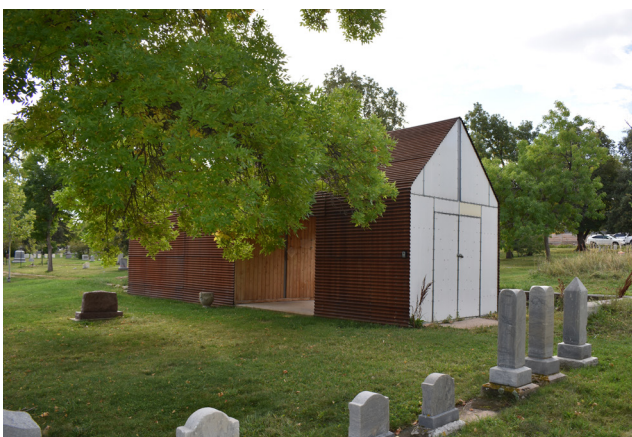
**Volunteer Shed** - This shed is a rectangular wood and corrugated metal structure with a central breezeway. The shed was built in 2013. It has a small landscaped area and concrete sidewalk at the east side. There is a concrete retaining wall at the south and west sides with corrugated metal siding and a concrete landing at the west end. The building is in good condition but the glass Chronology plaque is broken and needs to be replaced in kind.

*Figure 1-13. Volunteer Shed, 2022*  
(source: Mundus Bishop)

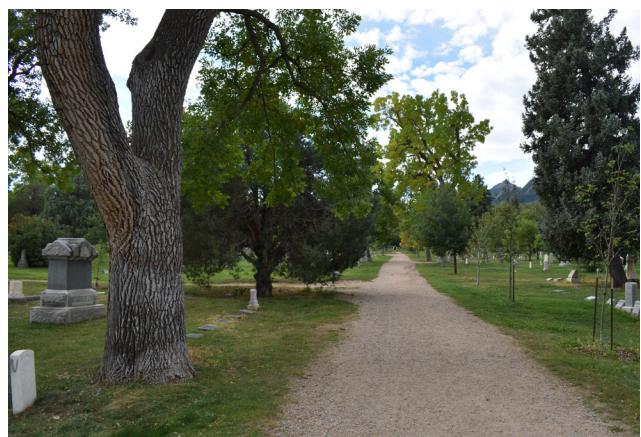
*Figure 1-14. Mature deciduous and conifer trees, 2022*  
(source: Mundus Bishop)

Mature deciduous and evergreen trees are dispersed throughout the cemetery. Deciduous trees include cottonwood, elm, catalpa, linden, crabapple, Kentucky coffee tree, oak, and ash. Conifer trees include Colorado spruce, Douglas fir, juniper, and cedar. Many of the mature trees are reaching the end of their life span and likely date to the 1920s and 1930s when the Park Cemetery Association added vegetation to the property. Some trees have been recently replaced.

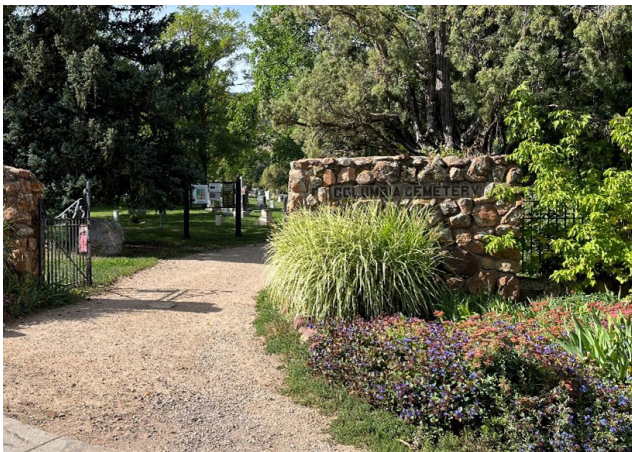
Pioneer Gateway is constructed of mortared stone masonry. The south pier is approximately 9'-8" wide by 6'-8" tall and 2'-8" thick. The north pier is approximately 9'-5" wide by 6'-8" tall and 2'-4" thick. The stones used to construct the piers are a mix of local red sandstone and granite. The stones are set in a hard mortar applied in different campaigns, one of which included large aggregate. It is unknown how deep below grade the piers extend.

Generally the Pioneer Gateway is in good structural condition. The piers appear to be plumb and no widespread cracking of the masonry units or mortar. Some of the sandstone units are slightly eroded, however, none to the point of significant structural section loss. The most major threat to the structural stability of the Gateway is how close the vegetation is growing to the masonry (in some cases it is growing on the masonry structure). Not only can the vegetation harbor excess moisture against the structure and cause the sandstone units to weather quicker, but also the root systems of the vegetation can grow and extend into the structure and cause damage in the future.

Figure 1-16. Pioneer Gateway at the northeast corner of the Columbia Cemetery, 2022 (source: JVA)

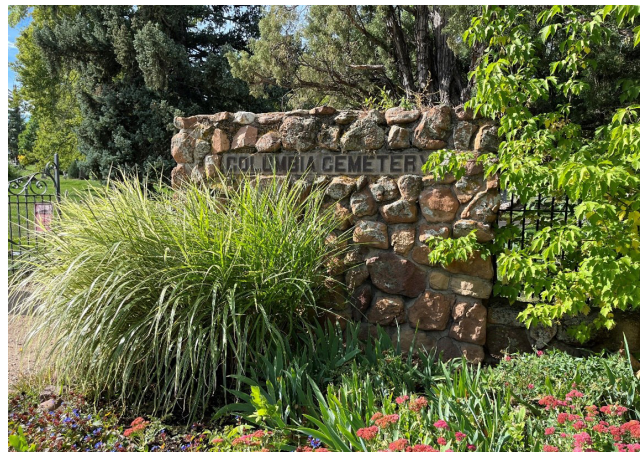
Figure 1-17. Note the close proximity of vegetation to the stone structure, 2022 (source: JVA)

Preserve and repair extant structural features including the masonry piers.

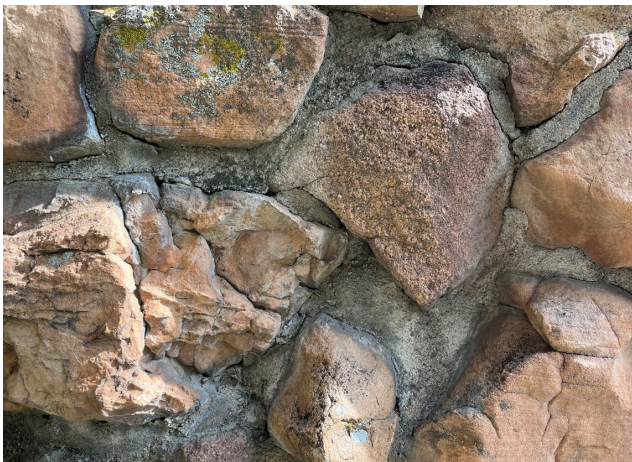
Figure 1-18. Some of the sandstone units are slightly eroding as evidenced by their rounded edges on the Pioneer Gateway, 2022 (source: JVA)

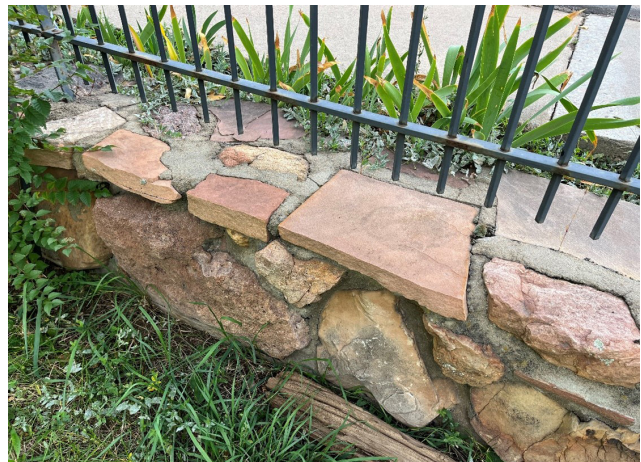
Figure 1-19. Typical stone masonry site wall around the east and north sides of the perimeter of the Columbia Cemetery, 2022 (source: JVA)

Generally the site walls appear to be in good structural condition with no signs of major displacement or failure. However, there are several deferred maintenance items that could cause structural issues in the future if not addressed. These include the close proximity of vegetation to the wall (particularly along the north wall) and routine maintenance of the mortar joints of the masonry (especially the top face of the wall since there is no parge coat or coping stones).

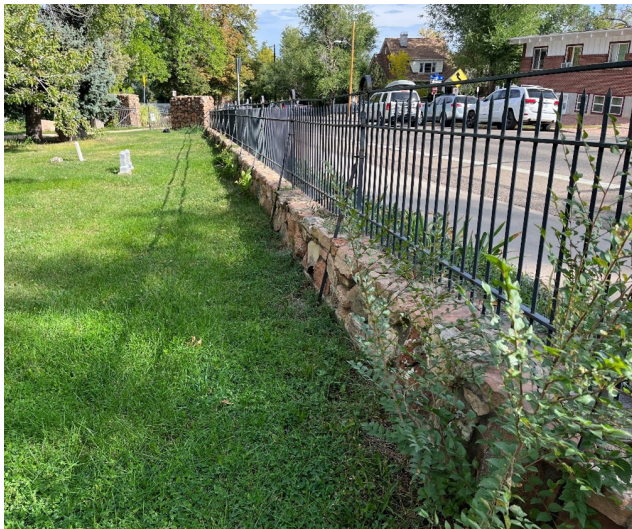
Figure 1-20. Typical stone masonry site wall as seen along the east perimeter of the Columbia Cemetery, 2022 (source: JVA)

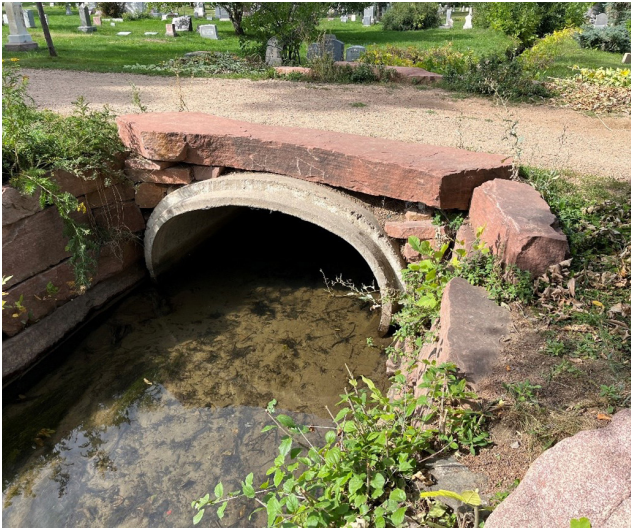
There are two ellipse-shaped culverts located at the Columbia Cemetery, both of which are constructed of reinforced concrete. The west culvert is 4" thick and has inside dimensions of 60" wide by 36" tall. The east culvert is 5 ½" thick and has inside dimensions of 72" wide by 42 ½" tall (it may be taller as quite a bit of sediment has collected at the base of the culvert). On the exposed ends at the walkway level, stacked red sandstone units conceal the visible portions of the culverts.

From a surficial perspective, the culverts are in fair condition. Although they appear to be performing their function, there are some small spalls and exposed rebar in discrete locations. There is also some scour of the cement paste exposing the aggregate of the concrete. Please note that these culverts were not reviewed by a civil engineer and they will need to be in the future to determine if they are adequate for the flow of water and loads of the walkway surface.

Figure 1-22. East side of the easternmost culvert, 2022 (source: JVA)

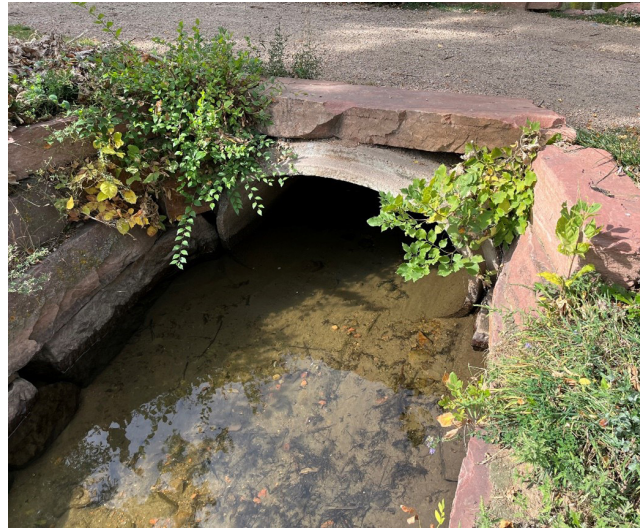
Figure 1-23. East side of the westernmost culvert, 2022 (source: JVA)

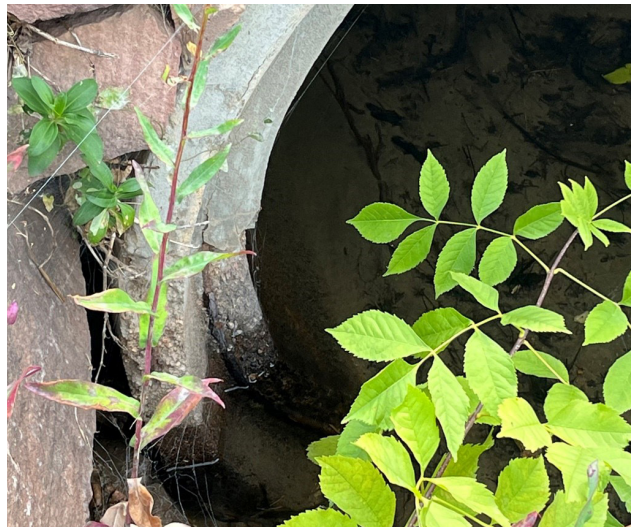
Figure 1-24. Concrete spalling on one of the concrete culverts, 2022 (source: JVA)

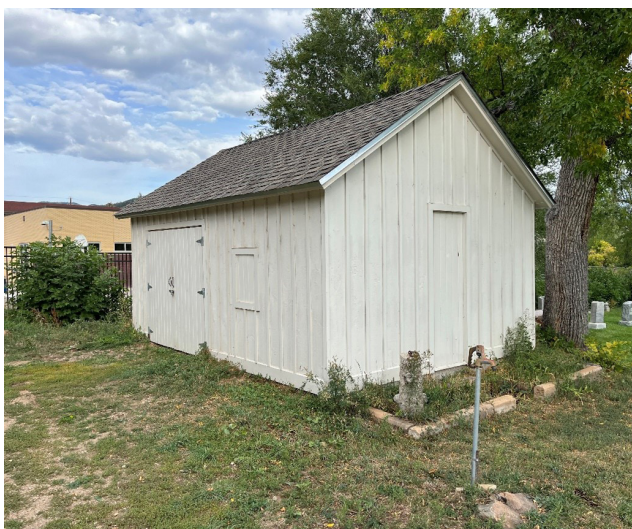
The Maintenance Shed is constructed of wood roof and wall framing on an integral concrete foundation and floor. It was rehabilitated in 2014.

Figure 1-25. Southeast corner of the North or Historic Shed at the Columbia Cemetery, 2022 (source: JVA)

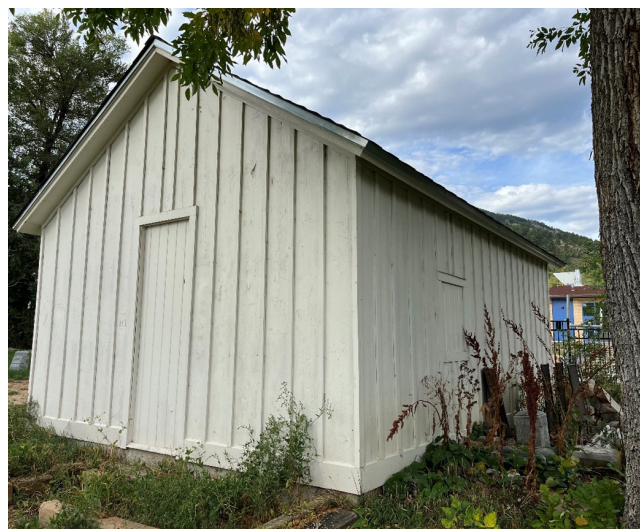
Figure 1-26. Vegetation adjacent to the building along the north elevation, 2022 (source: JVA)

There are a few locations where there is some impact damage to the wood siding that have created holes in the envelope. Other areas of the trim and siding are deteriorating due to decay fungi infestation, typically close to grade or where vegetation is close to the building. The trim at the west jamb of the south door is broken at the base.

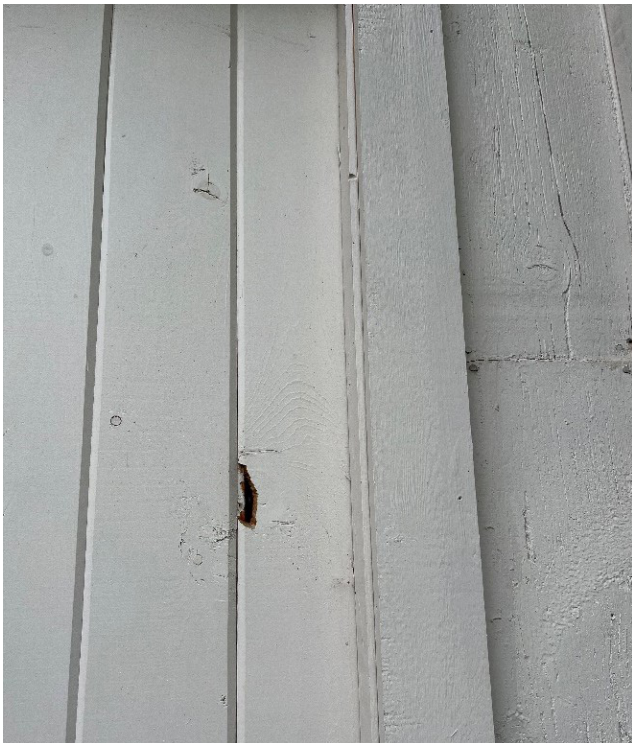
*Figure 1-27. Impact damage on a panel in the wood door of the building, 2022 (source: JVA)*

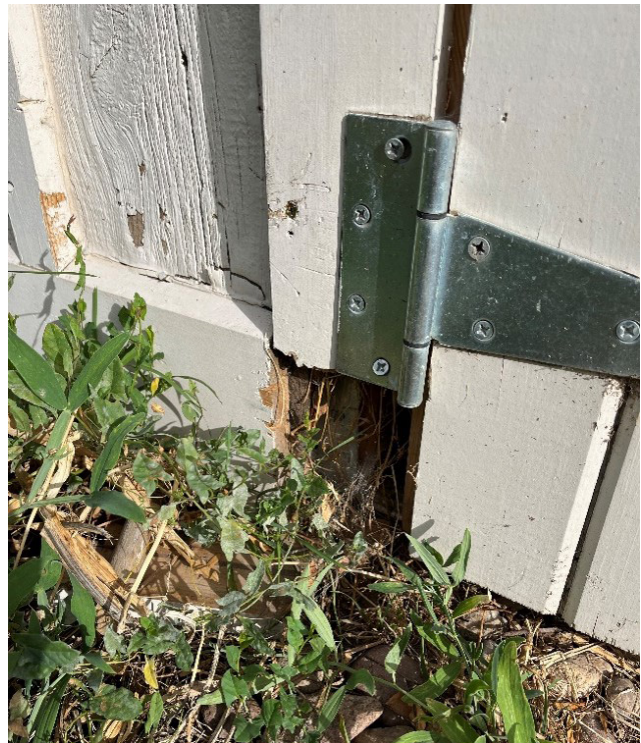
*Figure 1-28. Broken trim at the west jamb of the south door, 2022 (source: JVA)*

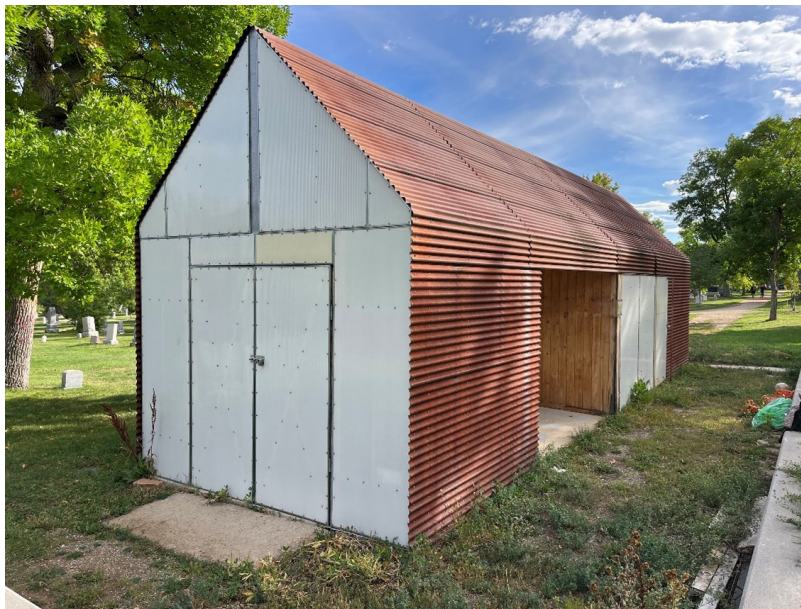
The volunteer shed in Columbia Cemetery was designed and constructed in 2011 by CU Architectural and Planning Students. It is constructed of wood and rod roof truss framing, with wood and rod walls on a concrete floor and foundation.

Figure 1-29. Southwest corner of Volunteer Shed at Columbia Cemetery, 2022  
(source: JVA)

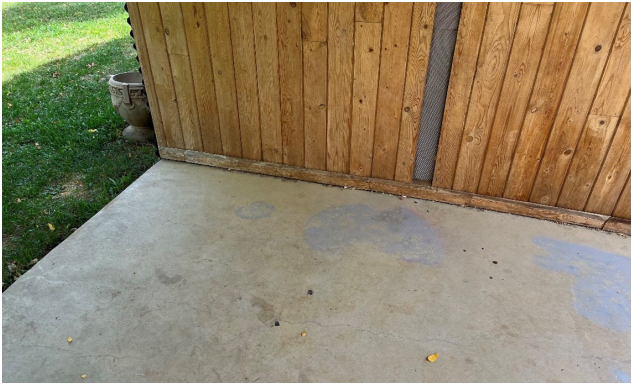
The floor is a concrete slab on grade. As mentioned above, if the building is founded on a turned down slab edge, the floor and foundation are integral.

Where visible the floor appears to be in good condition with no signs of widespread displacement or major cracking.

Figure 1-30. Concrete floor of Volunteer Shed as seen from the Breezeway, 2022 (source: JVA)

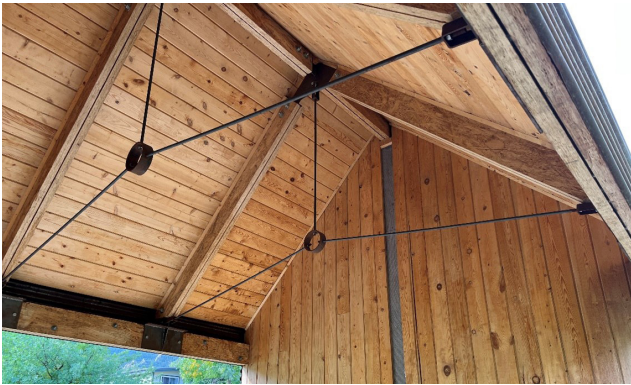
The roof framing is in good to fair condition. The framing is adequate for the snow load associated with the site, however, the span rating of the plywood is unknown. If the plywood installed is rated to span 4', it is likely adequate. However, if the plywood has a lesser span rating, the roof is not adequate for the roof dead and snow loads.

Figure 1-31. Typical roof framing of Volunteer Shed, 2022 (source: JVA)

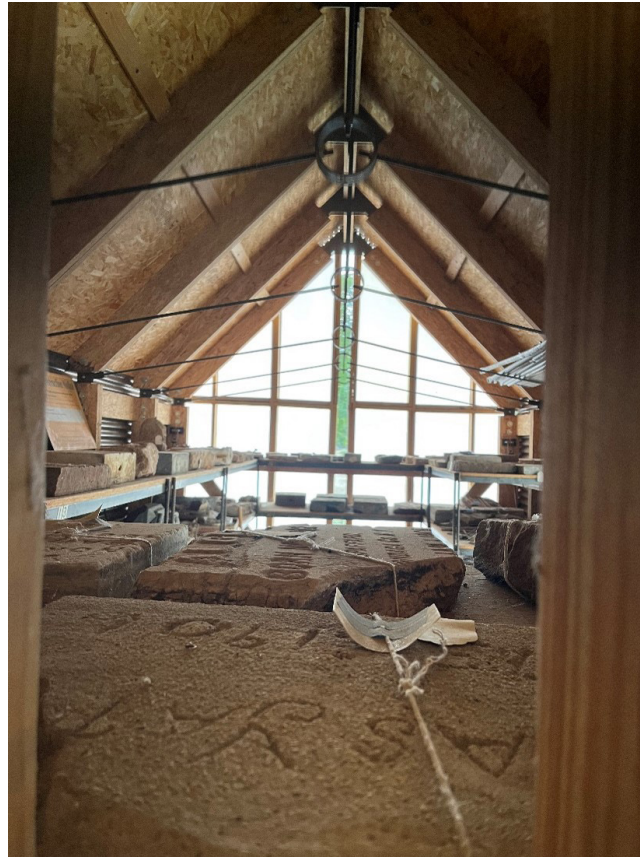
The walls of the shed are framed with fitch plate studs aligned with each truss at 4'-0" on center. The fitch plate studs are composed of two 1 3/4" by 7 1/4" LVL members with a steel plate in the center. The sizes could not be confirmed since the interiors of the buildings were not accessible during site observations.

At the interior spaces, the roof trusses connect to the wall studs with a custom steel saddle and steel plate attached to the wall stud fitch plate. The tops of the wall studs are braced laterally with a let in 7 1/4" LVL beam on the exterior face of the wall.

Figure 1-32. Interior of the east portion of Volunteer Shed. Note the roof and wall framing., 2022 (source: JVA)

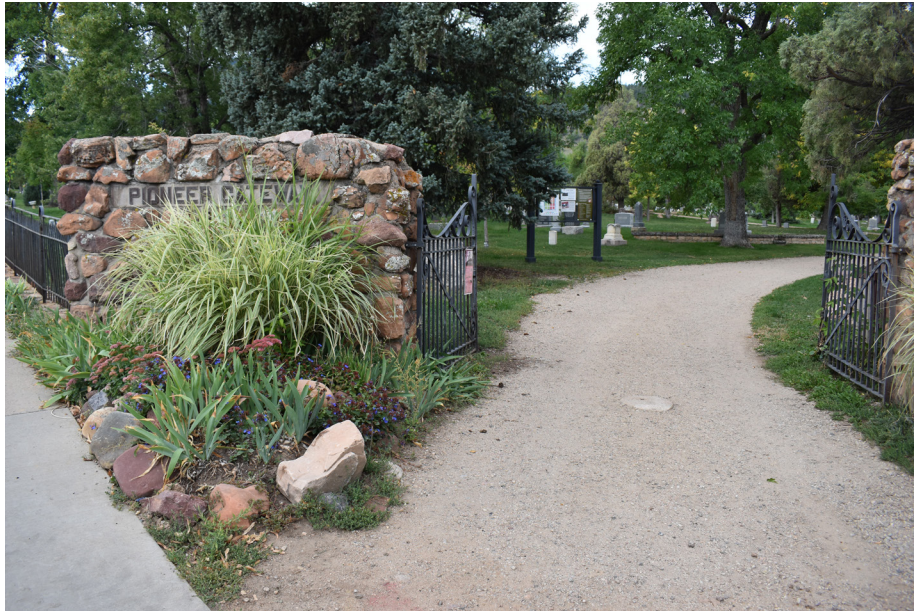
*Figure 1-33. Pioneer Gateway, stone wall, iron fence and gate, 2022 (source: Mundus Bishop)*

Stone Wall - A stone wall extends south and west of the Pioneer Gateway and retains the street grade along 9th Street. It extends in the opposite direction along Pleasant Street for approximately 30 feet. This wall is in fair condition, with some repair, resetting, and repointing of stones needed. In some places, vegetation threatens the structural integrity of the wall.

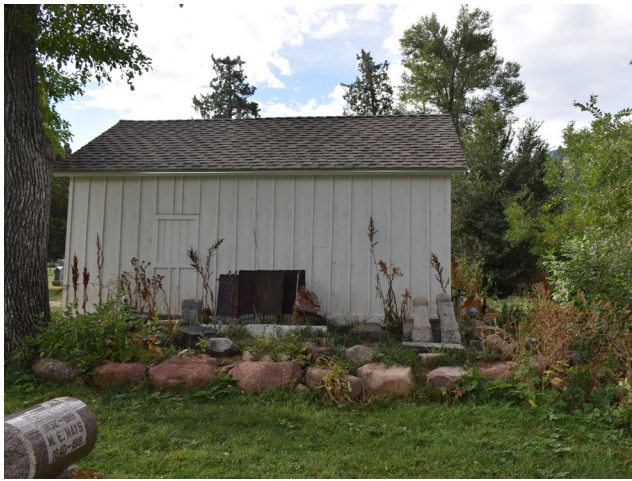
Figure 1-35. Maintenance shed with boulder wall, 2022  
(source: Mundus Bishop)

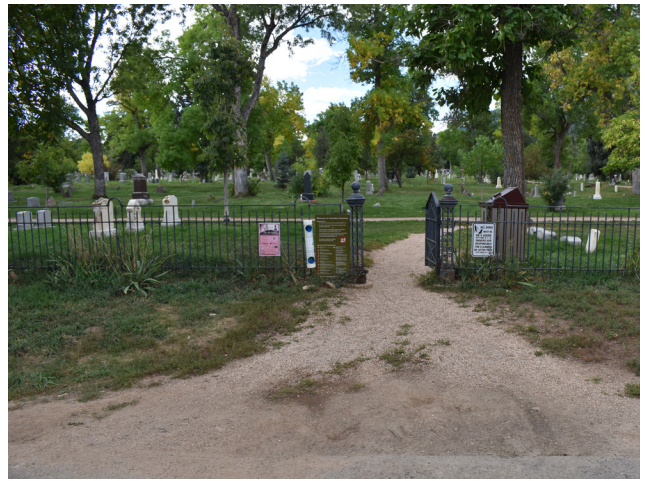
Figure 1-36. North entrance gate, 2022 (source: Mundus Bishop)

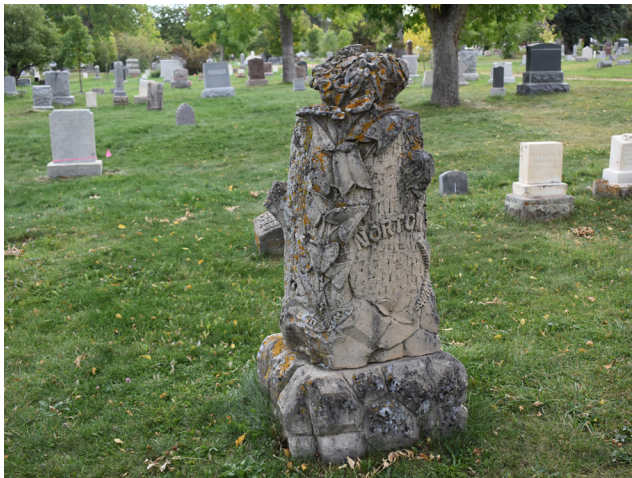
Figure 1-37. Grave marker, 2022  
(source: Mundus Bishop)

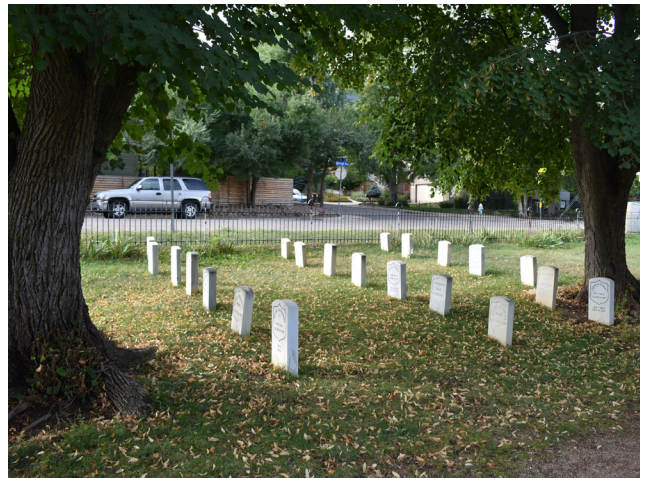
Figure 1-38. Marble grave markers for Civil War soldiers, 2022  
(source: Mundus Bishop)

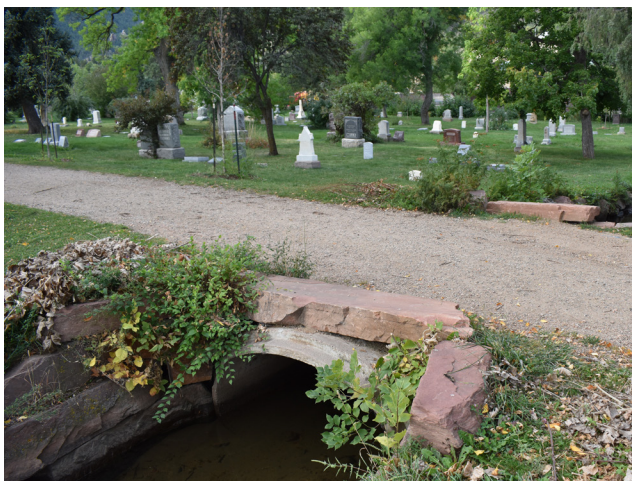
Figure 1-39. Culvert at New Anderson Ditch, 2022  
(source: Mundus Bishop)

Culverts - There are four (4) culverts located along the New Anderson Ditch. They are concrete culverts covered with sandstone block in good condition. Some repair, resetting, and repointing of the sandstone is needed. These may date to 1915 when the road system was completed.

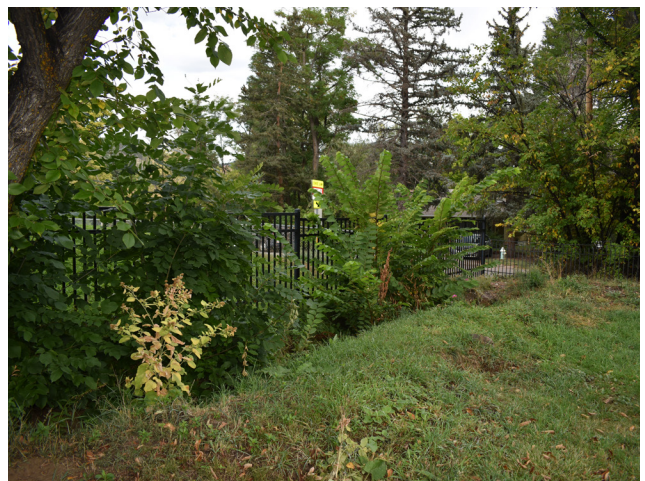
**Narrow Trench** - A narrow trench is located at the western edge of the cemetery. The trench is in poor condition; it is uneven and collapsing in places, with no hard edge and is overgrown with riparian vegetation. Some headstones are in close proximity to the trench and are threatened by undercutting and erosion.

Figure 1-40. Narrow trench, 2022 (source: Mundus Bishop)
