CHAUTAUQUA PARK

COLORADO CHAUTAUQUA NHL

MAY 2023

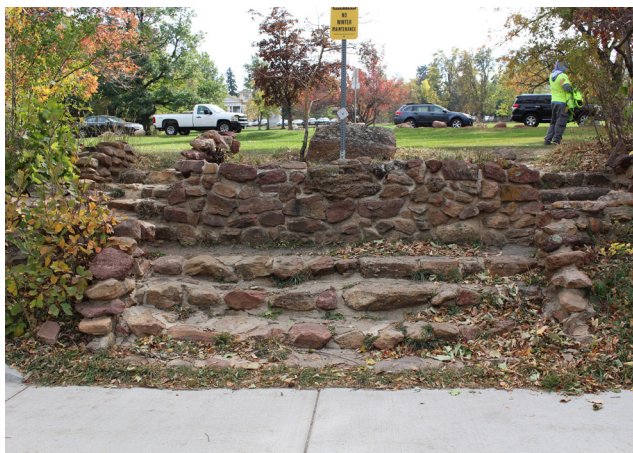
Lincoln Street Steps (Queen's Gate, 1917) – Queen's Gate is a pedestrian entrance consisting of a series of shallow stone steps, flanked by stone rubble walls that lead into the oval lawn of Chautauqua Green. The lower steps are broad and open, connecting with Baseline Road and terminating at a stone paved terrace and stone rubble wall. A contemporary metal sign with the message "Caution: No Winter Maintenance" is in the center of the wall, diminishing the historic appearance but providing an important safety notice. The upper stone steps connect to the stone paved terrace and flank the stone rubble wall. Queen's Gate retains integrity, but is in poor condition due to failing mortar joints, inappropriate mortar repairs and vegetation that is encroaching on the stone rubble wall and stone steps.

Figure 1-6. Lincoln Street Steps (Queen's Gate), 2020 (source: Mundus Bishop)

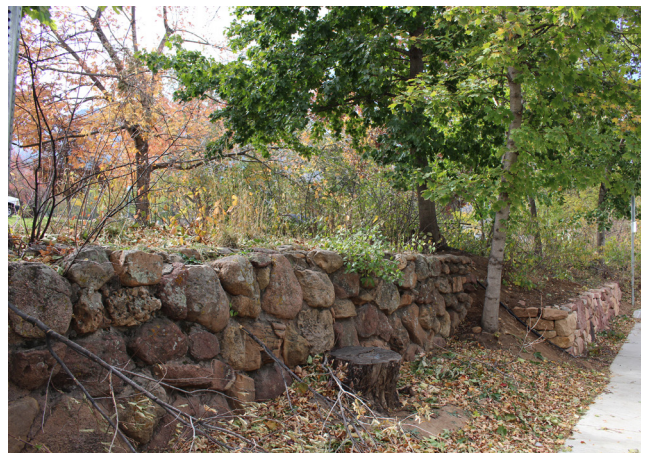
Stone Rubble Walls – Original stone rubble walls extend from the east side of King's Gate to Queen's Gate. The stone rubble walls retain integrity and are in good condition.

Figure 1-7. Stone rubble wall between Queen's Gate and stone walls, 2020 (source: Mundus Bishop)

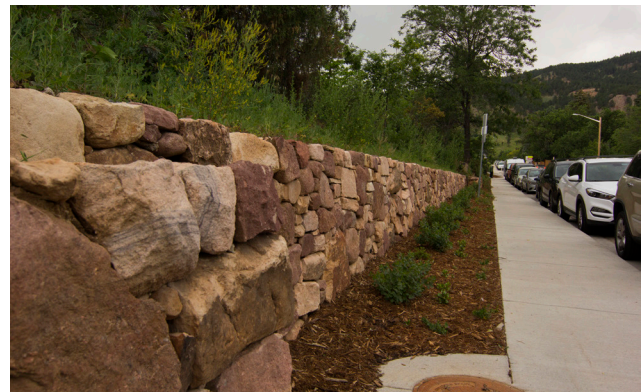
Stone Walls - Stone walls were added to the northern edge of Chautauqua Park in 2017 as part of improvements to Baseline Road that included a sidewalk and parking spaces. The stone walls extend between King's Gate stone rubble wall and Queen's Gate, and from Queen's Gate to the west for the length of Chautauqua Green, functioning to retain grade. The stone walls are built using a stone material and in a form and size that is compatible with, but different than, the original stone rubble walls.

Figure 1-9. Stone walls and sidewalk built in 2017 (source: Mundus Bishop)

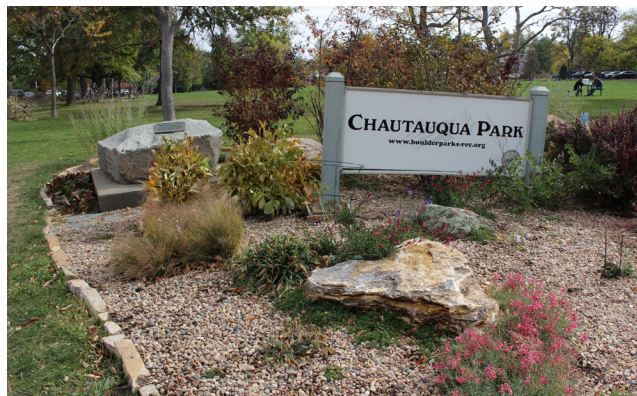
Rock Miner's Memorial Rose Gardens – The rose garden in northwest corner of Chautauqua Green surrounds the Rock Miners Memorial, and was built in 1981. The garden is in fair condition.

Figure 1-12. Garden at Rock Miner's Memorial and Entrance Sign, 2020 (source: Mundus Bishop)

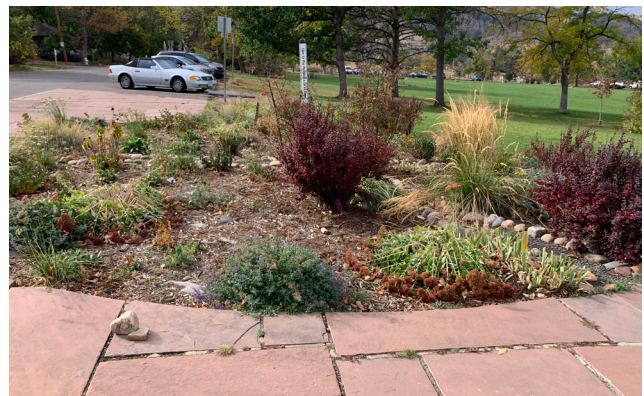
Peace Garden – This garden was installed in 2002 in front of the Dining Hall, and consists of smaller planting beds divided by small rocks that form a peace symbol. The Peace Garden is in good condition and is non-contributing.

Figure 1-13. Peace Garden near Dining Hall, 2020 (source: Mundus Bishop)

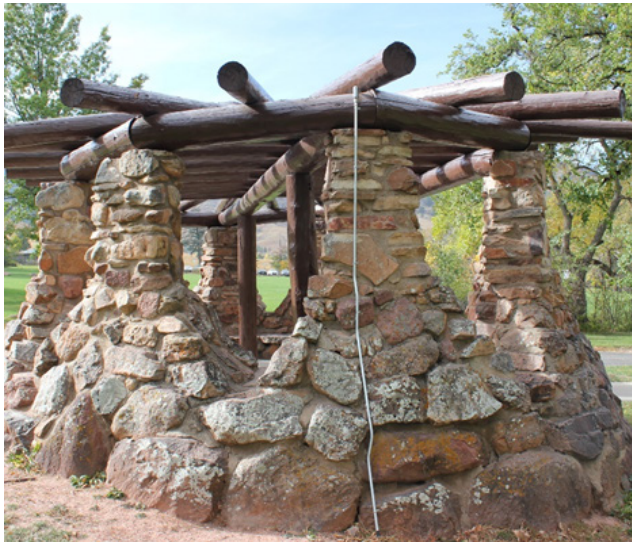
The stone piers are structurally in good condition; however, there are areas of significant mortar erosion, especially around the bases of the piers, and patches of mortar repointing that are not compatible with the original structure. The stones near grade have a significant amount of lichen growth. This does not compromise the structure itself but changes its appearance and is an indication that moisture is prevalent. This indicates that more frequent maintenance of the mortar joints may be necessary. The timber posts have vertical cracks or checks; these are shrinkage cracks and are not of structural concern.

Figure 1-16. The Arbor, note lichen growth and eroded mortar joints, 2020 (source: JVA)

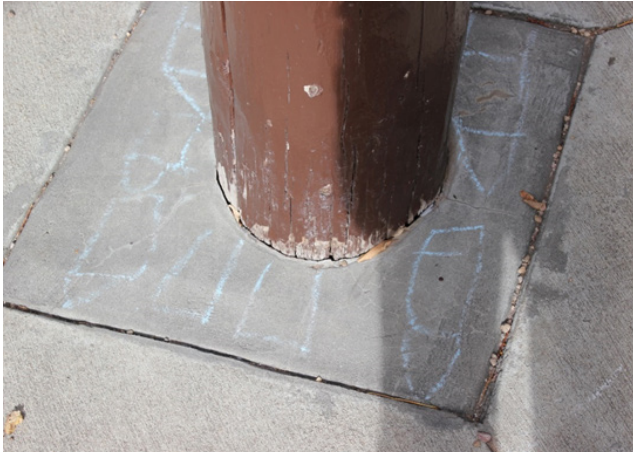
Overall, the foundation of the stone piers is in good condition. There is no evidence of settlement or settlement related cracking. The east timber post shows signs of decay at its base that bears directly on its foundation element and is tightly surrounded by the concrete sidewalk, both encourage moisture to remain rather than dry. (Re: Figure 1-19) The west post has new concrete around its base, indicating that it could have been recently replaced; however, this bearing condition could lead to the same moisture related decay pattern in the future.

Figure 1-18. Decay at base of timber post, 2020 (source: JVA)

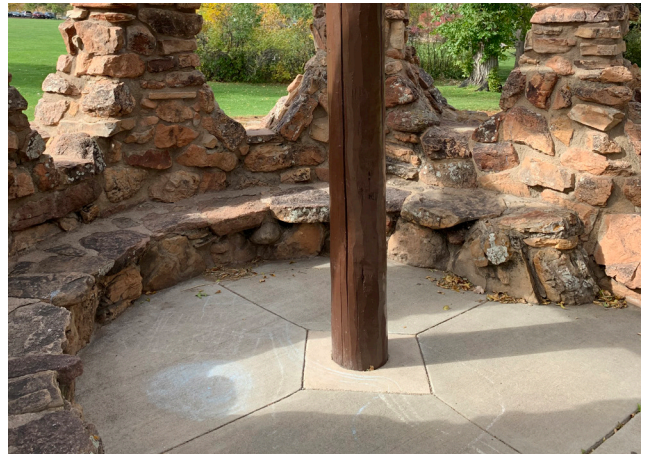
The joined pier bases create the backs to built-in rubble masonry benches that extend along the lengths of the curved ends. The benches are in good condition.

Figure 1-21. Curved bench, 2020 (source: JVA)

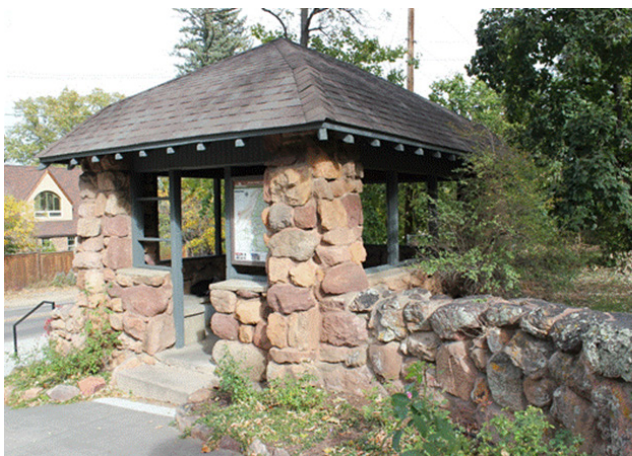
Figure 1-22. West wall showing attached retaining wall, 2020 (source: JVA)

The Shelter House is integral with the stone rubble wall that connects with the structure at the northeast and southwest buttresses. The site has a sloped grade that sharply declines towards the north. The shelter walls are also retaining soil in some locations (the slab elevation is below grade at the south wall and above at the north). The knee walls also serve as the back to the concrete benches inside the shelter and along the street-facing, north façade, where the bench has a rubble stone base with a concrete coping. Generally the walls are in good condition, there is evidence that spalls have been repaired in the past.

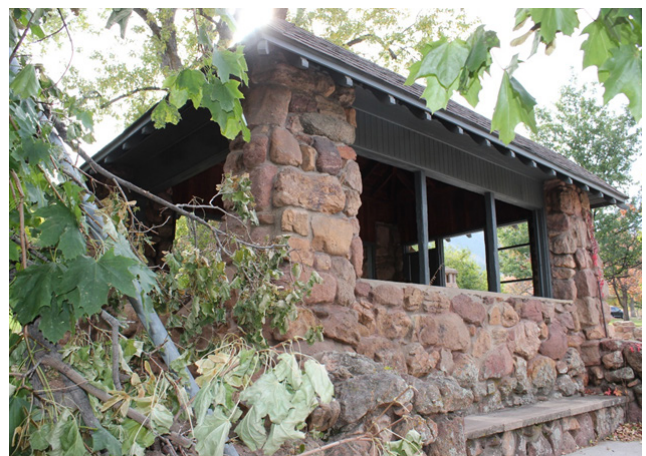
Figure 1-23. North wall of the Shelter House, 2020 (source: JVA)

The stone walls are in good condition. Patches of mortar repointing are not compatible with the original structure, and are beginning to crack and separate from the stones indicating that the repointing mortar is too strong. The repointing is a different color. There is a vertical crack in mortar joints in the northwest buttress caused by differential thermal expansion between the buttress and the main wall. Lichen growth is present at the bottom two-feet of the north wall.

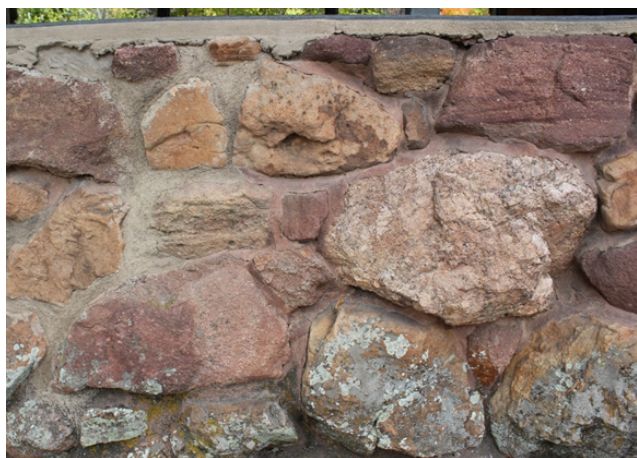
Figure 1-24. Repair mortar – note red color and separation cracks, 2020 (source: JVA)

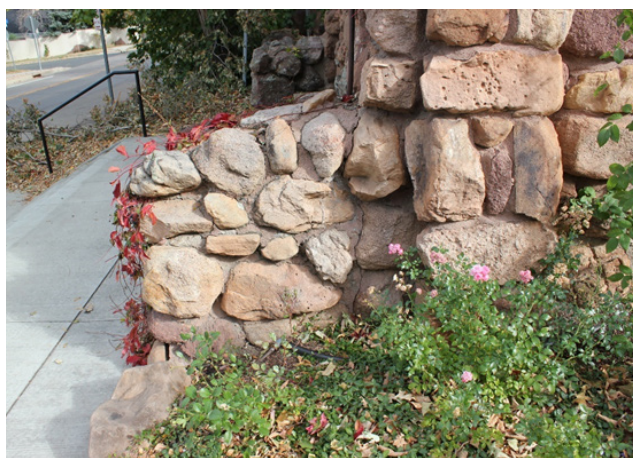
Figure 1-25. Differential settlement crack at northwest buttress, 2020 (source: JVA)

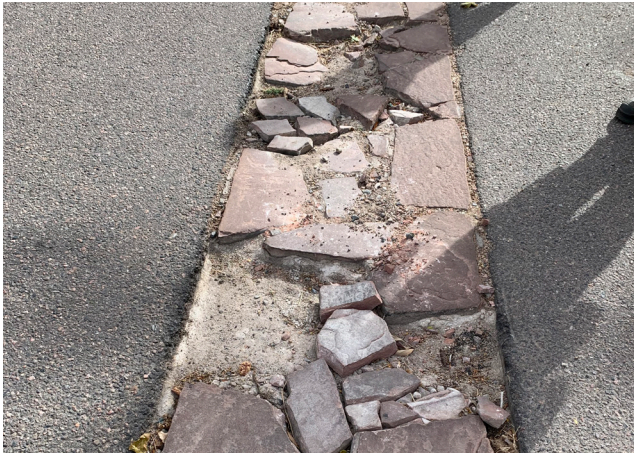
Stone gutters line Kinnikinic and Sumac Drive. The original gutters were likely built in 1907 when the roadway was graveled. Segments of the stone gutters are in fair to poor condition. Portions have been replaced. In 1987 stone gutters at Sumac Drive were rebuilt when the road was narrowed. These have a steep side slope and are sandstone set in concrete and are non-contributing. A portion were recently replaced with compatible materials and these are in good condition.

Figure 1-37. Stone gutter along Sumac Drive, 2020 (source: Mundus Bishop)

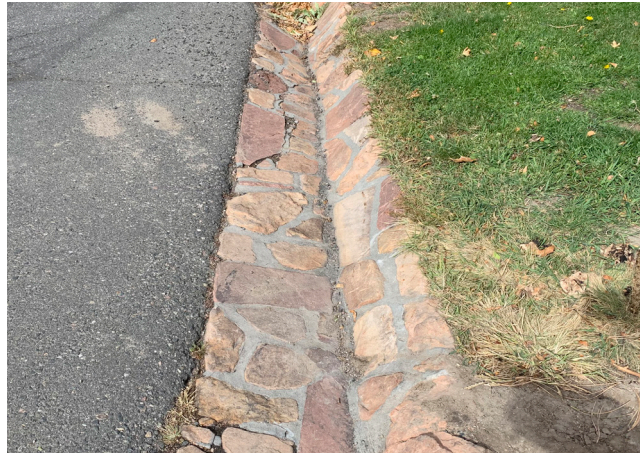
Figure 1-38. Non-contributing stone gutter along Sumac Drive, 2020 (source: Mundus Bishop)

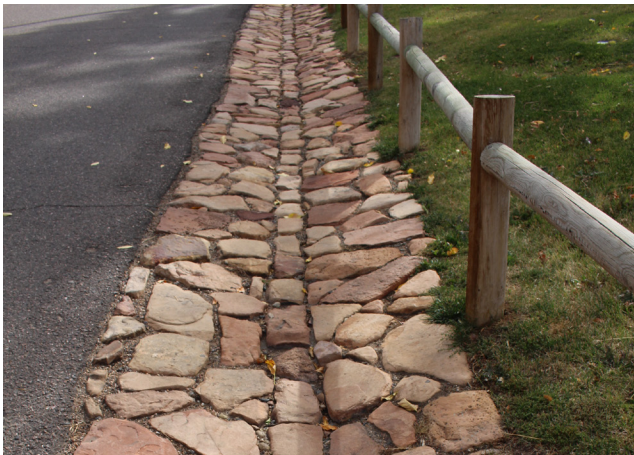
Figure 1-39. Stone gutters built using in-kind compatible materials on Sumac Drive, 2020 (source: Mundus Bishop)
