COLUMBIA CEMETERY

JULY 2023

The report documents the history, significance, integrity and existing condition and provides treatment guidance for the resource. It does not evaluate for listing in the National Register of Historic Places. If the resource has been previously listed or evaluated it is referenced and footnoted.

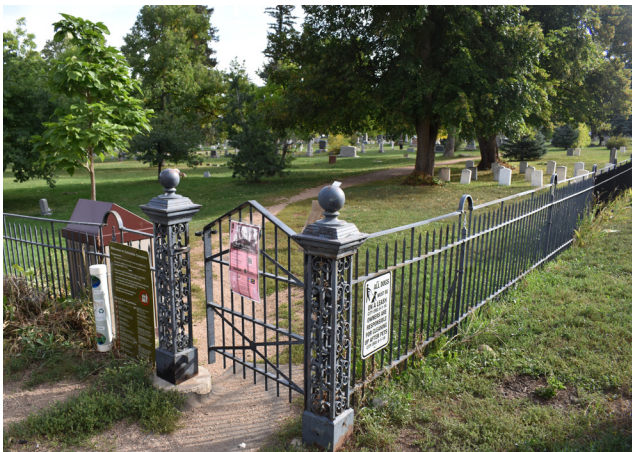
Figure 1-5. Fence and gate at the southwest corner of the property, 2022 (source: Mundus Bishop)
8-16

Metal Fence and Gates - A **metal** picket fence with a top rail surrounds the cemetery on three sides. The fence varies in condition but overall is in need of sanding and painting, and portions should be replaced in-kind. There

is a section on the southwest that appears to have been a recent restoration. Areas of rust, peeling, and damage from vehicles is apparent along 9th Street. The attachment plates and concrete footings are mostly secure and functioning well. Three decorative small metal gates occur along the fenceline, at the southwest, southeast, and north side of the cemetery. They are in need of some sanding, painting, and replacement of parts in-kind.

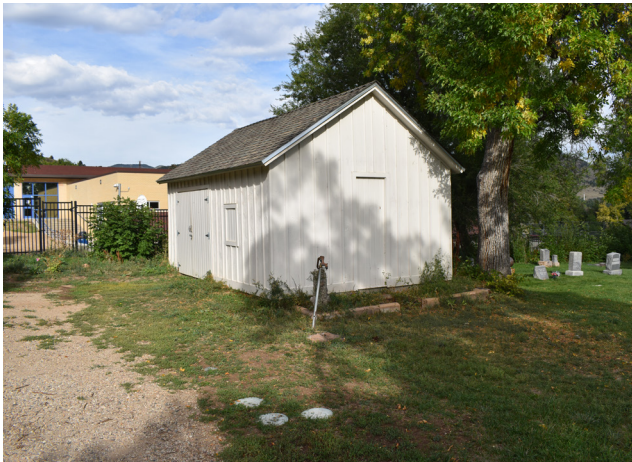
Figure 1-11. Maintenance Shed, 2022
(source: Mundus Bishop)

Maintenance Shed - This shed is a white, rectangular (15'x20'), wood vertical board and batten structure with an asphalt roof. It was originally built circa 1882 and rehabilitated in 2015. Material storage is on its west and north sides. Stone boulders extend from the west side to the north and end at a mature tree. There is overgrown vegetation at the west side along the narrow trench. A low wall is near the east side access.

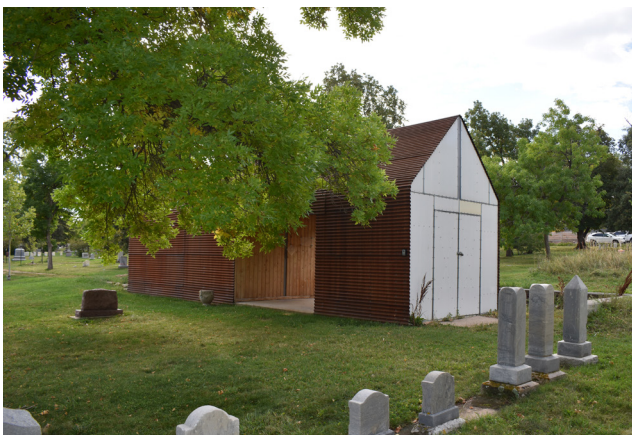
Volunteer Shed – This shed is a rectangular wood and corrugated metal structure with a central breezeway. The shed was built in 2012. It has a small landscaped area and concrete sidewalk at the east side. There is a concrete retaining

wall at the south and west sides with corrugated metal siding and a concrete landing at the west end. The building is in good condition but the Chronology plaque is broken and needs to be replaced in-kind.

Figure 1-13. Volunteer Shed, 2022
(source: Mundus Bishop)

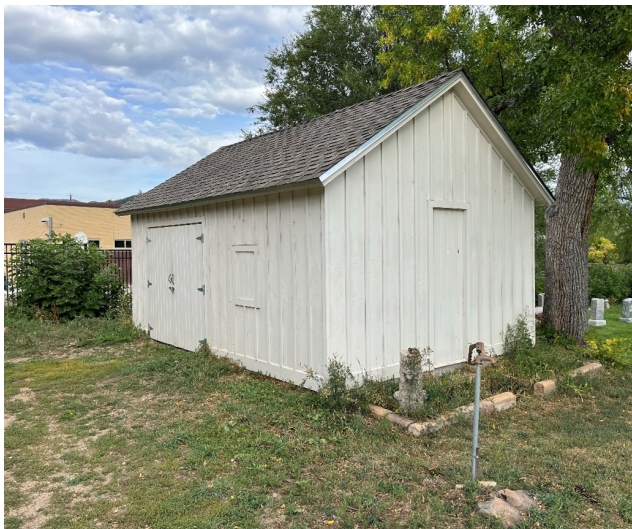
Figure 1-25. Southeast corner of the North or Historic Shed at the Columbia Cemetery, 2022 (source: JVA)

The wall framing is in good structural condition from the exterior showing no signs of failure or displacement. There are some minor issues located in isolated locations.

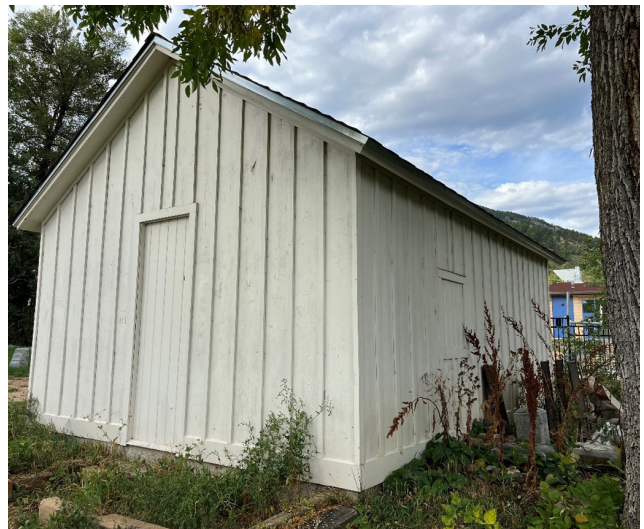
Figure 1-26. Vegetation adjacent to the building along the north elevation, 2022 (source: JVA)

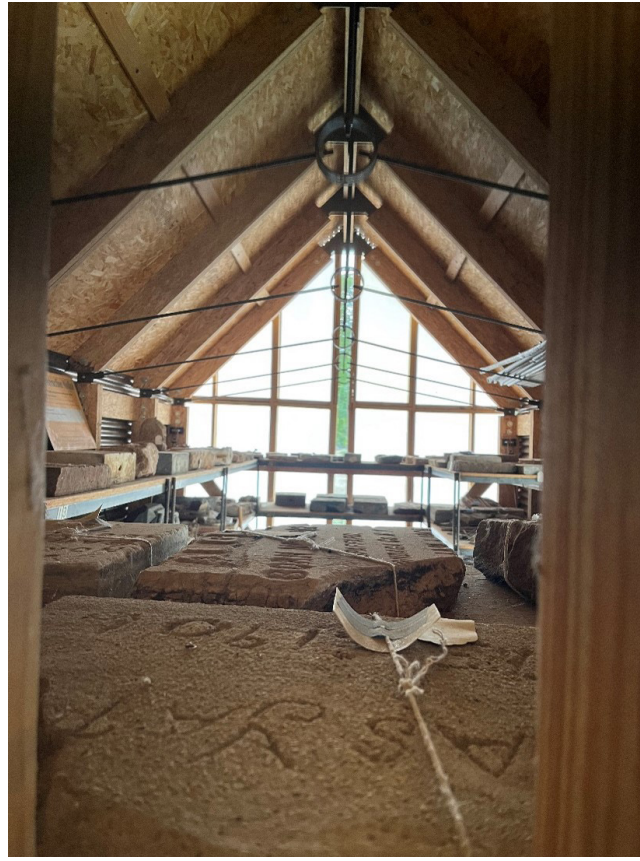
The wall framing is in good structural condition showing no signs of failure or widespread displacement.

Figure 1-32. Interior of the east portion of Volunteer Shed. Note the roof and wall framing., 2022 (source: JVA)

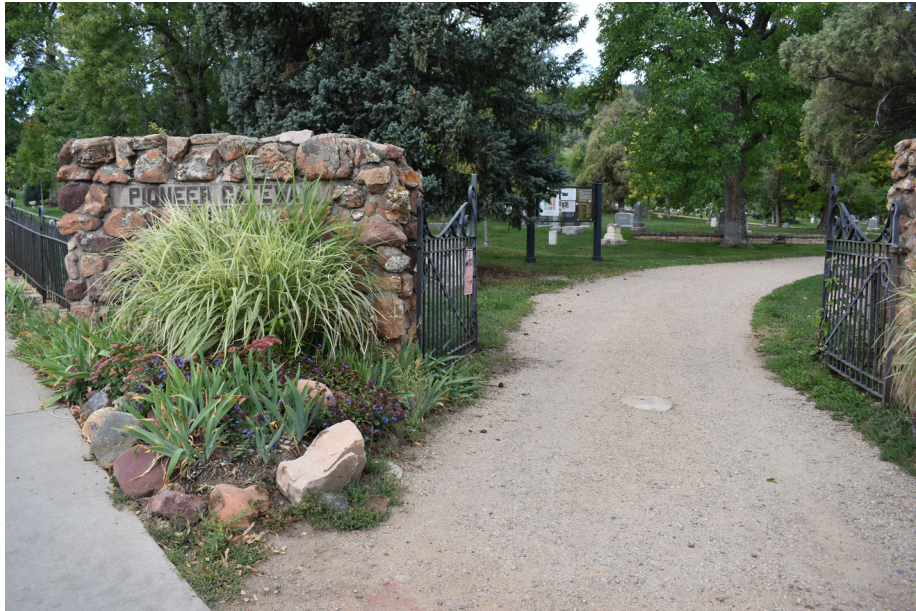
Figure 1-33. Pioneer Gateway, stone wall, iron fence and gate, 2022 (source: Mundus Bishop)

Stone Wall - A low stone wall extends south and west of Pioneer Gateway and retains the street grade along 9th Street. It extends in the opposite direction along Pleasant Street for approximately 30 feet. This wall is in fair condition, with some repair, resetting, and repointing of stones needed. In some places, vegetation threatens the structural integrity of the wall.
