**Making Your Historic Building Energy
Efficient: Volume 1 Principles & Approaches
August 2007**

**Prepared for:
City of Boulder
Office of Environmental Affairs**

**Prepared by:
Synertech Systems Corporation
www.SynertechSystemsCorp.com
Tom Wilson, Larry Kinney, Wyncia Clute**

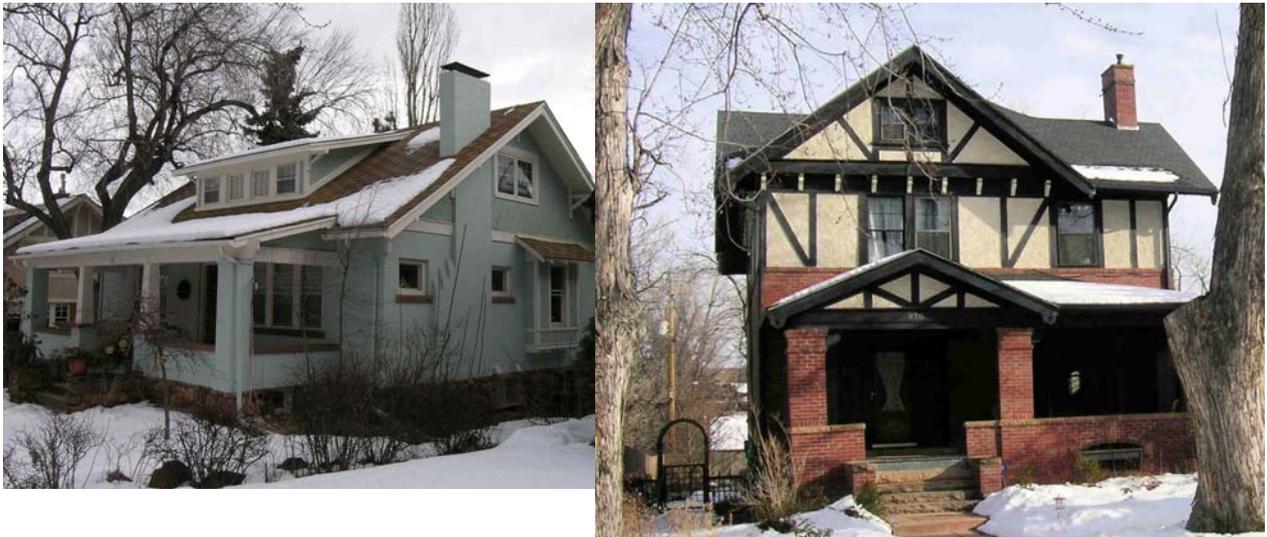
Figure 1-1. Historically contributing buildings located in designated historic districts, each of these houses had energy audits done in the winter of 2006-07. A number of opportunities were discovered for cost-effective energy-related retrofits in each house that will not affect their architectural or historic integrity.

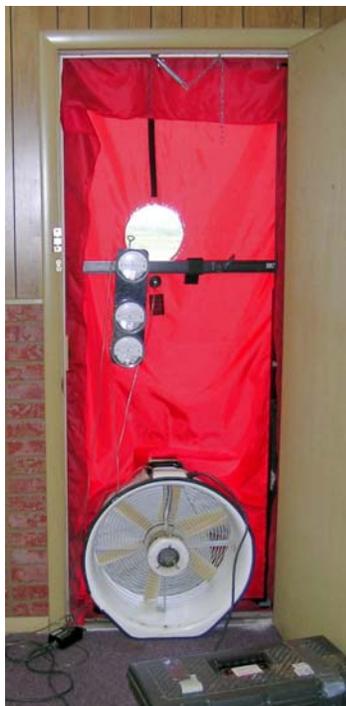
Figure 2-1. The blower door can be set up in a variety of doorways. The meters allow for measuring flow versus pressure difference as the fan speed is varied. The results can help estimate the magnitude of convective losses over a heating season. The heating bill to offset convective losses in some homes in Boulder's historic district exceed \$500 per winter.

Although it is important to air seal dwellings wherever they are leaky, it is particularly important to seal dwellings in crawl spaces and between ceilings and unoccupied attics. Occupants can find many leaks on their own, but some of the most wasteful are often hidden from view. This is why energy auditors use a “blower door”—a calibrated, variable speed fan—to depressurize a home (Figure 2-1). This test determines the homes’ degree of air tightness and assists in locating leaks in the building’s envelope and in its duct system. After temporarily setting up the blower door in an exterior doorway, the technician configures the house for wintertime conditions, but turns off all combustion equipment for the period of the test. The technician then adjusts the speed of the fan to depressurize the house to the point where it simulates the effect of about a 20 mph wind on all sides of the building at once. If the fan must work hard to create this much pressure difference, flow through the fan is high and the house is quite leaky.

With the fan pulling air into the house from leakage areas, the technician systematically checks all areas within the building. Many leakage sites are unobvious—and some suspected sites are found not to leak at all. In all events, the process allows for pinpointing where infiltration/exfiltration lurks—and thereby where air sealing remediation should be undertaken.

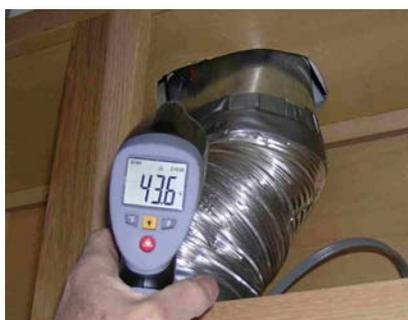
Figure 2-2. Infrared (IR) sensors like this one measure surface temperatures at a distance.

Sometimes this process is made more precise by the use of an infrared (IR) temperature sensor that facilitates quickly determining temperatures on surfaces at some distance from the observer. The IR sensor pictured in Figure 2-2 shows a cold air leak close to the duct of a ventilation fan in a kitchen cabinet. Leakage from such places is difficult to find with the unaided eye, yet that was the largest leak found in this new house built for high energy efficiency.

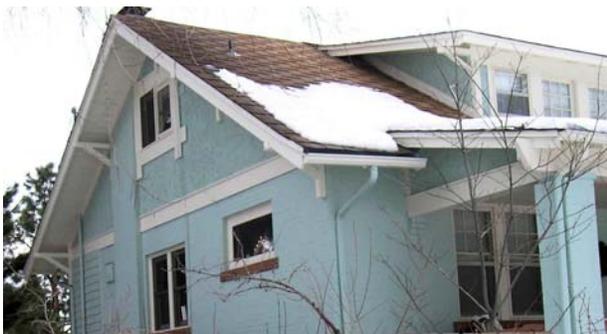
Figure 2-3. Snow on the roof of this historic house suggests a lack of insulation toward the peak of the roof.

Missing or substantially deteriorated insulation is quite common in older buildings. In addition, sometimes insulation is found in several areas, like a ceiling and floor in an attic area, part of which is next to an extra bedroom or office that was probably added well after the original house was built. Frequently, the insulation is inadequate and air leakage usually reduces the effectiveness of what there is to close to zero. The problem that needs to be solved in cases like these is to “define” the envelope with care, then ensure that it is air sealed and thoroughly insulated from the outside world (Figures 2-3 through 2-5).

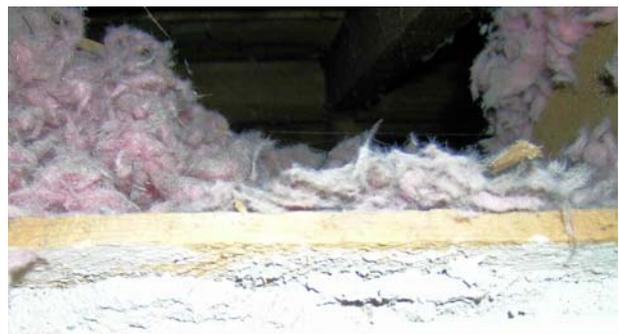
Figure 2-4. Sure enough, insulation under the rooftop is less than an inch thick.

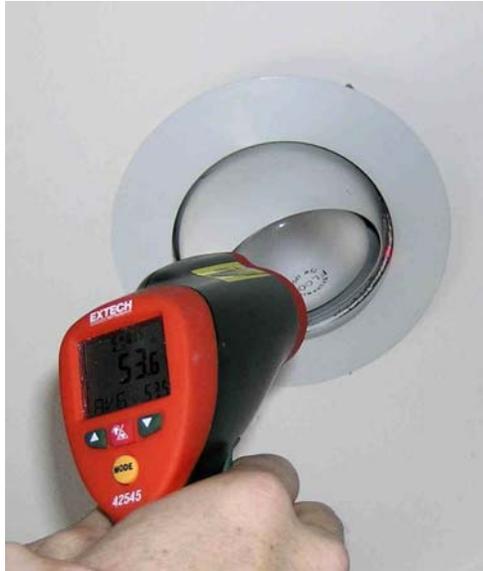
Figure 2-5. A scan of a recessed light fixture in the hallway immediately under the rooftop shows a cold area owing to lack of insulation and failure of air sealing.

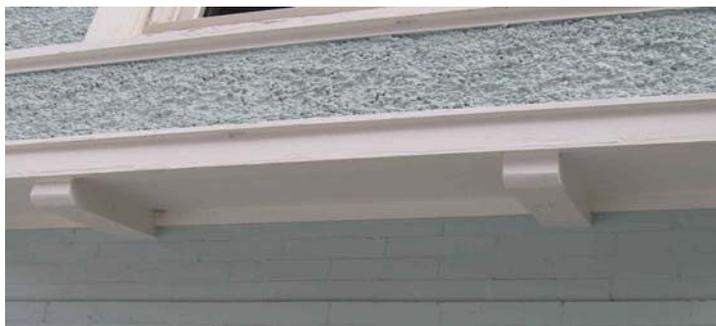
Figure 2-7. Areas like this that protrude from under windows are frequently sources of air leakage and are rarely insulated.

Figure 2-6 illustrates areas where insulation voids are common and Figures 2-7 and 2-8 picture two cases in a historic house in Boulder.

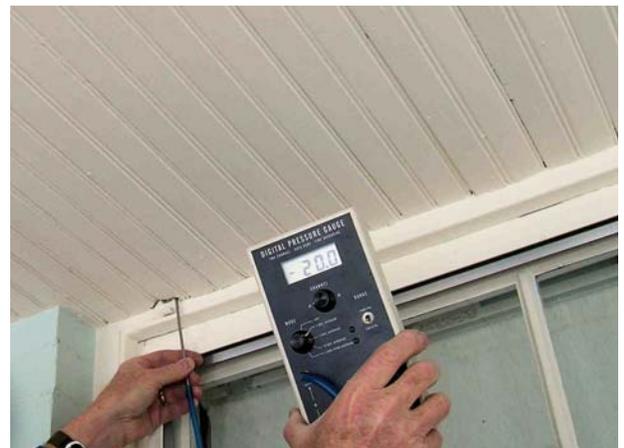
Figure 2-8. Measuring pressure differences between the outside and the cavity above the ceiling of this large porch while the blower door was running showed that the porch is thermally connected to the home's envelope. Blowing cellulose to high density in the cavities closest to the exterior wall will stop the flow of air, save energy, and increase comfort in the bedrooms above

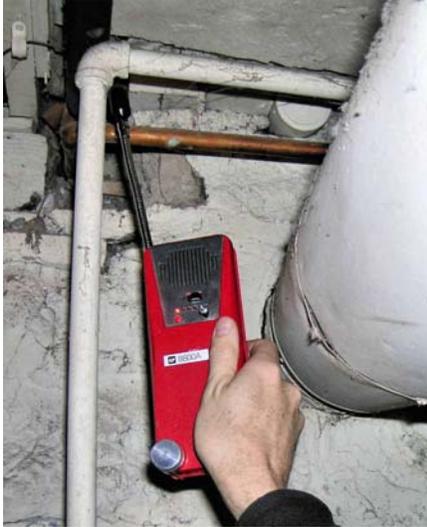
Figure 2-9. Combustion gas sniffer at work.

Energy auditors or technicians spend a good deal of time examining heating, cooling and hot water systems, as well as dryers, cooking stoves and ovens. The agenda is to inspect for both safety and efficiency issues with a view to making improvements. Typically, older buildings have a labyrinth of gas piping and associated couplings and valves. In tracing what goes where, a combustion gas detector is used to identify any gas leaks which may occur along the line (Figure 2-9). Additionally, each appliance is fired and evidence of carbon monoxide, a deadly but odorless gas, is tested using multi-purpose digital equipment (Figure 2-10). Such devices also measure the temperature and portions of various gases in the exhaust stack (typically oxygen, carbon dioxide, and carbon monoxide) as the appliance is operated. The result yields a useful measure of both the safety and the relative efficiency of the combustion process.

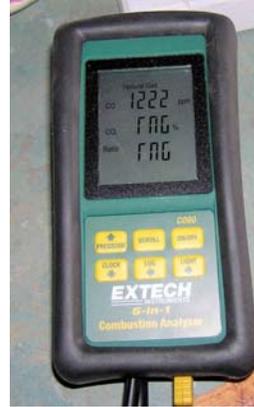
Figure 2-10. Combustion analyzer capable of measuring five functions. This one found a surprisingly high carbon monoxide reading associated with the broiler in a modern, high-end cooking stove.

This combustion analysis measures what is termed “steady-state” combustion efficiency, which is how efficiently the appliance burns fuel when operating at full bore. Many older appliances rely on natural venting chimneys to exhaust their combustion by products, so these appliances also suffer significant “standby losses” as heat generated during the burning process continues to escape up the chimney when the appliance not firing. Standby losses can amount to another 10 to 20% reduction in overall seasonal operation efficiencies, typically designated Annual Fuel Utilization Efficiency (AFUE).

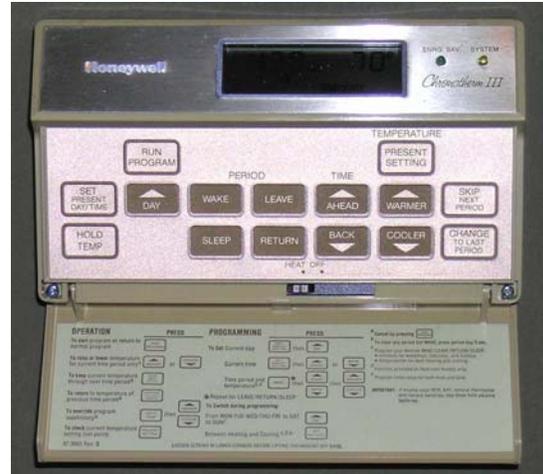
Figure 2-12. Electronic thermostats can save energy while preserving comfort.

Multi-set-back electronic thermostats are now widely available at modest costs. They are easy to install and energy (and money) can be saved automatically without causing discomfort (Figure 2-12).

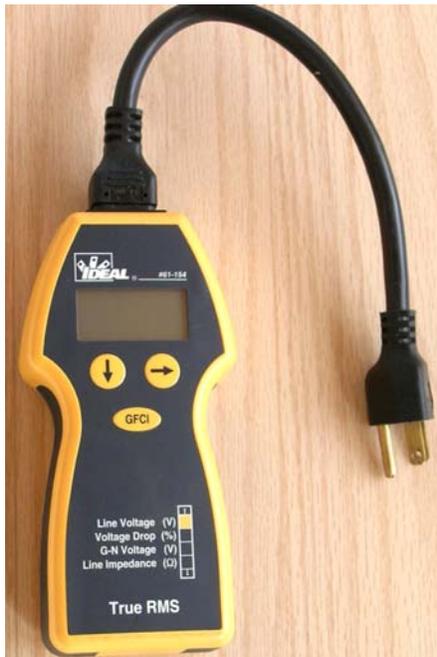
Figure 2-14. Suretest multipurpose circuit testing meter.

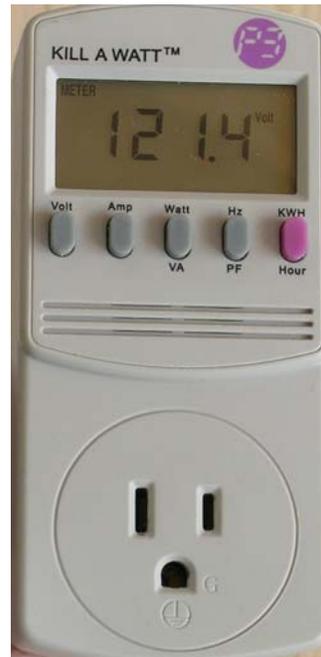
Figure 2-15. Kill-a-Watt electric power and energy meter

After testing the outlets associated with refrigerators and freezers, the auditor routinely installs a simple watt hour meter to monitor electric energy use of these appliances over the period of the audit (Figure 2-15). This enables normalizing consumption data for a longer period (month or year) to estimate if it would be cost effective to replace a particularly inefficient model with a modern refrigerator or freezer. Refrigerators and freezers represent a substantial portion of the electric bill in many homes, about 12 percent nationally. Many older units use 1200 kW/year or more - but new ENERGY STAR-rated units typically consume well less than 500 kW/year.

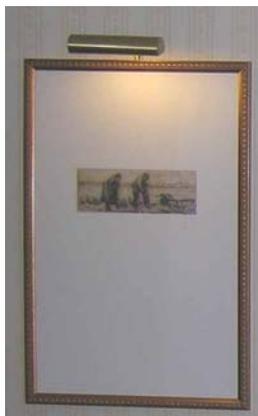
Figure 2-16. This painting is illuminated by a pair of 4 watt CFL lights small enough to fit in one's hand rather than a pair of 20 watt tubular incandescent bulbs.

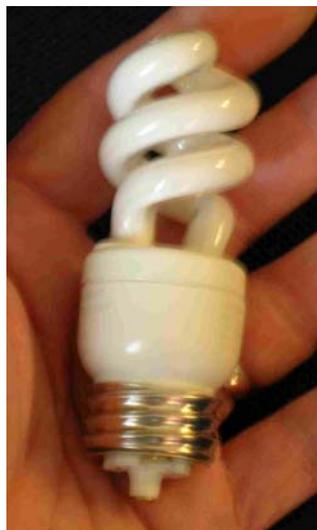
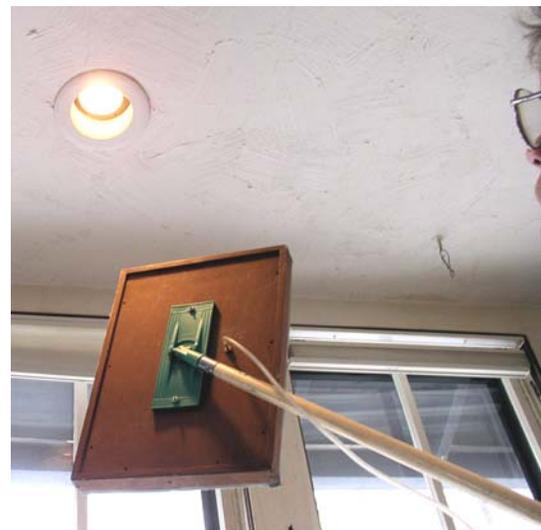
Figure 2-17. An auditor prepares to assess a recessed lighting fixture on the 1st story of a 3rd story house for air leakage (with the blower door running.) It was quite leaky.

Over 20 million recessed lighting fixtures are installed every year, and substantial percentages are installed at the interface between ceilings and attics. Figure 2-17 shows typical installations in a historic home in Boulder.

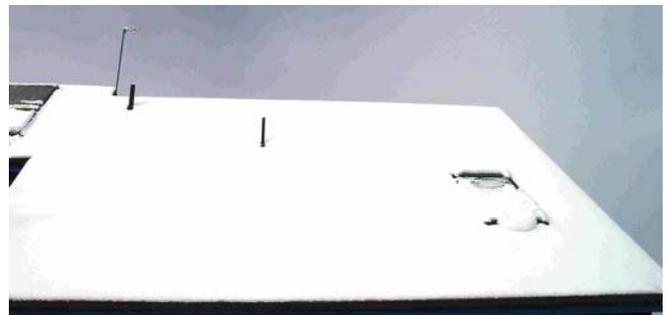
Figures 2-18 and 2-19. Pre- and post-retrofit effects of solving convective and conductive problems with recessed (can) lights in a second floor room of a well-insulated home.

Figures 2-18 and 2-19 show before-and-after photographs of a home in Colorado on snowy days. The house had leaky can lights in the ceiling that were successfully retrofitted. Even when lights are not used, leakage of warm air via stack effect is powerful enough to cause snow melt. The cans were retrofitted with a completely air sealed reflector-and-ballast system then insulated as described in Section 3.
