# VULNERABILITIES ASSESSMENT

SUSTAINABILITY AND RESILIENCE STRATEGY FOR THE  
COLORADO CHAUTAUQUA NATIONAL HISTORIC LANDMARK

JANUARY 2020

RESILIENT ANALYTICS, INC  
THE CRAIG GROUP

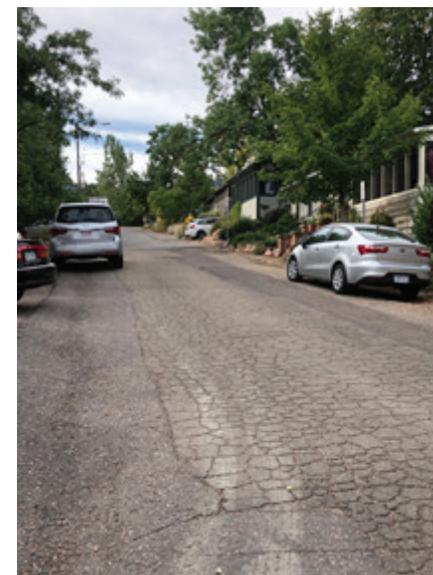
*Figure 2: The road surfaces within the Chautauqua site are being damaged by heat and precipitation.*

While the buildings are in relatively good condition, the current conditions of the roads and paths are less favorable. Due to exposure to water and vehicular traffic and increased heat, the asphalt surface of the roads and pathways has deteriorated and, in some cases, should be considered as failed. Similarly, the historic stone drainage swales alongside the roads have significantly deteriorated over time due to soil movement and weather exposure. And finally, the drainage areas are seeing increased erosion due to precipitation and flooding events. Figures 2 through 4 illustrate the degradation of the infrastructure within the Chautauqua NHL District.

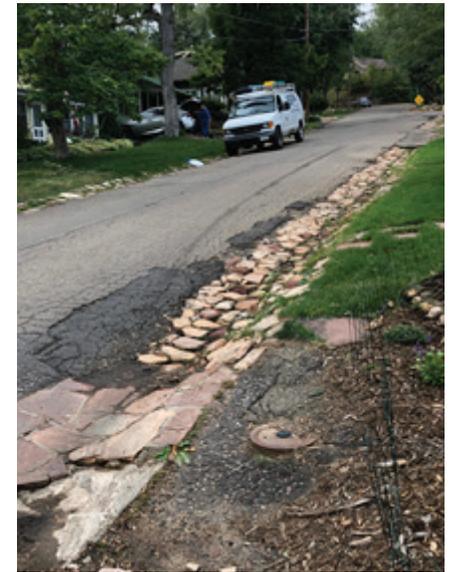
*Figure 3 The Chautauqua site has a long history of battling water drainage issues with the historic stormwater system.*

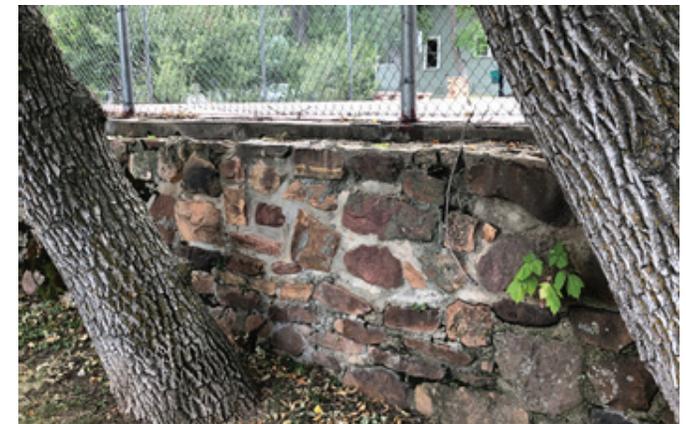
*Figure 4: The retaining walls throughout the Chautauqua site are experiencing degrees of failure as increased water pressure, soil movement, and age are combining to threaten the stability of the walls.*

Similar to some of the challenges faced by the landscape areas due to changing conditions, many of the retaining walls surrounding the district are failing due to increased water pressure from increased precipitation events.

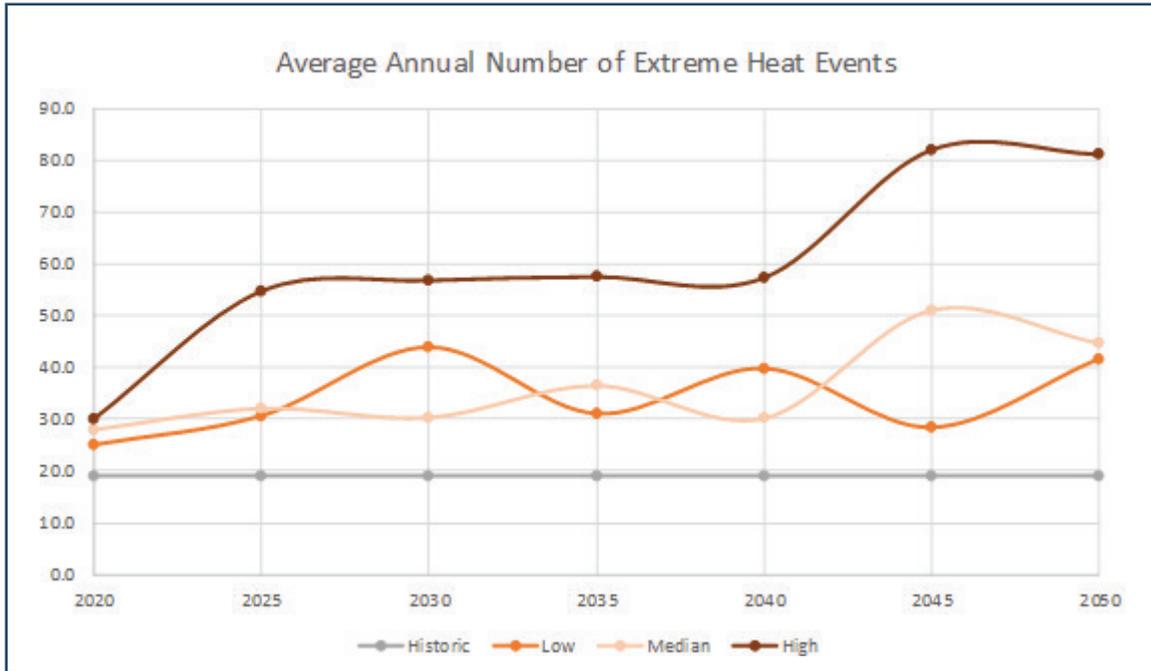
Figure 5: The climate models project an increase in extreme events (temperatures over 95 degrees) in the Chautauqua region over the next several decades.

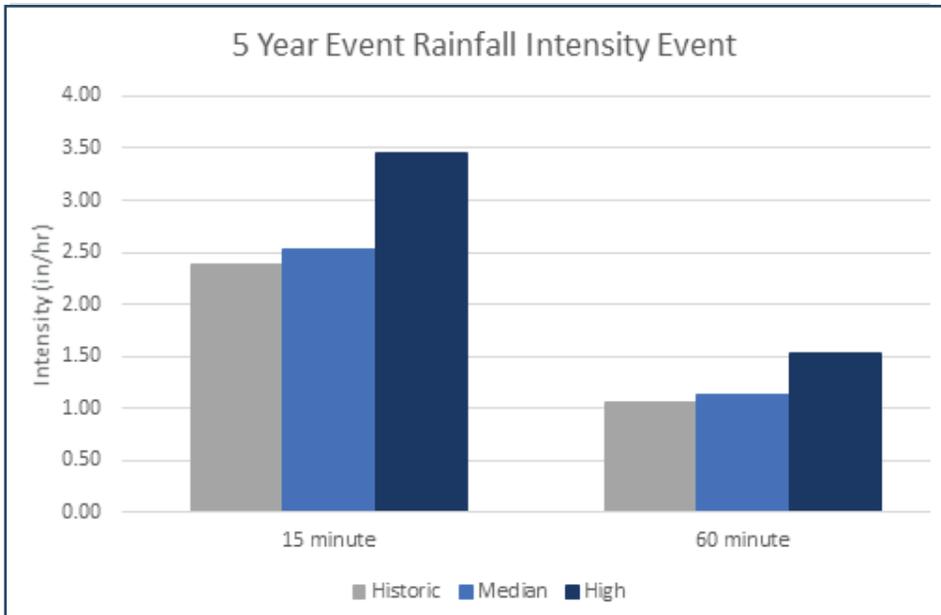
Figure 6a (below left): The high climate models project an increase of approximately 45% in intensity of the 5-year precipitation event in the Chautauqua region over the next several decades.

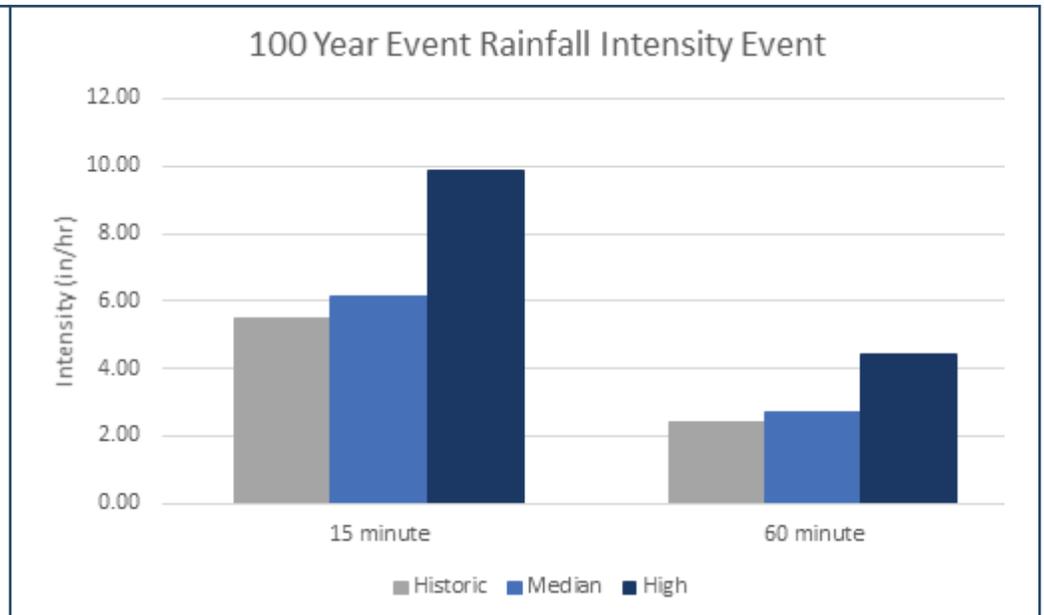
Figure 6b (below right): The high climate models project an increase of approximately 80% in intensity of the 100-year precipitation event in the Chautauqua region over the next several decades.

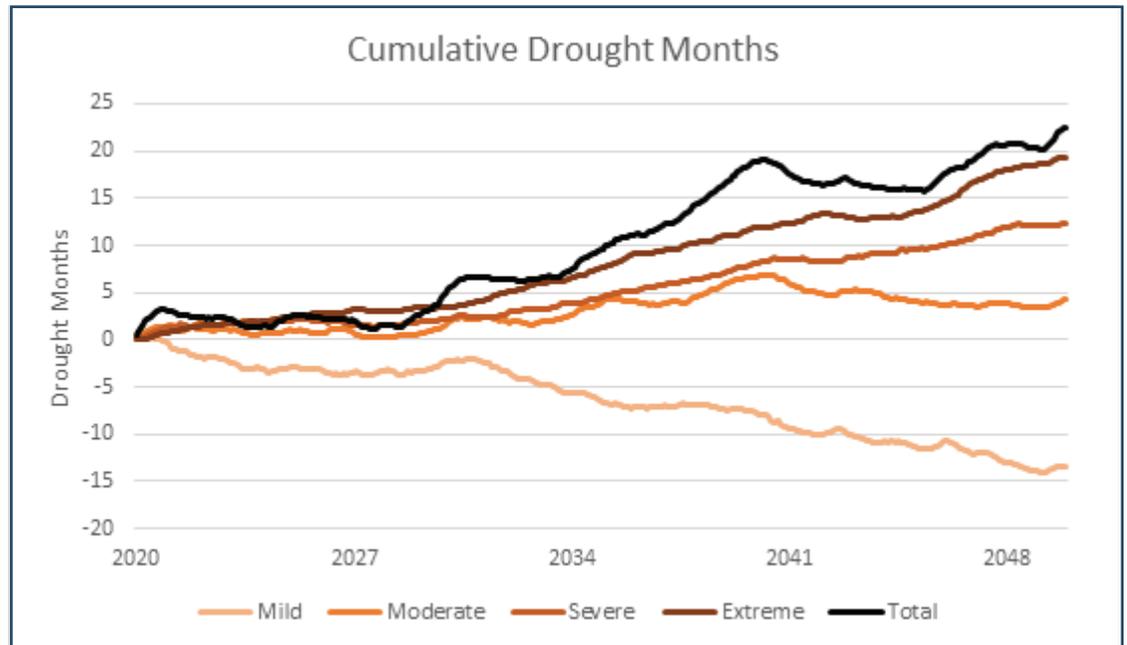
Figure 7 (below): The climate models project an increase in the number and type of drought events in the Chautauqua region over the next several decades.

The combination of changes in temperature and precipitation result in changes in projected drought events. As illustrated in Figure 7, the type of drought events will change over the next 30 years in the region. Table 1 details the possible impacts for each drought category. The number of mild drought events will subside. However, these events will be replaced by severe and extreme drought events.

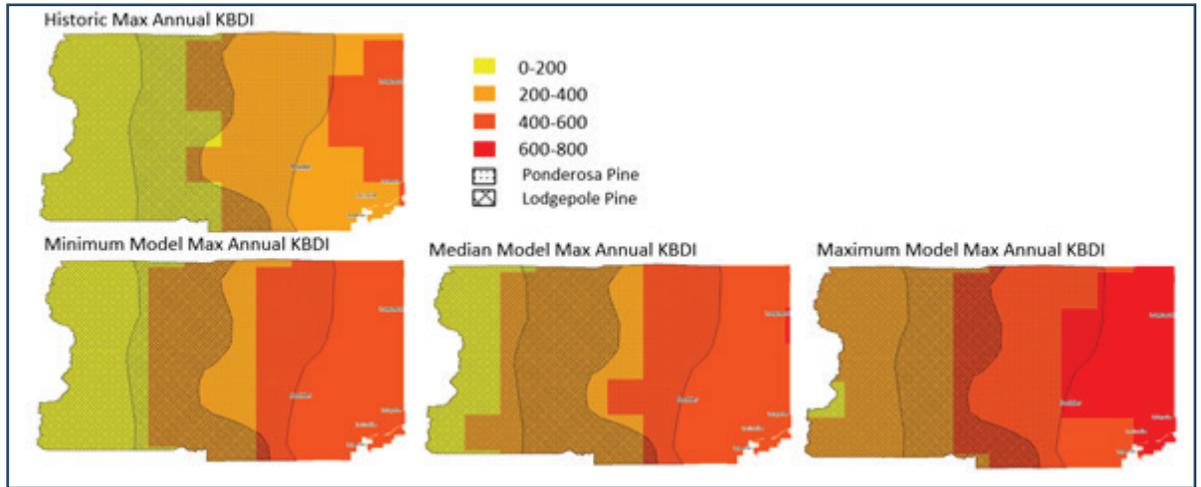
Figure 8 (above): The climate models project an increase in wildfire risk under all scenarios

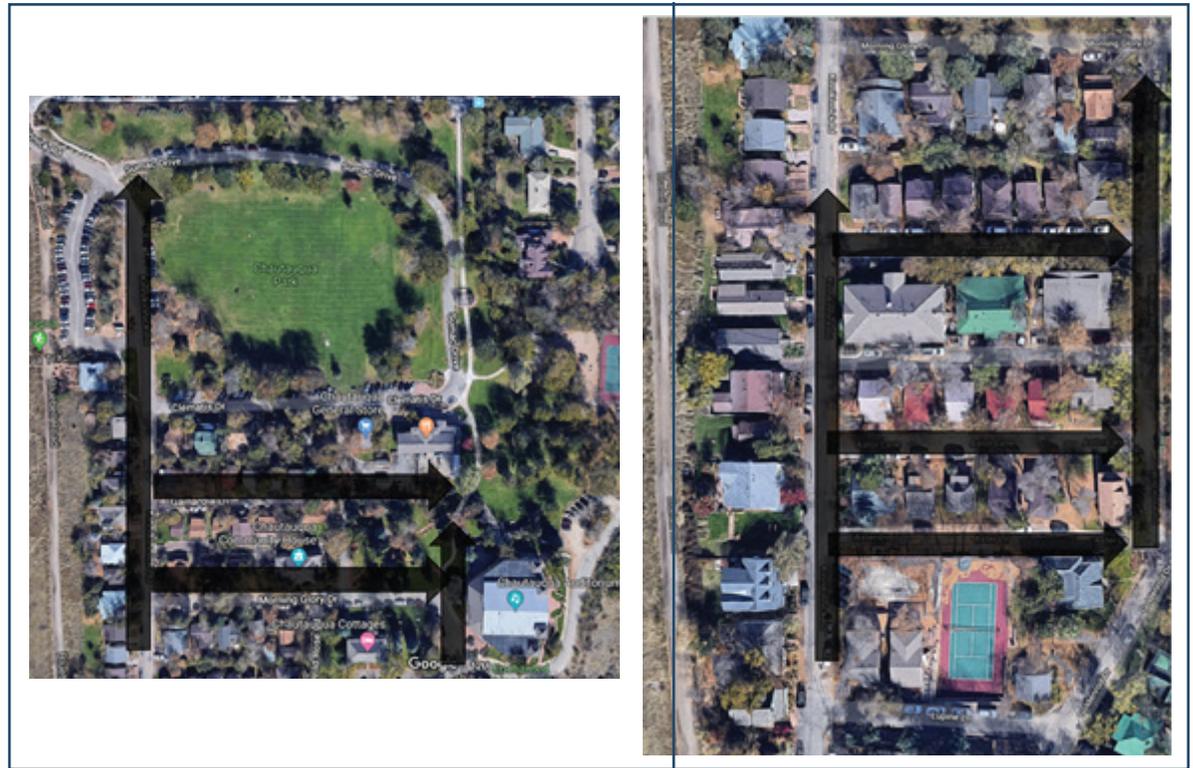
Figure 9 (above): Drainage patterns at Chautauqua.

Within the realm of water challenges, as evidenced by previous drainage studies such as the stormwater study in 2002, the overall theme that threatens the long-term sustainability of the Chautauqua NHL District is drainage. As illustrated in Figure 9, the drainage patterns that are dominant at the site are either directly downslope to the north out to the main lawn and further to Baseline Road or down through the alleys to the east and then north to the single stormwater inlet adjacent to the Auditorium.

The natural extents of the site determine that the grading is steep for effective stormwater management. Steep slopes are typically defined as greater than 25 percent. Currently the site is graded in a way that serves sheet flow across the site with the goal of concentrating water and diverting water at the low points of the site.

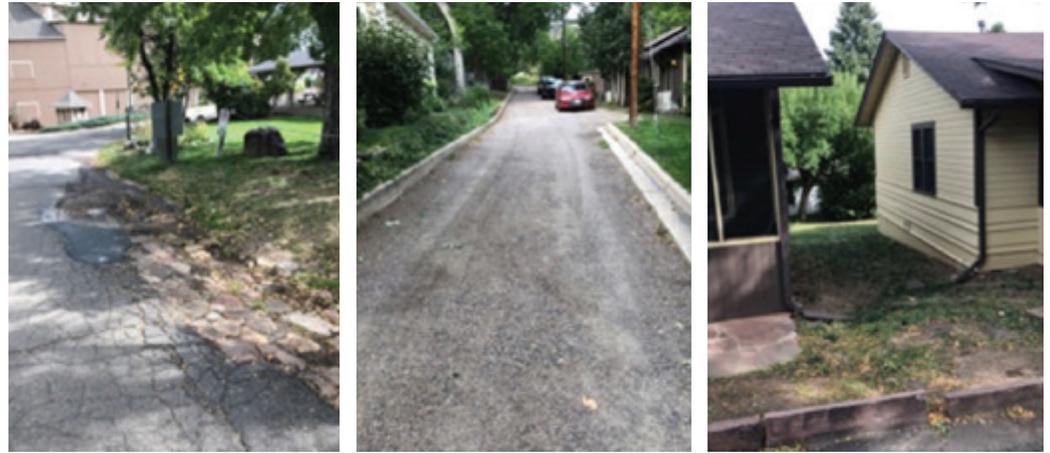
*Figure 10 (top row): Examples of drainage damage to roads and areas between cottages.*

As illustrated in Figures 10 and 11, these increases in flows is resulting in water damage at the site and is therefore a key vulnerability. As illustrated, the continuous draining of water leads to a slow destruction of the roads. The weakening of the subbase by the water creates a vulnerability that is exacerbated by the traffic running over the roads as well as the lack of alternative direction for the water to travel. For the alleys, the use of gravel as a surface material creates a vulnerability where the material is regularly washed away in intense precipitation events. Compounding this issue is the existence of the historic swales running alongside the roads. These rock lined swales are becoming increasingly uneven and eroded over time as the base is eroded beneath the swales.

The area between the cottages is an area where immediate attention is required as the increasing intensity of precipitation events is eroding soil and materials that are critically needed to retain water. In cases where the neighboring cottages are located on the slope of the site, primarily on the east and west sides of the neighborhood, the erosion has left neighboring down-slope cottages vulnerable to runoff from upslope cottages. This is resulting in dampness in the crawl spaces and subsequent challenges such as mold and rot. This vulnerability will continue to grow as increasingly significant precipitation events begin to occur

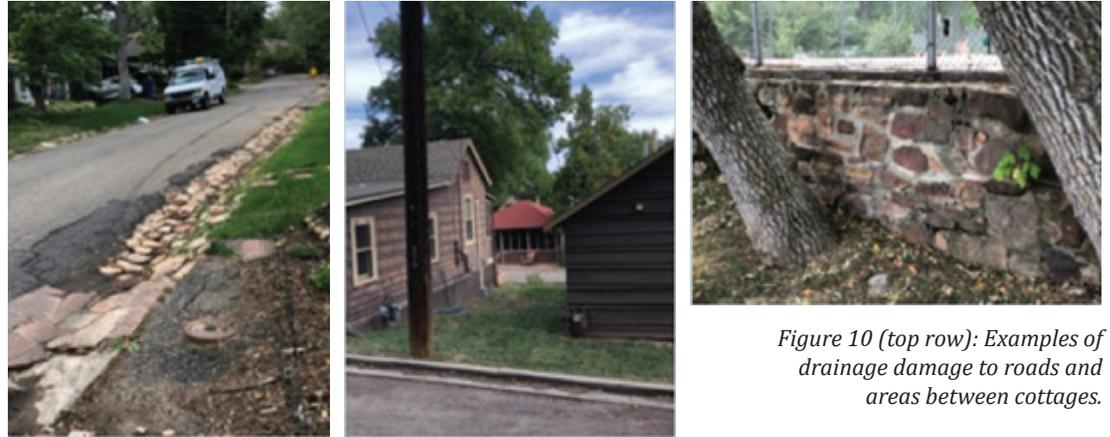
*Figure 11 (bottom row): Examples of drainage damage to roads, areas between cottages, and retaining walls.*

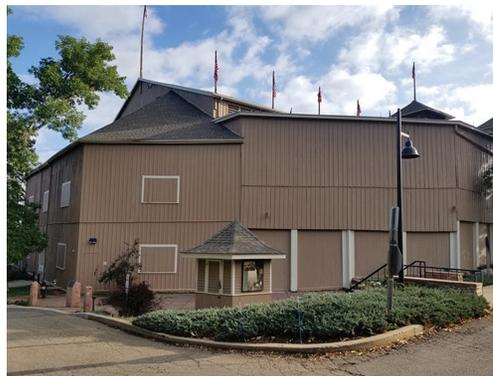
*Figure 12 (top left): The Chautauqua Auditorium lies at the junction of multiple drainage patterns creating a vulnerability to precipitation and flooding events.*

In terms of the Auditorium, its location adjacent to the single stormwater inlet at the site (Figure 12) will likely cause a back-up of the stormwater system and cause localized flooding with increasingly intense precipitation events. The recipient of these floodwaters will be the Auditorium on its west side. This is a vulnerability that must be addressed before it leads to the damage of the building's foundation.

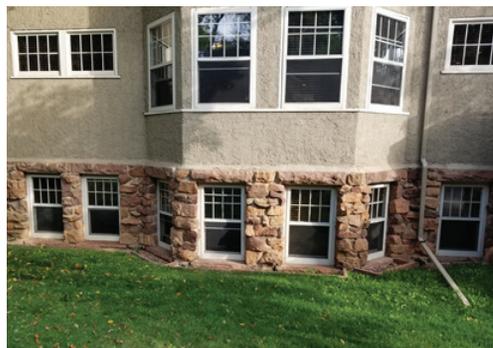
*Figure 13 (bottom left): The Chautauqua Community House lies at grade with exposed windows creating a vulnerability to precipitation and flooding events.*

Similarly, the Community House is significantly at risk from increasing precipitation events as its southern side is at grade and the window wells will inevitably be exposed to water damage (Figure 13). Enhancing the effect will be the lawns that have been planted around the building that retain relatively small amounts of water. In essence, the site is currently funneling water and debris toward the

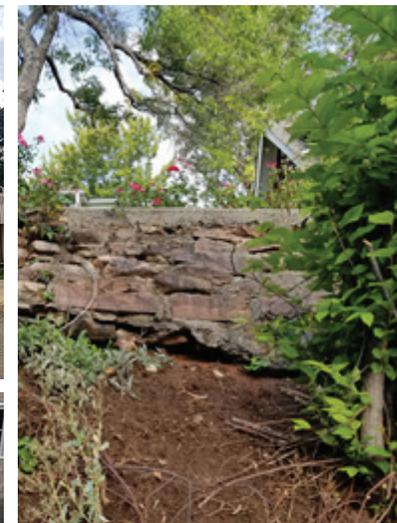
*Figure 14 (right): Increased pressure from water is causing the failure of retaining walls on the eastern side of the Chautauqua site.*

In addition to the buildings, the increasing movement of water at the site is resulting in retaining walls being threatened at multiple points as a result of hydraulic pressure from saturated soil, particularly around the upper tennis court area and along the eastern border (Figure 14). The increasing pressure being placed on these walls from trapped water as well as the failure of the soil from increasing cycles of drought and intense precipitation, are an immediate concern.

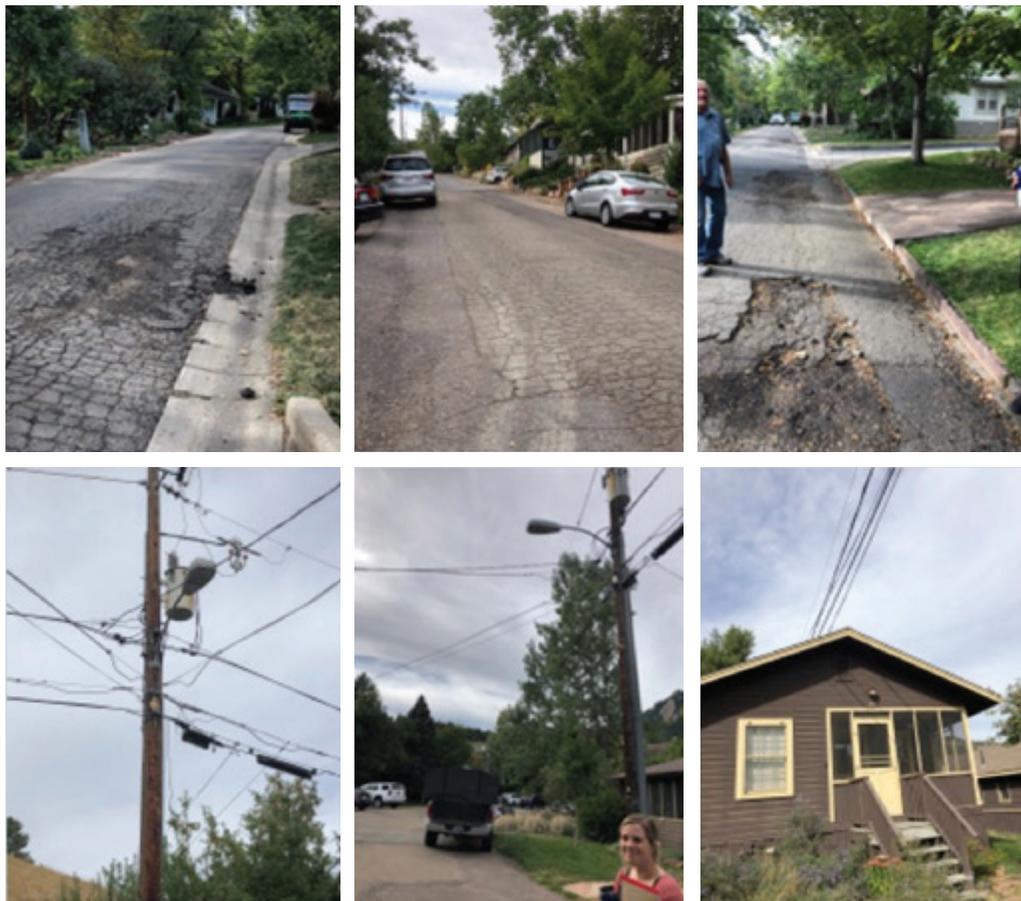
The impact of heat on infrastructure is first highlighted by the impact on roads. Specifically, as illustrated in Figure 19, the asphalt on roads breaks down in extreme heat

events. With the increasing traffic and size of vehicles traversing these roads, the breakdown of the roads is accelerating.

This effect is seen in several areas. First, the area of the roads throughout the site that are adjacent to the rock-lined swales is failing as the cracking of the road surface is aggravated by the connection to a different material. Second, the heat is causing the surface of the roads to soften and result in severe cracking through-

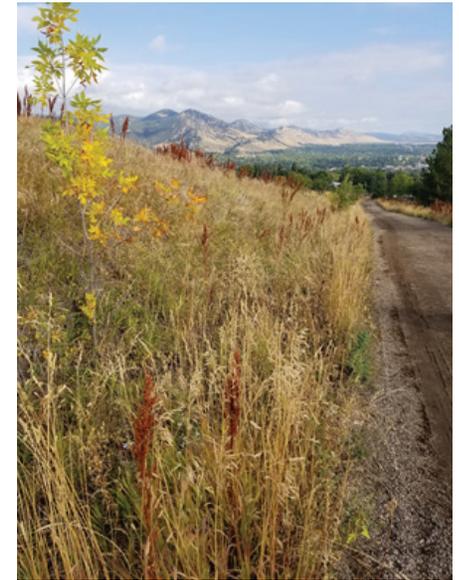
*Figure 21: Vegetation in the summer months creates fuel for possible fires as it dries out due to lack of water.*

Figure 21 illustrates how the vegetation surrounding the site is increasingly stressed during the hot summer months and how that increases the threat to the site

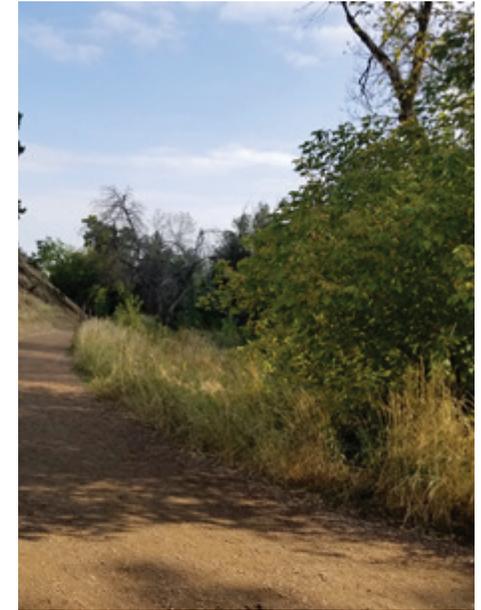
As the adjacency to Open Space is a specific concern, a few notes about this are warranted as a specific vulnerability. The Chautauqua NHL District is surrounded on three sides by municipally owned land. To the west, south and east lies open space which is managed by the City of Boulder Open Space and Mountain Parks (OSMP). This open space is the “crown jewel” and the most visited open space in the open space system. The trails immediately surrounding the District (Chautauqua Trail, Bluebell Road, McClintock Trail, and Enchanted Mesa) see more than 600,000 annual visits. The recent OSMP Master Plan identifies “Ecosystem Health and Resilience” as the first of five focus areas. Adjacency to this open space network affects vulnerability in two directions – open space poses risks for the Chautauqua NHL District and conversely the district poses risks for open space (Figure 24).

*Figure 24: Adjacency to Open Space creates an increasing challenge for the Historic District as greater number of visitors arrive at the site each year.*

While activity on open space poses threats to the district, conversely, threats from within the Chautauqua NHL District pose threats to the open space. For example, a fire within the built area poses a potential threat to the thousands of acres of adjacent open space. Additionally, damage to Chautauqua NHL District could reduce accessibility of the park via closed areas from fire and washed out roads.
