HARBECK-BERGHEIM HOUSE

FINAL DRAFT NOVEMBER 11, 2022

The report documents the history, significance, integrity and existing condition and provides treatment guidance for the resource. It does not evaluate for listing in the National Register of Historic Places. If the resource has been previously listed or evaluated it is referenced and footnoted.

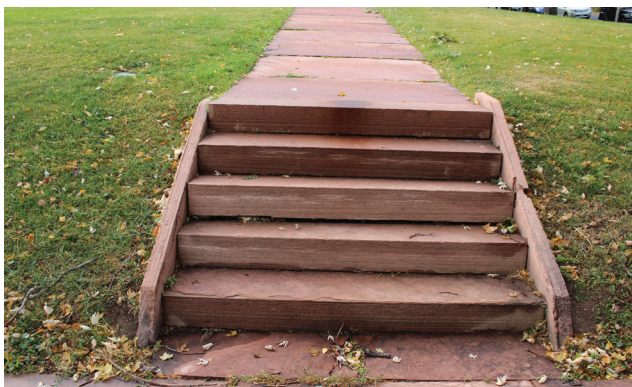
The circulation pattern for pedestrians consists of stone paved sidewalks along Euclid Avenue and 12th Street, stone steps and a stone paving leading up to the main entry of the building from Euclid Avenue, and a stone pavers from 12th Street to building's back entry. (Figure 1-3). The stone paved sidewalk and steps are contributing features. An accessible path does not exist to the front porch.

Figure 1-3. Sandstone steps and walk to Main Entry from Euclid Avenue, 2020 (source: Mundus Bishop)

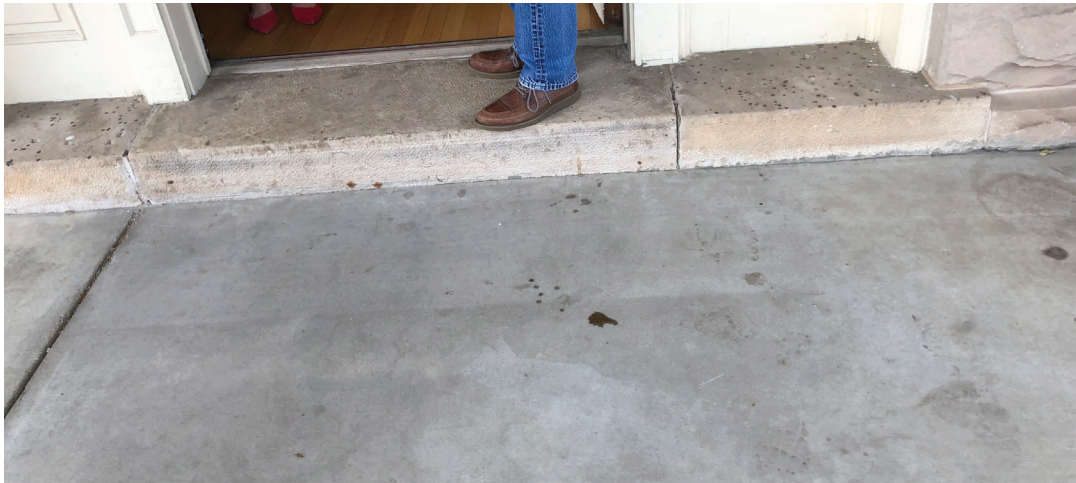
Front Porch: The walls surrounding the porch appear to be made of the same stone as the main building. Overall the stone is in fair shape, with a few areas in poor condition. The primary areas of concern are on the interior faces of the wall on the north side, and around the main entry stair to the north. Significant wear to the stone and mortar is evident and large amounts of both have been weathered away, mostly likely from use of salts and chemical deicers. Graffiti and its removal have caused damage to the stone at both the porch and the main building walls.

Figure 1-9. Porch transition at the main entry door, 2020 (source: Ratio)

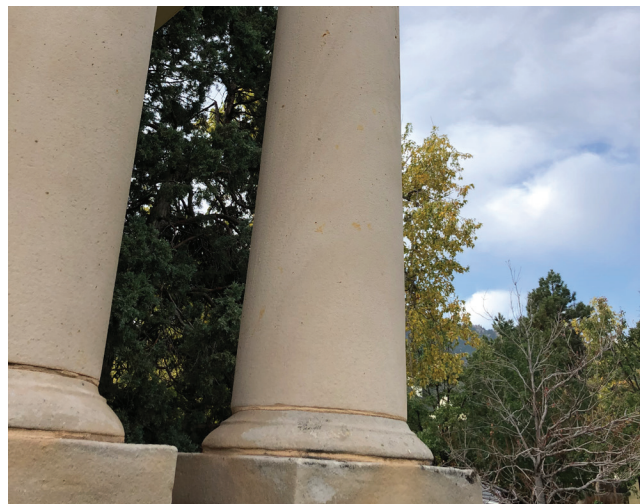
Wrap-around porch walls appear to be a different type of stone, which is in fair condition. Several cap stones are covered with lichens. The entry steps to the porch were noted as Lyons sandstone in previous building evaluations, and appear to be in good condition with some uneven gaps due to ground settling. Four large stone columns support the porch roof and the stone appears to be in good condition. The mortar is in fair to poor condition and in need of repointing.

Figure 1-13. Porch columns, 2020 (source: Ratio)

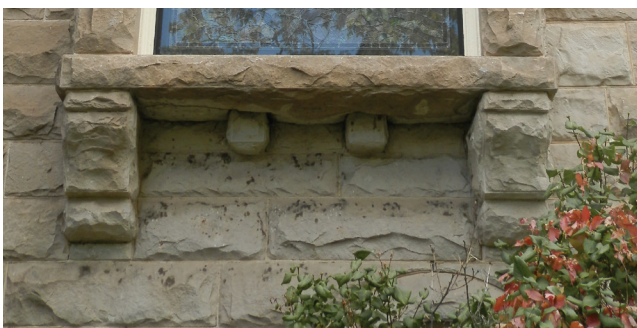
West Facade: The stone overall appears to be in good condition on the west face. The stone detailing below one windows has some evidence of water damage. Another area toward the bottom of the wall has significant amounts of lichen. A few stones have damaged stone faces or faces are damaged or weathered away.

Figure 1-20. Stone detailing below window, 2020 (source: Ratio)

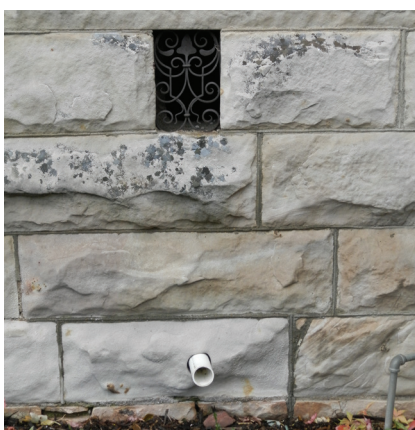
Figure 1-21. Lichen and weathered stone, 2020 (source: Ratio)

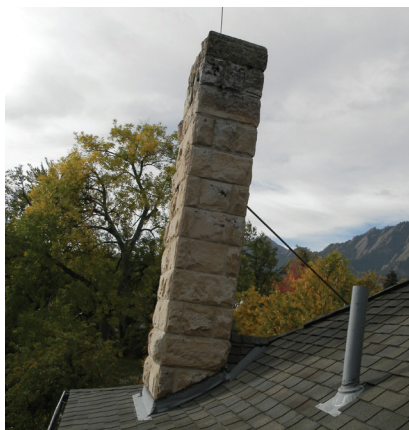
Chimneys: The stonework on the chimneys appears to be in fair to poor condition. Many stones are very worn and weathered with portions of the stones missing, and significant mortar missing. Of the three chimneys, one, in the north east corner, appears to be in the worst condition.

Figure 1-22. South east chimney, 2020 (source: Ratio)

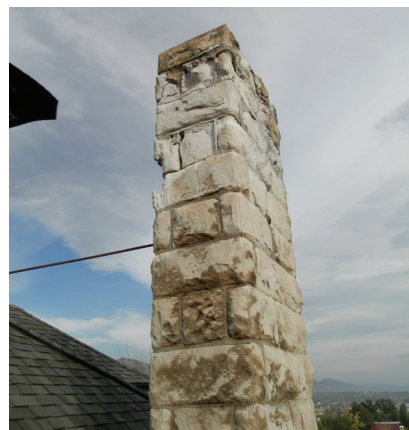
Figure 1-23. North east chimney, 2020 (source: Ratio)

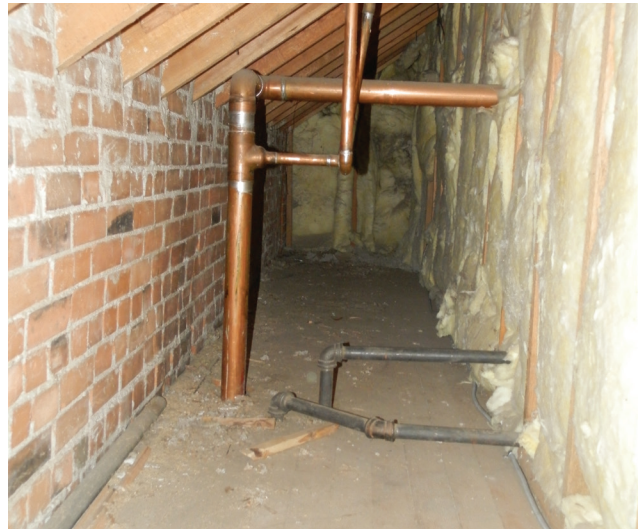
Exposed brick is in the basement and attic. The brick overall appears to be in fair condition. Primary areas of damage are those where ductwork or other penetrations have been made through the brick walls. The resulting openings left holes in the brickwork, and the attempted sealing material between the ducts and the brick has not functioned properly, causing more damage to the surrounding bricks and integrity of the walls in those areas.

Figure 1-25. Eave attic masonry, 2020 (source: Ratio)

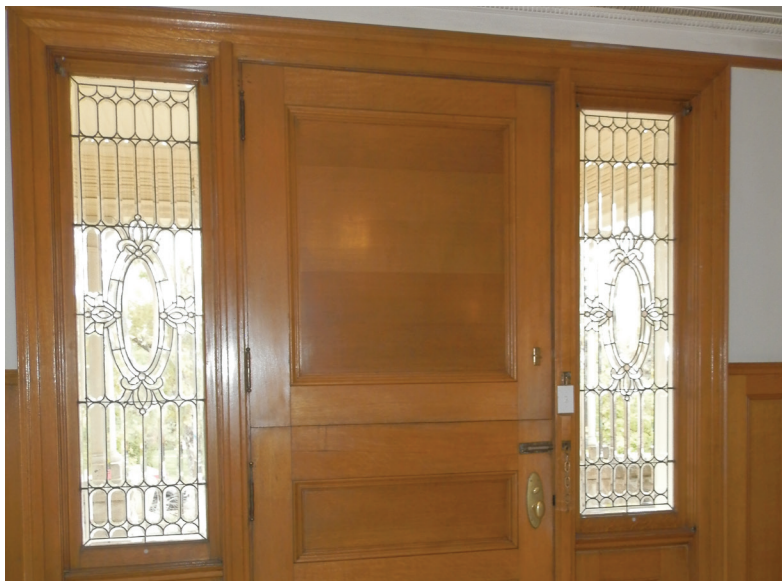
The exterior window glazing is in good condition overall with no major cracks or missing panes. A few basement windows have had the glazing removed for ventilation of interior appliances. The stained glass throughout the building has been repaired and appears to be in good condition

Figure 1-26. Stained glass at main north entry, 2020 (source: Ratio)

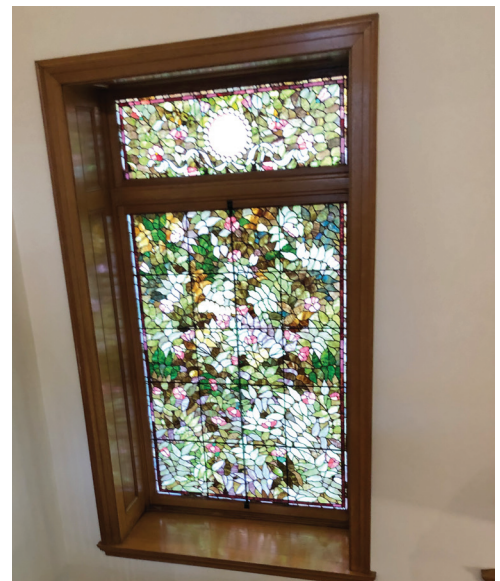
Figure 1-27. Stained glass at interior stairway, 2020 (source: Ratio)

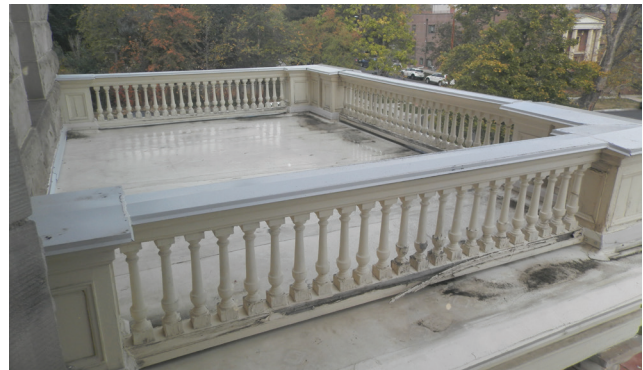
Exterior Porch: As viewed from ground level, the wood porch appears to be in fair condition with evidence of cracking and paint peeling. Below the porch, the wood soffit shows evidence of cracking and warping. During the site visit, a substantial yellowjacket nest was located behind the soffit. The wood railing wraps around the top of the porch and is in poor condition with areas of major splintering, and multiple areas where the bare wood is exposed. An attempt at protecting the top of this wood was made at some point in the past is with the addition of metal caps that cover the tops of the rails. It is unclear what the condition of the wood beneath

Figure 1-29. Railing above entry porch, 2020 (source: Ratio)

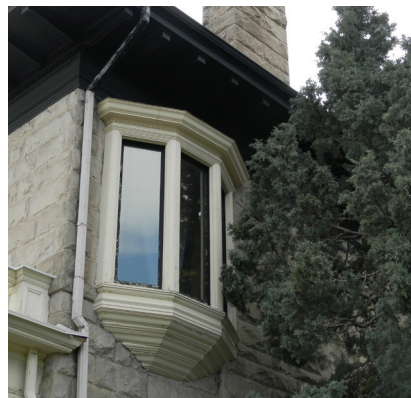
Exterior Windows and Doors: The wood windows and doors vary in condition based upon their locations. Many exterior frames and sashes have peeling and cracking paint over most exterior surfaces.

Figure 1-31. Wood window, 2020 (source: Ratio)

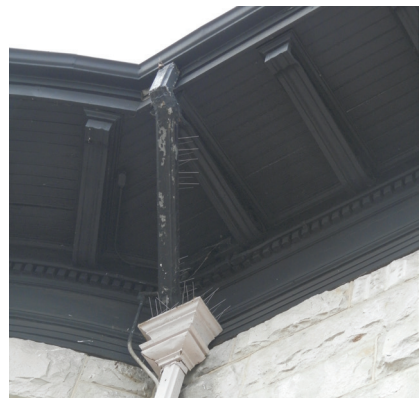
Exterior Roof: In general, the roof eaves and soffits appear to be in good condition. The brackets and wood detailing appears intact, with little evidence of rot or damage. The metal gutters and downspouts around the building are in poor to fair condition. The exterior wall finish around the attic appears to be in fair condition. A few areas have paint missing, and some weathering, but most finishes have little to no damage.

Figure 1-32. Roof soffits, 2020 (source: Ratio)

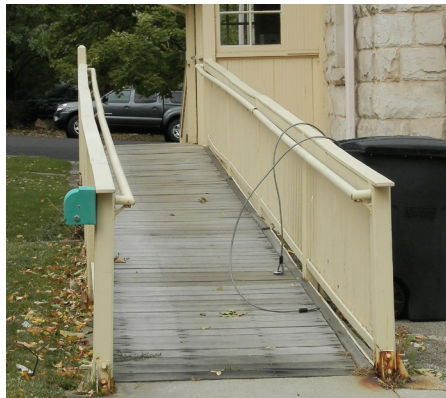
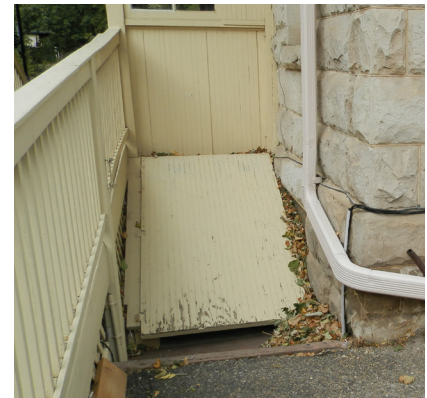
Exterior South Porch: The enclosed porch is used as the main entrance with the attached ramp providing an accessible entry. The porch walls are bead board and appear to be in fair condition with some warping and cracking. The flooring has been painted and is worn with signs of weathering, primarily near the exterior door. An entry ramp and stair have been added to access the south porch that are not original to the building. These additions appear to be in fair condition and have significant rust on the metal elements that connect the ramp to the concrete slab below. Just east of this porch area is a staircase leading to the basement, which is below the porch. The cellar door is covered by a plywood covering and is kept closed due to vagrancy concerns.

Figure 1-33. South porch entry ramp, 2020 (source: Ratio)

Figure 1-35. South porch entry ramp, 2020 (source: Ratio)

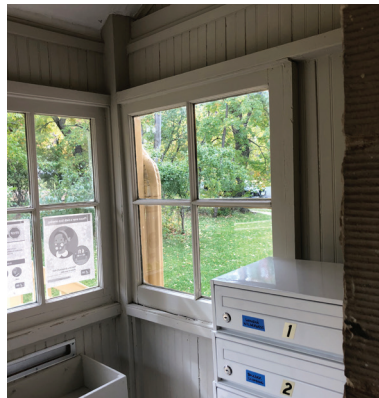
Figure 1-34. South porch interior, 2020 (source: Ratio)

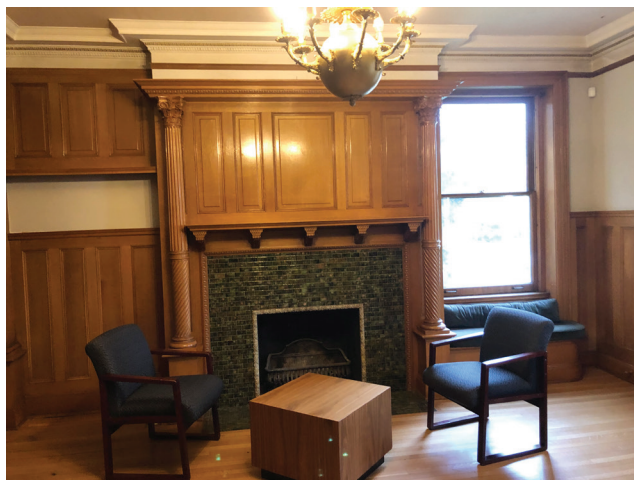
Interior Lobby: The lobby has wood wall paneling, a wood fireplace surround, and wood detailing leading up to the main staircase. The majority of these decorative wood elements are in good condition. The front door is a Dutch door and is fully functioning. The detailing appears to be intact with minimal wear. Two primary areas of wear are around the window seat and at the exposed treads of the staircase.

Figure 1-36. Lobby wood paneling, 2020 (source: Ratio)

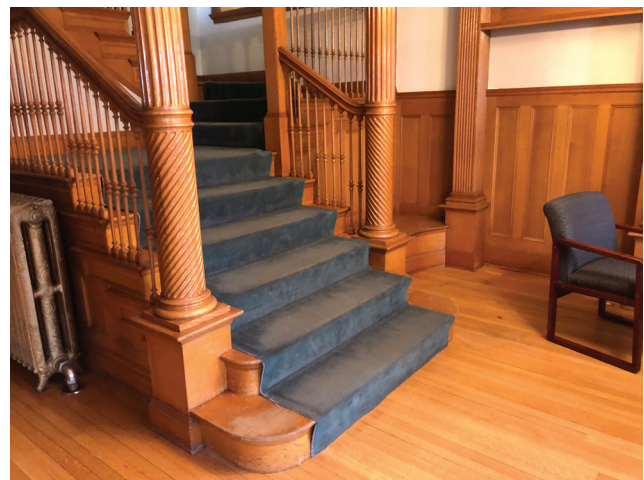
Figure 1-37. Main staircase Ratio, 2020 (source: Ratio)

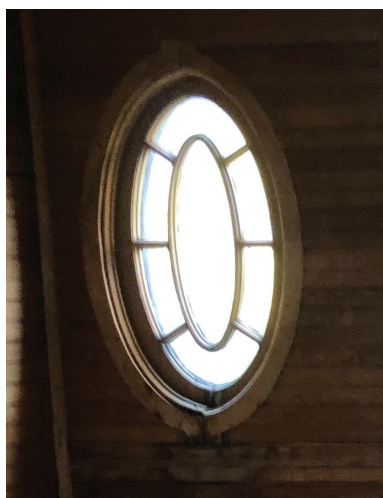
Interior Windows and Doors: The larger window interiors appear to be in good condition overall. Many interior windowsills show significant wear, weathering, or water damage. Many of the circular and oval windows have significant cracking in their frames and sashes. In general, the doors appear to be in fair condition. The hardware and other areas of use have finishes that are worn, scratched, or scuffed. At some locations where the doors have been painted, the painted finish is scratched or peeling.

Figure 1-38. Oval attic window, 2020 (source: Ratio)

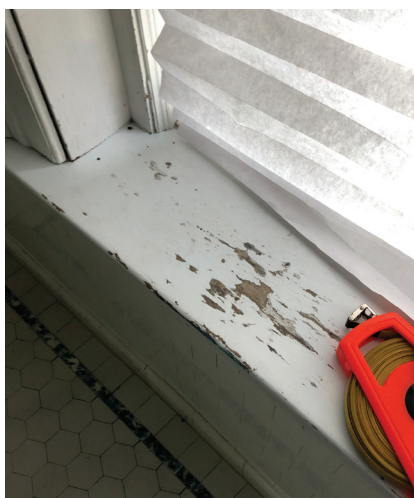
Figure 1-39. Interior window sill, 2020 (source: Ratio)

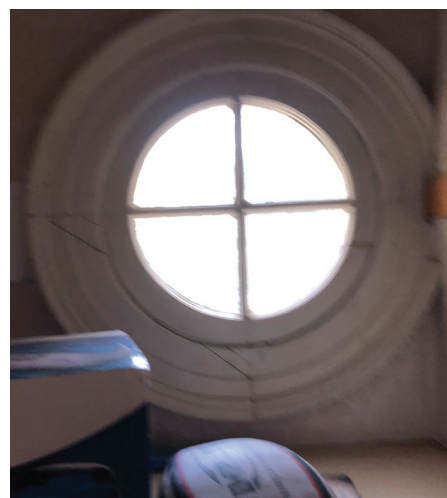
Figure 1-40. Circular window, 2020 (source: Ratio)

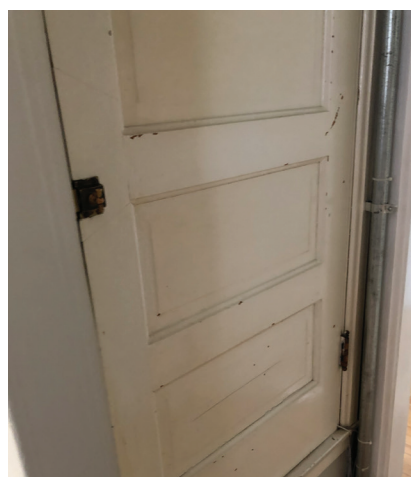
Figure 1-42. Painted interior door Ratio, 2020 (source: Ratio)

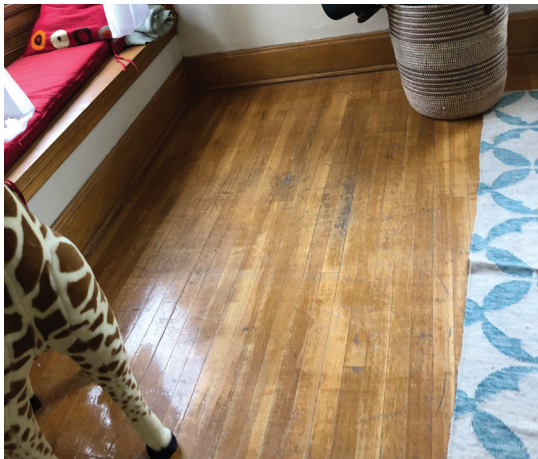
Wood Flooring: Wood flooring throughout the building appears to be in fair condition. A few larger areas of concern showing burn marks or water damage, however most flooring has general wear and scratching. In the attic, wood flooring appears to be in worse condition than the rest of the building with gapping between boards, and noticeable scratching. The flooring does not appear to have the same quality or finish as the rest of the building.

Figure 1-44. Wood flooring, 2020 (source: Ratio)

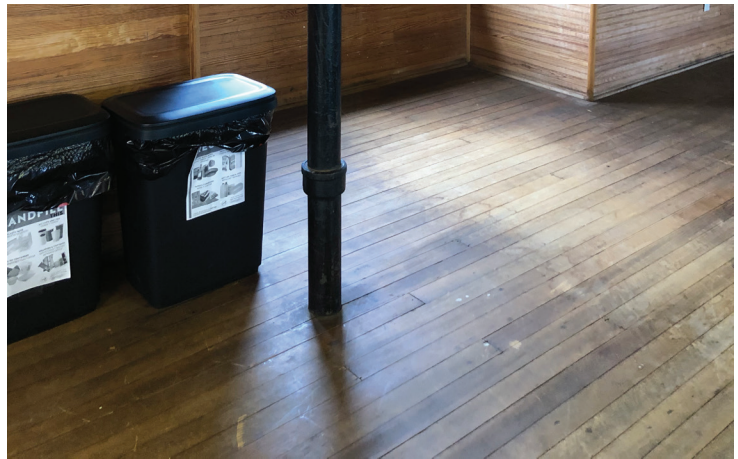
Figure 1-45. Attic flooring, 2020 (source: Ratio)

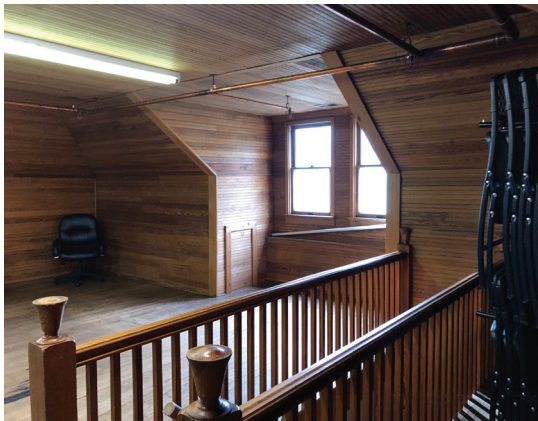
Attic: The walls and ceilings in the attic are wooden bead boards, which appears to be in fair condition overall, with some areas where the panels have been replaced. Water damage below the exterior windows. The stairs to the attic are in fair condition but are severely worn and scratched on the risers and treads. Wood guardrails are in good condition with some minor scrapes and scuffs on the interior surfaces.

Figure 1-46. Attic finishes, 2020 (source: Ratio)

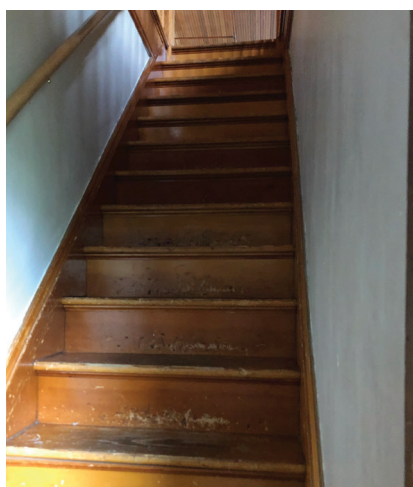
Figure 1-47. Attic staircase, 2020
(source: Ratio)

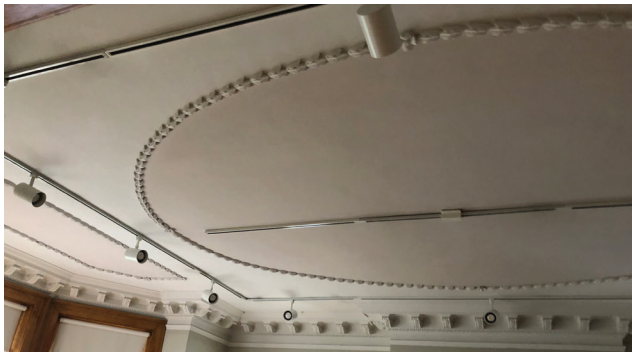
Apart from some detailing on the one of the first-floor ceilings, the interior wall and ceiling finishes are a mix of painted and unpainted wallpaper. Previous attempts to remove the wallpaper were unsuccessful, and the wallpaper was painted over. Most finished surfaces are in good condition. A few areas have peeling wallpaper. A portion of the plaster finish has come off the wall in the second-floor closet.

Figure 1-53. Ceiling detailing, 2020 (source: Ratio)

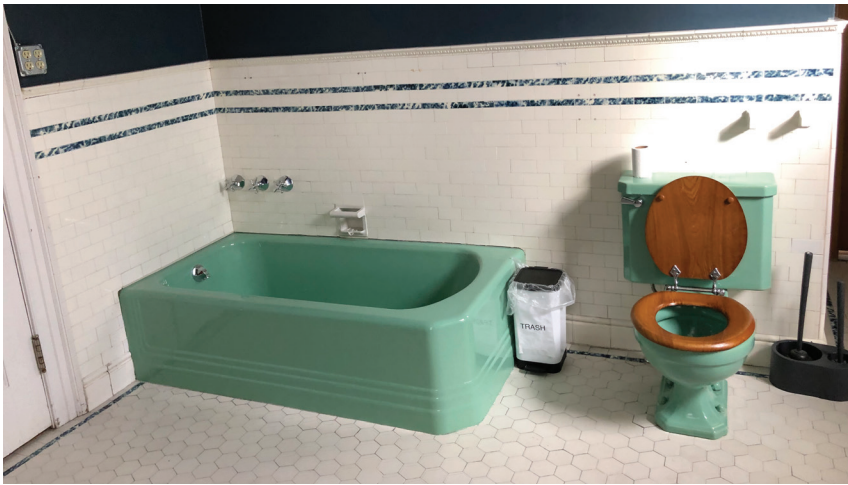
Tiling: Tile work includes restrooms on each floor, and the basement kitchen. In the second level restroom the tile wainscot and floor are in keeping with the character of the building and appear to be in good condition. Adjacent to the restroom is a separate shower that has tile walls and concrete flooring. The tile is in good condition but is not original to the building or in keeping with the character. The first-floor restroom was modified for accessibility. The floor tile appears to be in good condition and matches the character of the building. The walls in the first-floor restroom are a bead board wainscot with wood trim that are in good condition. In the basement, the kitchen and restroom floor tiles are not original to the building and appear to be in fair condition. Portions of the grout need repair.

Figure 1-55. Second floor restroom, 2020 (source: Ratio)

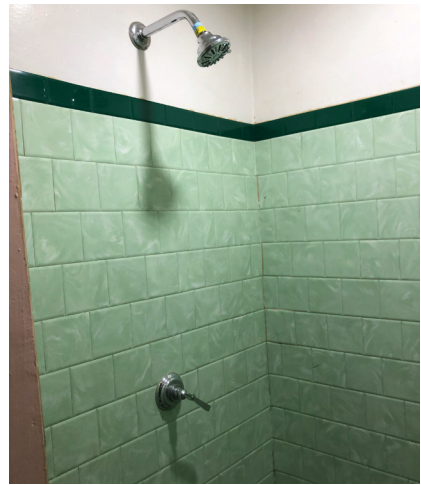
Figure 1-56. Shower tile, 2020 (source: Ratio)

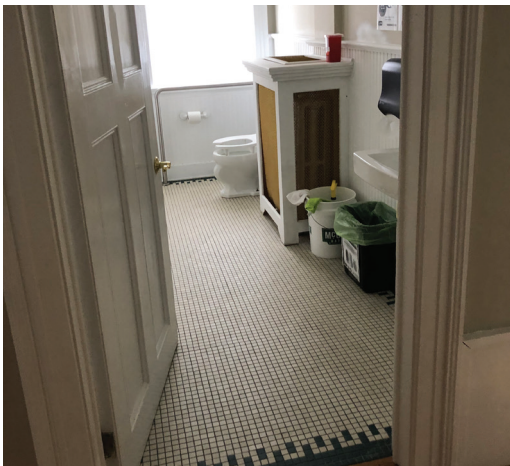
Figure 1-57. First floor restroom, 2020 (source: Ratio)

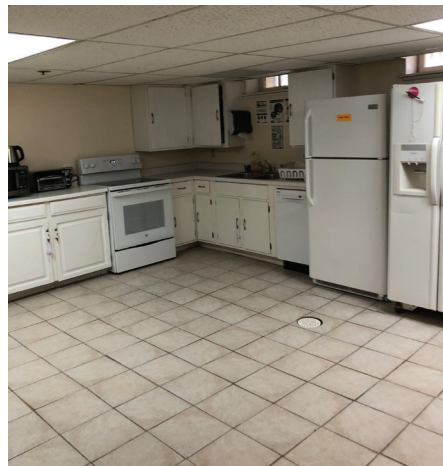
Figure 1-58. Basement kitchen, 2020 (source: Ratio)

Basement Finishes: The basement kitchen has an acoustical tile ceiling that is in fair condition. Most of the basement flooring is concrete, which appears to be in good condition other than a rough transition between two slabs at one of the doorways. The finished rooms of the basement, other than the kitchen and restroom, have carpeted floors that are in good condition but not original. These same rooms have doors that are not original to the building and appear to be hollow core construction. Exterior windows in the basement appear to be in fair to poor condition with a few locations that have missing or broken hardware. Some windows have been nailed shut.

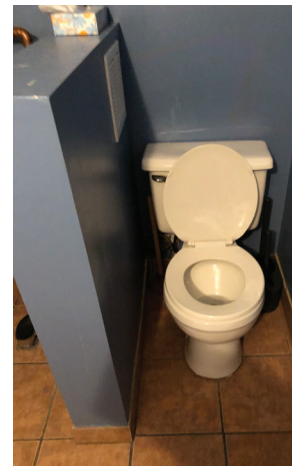
Figure 1-59. Basement restroom, 2020 (source: Ratio)

Overall, the foundation is in good condition. Efflorescence was evident at the interior faces of the basement walls that is evidence of past water infiltration (Figure 1-59). An exterior building condition evaluation was prepared by CSC in February 1991. Many of the eroded mortar joints and water infiltration issues identified in the report appear to have been addressed since the report was issued. The basement slab slopes near the southeast corner of the building, however this was likely intentional to allow the slab to drain and is not indicative of structural settlement.

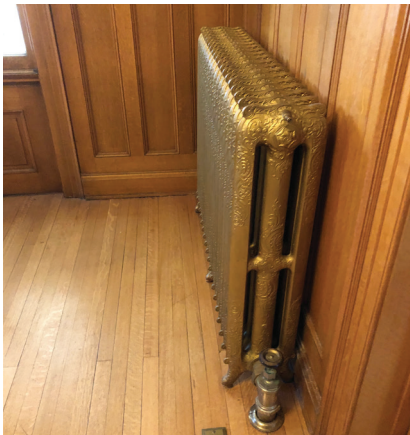
Most of the building is conditioned with radiators for heating and no method for cooling other than natural ventilation through the exterior windows. The attic has its own air conditioning system for heating and cooling. At the time of the site visit, all heating and cooling systems appeared to be in working order.

Figure 1-60. Radiator, 2020 (source: Ratio)

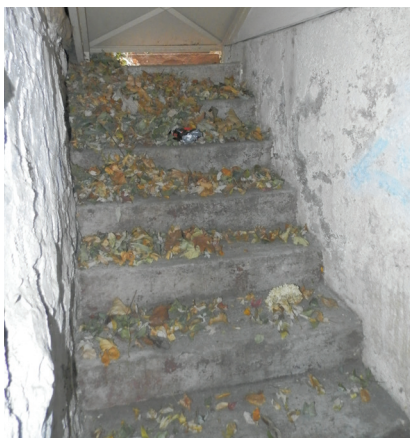
Exterior Basement Staircase: The exterior stairs are covered and inaccessible. The steps are concrete. They appear to be in fair condition, though they do not appear to meet current code requirements regarding tread and riser dimensions.

Figure 1-62. Exterior basement stair, 2020 (source: Ratio)

The site includes three stone chimneys, two on the east and one the west side of the house. The porch railing and stair are constructed of a stone similar to that used for the building. The weather-related erosion of stone units and mortar joints in the chimneys has progressed to the point that the stones above the eroded units may become unstable and fall from the chimney (Figure 1-62).

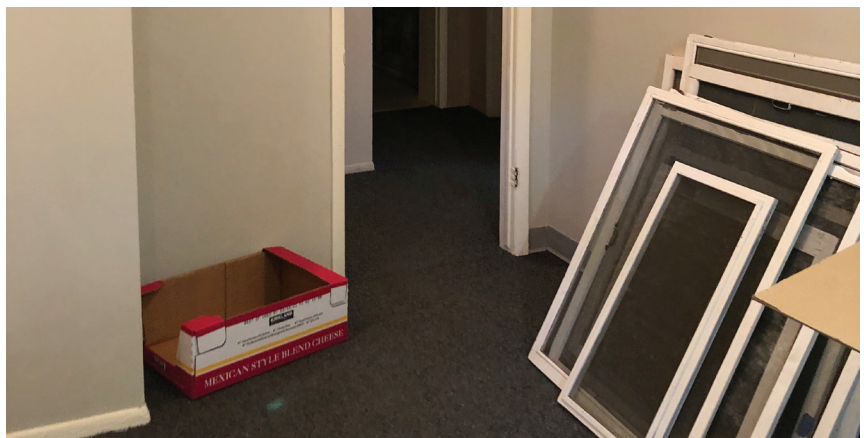
Figure 1-63. Basement finishes, 2020 (source: Ratio)
