# PLATT FARMHOUSE

FINAL DRAFT NOVEMBER 11, 2022

| Existing Condition ..... | 6-13 |

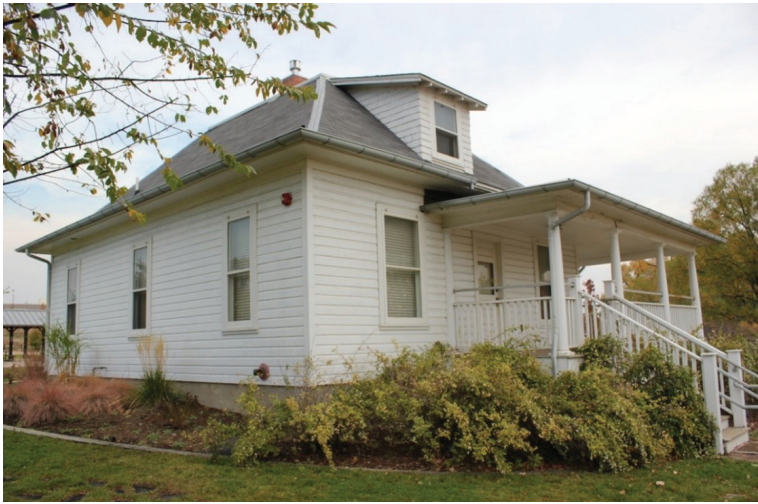
The farmhouse has a wrap-around front porch supported by wood columns. The rear entrance has an accessible concrete ramp. The porch and ramp are in good condition. The paint on the porches wood framing elements is failing. If not properly maintained, moisture can penetrate the paint layer and cause the wood material to deteriorate.

Figure 1-23. Front and west elevation of Platt Farmhouse, 2020 (source: JVA)

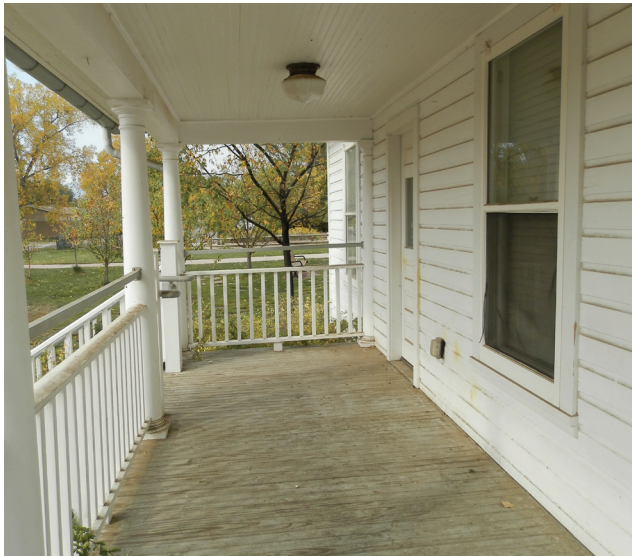
**Porch Flooring:** The wood floor of the porch and the entry stairs are in poor to fair condition. The tongue and groove boards are intact and functional, but are unfinished and showing considerable wear, weathering, and warping.

**Porch Framing:** The porch floor framing appears to be in good condition. The porch roof framing and soffit finish are in fair to poor condition. There is considerable wear, weathering, and cracking and peeling paint on both the support beams and the wood soffit material.

Figure 1-33. South porch, 2020 (source: Ratio)

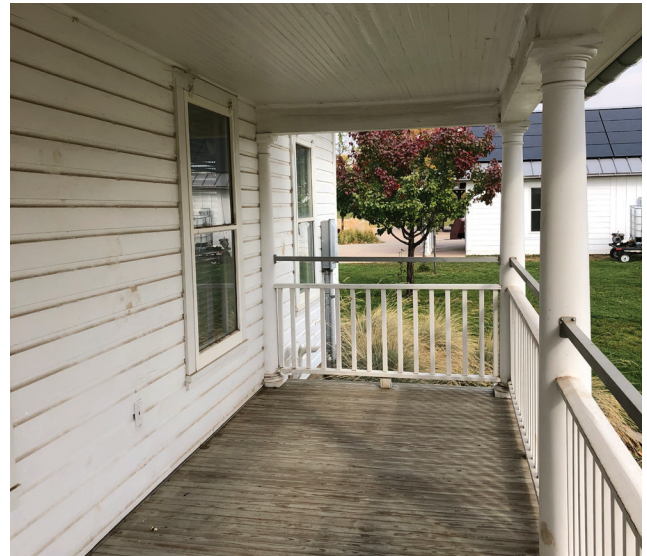
Figure 1-36. East porch, 2020 (source: Ratio)
