HARBECK-BERGHEIM HOUSE

MAY 2023

The report documents the history, significance, integrity and existing condition and provides treatment guidance for the resource. It does not evaluate for listing in the National Register of Historic Places. If the resource has been previously listed or evaluated it is referenced and footnoted.

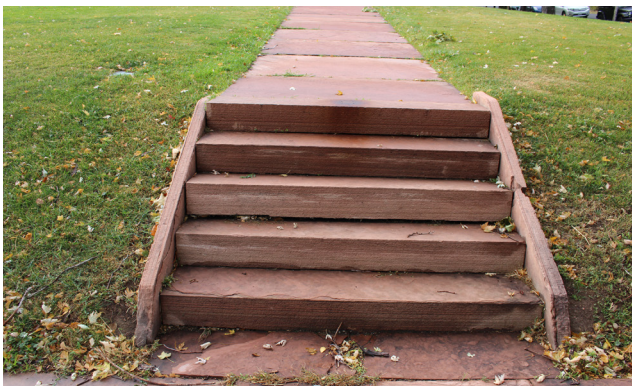
Pedestrian circulation consists of sandstone paved sidewalks along Euclid Avenue and 12th Street, sandstone steps and sandstone paving leading to the main entry from Euclid Avenue, and a sandstone paved walk from 12th Street to building's rear entry. The stone paved sidewalk and steps are original features. A path to the main entry does not meet ADA requirements for accessibility. The sandstone paving ranges from poor to fair condition due to heaved stones, stones out of alignment, and cracked stones. A path does not exist to the front porch. The sandstone paved sidewalks on Euclid Avenue and 12th Street are within the city's right-of-way and are not maintained by Boulder Parks and Recreation.

Figure 1-3. Sandstone steps and sandstone paving to main entry from Euclid Avenue, 2020 (source: Mundus Bishop)

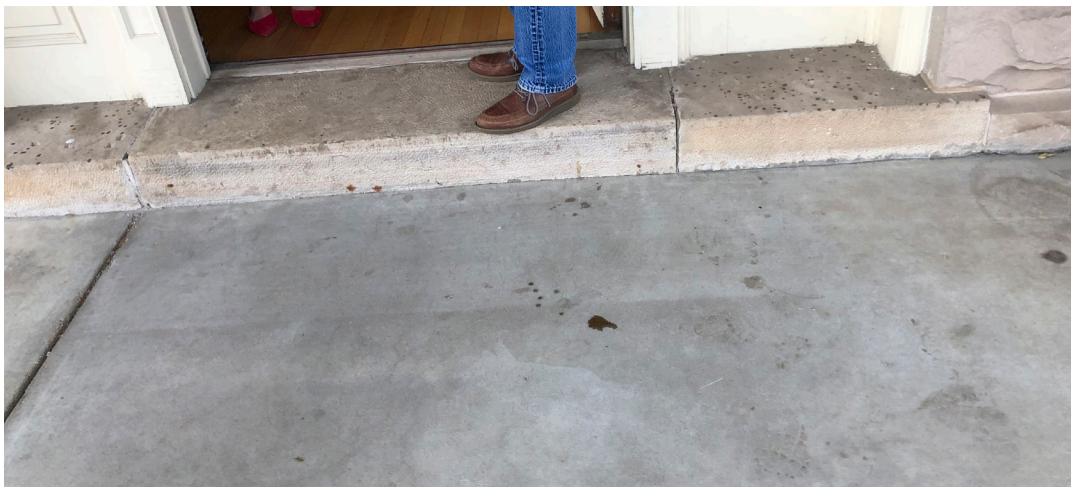
The wrap-around porch and portico flooring is poured concrete and is positioned lower than the finished floor of the first level. The concrete flooring does not seem to be original to the building, but appears to be in good condition with no major damage or cracks.

Figure 1-9. Porch transition at the main entry door, 2020 (source: Ratio)

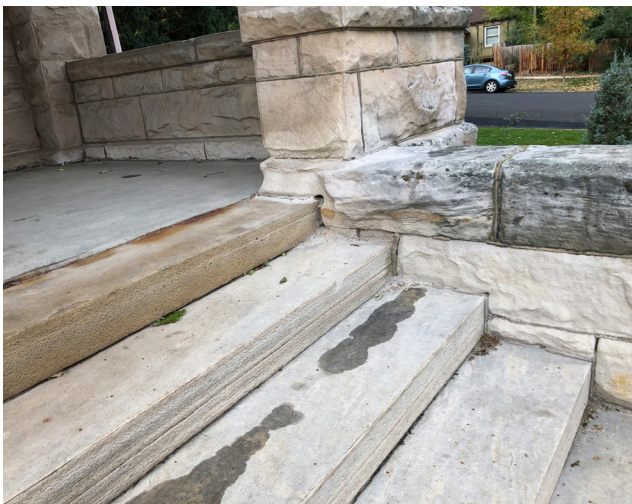
Walls appear to be a different type of stone at the wrap-around porch. This stone is in fair condition. Several capstones are covered with lichen. The entry steps to the porch were noted as Lyons sandstone in previous building evaluations, and appear to be in good condition with some uneven gaps due to ground settling. Four large stone columns support the porch roof and the stone appears to be in good condition. The mortar is in fair to poor condition and in need of repointing.

Figure 1-12. Main entry steps, 2020 (source: Ratio)

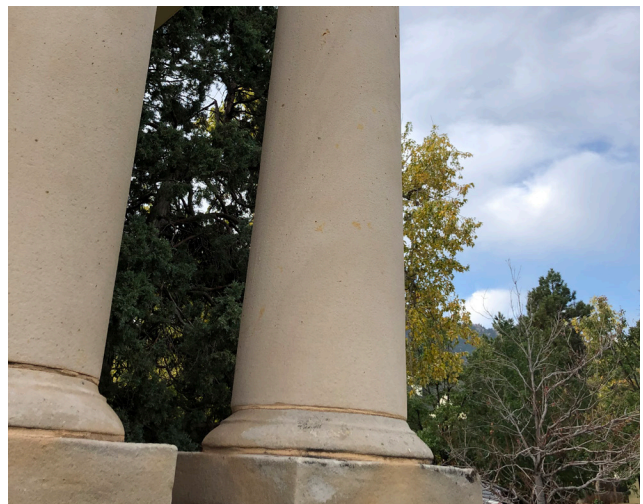
Figure 1-13. Porch columns, 2020 (source: Ratio)

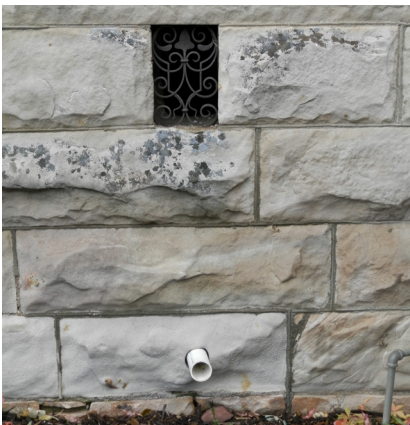
West Facade: The stone overall appears to be in good condition on the west face. The stone detailing elevation below one window has evidence of water damage. Another area toward the bottom of the wall has significant amounts of lichen. A few stones have damaged stone faces or faces that are damaged or have weathered away.

Figure 1-21. Lichen and weathered stone, 2020 (source: Ratio)

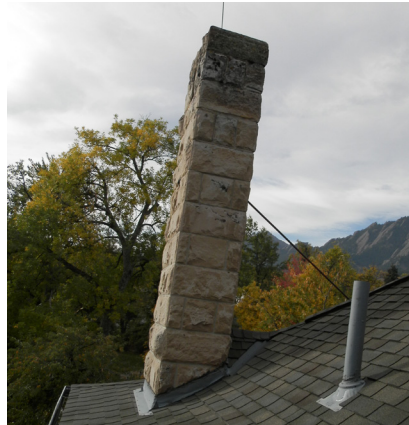
Chimneys: The stonework on the chimneys appears to be in fair to poor condition. Many stones are very worn and weathered with portions of the stones missing, and significant mortar missing. Of the three chimneys, one, in the north east corner, appears to be in the worst condition.

Figure 1-22. South east chimney, 2020 (source: Ratio)

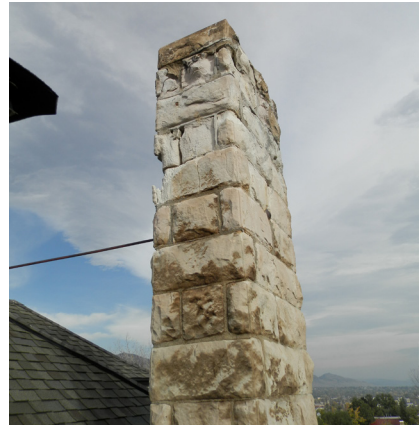
Figure 1-23. North east chimney, 2020 (source: Ratio)

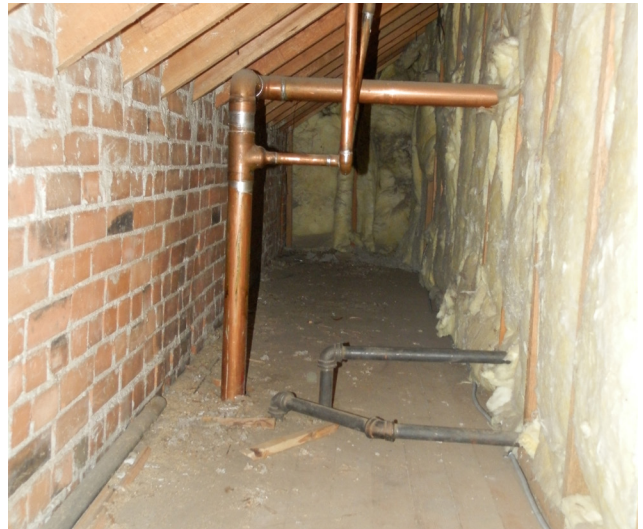
Exposed brick is in the basement and attic. Overall, the brick is in fair condition. Primary areas of damage are those where ductwork or other penetrations have been made through the brick walls. The resulting openings left holes in the brickwork. The attempted sealing material between the ducts and the brick has not functioned properly, causing more damage to the surrounding bricks and impacting the integrity of the walls in those areas.

Figure 1-25. Eave attic masonry, 2020 (source: Ratio)

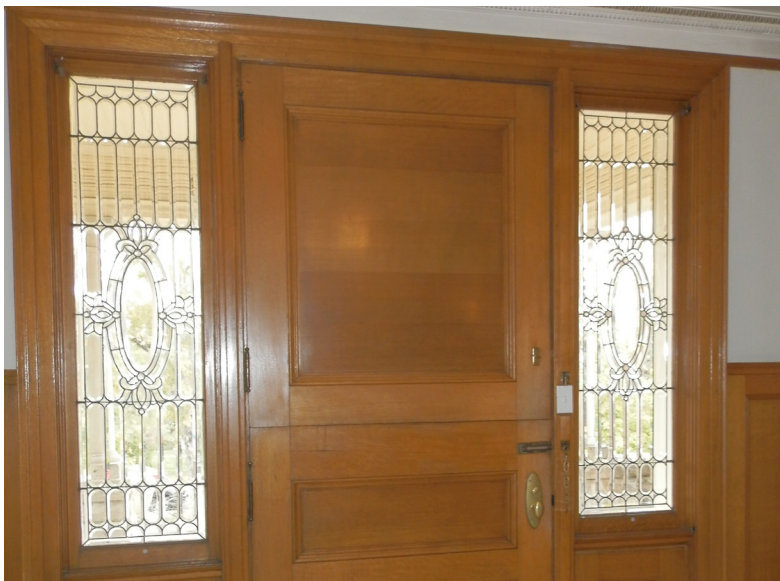
The exterior window glazing is in good condition overall with no major cracks or missing panes. A few basement windows have had the glazing removed for ventilation of interior appliances. Stained glass in the building has been repaired and is in good condition

Figure 1-26. Stained glass at main north entry, 2020 (source: Ratio)

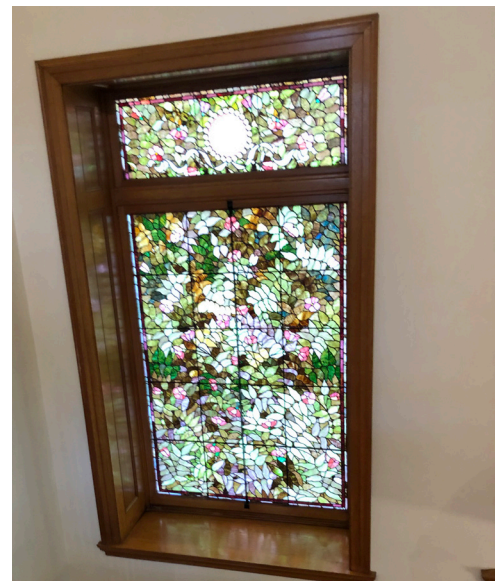
Figure 1-27. Stained glass at interior stairway, 2020 (source: Ratio)

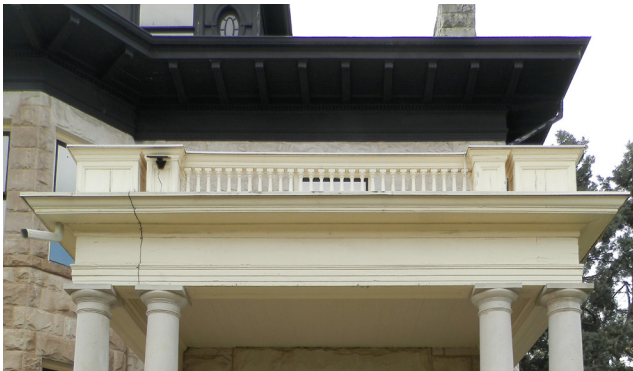
Portico: As viewed from ground level, the wood portico appears to be in fair condition with evidence of cracking and paint peeling. Below the portico, the wood soffit shows evidence of cracking and warping. During the site visit, a substantial yellowjacket nest was located behind the soffit. The wood balustrade wraps around the top of the portico and is in poor condition with areas of major splintering, and multiple areas where the bare wood is exposed. An attempt at protecting the top of this wood was made at some point in the past with the addition of metal exterior roof caps that cover the tops of the rails.

Figure 1-28. Portico roof, 2020 (source: Ratio)

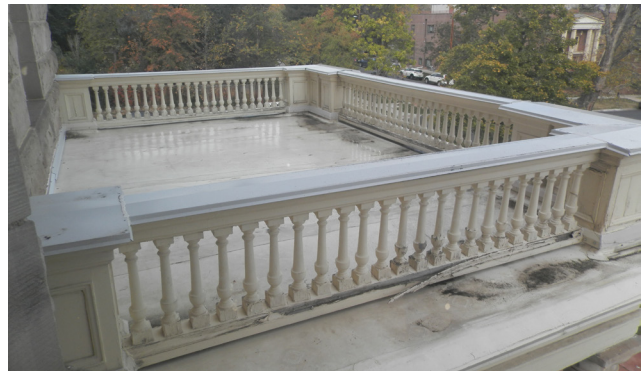
Figure 1-29. Portico balustrade on north elevation, 2020 (source: Ratio)

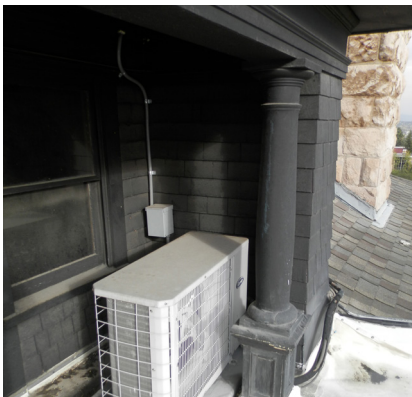
In general, the portico roof eaves and soffits appear are in good condition. The brackets and wood detailing appears intact, with little evidence of rot or damage. The metal gutters and downspouts around the building are in poor to fair condition. The exterior wall finish around the attic is in fair condition. A few areas have paint missing, and some weathering, but most finishes have little to no damage.

Figure 1-30. Attic exterior, 2020 (source: Ratio)

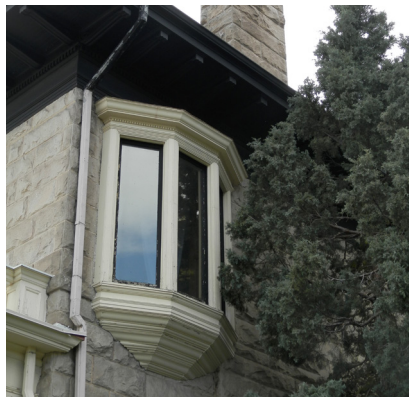
Figure 1-31. Wood window, 2020 (source: Ratio)

The exterior portion of the wood windows and doors vary from fair to poor condition based upon their locations. Many exterior frames, sills, and sashes have peeling and cracking paint over most exterior surfaces.

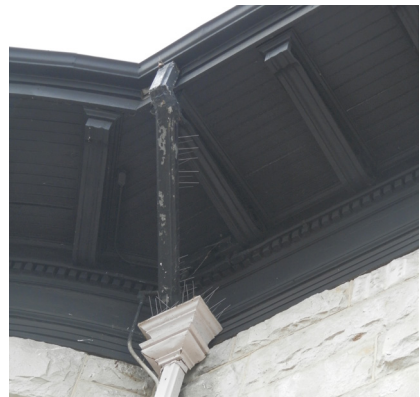
Figure 1-32. Roof soffits, 2020 (source: Ratio)

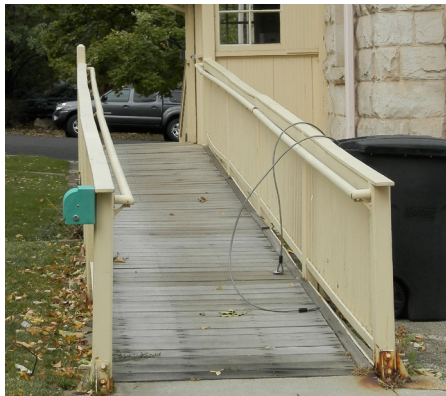
South Porch: The enclosed porch is used as the secondary entrance with a wood ramp providing an accessible entry. The porch walls are bead board and appear to be in fair condition with some warping and cracking. The flooring has been painted and is worn with signs of weathering, primarily near the exterior door. An entry ramp and staircase have been added to the south porch, and are not original to the building. These additions are in fair condition and have significant rust is on the metal elements that connect the ramp to the concrete slab below. Adjacent to the porch on the east side is a staircase leading to the basement. These stairs are covered by a plywood panel.

Figure 1-33. South porch ramp, 2020 (source: Ratio)

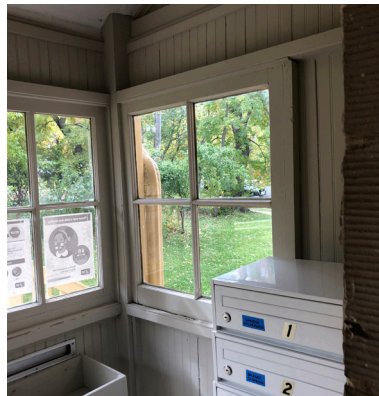
Figure 1-34. South porch interior, 2020 (source: Ratio)

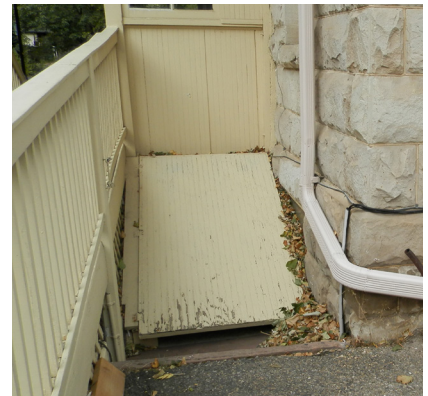
Figure 1-35. South porch staircase to basement, 2020 (source: Ratio)

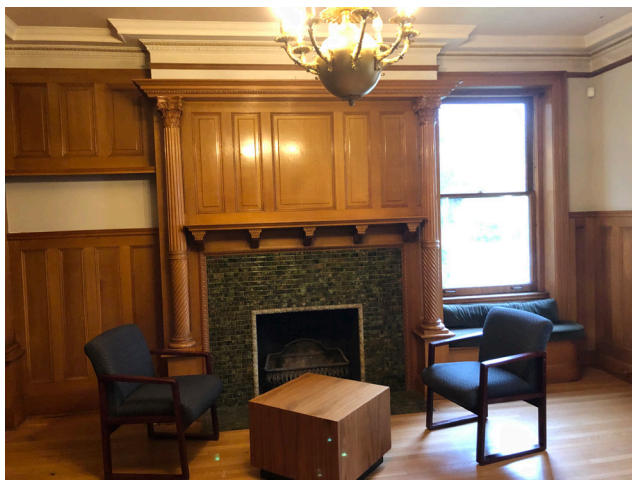
Foyer: The foyer has wood wall paneling, a wood fireplace surround, and wood detailing leading up to the main staircase. The majority of these decorative wood elements are in good condition. The front door is a Dutch door and is fully functioning. The detailing appears to be intact with minimal wear. Two primary areas of wear are around the window seat and at the exposed treads of the staircase.

Figure 1-36. Foyer wood paneling, 2020 (source: Ratio)

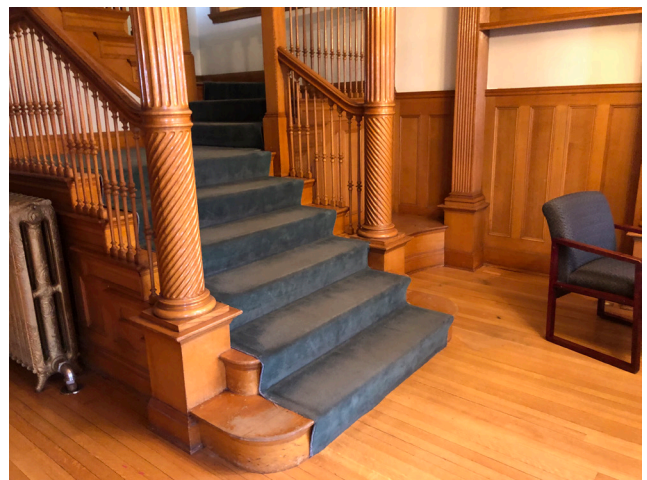
Figure 1-37. Main staircase, 2020 (source: Ratio)

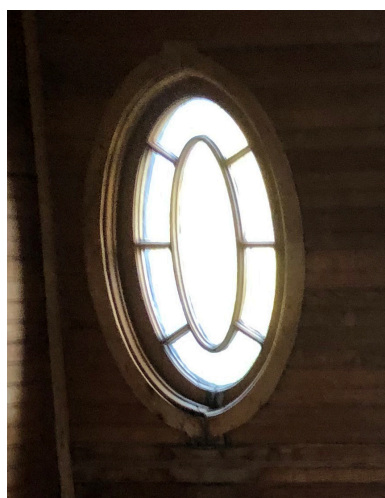
Windows and Doors: The interior portion of the windows are in good condition. Many interior windowsills show significant wear, weathering, or water damage. Many of the circular and oval windows have significant cracking in their frames and sashes. In general, the doors are in fair condition. The hardware is worn, scratched, or scuffed. At some locations where the doors have been painted, the painted finish is scratched or peeling.

Figure 1-38. Oval attic window, 2020 (source: Ratio)

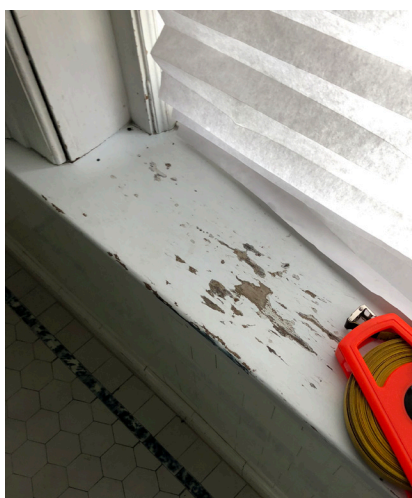
Figure 1-39. Interior sill at the south facing window in second floor bathroom, 2020 (source: Ratio)

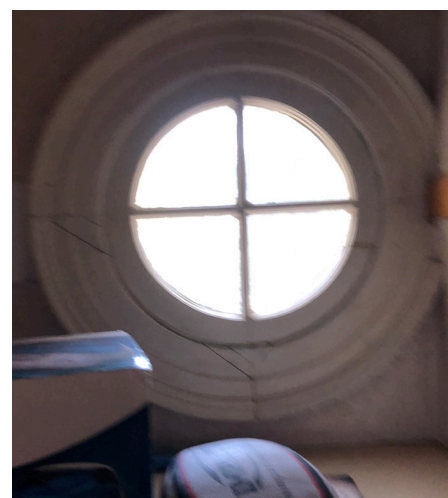
Figure 1-40. Interior west facing circular window in first floor closet, 2020 (source: Ratio)

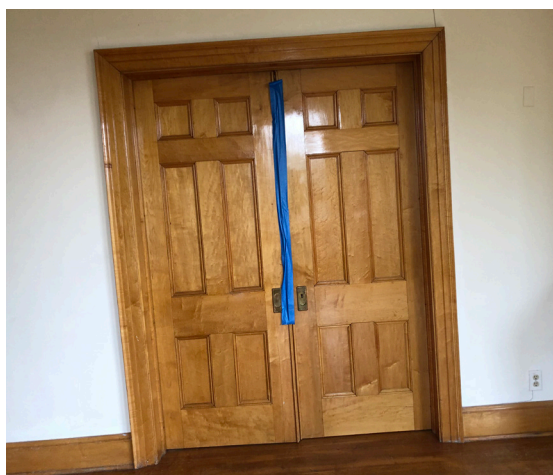
Figure 1-41. Interior wood pocket doors, 2020 (source: Ratio)

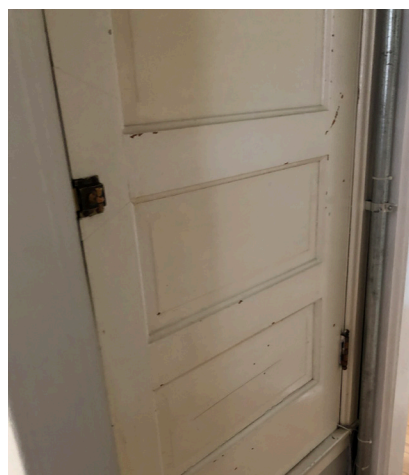
Figure 1-42. Painted interior door Ratio, 2020 (source: Ratio)

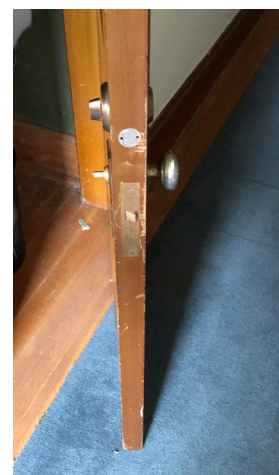
Figure 1-43. Door hardware, 2020 (source: Ratio)

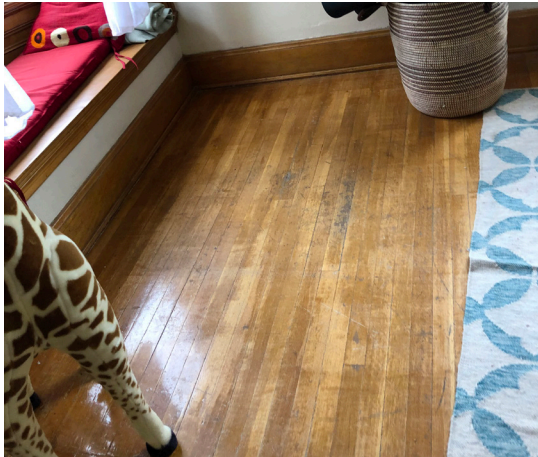
Wood Flooring: Wood flooring throughout the building is in fair condition. Aside from a few areas where there are burn marks and water damage, most of the hardwood flooring has general wear and scratching. In the attic, wood flooring appears to be in worse condition than the rest of the building with gaps between boards, and noticeable scratching. The flooring does not appear to have the same quality or finish as the rest of the building.

Figure 1-44. Wood flooring, 2020 (source: Ratio)

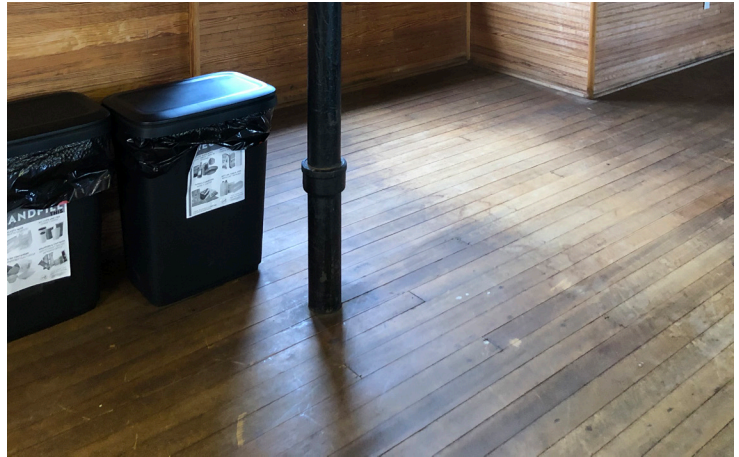
Figure 1-45. Attic flooring, 2020 (source: Ratio)

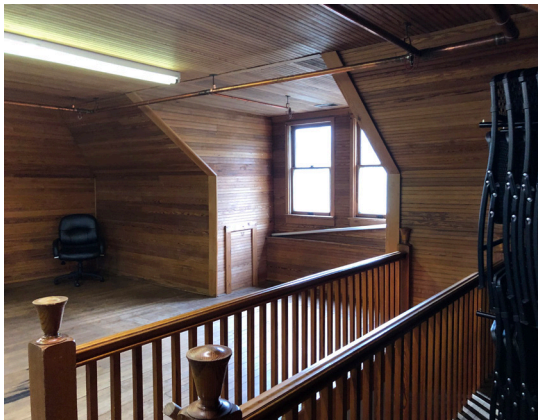
Attic: The walls and ceilings in the attic are wooden bead boards, which is in fair condition overall, with some areas where the panels have been replaced. Water damage is visible below the exterior windows. The stairs to the attic are in fair condition but are severely worn and scratched on the risers and treads. Wood guardrails are in good condition with some minor scrapes and scuffs on the interior surfaces.

Figure 1-46. Attic finishes, 2020 (source: Ratio)

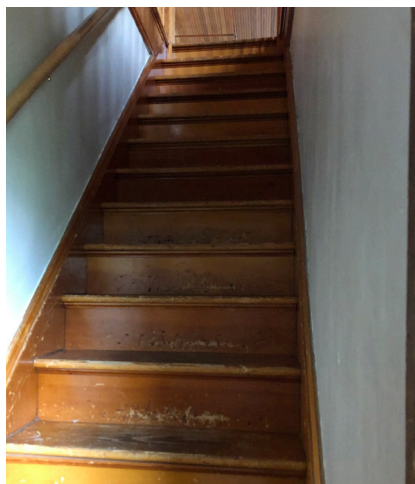
Figure 1-47. Attic staircase, 2020 (source: Ratio)

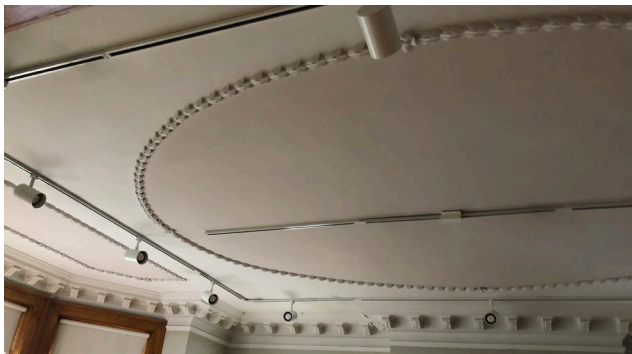
Figure 1-53. Ceiling detailing, 2020 (source: Ratio)

Apart from some detailing on the one of the first-floor ceilings, the interior wall and ceiling finishes are a mix of painted and unpainted wallpaper. Previous attempts to remove the wallpaper were unsuccessful, and the wallpaper was painted over. Most finished surfaces are in good condition. A few areas have peeling wallpaper. A portion of the plaster finish has come off the wall in the second-floor closet.

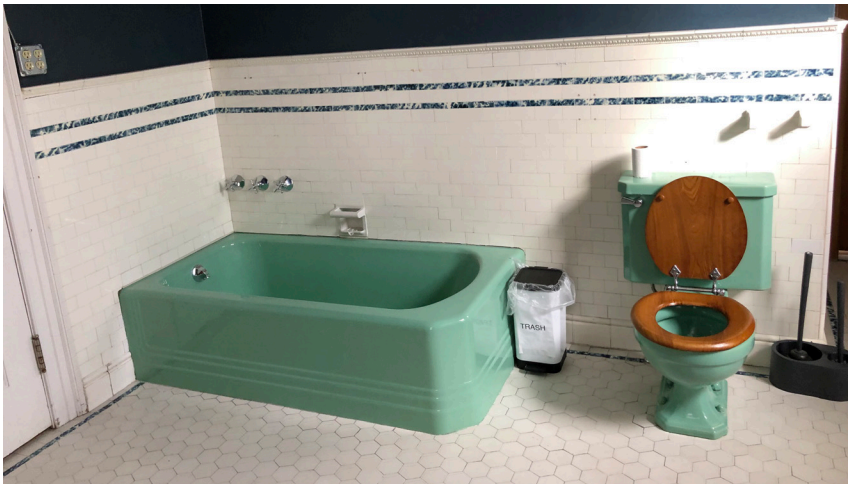
Tiling: The basement kitchen and restrooms on each floor have tile floors. In the second level restroom the tile wainscot and floor are in good condition. Adjacent to the restroom is a separate shower that has tile walls and concrete flooring. The tile is in good condition but is not original to the building or in keeping with the character. The first-floor restroom was modified for accessibility. The floor tile is in good condition and matches the character of the building. The walls in the first-floor restroom are a bead board wainscot with wood trim that are in good condition. In the basement, the kitchen and restroom floor tiles are not original to the building, but are in fair condition. Portions of the grout need repair.

Figure 1-55. Second floor restroom, 2020 (source: Ratio)

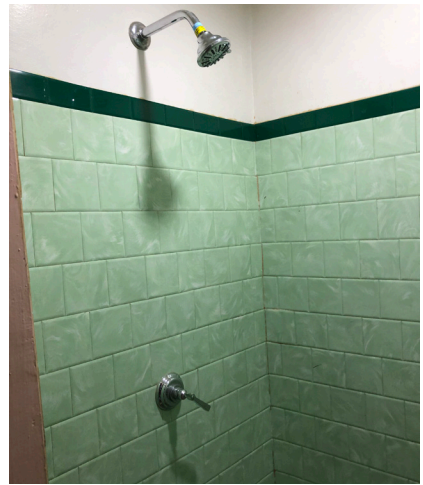
Figure 1-56. Shower tile, 2020 (source: Ratio)

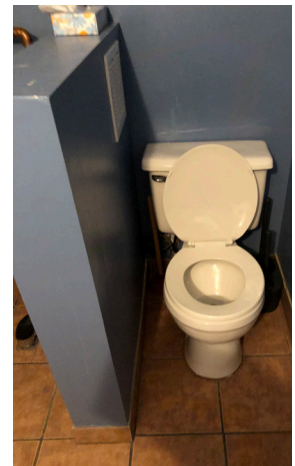
Figure 1-59. Basement restroom, 2020 (source: Ratio)

Overall, the foundation is in good condition with no indications of wide-spread settlement such as cracking in the walls above grade. Efflorescence was evident at the interior faces of the basement walls that is evidence of past water infiltration (Figure 1-59). The basement slab slopes near the southeast corner of the building, however this was likely intentional to allow the slab to drain and is not indicative of structural settlement. An exterior building condition evaluation was prepared by CSC in February 1991. Many of the eroded mortar joints and water infiltration issues identified in the report appear to have been addressed since the report was issued.

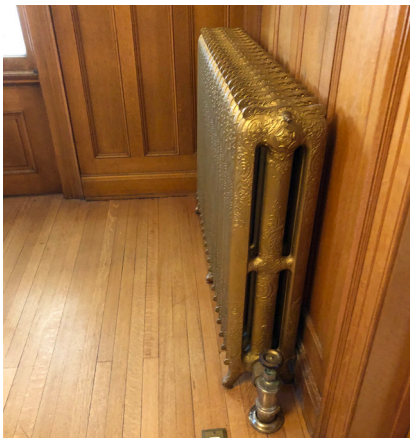
Figure 1-60. Radiator, 2020 (source: Ratio)

Most of the building is conditioned with radiators for heating and no method for cooling other than natural ventilation through the exterior windows. The attic has its own air conditioning system for heating and cooling. At the time of the site visit, all heating and cooling systems appeared to be in working order. A building systems engineer will need to be procured by the city to conduct a thorough analysis to confirm compliance and performance of existing systems.

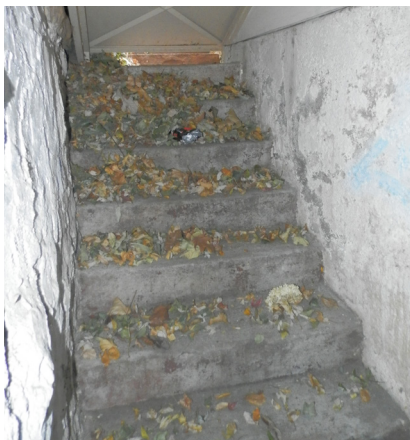
Exterior Basement Staircase: The exterior staircase is covered and inaccessible from the exterior. The steps are concrete. They appear to be in fair condition, though they do not appear to meet current code requirements regarding tread and riser dimensions.

Figure 1-62. Exterior basement staircase, 2020 (source: Ratio)

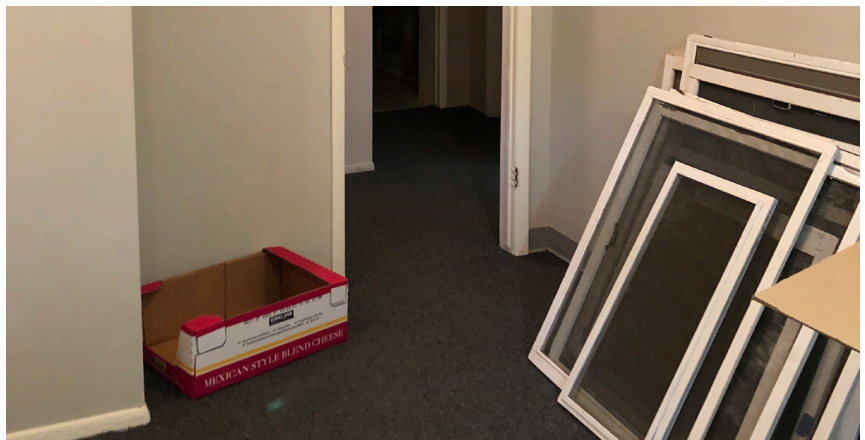
Figure 1-63. Basement finishes, 2020 (source: Ratio)

Basement Finishes: The basement kitchen has an acoustical tile ceiling that is in fair condition. Most of the basement flooring is concrete, which is in good condition other than a rough transition between two slabs at one of the doorways. The finished rooms of the basement, other than the kitchen and restroom, have carpeted floors that are in good condition but not original. These same rooms have doors that are not original to the building and appear to be hollow core construction. Exterior windows in the basement are in fair to poor condition with a few locations that have missing or broken hardware. Some windows have been nailed shut.
