BOULDER FIRE STATION NO. 2

MAY 2023

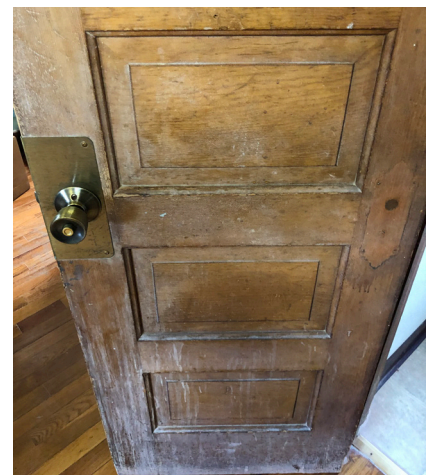
Figure 1-15. Upper level restroom door, 2020 (source: Ratio)

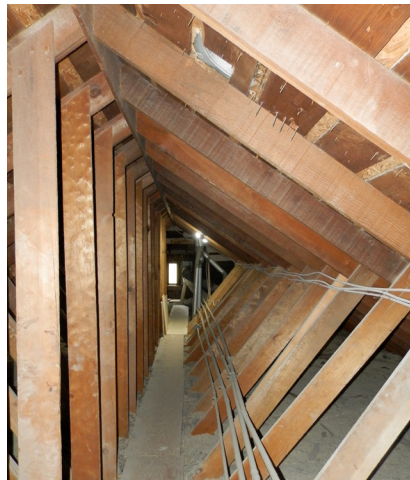
Figure 1-17. Roof framing in attic, 2020 (source: Ratio)

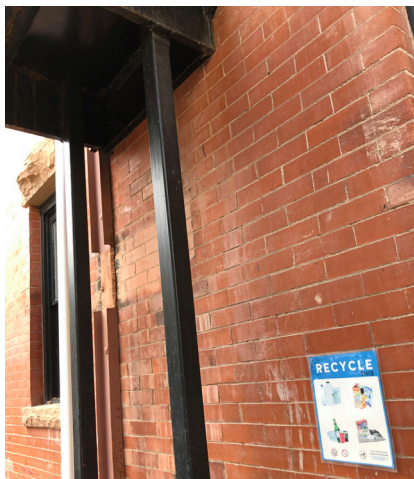
Exterior Stair: The exterior stair is not original to the building. There is evidence that there was a previous exterior staircase to the upper level that was installed in a slightly different location. The exterior stair is in poor condition. It is not well secured to the building and is corroding in multiple areas.

Figure 1-19. Evidence of previous exterior stair landing, 2020 (source: Ratio)

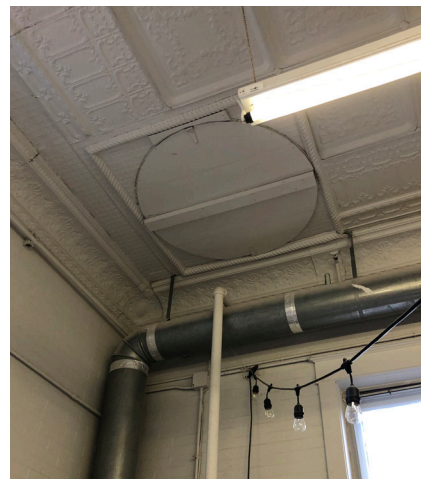
Ceiling Tiles: The painted metal ceiling tiles are not original to the structure and were likely added after the period of significance in order to look historic. They are in good condition. Indication of the fire pole opening is visible from the first and second floors.

Figure 1-21. Original fire pole location, 2020 (source: Ratio)

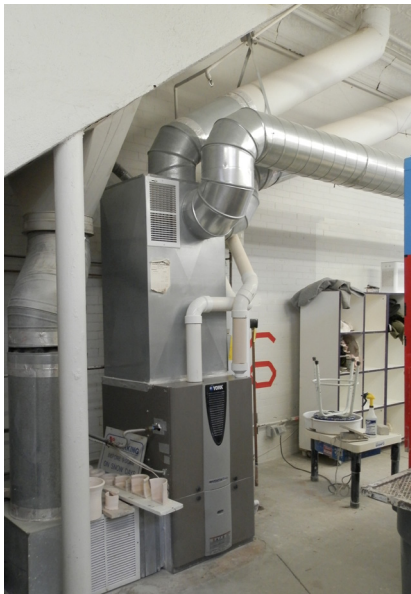
The building has a mechanical system for heating and cooling that is not original to the building. Restroom facilities are on both levels with an accessible restroom on the lower level. A variety of mop sinks/ paint sinks are within the space for the ceramic studio. A building systems engineer will need to be procured by the city to conduct a thorough analysis to confirm compliance and performance of exiting systems.

*Figure 1-22. Mechanical unit, 2020
(source: Ratio)*

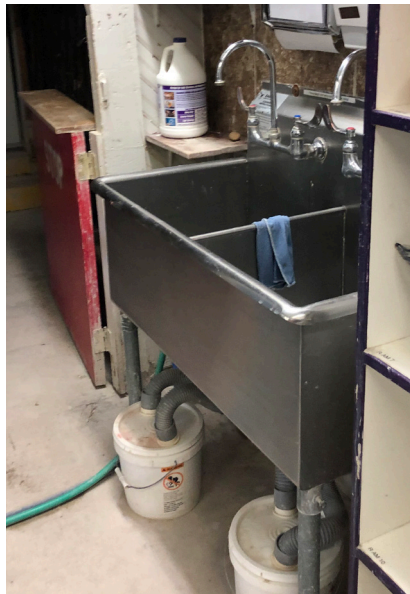
*Figure 1-23. First-floor mop sink, 2020
(source: Ratio)*

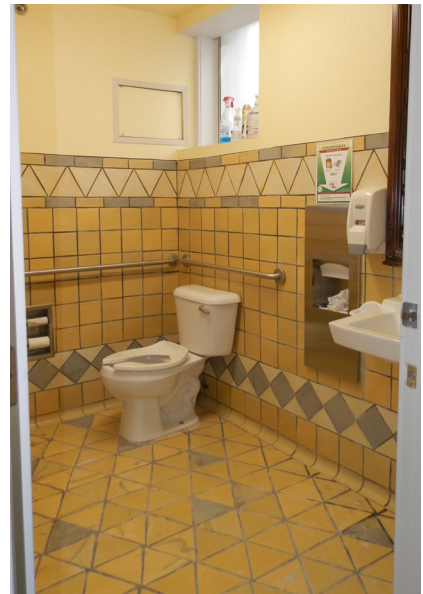
*Figure 1-24. Lower level accessible
restroom, 2020 (source: Ratio)*

Tile: The lower level restroom has decorative tile finishes on the floor and walls that are in good condition. It is unclear if this tile was placed during the period of significance. Further analysis will need to be conducted in order to confirm before any replacement of tile in the future.

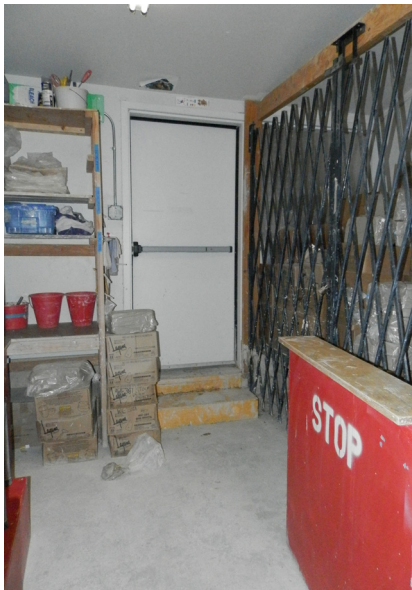
Loading/Storage Area: The lower level addition has two exterior doors, one at grade level, and one that is raised for pallet loading. The pallet storage area is raised above floor level and is enclosed in a locked gate.

Figure 1-25. Storage addition, 2020 (source: Ratio)

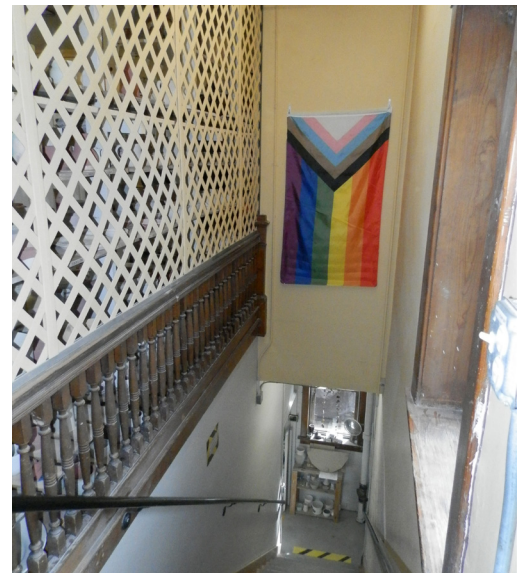
Interior Stair: The bottom steps are concrete with safety painting. Portions of the paint could use retouching, and there is some damage to the corner of the steps. The main portion of the stair is wood, with applied metal treads and nosings added to each step. The metal is worn, but functional. The condition of the wood below the treads is unknown, but the portions of wood that remain exposed are in fair to poor condition.

Figure 1-39. Top of interior stair, 2020 (source: Ratio)
