PLATT FARMHOUSE

MAY 2023

The report documents the history, significance, integrity and existing condition and provides treatment guidance for the resource. It does not evaluate for listing in the National Register of Historic Places. If the resource has been previously listed or evaluated it is referenced and footnoted.

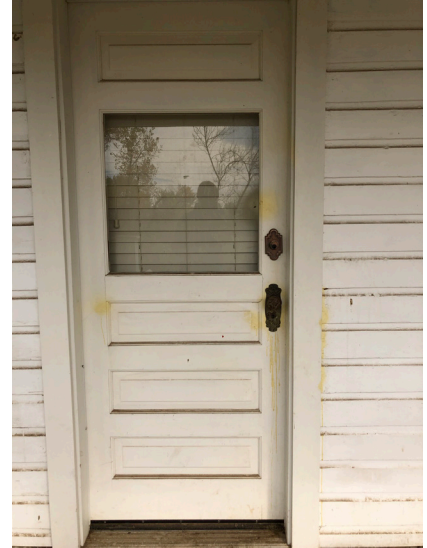
Figure 1-11. South elevation door, 2020 (source: Ratio)

Windows and Doors: The windows and doors appear to be in good condition with no obvious signs of wear or damage. Based on the City-provided building drawings of rehabilitation it appears the windows and doors are a mix of both original and replacements. Replacement windows and doors appear to match the design and materials of the original components. Recent work includes the addition of a sliding barn door and wood finish at the first floor office.

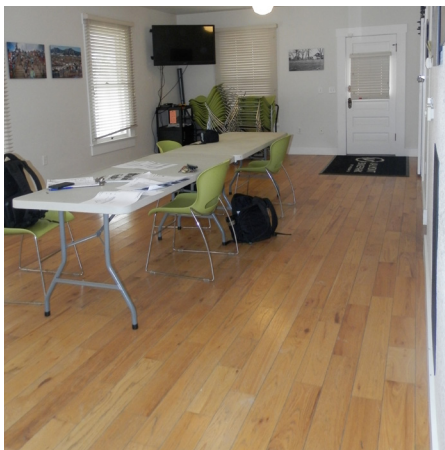
Figure 1-12. Hardwood flooring on the first floor, 2020 (source: Ratio)

Hardwood Flooring: Both levels of the interior have wood plank flooring, that appears in good condition. The interior stairs have a wood finish. The stairs appear to be in good condition with the exception that a few nosing boards are loose.

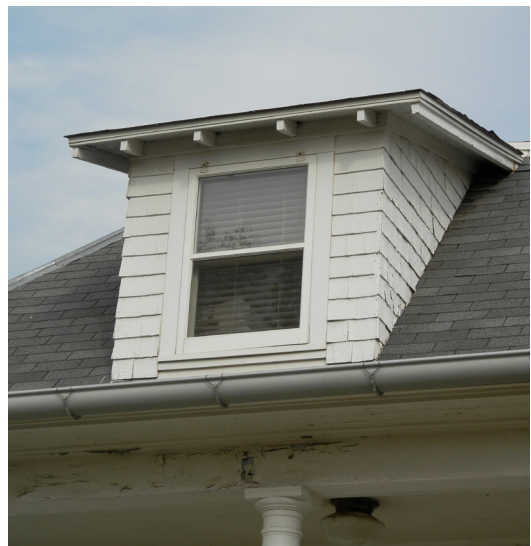
Figure 1-16. Wood shingle dormers, 2020 (source: Ratio)

Shingles: The main portion of the roof is finished with asphalt shingles, which appear to be in good condition. The upper dormers have an exterior wall finish of painted wood shingles. From ground level observation the shingles appear to be in fair condition.

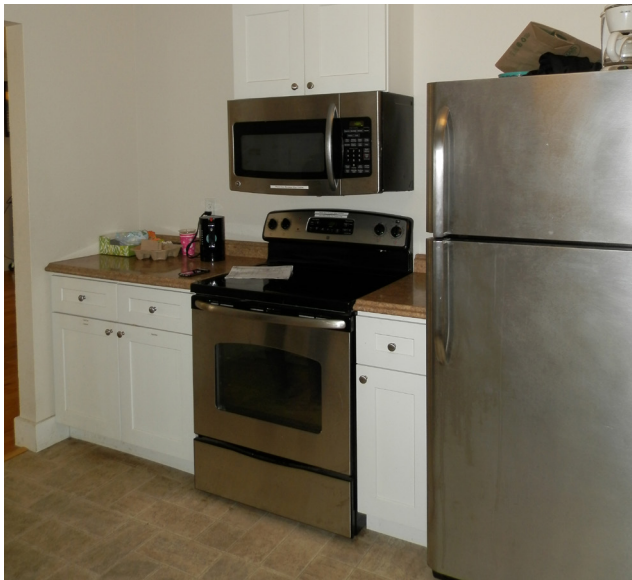
Figure 1-19. Kitchen area with tile floor, 2020 (source: Ratio)

Tile Floors: Both the kitchen and the restroom have tile finishes. The tile is in good condition.

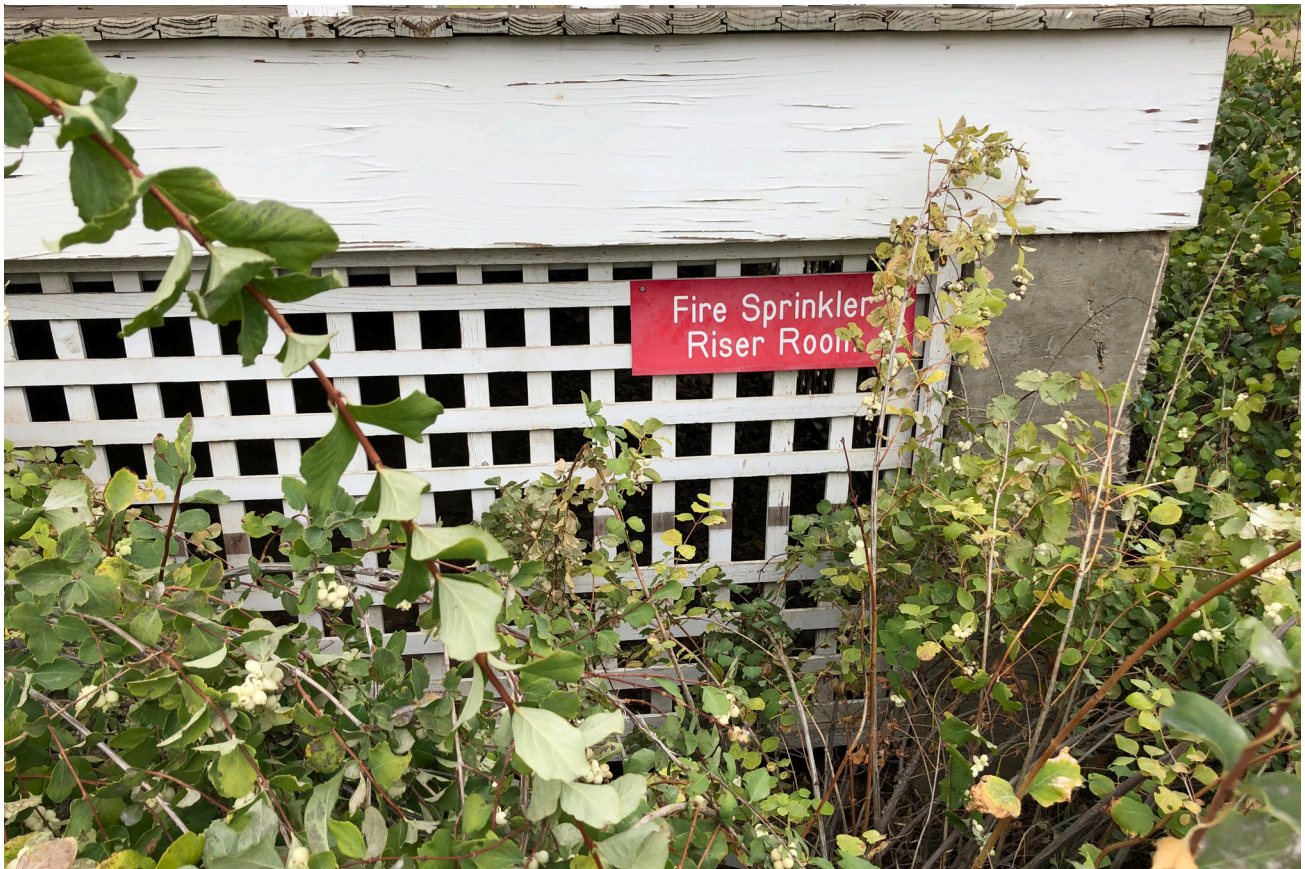
Figure 1-31. Crawl space access, 2020 (source: Ratio)

Mechanical: The swamp cooler and furnace for the building appear to be in working condition. They are located in the crawl space below the building, that is accessed behind the slatted wood screens below the porch. A building systems engineer will need to be procured by the city to conduct a thorough analysis to confirm compliance and performance of existing systems.

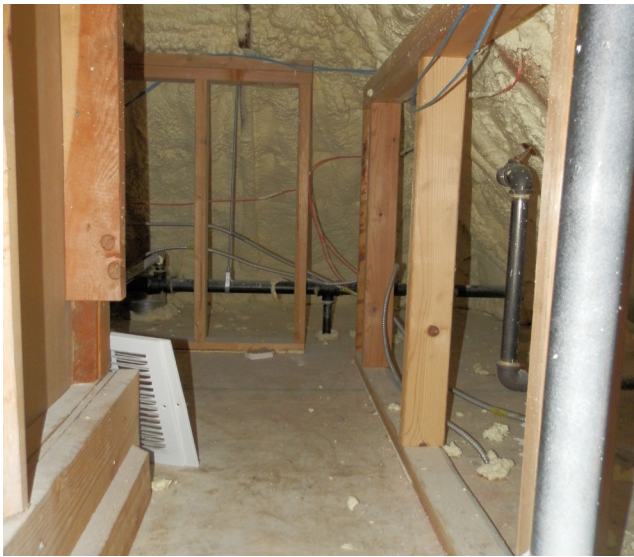
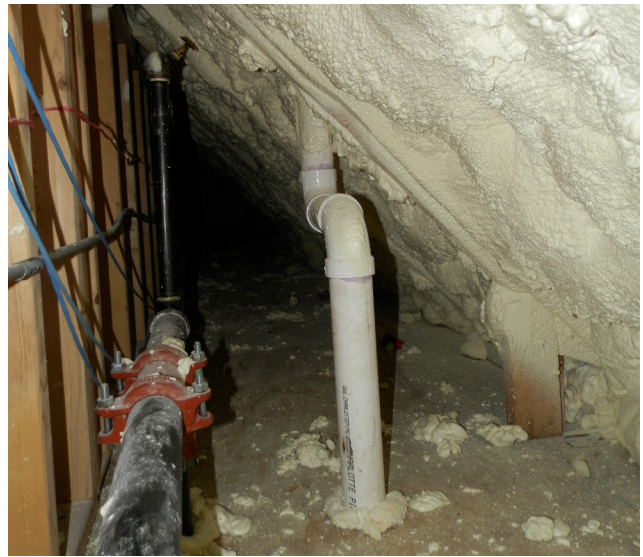
Figure 1-32. Attic space, 2020 (source: Ratio)

Attic: The attic was partially renovated into an office space, likely at the time of relocation. The rest of the attic remained unfinished and is accessed through access panels on the added partition wall. There are two wall panels that appear to be the access for the unfinished attic space. In both access panels there is a hole cut into them. It is unclear the intent of the holes or if there is a grille missing from these locations. Otherwise the attic spaces are in good condition.

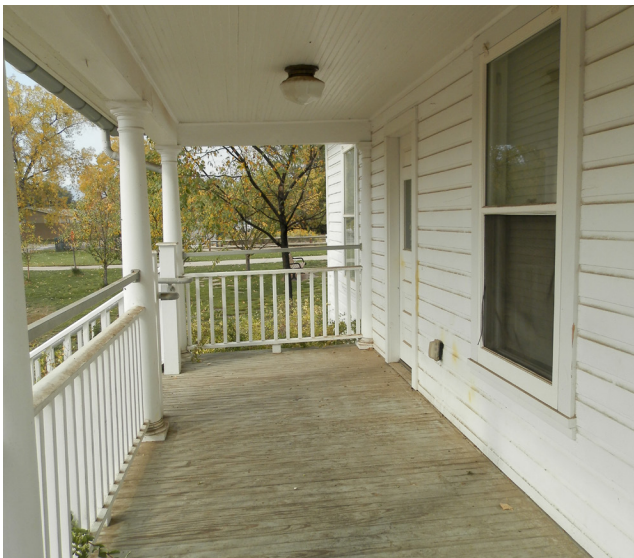
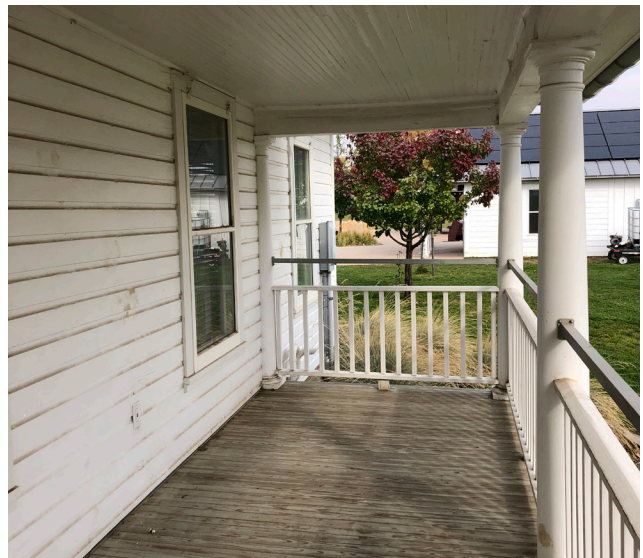
Figure 1-33. South porch, 2020 (source: Ratio)

Porch Flooring: The wood floor of the porch and the entry stairs are in poor to fair condition. The tongue and groove boards are intact and functional, but are unfinished and showing considerable wear, weathering, and warping.

Porch Roof and Soffit: The porch roof is in good condition. The wood soffit is in fair to poor condition. There is considerable wear, weathering, and cracking and peeling paint on both the support beams and the wood soffit material.
