GLEN HUNTINGTON BANDSHELL

MAY 2023

The report documents the history, significance, integrity and existing condition and provides treatment guidance for the resource. It does not evaluate for listing in the National Register of Historic Places. If the resource has been previously listed or evaluated it is referenced and footnoted.

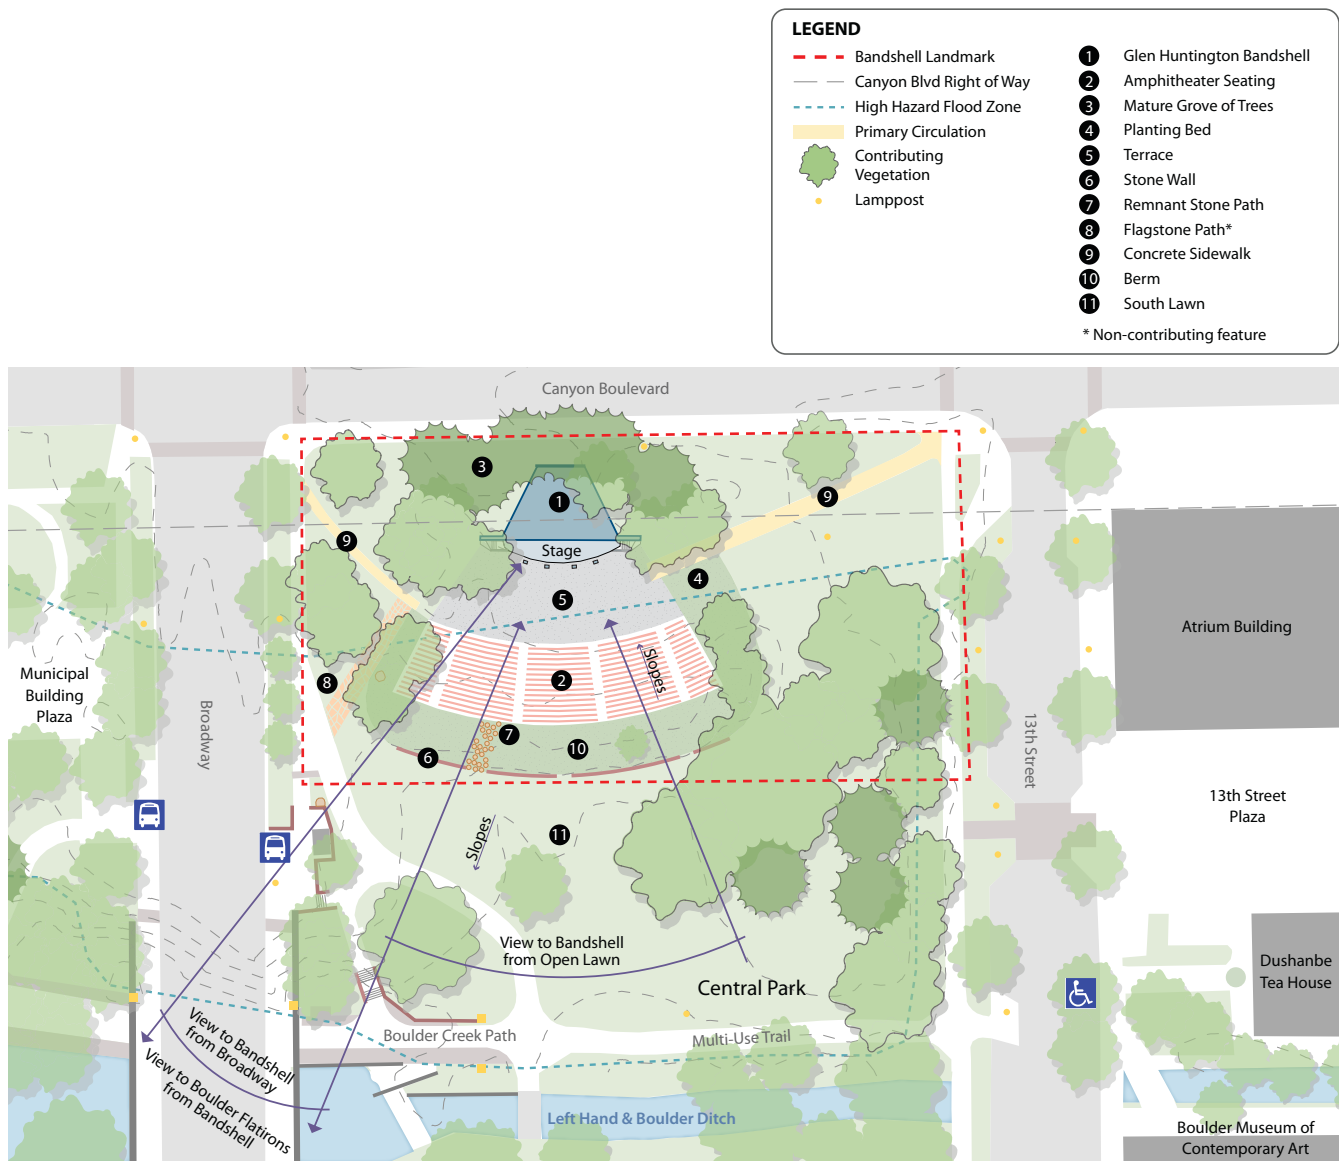
Figure 1-14. Bandshell Existing Condition, 2022 (source: Mundus Bishop)

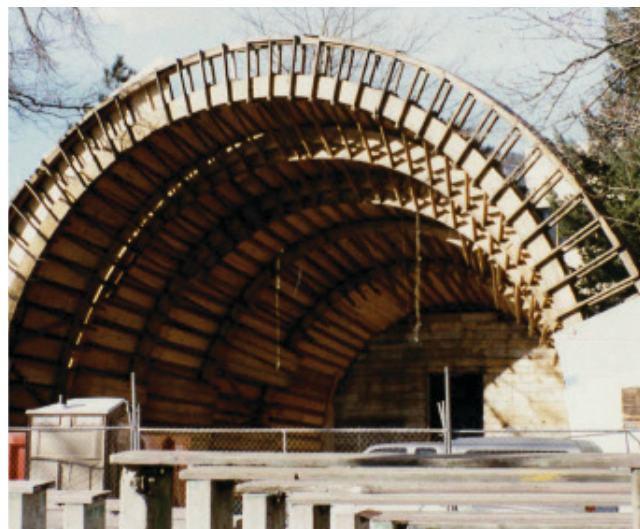
Figure 1-25. Renovation of the Bandshell framing, 1996
(source: City of Boulder)

The framing of the roof structure was not visible during the site observations; however, the roof framing appears in fair structural condition. Although the overall system is performing well structurally with no signs of deflection or failure, the sheathing surrounding the largest southernmost arch showed signs of moisture related deterioration (i.e. peeling and flaking paint, minor warping at the edges of the panels, etc.). This indicates it is likely that moisture has infiltrated the wood roof framing and that the wood framed structure below may have suffered some degree of moisture related deterioration. An investigation performed by JVA in 2014 noted that where the arches are in contact with the steel saddle base plates, they were showing signs of minimal moisture-borne deterioration. It does not appear any action was taken to remedy this, so the condition has likely worsened.
