Trail Condition Monitoring Report

2019-2023 Survey

Prepared by Jake Engelman
City of Boulder Open Space and Mountain Parks
August 2024

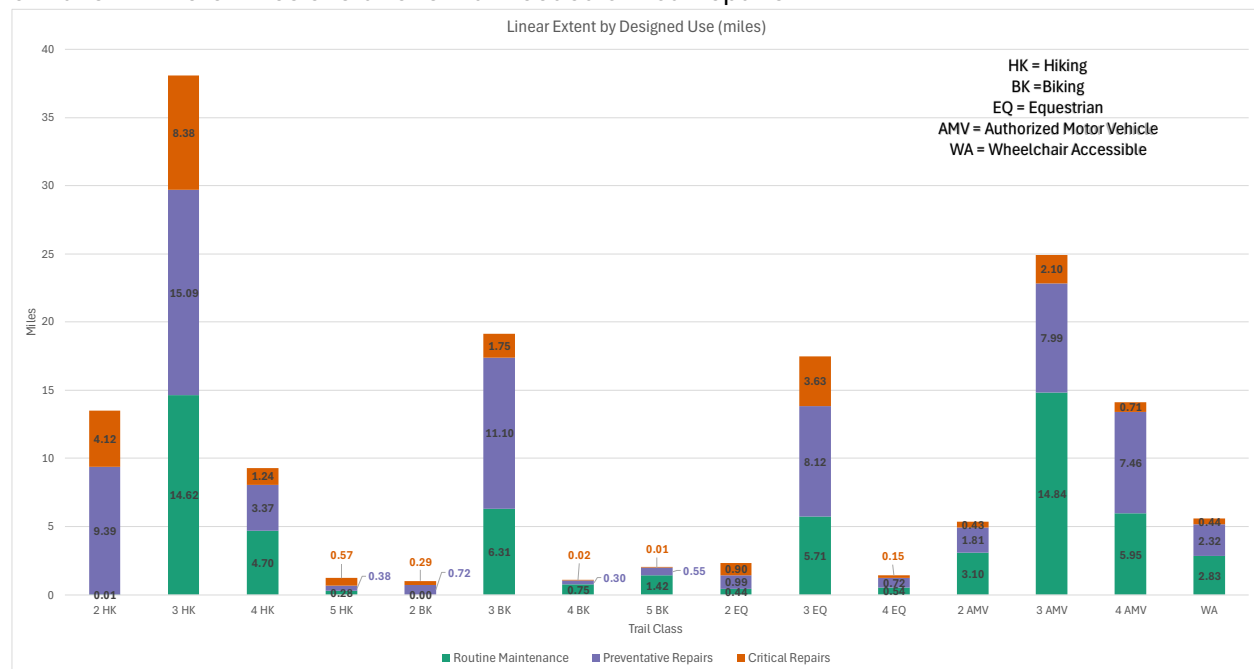
Figure 6: Linear extent of condition states of stations categorized by trail management objective and condition state grouped by use and ordered from least developed (left) to most developed (right).

OSMP builds and maintains trails based on the designed and managed uses. Appendices B-F show the trail design standards. Condition data can show general condition patterns within those trail classes when broken down to a station level. Figure 6 shows that the largest amount of mileage falls into Class 3 hiking trails, and most of that mileage is in routine maintenance or preventative repairs condition. Class 2 hiking and biking trails are the only trails with zero miles within the routine maintenance category. Conversely, Class 4 and 5 biking trails are the only class of trails with zero miles of stations that needed critical repairs

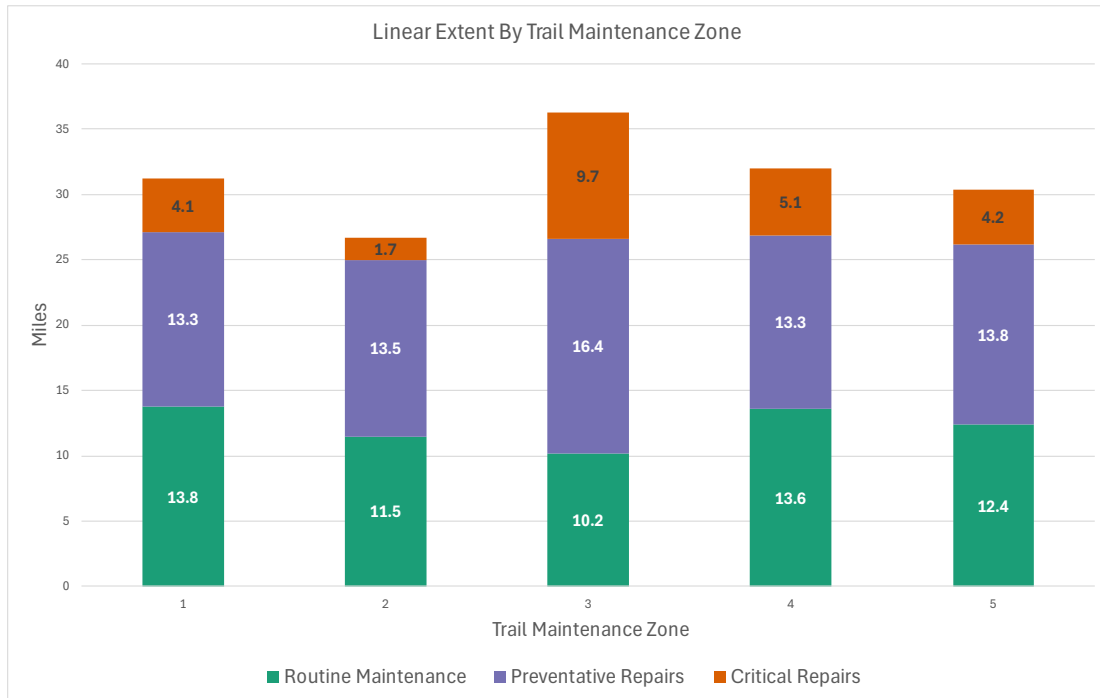
Figure 7: Trail condition extent by trail maintenance zone

OSMP utilizes trail maintenance zones to organize and prioritize management (Figure 2). Each trail maintenance zone contains around 30 miles of trails. Each zone’s trails generally have common physical landscape characteristics, soil types, topography, and managed uses. When looking at station-level data, trail maintenance Zone 3 contains the highest number of trails needing preventative or critical repairs (Figure 7). Zones 1 and 4 contain the greatest extent of mileage in routine maintenance.

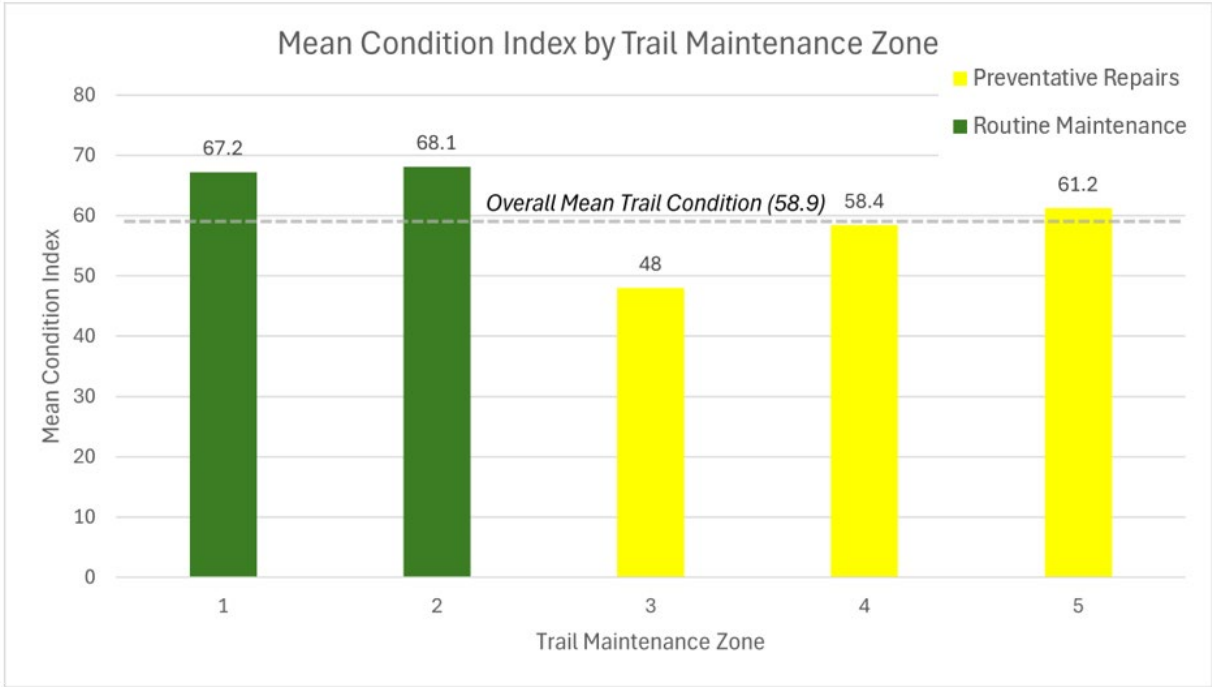
Figure 8: Mean condition index of trails categorized by trail maintenance zone

Overall, the average TCI across the entirety of OSMP-managed lands was 59. Figure 8 shows that average condition varied among trail maintenance zones. Zone 3 had the lowest average trail condition (48). Zone 3 covers the mountain backdrop of OSMP land and contains many trails that were never designed but rather were adopted into the trail system. These trails are known internally to the department as Legacy Trails. Some examples of Legacy Trails include Fern Canyon, the 1st/2nd flatiron, Saddle Rock, and Shadow Canyon. Zone 2 has the highest condition index and consists of the highest concentration of trails designed, built, or repaired using industry-standard sustainable trail practices. Zones 1 and 2 had an average condition index that fell into the routine maintenance condition. All other zones fell into the preventative repairs category.

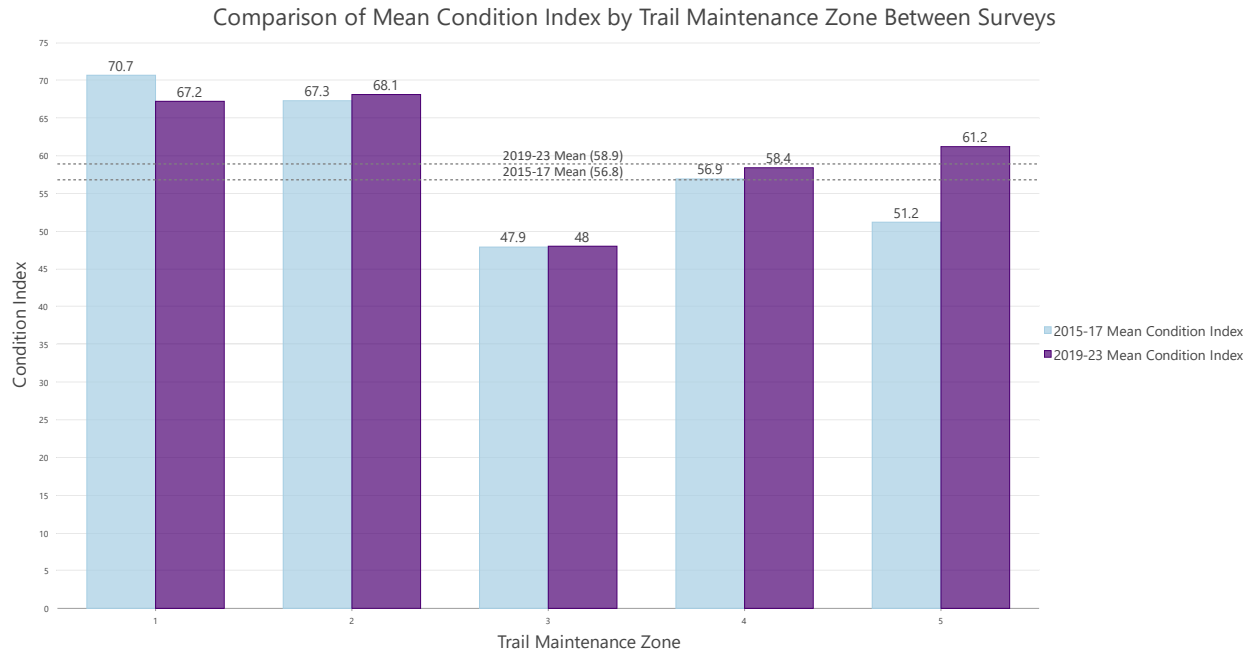
Figure 12: Comparison of mean condition index by Trail maintenance Zones by survey period

Overall, the average condition index score for trail segments managed by OSMP slightly improved since the last round of monitoring. The average condition index increased from 57 in the 2015-17 survey to 59 in the 2019-2023 survey. Every trail maintenance zone saw improvements except Zone 1, which saw a slight decrease in condition index from 70.7 in 2015-17 to 67.2 in 2019-23 (Figure 12). Trail maintenance Zone 5 saw the most significant increase in the average condition index from 51.2 in 2015-17 to 61.2 in 2019-23 (Figure 12).

Trail maintenance Zone 1 saw a slight decrease in the average condition index. Still, major project work completed after Zone 1 was surveyed, including work in the Gunbarrel Hill area, Sawhill Ponds, and Boulder Valley Ranch, should improve the average condition index in the next round of condition monitoring.

Major repair work and trail reroutes contributed to the significant improvements in trail maintenance Zone 5. Trail maintenance Zone 5 had several major repair projects that occurred between surveys repairing trails that were severely damaged in the 2013 flood. Trails that saw flood repairs in maintenance Zone 5 include Mesa trail, Shadow Canyon South trail, North and South Shanahan trails, and NCAR/Bear trail. Major re-routes that contributed to a higher zone score included three Mesa trail segments and portions of the Towhee and Homestead trails.

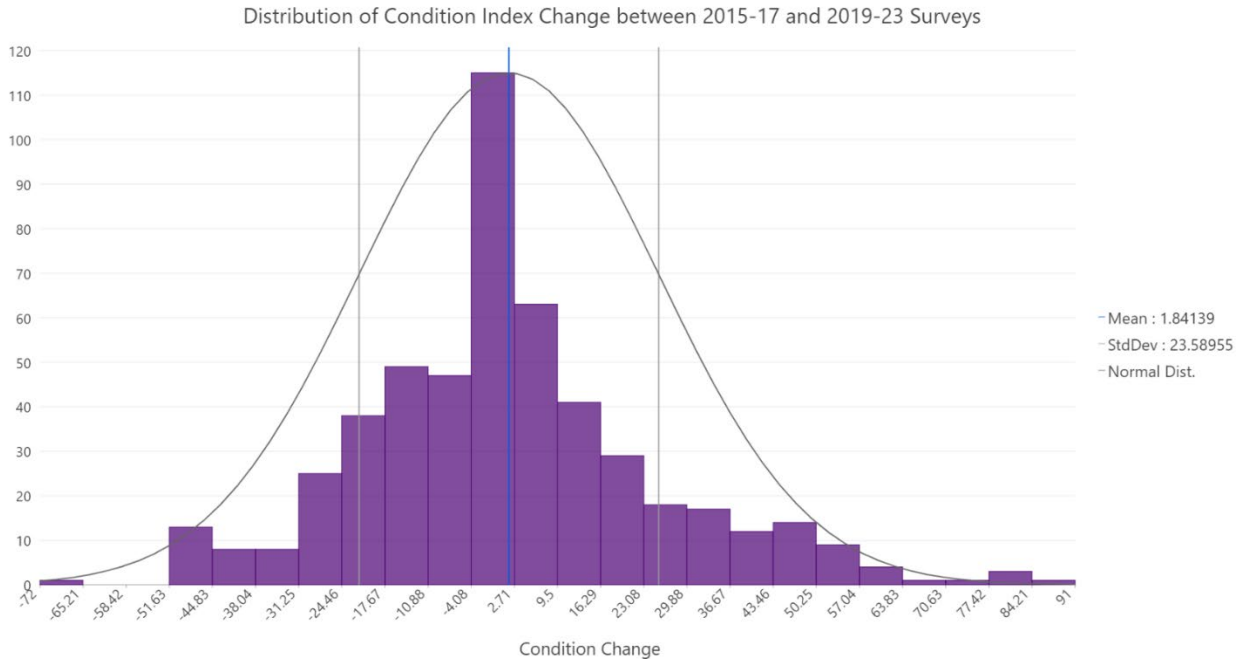
Figure 13: Distribution of condition index change of trail segments between the 2015-17 and 2019-23 surveys.

Examining the 2015-17 and 2019-23 survey data, OSMP analyzed the change in condition indexes for individual trail segments. On average, segments improved slightly, but there was considerable variability in the extent of change among segments (Figure 13), with the standard deviation of the change of 23.6. Changes outside that range are considered outliers and can be the most telling when looking for trails that had dramatic improvements or declines in condition.

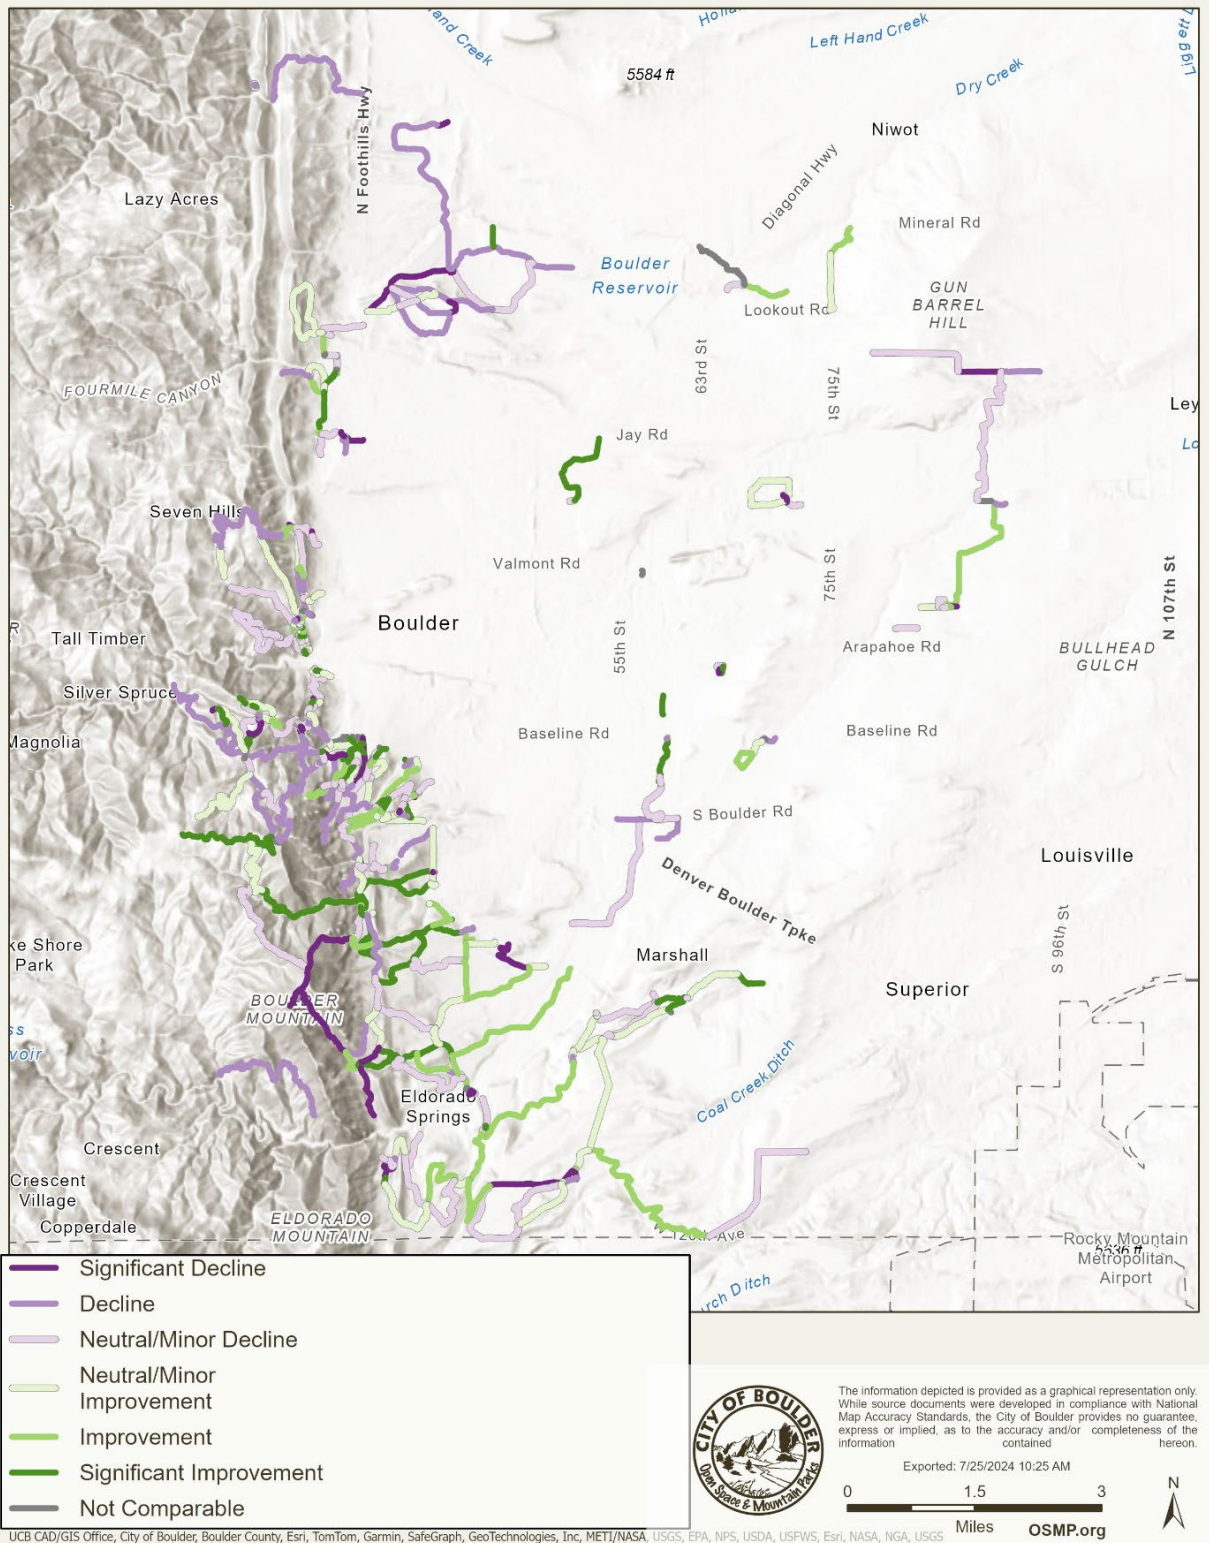
Figure 14: Condition segment changes by trail segment.

Figure 14 shows changes in the condition index on a segment level across the trails managed by OSMP. The trends in trail condition demonstrate the dynamic nature of managing a complex trail system. Trail work projects have made considerable improvements in systemwide trail conditions, while in some areas, aging infrastructure has continued to deteriorate; this demonstrates why a slight increase in the systemwide TCI is hard to achieve and reflects a significant amount of trail work. Trails that saw major improvements were those that had major repair or redesign work completed since the 2015-17 survey. Some examples of these trails are Green Mountain West Ridge, Bear Canyon, Chautauqua, Community Ditch (biking trail segments), and Foothills South. Trails that saw a significant decline in condition are found in the mountain backdrop or in the northern portion of the trail system. Some trails that saw substantial decreases in condition include Cobalt, Fern Canyon, and Flatirons Vista North. Several legacy trails, such as Saddle Rock Trail or Fern Canyon Trail, continued to have declining condition scores; however, the legacy trails that had major repair work done on them, such as the 1st/2nd Flatiron Trail and Sanitas, saw marked improvements in condition index.

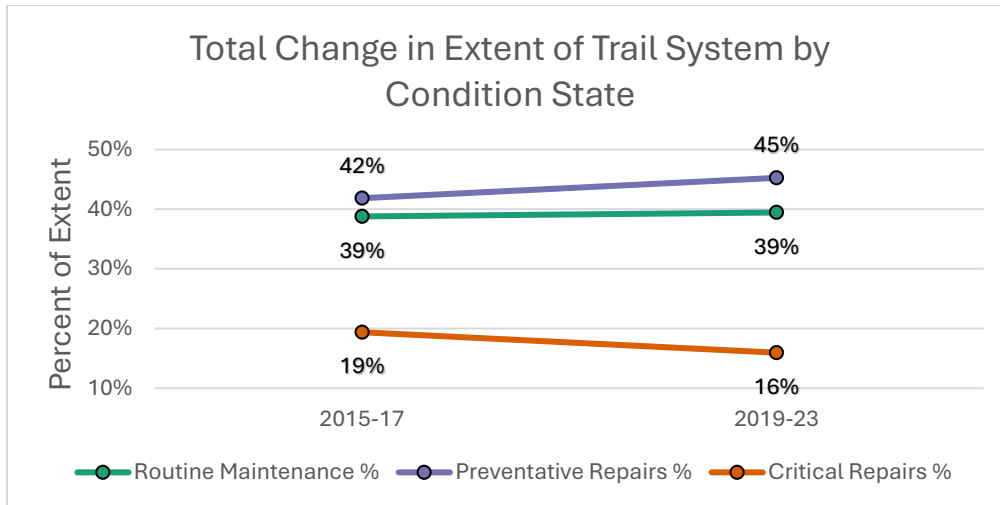
Figure 17: Total change in linear extent by condition state between the surveys

Figure 17 shows the change in the extent of mileage in different condition states. 2019-23 saw a decrease in the percent of mileage in a critical repair state with an increase in the percent of mileage in a preventative repair condition state.
