# Trail Condition Monitoring Report

2019-2023 Survey

Prepared by Jake Engelman  
City of Boulder Open Space and Mountain Parks  
August 2024

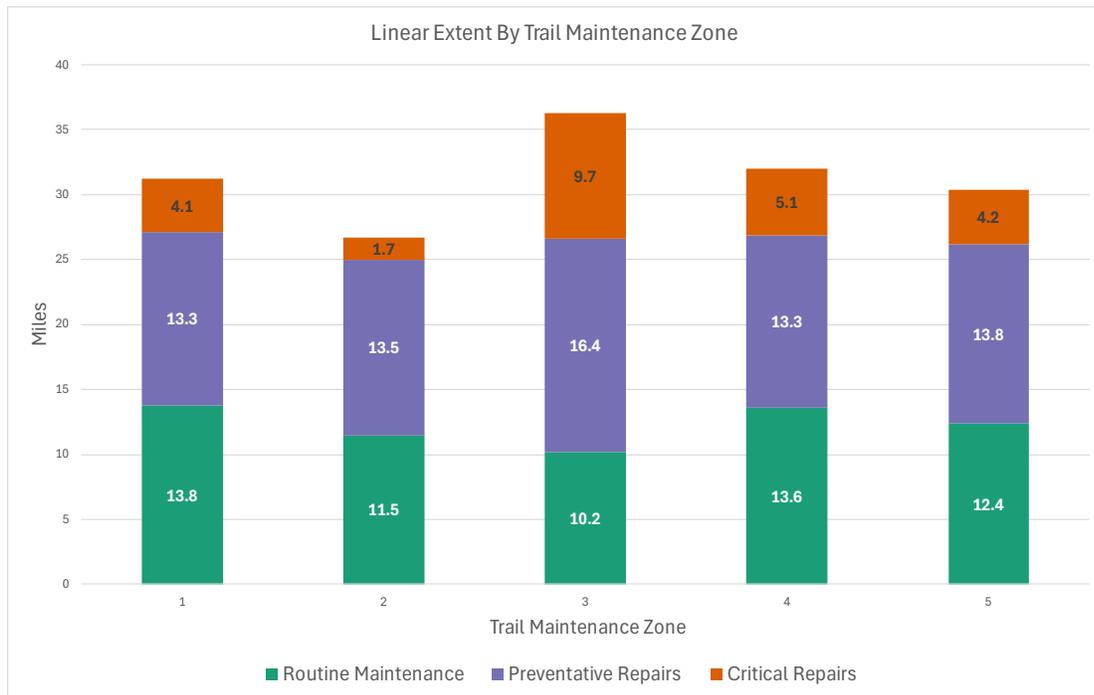
Figure 7: Trail condition extent by trail maintenance zone

OSMP utilizes trail maintenance zones to organize and prioritize management (Figure 2). Each trail maintenance zone contains around 30 miles of trails. Each zone’s trails generally have common physical landscape characteristics, soil types, topography, and managed uses. When looking at station-level data, trail maintenance Zone 3 contains the highest number of trails needing preventative or critical repairs (Figure 7). Zones 1 and 4 contain the greatest extent of mileage in routine maintenance.

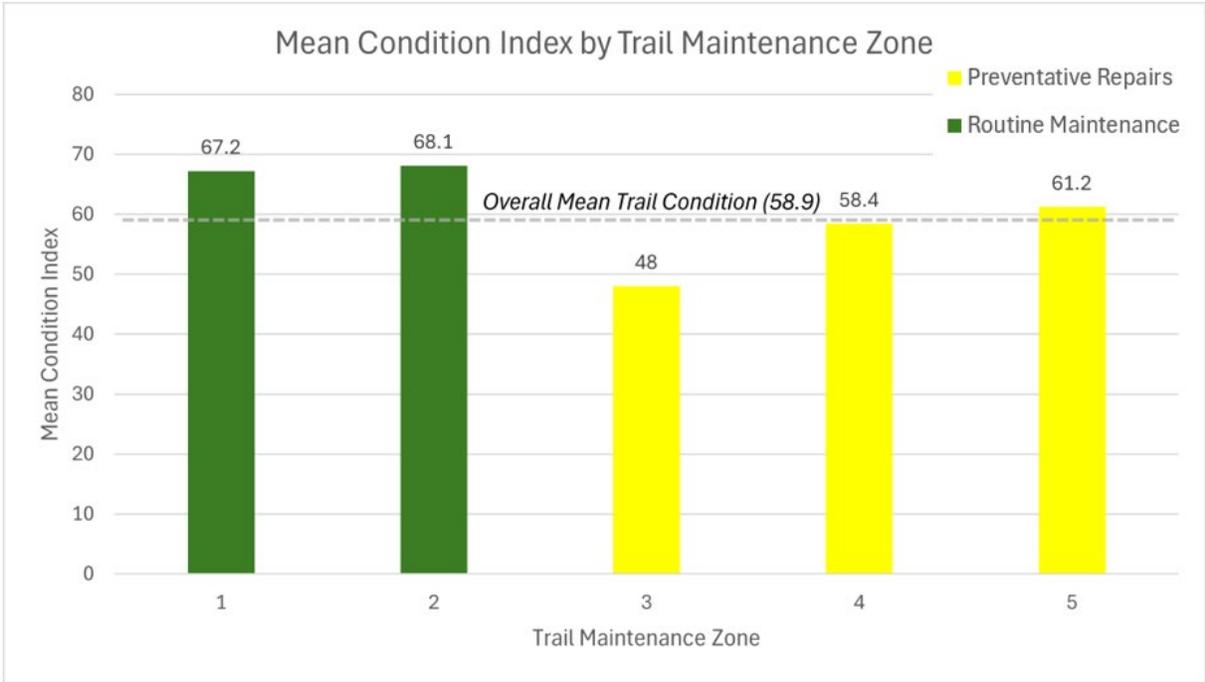
Figure 8: Mean condition index of trails categorized by trail maintenance zone

Overall, the average TCI across the entirety of OSMP-managed lands was 59. Figure 8 shows that average condition varied among trail maintenance zones. Zone 3 had the lowest average trail condition (48). Zone 3 covers the mountain backdrop of OSMP land and contains many trails that were never designed but rather were adopted into the trail system. These trails are known internally to the department as Legacy Trails. Some examples of Legacy Trails include Fern Canyon, the 1<sup>st</sup>/2<sup>nd</sup> flatiron, Saddle Rock, and Shadow Canyon. Zone 2 has the highest condition index and consists of the highest concentration of trails designed, built, or repaired using industry-standard sustainable trail practices. Zones 1 and 2 had an average condition index that fell into the routine maintenance condition. All other zones fell into the preventative repairs category.

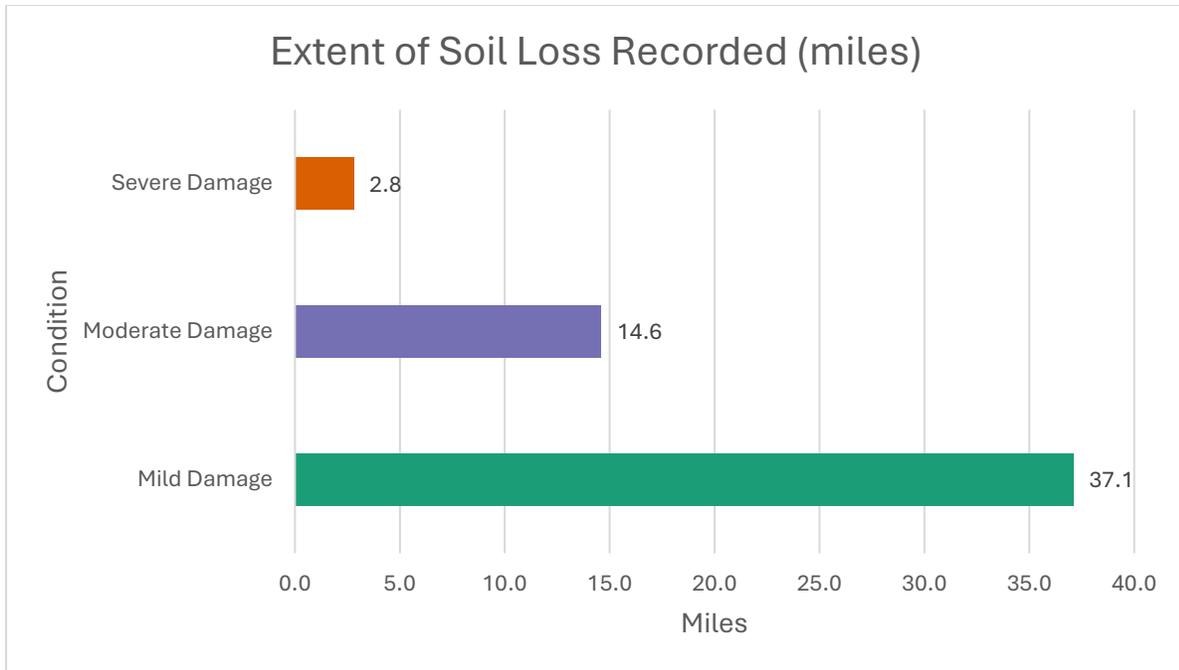
Figure 10: The linear extent of soil loss (erosion) measured during the 2019-23 condition monitoring.

Soil loss was recorded on 54.4 miles of trails throughout the OSMP trail system, accounting for approximately 35% of the total mileage surveyed. Of those 54 miles, 68% of the mileage exhibited mild soil loss, 27% moderate soil loss, and 5% severe soil loss (Figure 10).

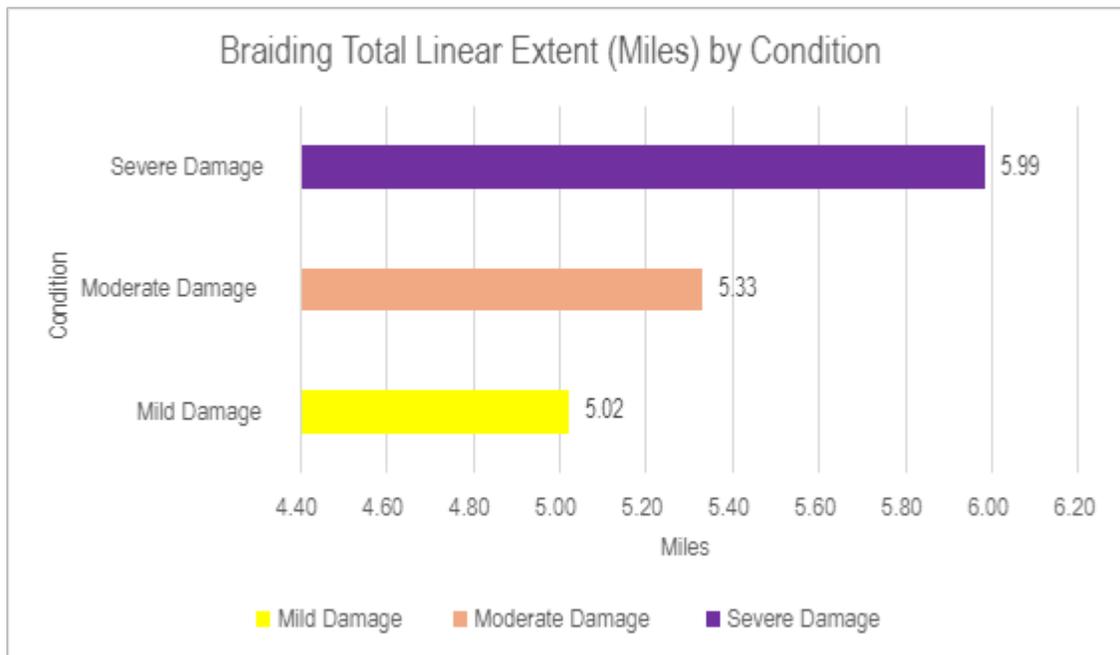
Figure 11: The linear extent of braiding surveyed categorized by condition.

Braiding was recorded on 16.3 miles of trails throughout the OSMP trail system. Of those, 16 miles (31% of the mileage) exhibited mild damage, 32% moderate damage, and 37% severe damage (Figure 11).

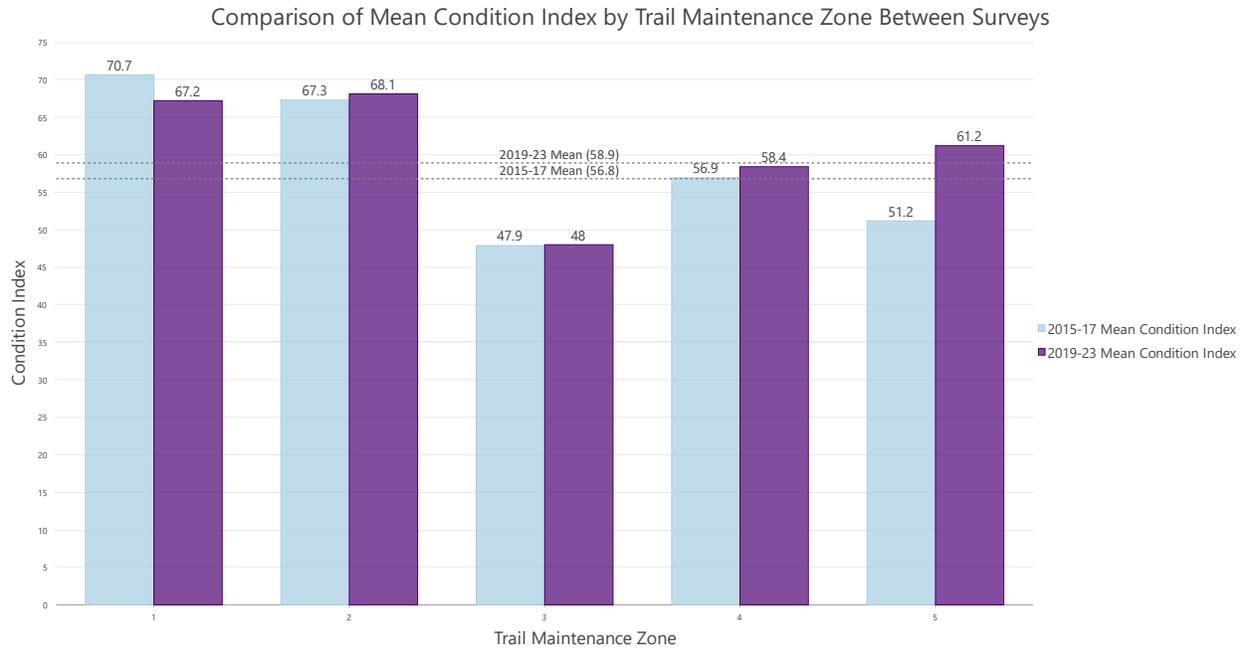
Figure 12: Comparison of mean condition index by Trail maintenance Zones by survey period

Overall, the average condition index score for trail segments managed by OSMP slightly improved since the last round of monitoring. The average condition index increased from 57 in the 2015-17 survey to 59 in the 2019-2023 survey. Every trail maintenance zone saw improvements except Zone 1, which saw a slight decrease in condition index from 70.7 in 2015-17 to 67.2 in 2019-23 (Figure 12). Trail maintenance Zone 5 saw the most significant increase in the average condition index from 51.2 in 2015-17 to 61.2 in 2019-23 (Figure 12).

Trail maintenance Zone 1 saw a slight decrease in the average condition index. Still, major project work completed after Zone 1 was surveyed, including work in the Gunbarrel Hill area, Sawhill Ponds, and Boulder Valley Ranch, should improve the average condition index in the next round of condition monitoring.

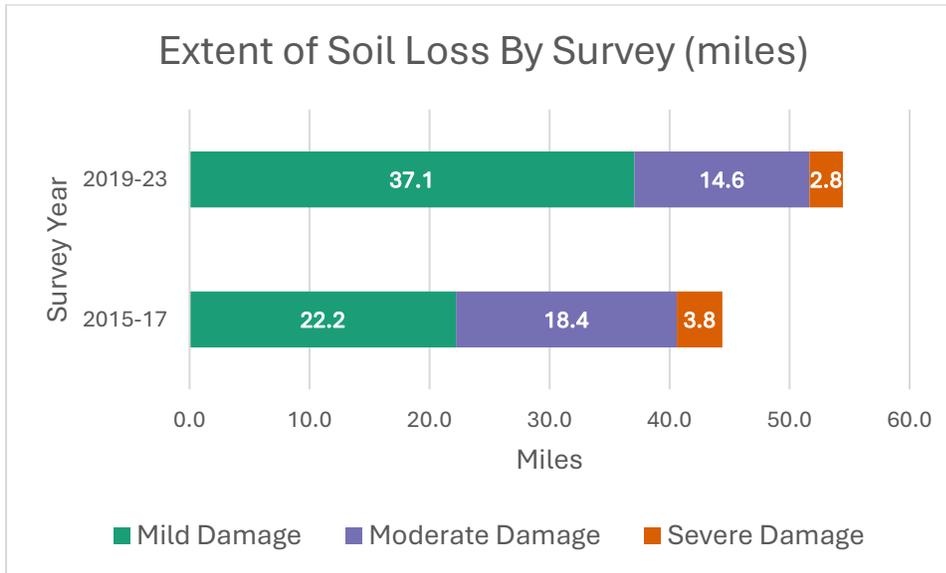
Figure 15: A comparison of soil loss between surveys.

The 2019-23 survey found a decrease in severe and moderate soil loss problems (Figure 15). Some of that decrease can be attributed to significant trail repair projects and trail re-routes. Many trails severely damaged in the 2013 flood were repaired between the 2015-17 survey and the most recent survey. The 2019-23 survey did find a significant increase in mild soil loss damage problems. These areas of mild damage should be considered in routine maintenance sweeps, so they do not develop into moderate or severe damage areas.

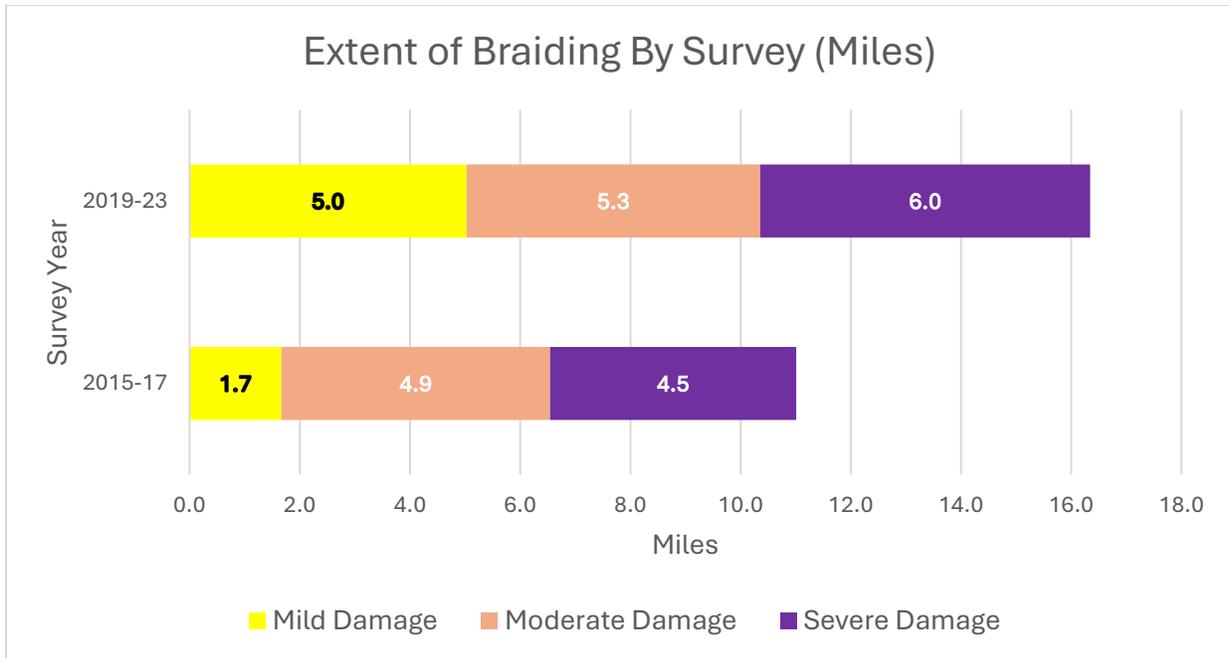
Figure 16: A comparison of the linear extent of braiding between surveys categorized by condition.

The 2019-23 survey recorded more instances of severe, moderate, and mild braiding along trails than the 2015-17 survey (Figure 16). Braiding can indicate other issues, such as drainage issues or erosion, that make the original trail alignment undesirable to travel upon.
