GLEN HUNTINGTON BANDSHELL

RESOURCE ASSESSMENT REPORT

DRAFT MARCH 2021

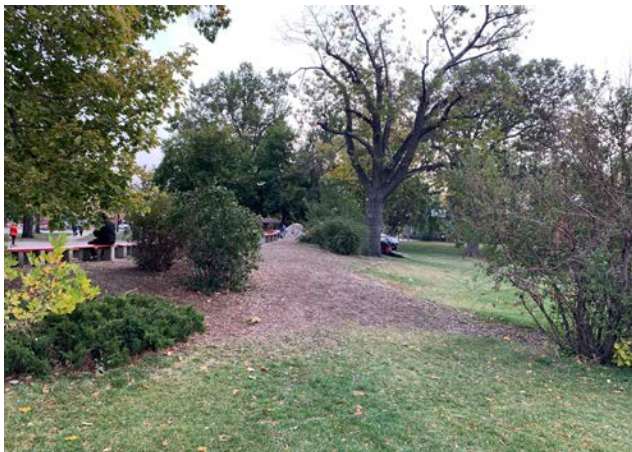
Topography of the Bandshell site, including the sloped amphitheater, the berm of the flood control levee, and the large level area between the Bandshell and amphitheater contribute to the significance of the Bandshell. The berm continues to mitigate flooding; however the oval shape is less legible. (Figure 1-5)

Figure 1-5. Landscaped Berm, 2020 (source: Mundus Bishop)

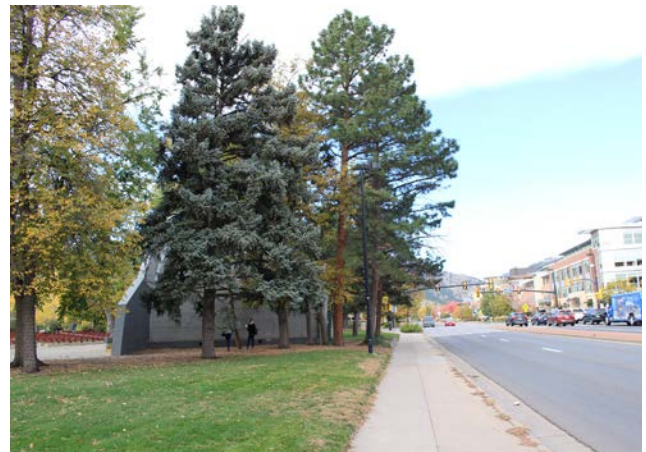
Figure 1-6. Mature grove of trees along Canyon Boulevard, 2020 (source: Mundus Bishop)

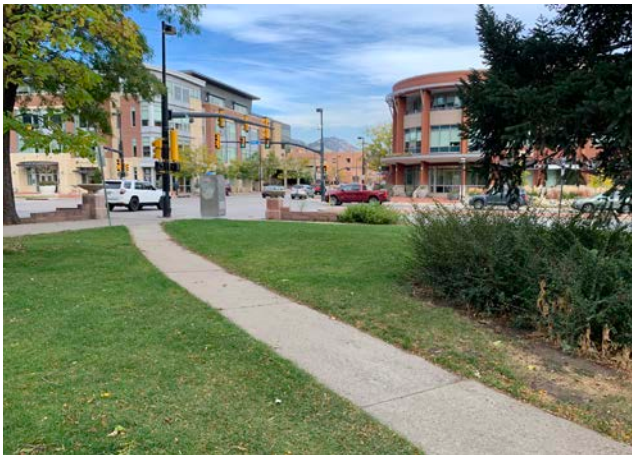
Figure 1-7. Primary circulation to the Bandshell, 2020 (source: Mundus Bishop)

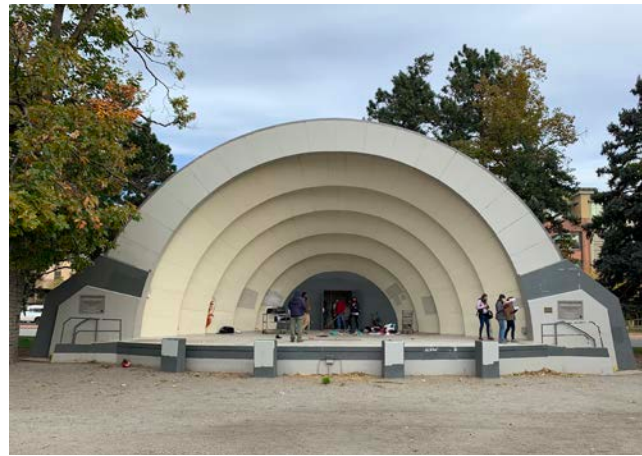
Figure 1-8. Level area in front of the Bandshell, 2020 (source: Mundus Bishop)

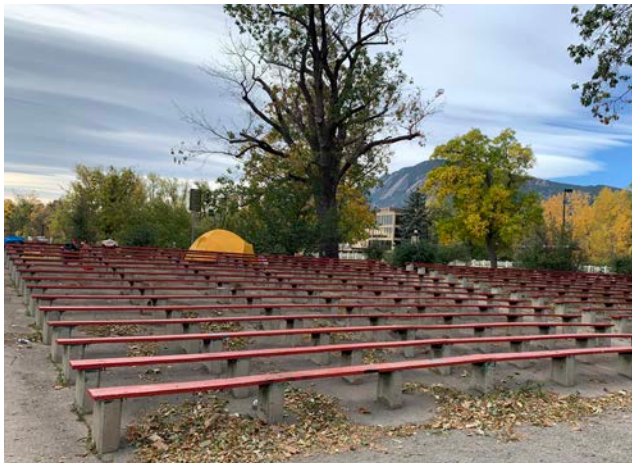
Character-defining features of the Bandshell include its original location and focal point within Central Park. Located on the northern edge of Central Park, the structure is prominent landmark along Canyon Boulevard. Its placement and its prominence within the park draw people in from surrounding thoroughfares to the amphitheater and front of the stage. Character defining features of the amphitheater include its sloped concrete terrace with fifteen rows, divided into three sections (Figure 1-11). The backside of the amphitheater is a planted berm/levee (Figure 1-12).

Figure 1-11. Seating at Bandshell, 2020
(source: Mundus Bishop)

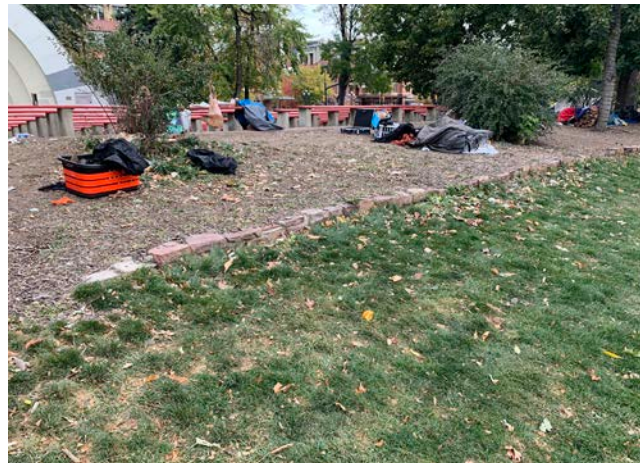
The sandstone retaining wall at the edge of the planting bed is a contributing feature (Figure 1-11).

Figure 1-12. Sandstone retaining wall, 2020
(source: Mundus Bishop)

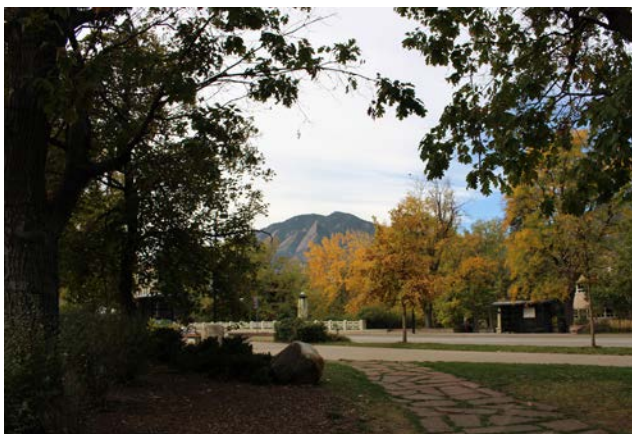
Prominent views on site include the view towards Bandshell from within the park, views towards the Boulder Flatirons from the stage and the paved gravel area, and views from adjacent streets including Broadway Street and 13th Street. These views contribute to the significance of the Bandshell. (Figure 1-13, 1-14)

Figure 1-13. View to Boulder Flatirons, 2020
(source: Mundus Bishop)

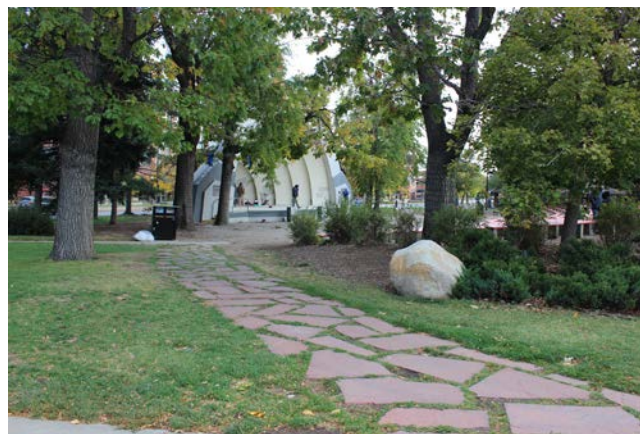
Figure 1-14. View from Broadway, 2020
(source: Mundus Bishop)

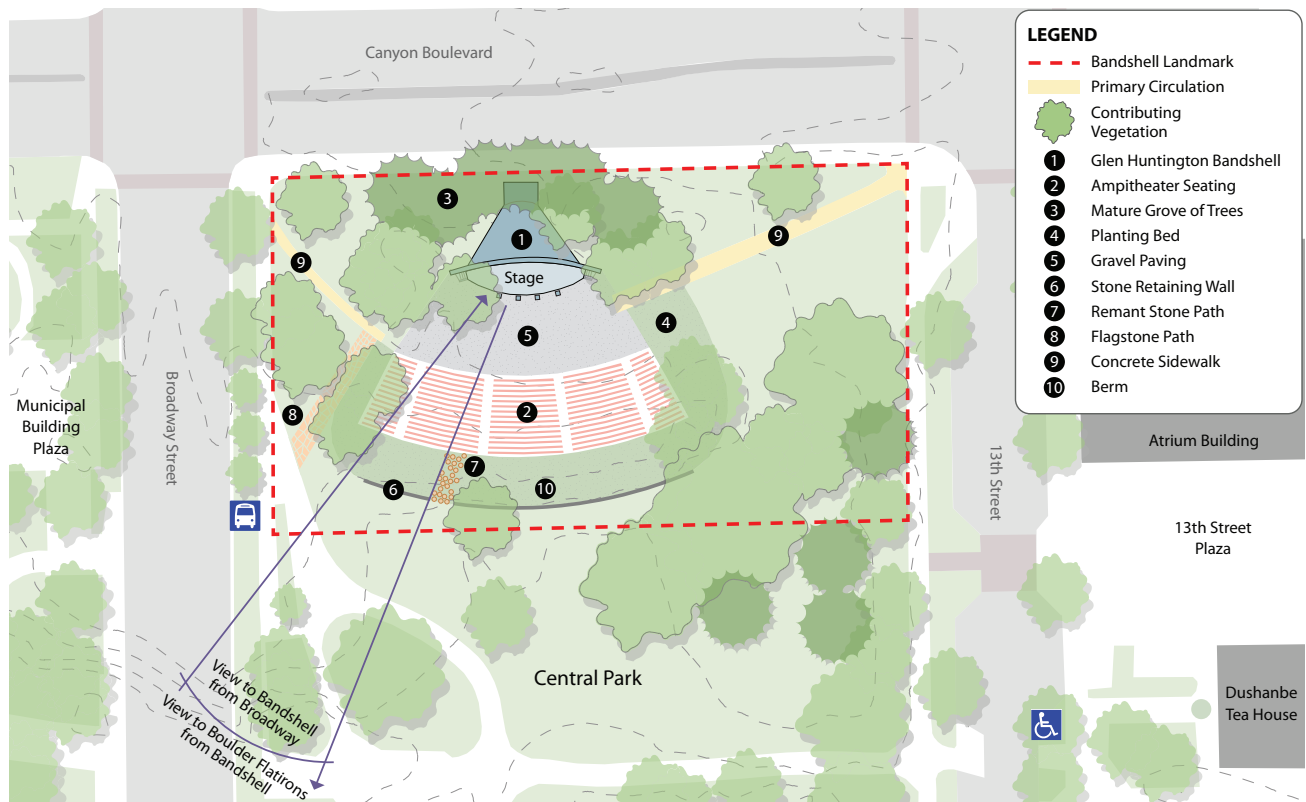
Figure 1-15. Bandshell Existing Condition, 2021 (source: Mundus Bishop)

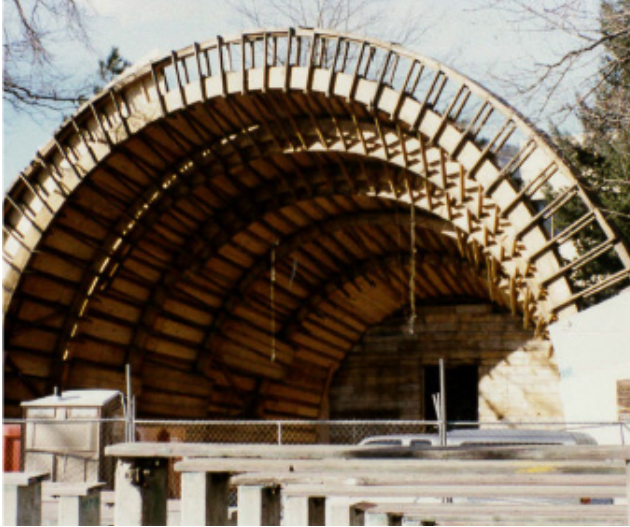
Figure 1-18. Renovation of the Bandshell framing, 1996 (source: City of Boulder)

The stage floor is sheathed in plywood and covered with a traffic coating. Although the framing was not accessible during this visit, there is documentation that the floor was reconstructed in 1996, consisting of three bays of (2) 2x12 joists spaced at 16 inches on center that span in the east-west direction. Two north-south dropped steel W8 beam lines supported on the original isolated concrete pedestals divide the framing bays. Along the flared east and west sides of the building, the joists bear on a wood plate atop the foundation wall.
