BOYD SMELTER/MILL SITE

RESOURCE ASSESSMENT REPORT

DRAFT MARCH 2021

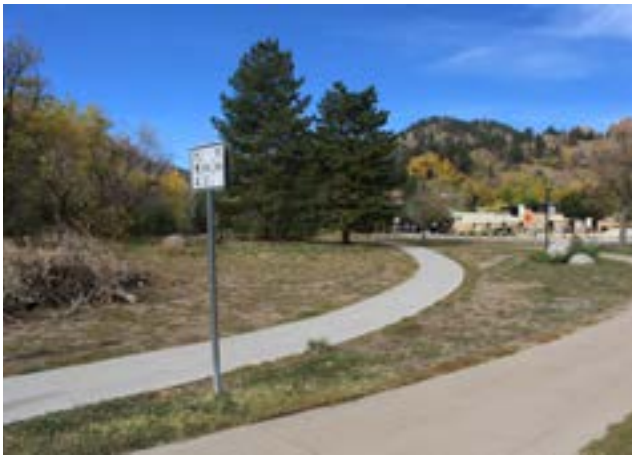
Boulder Creek Greenway is a multiple-use concrete pathway that connects Boyd Smelter/Mill Site to other City of Boulder park properties. The open field where the smelter and mill were located is adjacent to this trail.

Figure 1-3. Boulder Creek Greenway near Boyd Smelter/Mill interpretive sign, 2020 (source: Mundus Bishop)

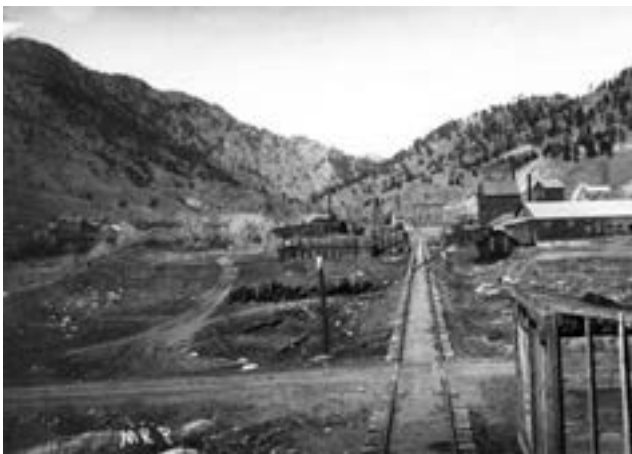
Figure 1-5. View of Boulder Canyon with Boyd Smelter's smoke stack visible in the background (left of the railroad tracks), BHS 219-1-52 (source: Carnegie Library for Local History)

The site features a prominent view to Boulder Canyon, which has become less prominent due to growth of trees on the site and along Boulder Creek (Figure 1-5 and 1-6).

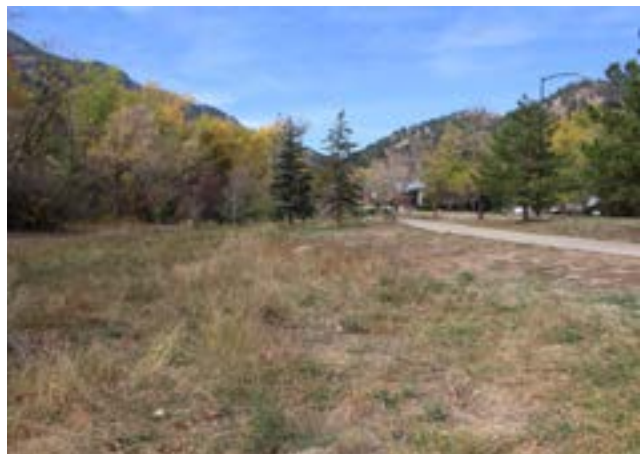
Figure 1-6. View of Boulder Canyon from the site, 2020 (source: Mundus Bishop)

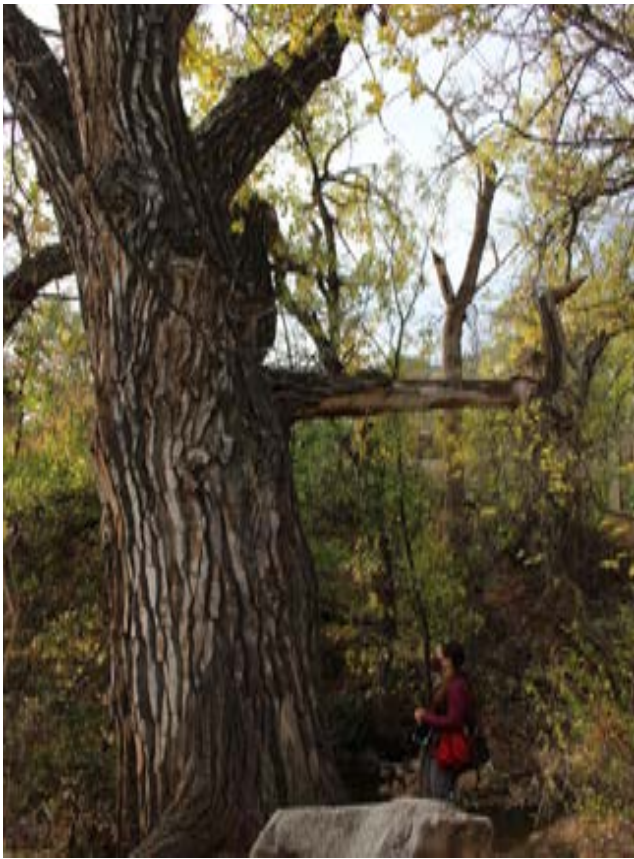
Little remains of the original vegetation, aside from one a few large riparian trees along the banks of Boulder Creek. Two of these prominent trees include Plains Cottonwood (80 in DBH) (Figure 1-10) and a large willow (60 in DBH).¹⁹ A few of the choke cherry bushes may also be historic.

*Figure 1-7. Plain's Cottonwood along Boulder Creek, 2020
(source: Mundus Bishop)*

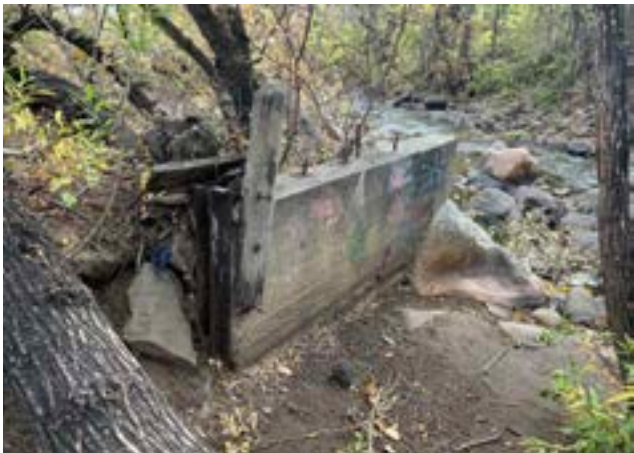
Concrete dam with headgate - Several dams and headgates diverted water from Boulder Creek into Boyd Smelter/Mill Site's holding ponds. The westernmost dam and headgate provided direct egress into Boulder Creek. Previous studies have indicated that other dams and headgates still remain in their original locations.²² The concrete dam and headgate shows evidence of recent vandalism (Figure 1-7).

*Figure 1-9. Concrete dam and headgate
(source: Mundus Bishop)*

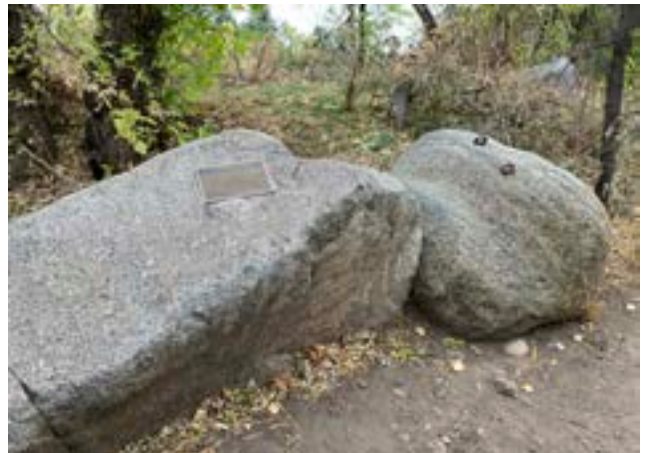
Boulder with Iron Hooks- Two boulders are adjacent to the soft surface trail in the southeast corner of the site. The larger boulder has two rusted iron rings fixed to it. The other boulder includes a plaque describing the significance of the Boyd Smelter/Mill Site. The origin of iron hooks is unknown, but is assumed to be associated with milling and smelter operations (Figure 1-8).

*Figure 1-10. Boulders with landmark plaque and rusted iron hooks
(source: Mundus Bishop)*

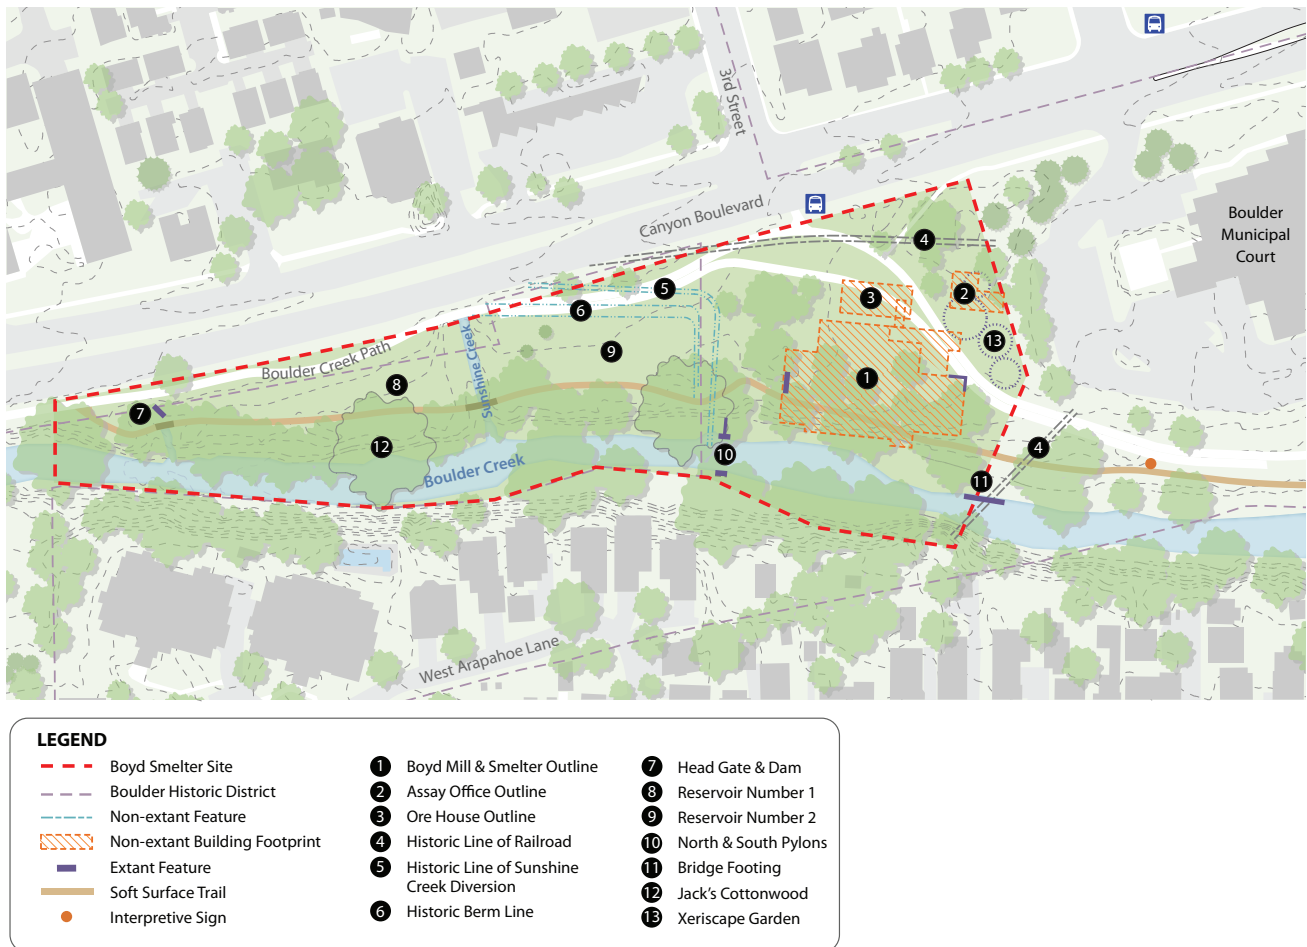
Figure 1-11. Boyd Smelter/Mill Existing Condition, 2021 (source: Mundus Bishop).

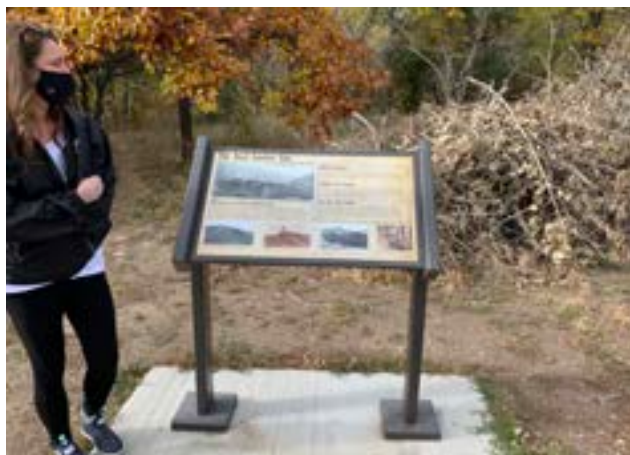
Interpretive Sign - The sign provides a brief history of the site and industrial operations along Boulder Creek (Figure 1-18).

Figure 1-18. Interpretive sign along Boulder Creek Greenway, 2020 (source: Mundus Bishop)

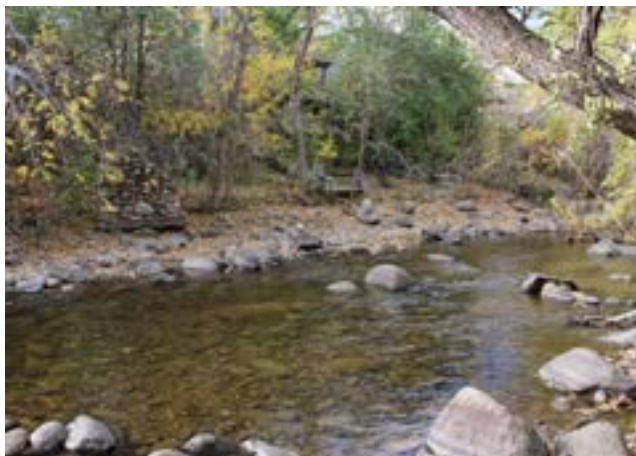
Overall, the masonry pylons are in fair condition. Although there are no signs of major failure or displacement, there are several issues that could be improved to increase the longevity of the pylons. Most of the following were identified at the north pylon due to access, but likely occur at the other pylons as well. Several of the masonry units, primarily the reused concrete, have cracked. Some stones are missing. In some areas, mortar is missing between the stones. Additionally, the mortar is quite hard or cementitious for direct contact with the softer stones (i.e. the sandstone). The parge coat cap atop the masonry pylon is cracked and does not cover all elements. Biogrowth on the masonry is abundant in shady areas of the pylons. The pylons directly adjacent to the banks of Boulder Creek are slightly undercut due to scour from the moving creek water.

Figure 1-19. South water pylon on private property (source: Mundus Bishop)

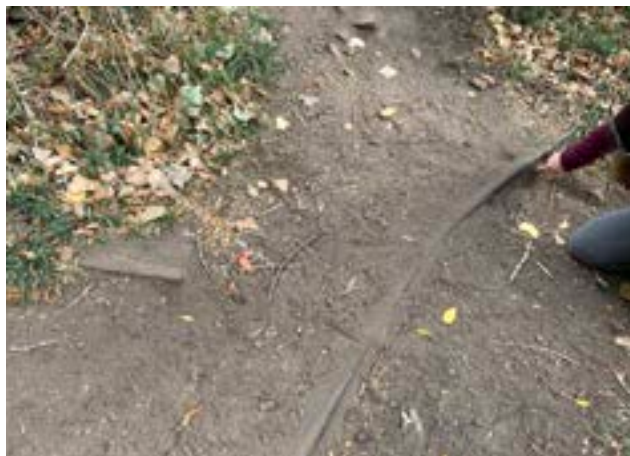
The girders are in fair condition. Although they are structurally stable, the north end of the girders are currently buried in the earth. If there is no substantial foundation element below these ends, the soil could settle and cause the north end of the girders to settle as well. Also, there are areas of the girders where rust has started to form due to exposure to the elements. Lastly, there are trees and other plant growing in close proximity to the steel girders that could cause the steel girders to displace down the road if the plants grow larger.

Figure 1-20. Steel line above ground, adjacent to the creek (source: Mundus Bishop)

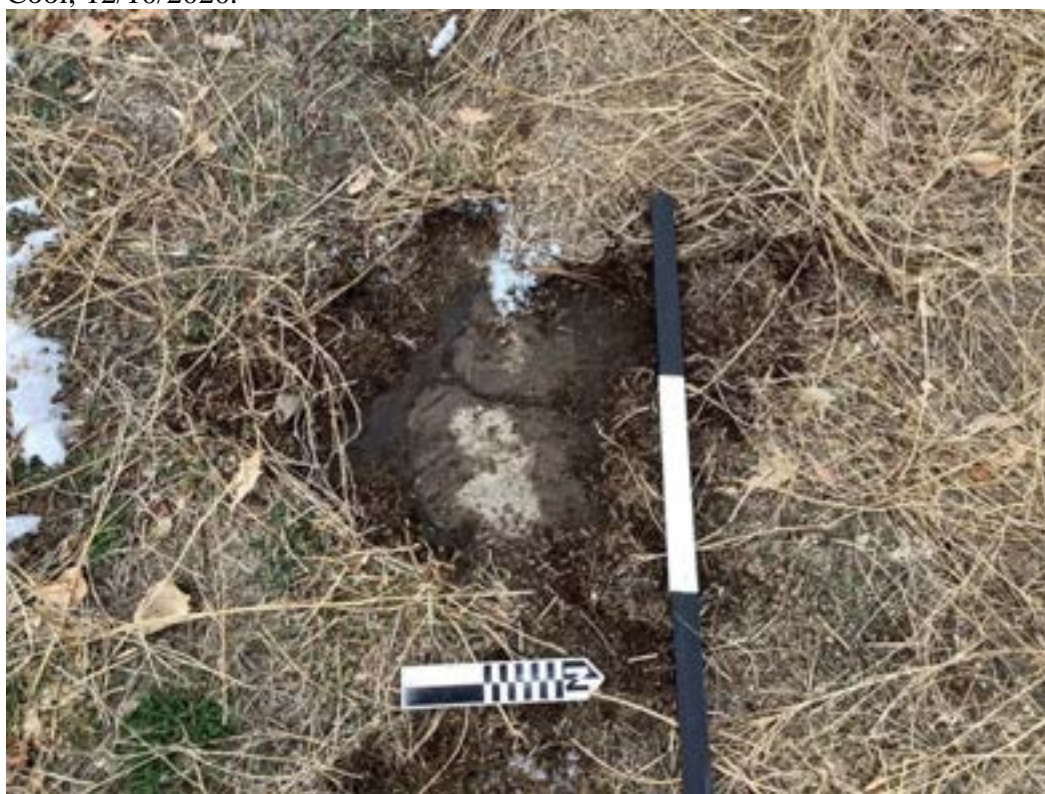
Figure 32. 5BL7094, Feature 6 exposed concrete, in plan view. A. Cool, 12/10/2020.

Wall	F6	16 in east-west × 11 in north-south	Small area of exposed concrete in vicinity of former east retaining pond, possibly part of dam
Depression	F7	50 ft east-west × 60 ft north-south × 2 ft deep	Irregular depression located within former east retaining pond
Berm	F8	234 ft long × 6 ft wide × 3 ft tall	Broken, irregular earthen berm forming south boundary of former west retaining pond
Headgate	F9	30 ft long × 13 in thick × 4 ft 6 in tall	Concrete headwall and former headgate

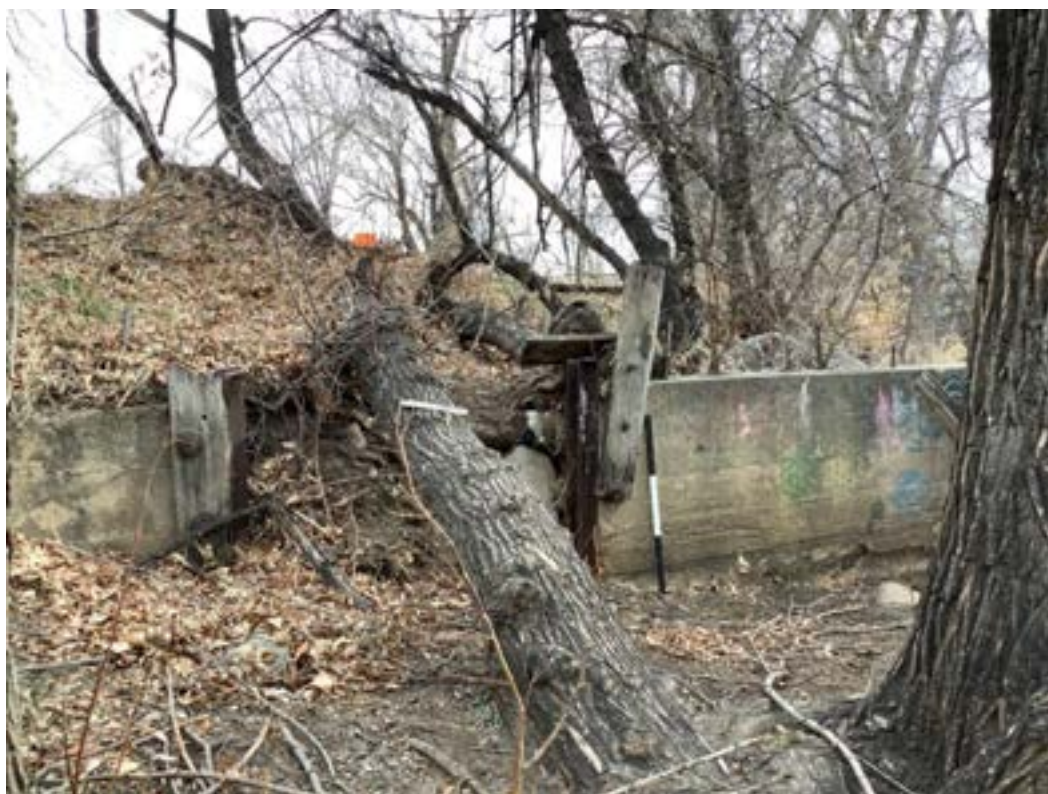
Figure 40. 5BL7094, Feature 9, facing northeast. A. Cool, 12/10/2020.

Between the two sections of concrete headwall is the headgate opening. Iron brackets fastened to the headwalls on either side of this opening would have stabilized a wooden headgate or slide gate that could be lowered or raised as needed to adjust the flow of water through the gate. The brackets are spaced 3.25 inches apart. Two degraded fragments of 7 × 1.5-inch lumber are fixed to the concrete headwalls on either side of the gate with large bolts. Three of the bolts have large washers embossed with "MALLEABLE PAT. MAY 10 & DEV 13.04 1 IN-30."
