CHAUTAUQUA GREEN

RESOURCE ASSESSMENT REPORT

DRAFT MARCH 2021

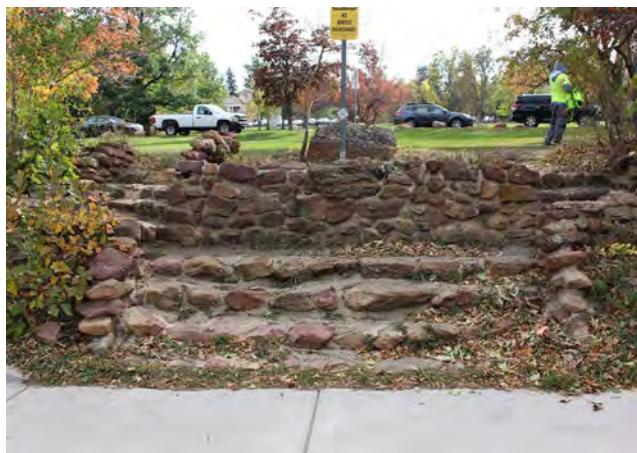
Figure 1-7. Lincoln Street Steps (Queen's Gate), 2020 (source: Mundus Bishop)

Lincoln Street Steps (Queen's Gate) – The structure consists of a series of shallow stone steps and was originally intended to be an additional pedestrian entrance along Baseline Road.²¹ A contemporary metal sign with the message "Caution: No Winter Maintenance" was placed in the center of the steps, diminishes the historic appearance. Queen's Gate retains integrity (Figure 1-7).

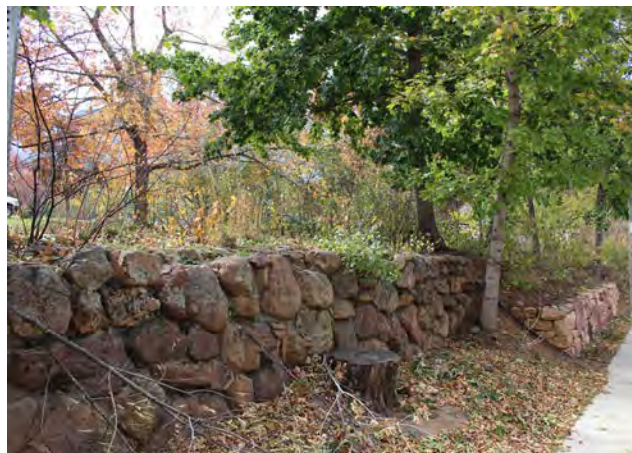
Figure 1-8. Historic retaining wall along Baseline Road, 2020 (source: Mundus Bishop)

Retaining Walls – The northern edge of the park is lined with several segmented retaining walls parallel to Baseline Road. The walls originally terminated at the Queen's Gate, but five additional sections of wall were built in 2017, extending to the vehicular entrance at Grant Street. At the King's Gates' stone towers, the retaining wall pivot south to form two parallel walls on both sides of the eastern sidewalk (Figure 1-33). The materials of the newer walls are compatible with the rustic character of the site (Figure 1-9).

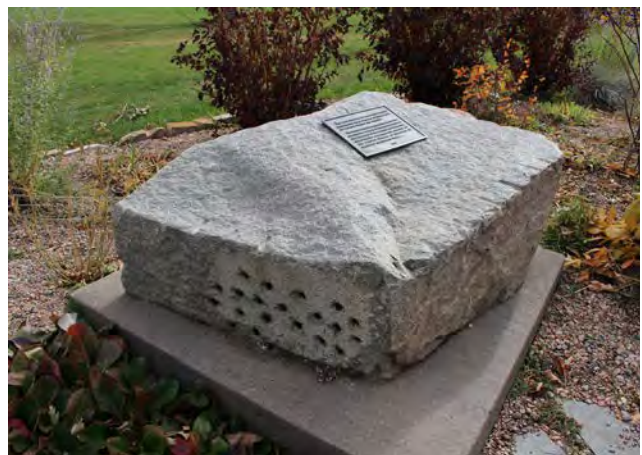
Figure 1-10. Miner's Memorial, 2020 (source: Mundus Bishop)

Rock Miners Memorial – Installed in 1954 near the entrance at Grant Street, this feature is a large boulder with a brass plaque commemorating the single-jack competitions that took place at the Colorado Chautauqua’ NHLs annual Fourth of July Celebration. The Miners Memorial is a non-contributing feature (Figure 1-10).²²

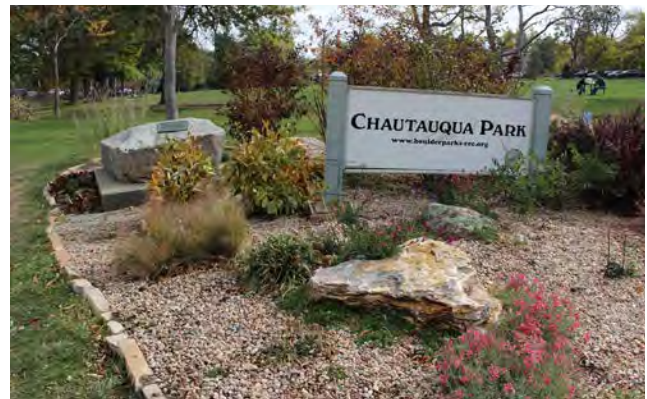
Figure 1-12. Garden around Miner's Memorial and Entrance Sign, 2020 (source: Mundus Bishop)

Rose Gardens – Two rose gardens were planted within the Chautauqua Park complex – one was planted in the northwest corner around the Miners Memorial in 1981 (Figure 1-12) while the other was planted at the northeast entrance of King's Gate in recent years. The rose garden at the King's Gate is a reconstruction built in recent years. Both gardens are non-contributing features, but the rose garden at the King's Gate could be considered compatible with the historic design (Figure 1-11 and 1-13).

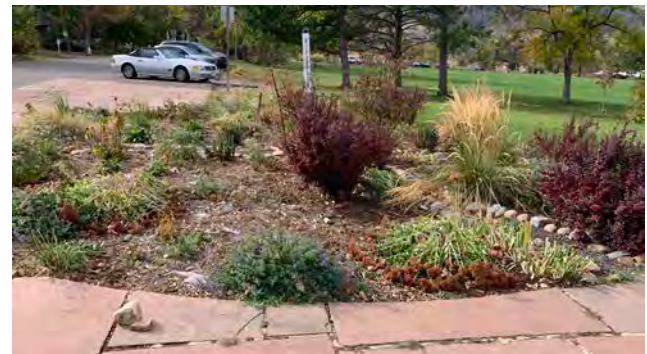
Figure 1-14. Peace Garden near Dining Hall, 2020 (source: Mundus Bishop)

Peace Garden – The Peace Garden was planted in 2002 in the southeast corner of the Green, in front of the Dining Hall. Planting beds are divided up with small rocks in the form of a peace symbol. The Peace Garden is non-contributing (Figure 1-14).

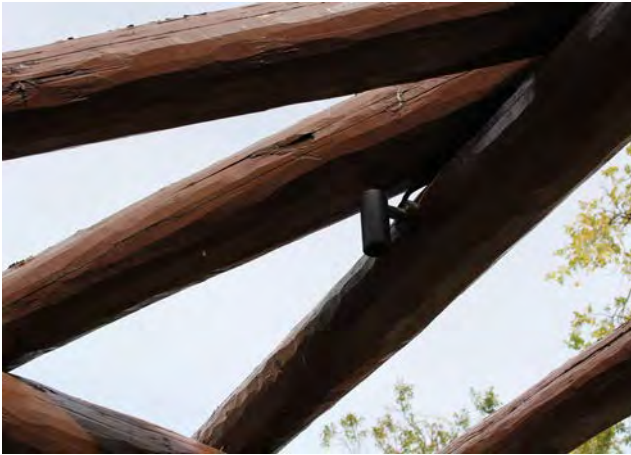
Figure 1-21. Interior lights hidden in timbers, 2020 (source: JVA)

During a recent renovation, interior lights were added to The Arbor. The lights are obscured by the timbers and do not detract from the historic appearance of the structure (Figure 1-21).

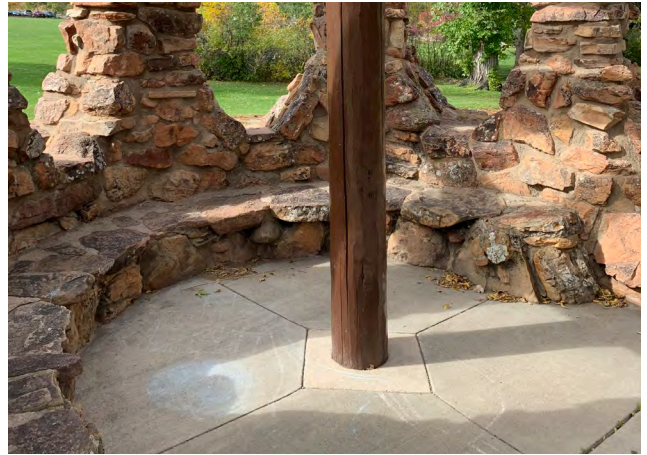
Figure 1-22. Curved bench, 2020 (source: JVA)

The joined pier bases create the backs to built-in rubble masonry benches which extend along the lengths of the curved ends. The benches are in good condition.

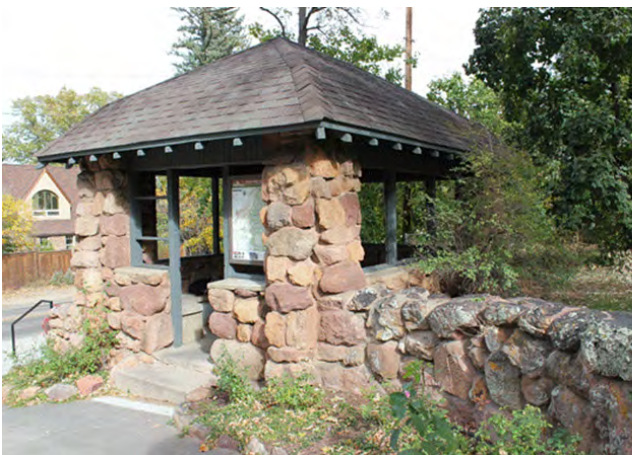
Figure 1-23. West wall showing attached retaining wall, 2020 (source: JVA)

The structure has rubble masonry walls which are approximately 20 inches thick. The walls consist of an L-shaped column in each of the four corners which are connected by a stone knee wall with a concrete coping forming large window openings between the corner columns. Historic photographs show the coping is original, but sections have been replaced over time. The base of the columns at the corners flare out to form buttresses. Wood framing in the openings creates the illusion of windows and supports the portion of the wall above the openings which is framed with wood. There is likely a concealed wood member or header spanning between the stone columns and intermediate window mullions that supports the roof framing. (Re: Figure 1-23 and Figure 1-24)

The Shelter House is integral with the site retaining wall, which connects with the structure at the northeast and southwest buttresses (Re: Figure 23). The site has a sloped grade that sharply decreases towards the north. The shelter walls are also retaining soil in some locations (the slab elevation is below grade at the south wall and above at the north). The knee walls also serve as the back to the concrete benches inside the shelter and along the street-facing, north façade, where the bench has a rubble stone base with a concrete coping. Generally the benches are in good condition, there is evidence that spalls have been repaired in the past.
