BOULDER FIRE STATION NO. 2

RESOURCE ASSESSMENT REPORT

DRAFT MARCH 2021

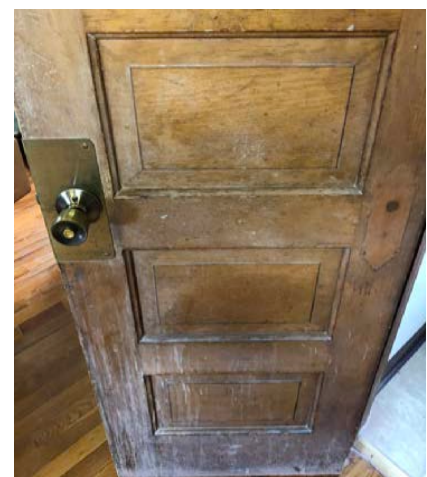
Figure 1-15. View of upper level restroom door, 2020 (source: Ratio)

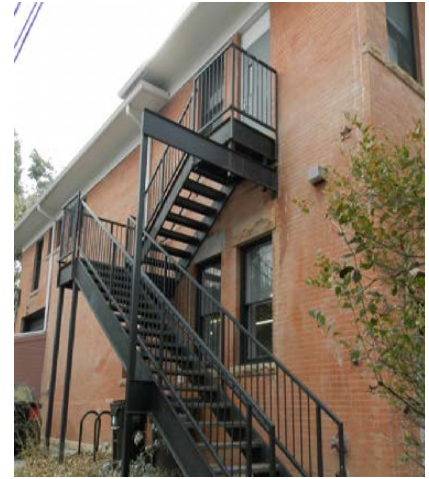
Figure 1-18. View of exterior staircase, 2020 (source: Ratio)

Primary Structural Features	Description of Primary Materials	Condition
Foundation	Continuous concrete or masonry strip footings	Good
Roofing	Hip roof 7:12 pitch and a gable dormer on north side	Good
Walls	Load bearing multi-wythe red clay brick	Good
Framing	Unknown, possible wood trusses	Good
Flooring	Concrete slab on grade	Good
Lateral Force Resisting System	Perimeter brick shear wall with steel moment frame	Good
Other	Non-original outdoor steel framed stair fire escape	Poor

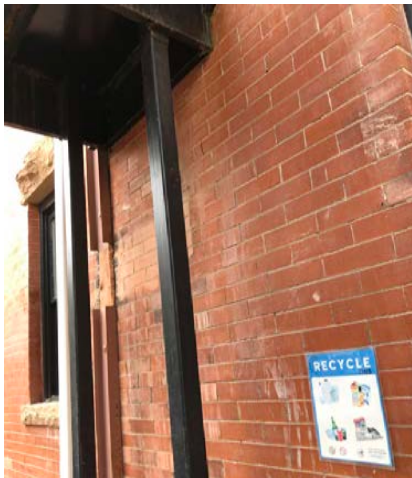
Figure 1-19. Evidence of previous exterior stair landing, 2020 (source: Ratio)

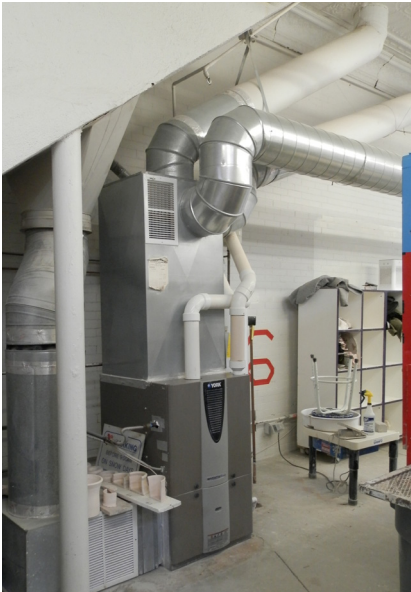
The building interior is fully powered and has a mechanical system for heating and cooling that is not original to the building. On both levels there are restroom facilities, with an accessible restroom on the lower level. In addition, there are a variety of mop sinks/paint sinks throughout the space for the current ceramic studio use.

Figure 1-22. View of mechanical unit, 2020 (source: Ratio)

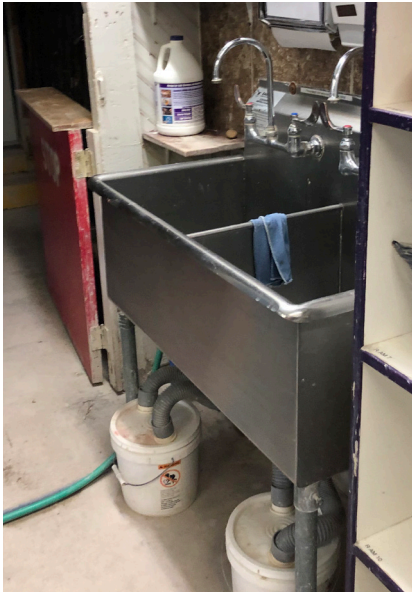
Figure 1-23. View of first-floor mop sink, 2020 (source: Ratio)

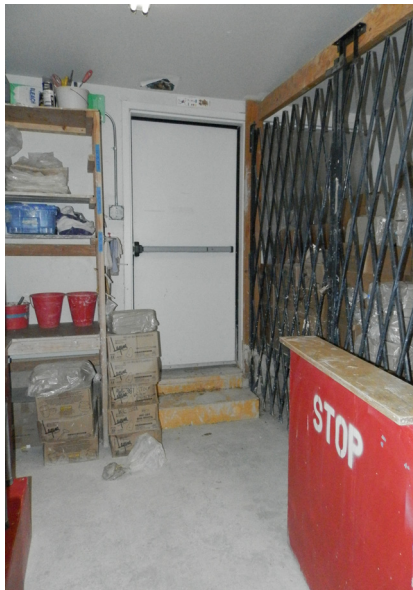
Loading/Storage Area: The lower level addition has two exterior doors, one to the exterior grade level, and one raised up that is for pallet loading. The pallet storage area is raised up above floor level and is enclosed in a locked gate.

Figure 1-25. View of storage addition, 2020 (source: Ratio)
