# PLATT FARMHOUSE

## RESOURCE ASSESSMENT REPORT

DRAFT MARCH 2021

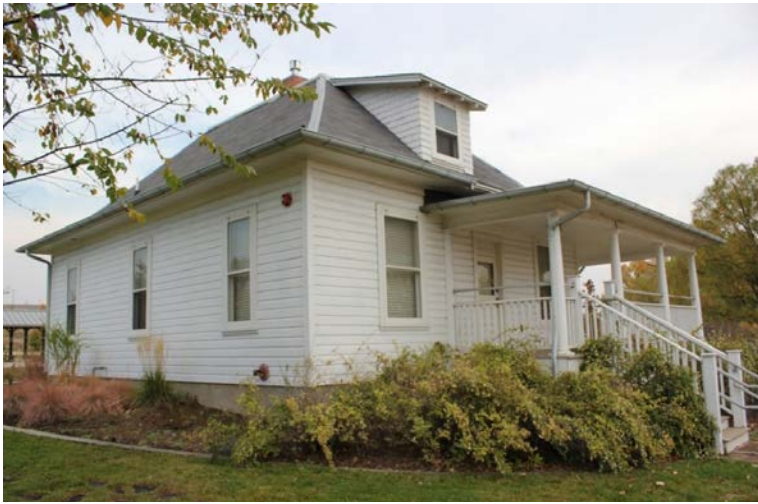
Figure 1-23. Front and west elevation of Platt Farmhouse, 2020 (source: JVA)

The house has a wrap-around front porch supported by wood columns. The rear entrance has an accessible concrete ramp. The porch and ramp are in good condition. The paint on the porches wood framing elements is failing. If not properly maintained, moisture can penetrate the paint layer and cause the wood material to deteriorate.

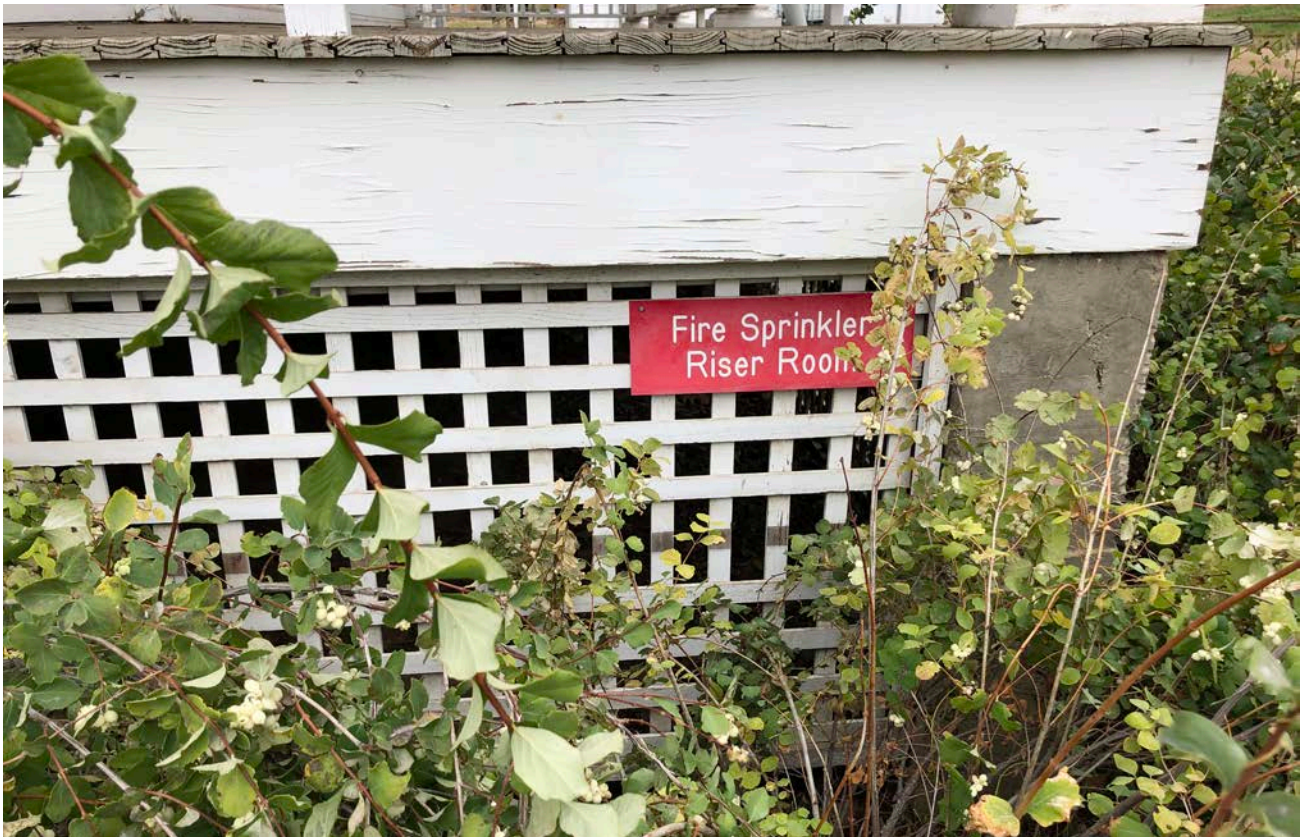
Figure 1-31. View of crawl space access, 2020 (source: Ratio)

**Mechanical:** The swamp cooler and furnace for the building appear to be in working condition. They are in the crawl space below the building, that is accessed behind the slatted wood screens below the porch.

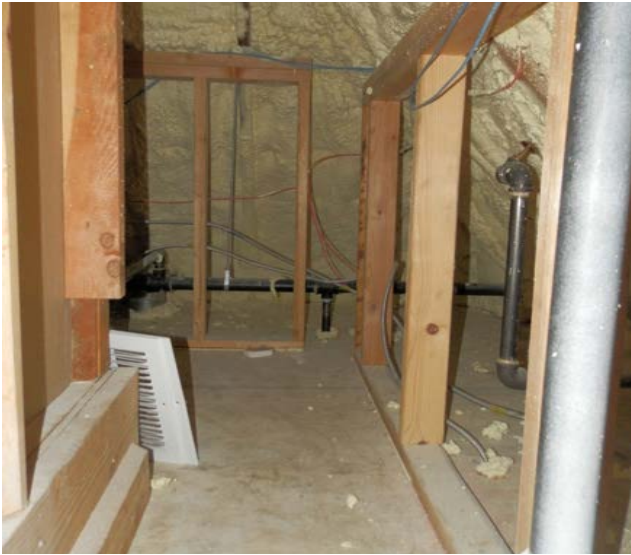
Figure 1-32. View of attic space, 2020 (source: Ratio)

**Attic:** On the upper level there are two wall panels that appear to be the access for the attic space below the eaves of the roof. In both access panels there is a hole cut into them. It is unclear the intent of the holes or if there is an infill panel or grille missing from these locations.

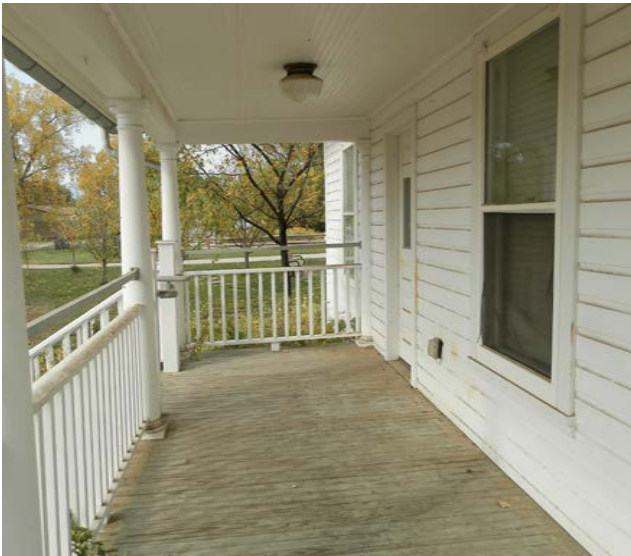
Figure 1-33. View of south porch, 2020 (source: Ratio)

**Porch Flooring:** The wood floor of the porch and the entry stairs are in poor to fair condition. The tongue and groove boards are intact and functional, but are unfinished and showing considerable wear, weathering, and warping.

**Porch Framing:** The porch floor framing appears to be in good condition. The porch roof framing and soffit finish are in fair to poor condition. There is considerable wear, weathering, and cracking and peeling paint on both the support beams and the wood soffit material.

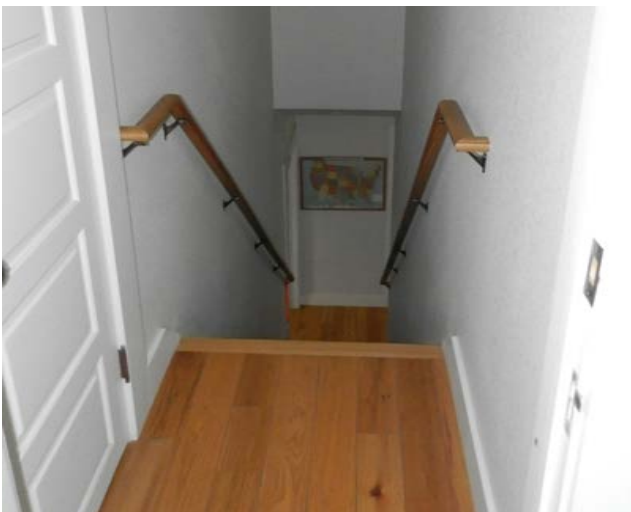
Figure 1-34. View of interior stairway, 2020 (source: Ratio)

Wood Flooring: Both levels of the interior have wood plank flooring, that appears to be in good condition. The interior stairs also have a wood finish. The stairs appear to be in good condition. The boards that make the nosings of the stairs do not appear to match the wood type of the rest of the stairs. There are also a few locations where the nosing boards are loose.

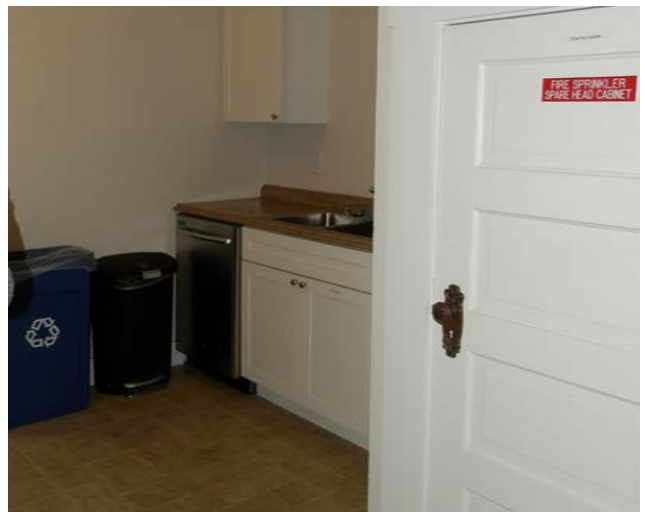
Figure 1-37. View of kitchen, 2020 (source: Ratio)

**Tile Floors:** Both the kitchen and the rest room have tile floor finishes, and the rest room has a tile wainscot on the wall. The tile work all appears to be in good condition.
