NATIONAL
TRUST
FOR
HISTORIC
PRESERVATION®

Repair or Replace Old Windows

A Visual Look at the Impacts

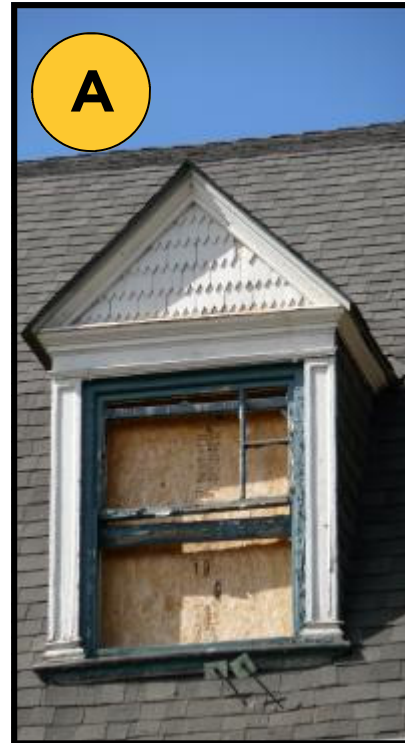
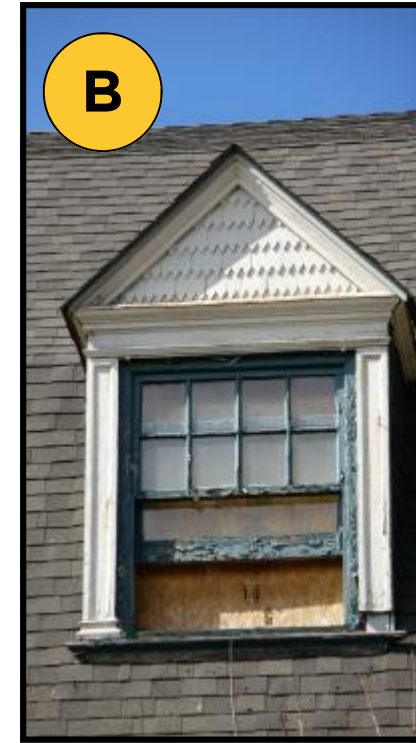
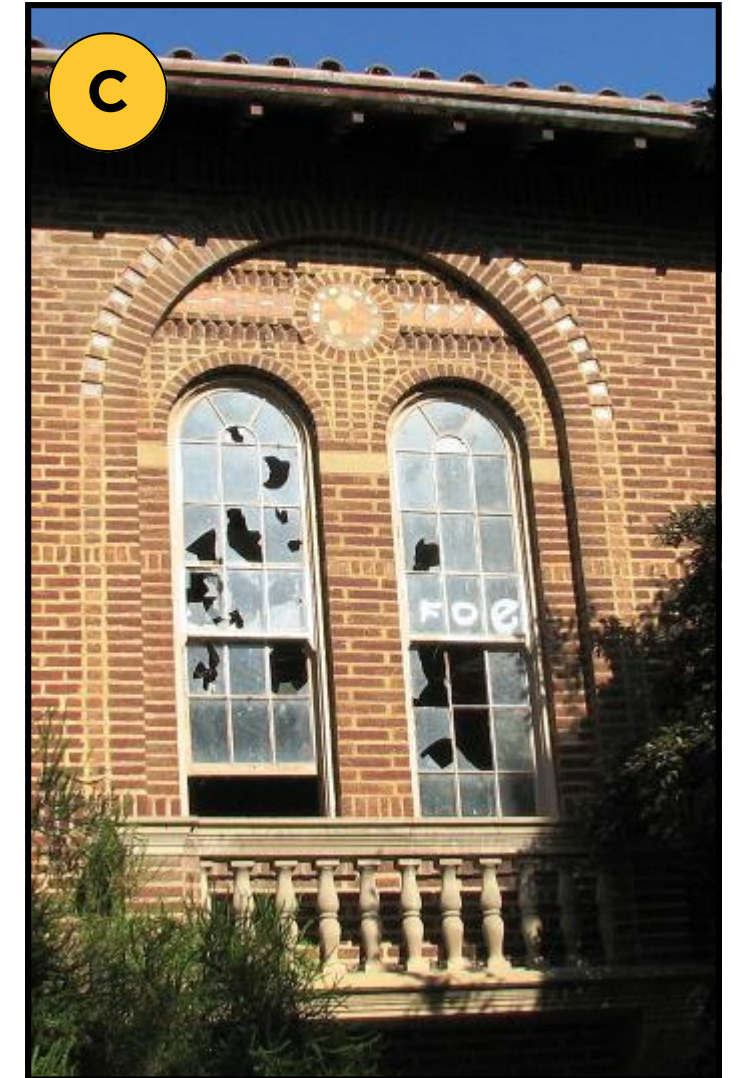
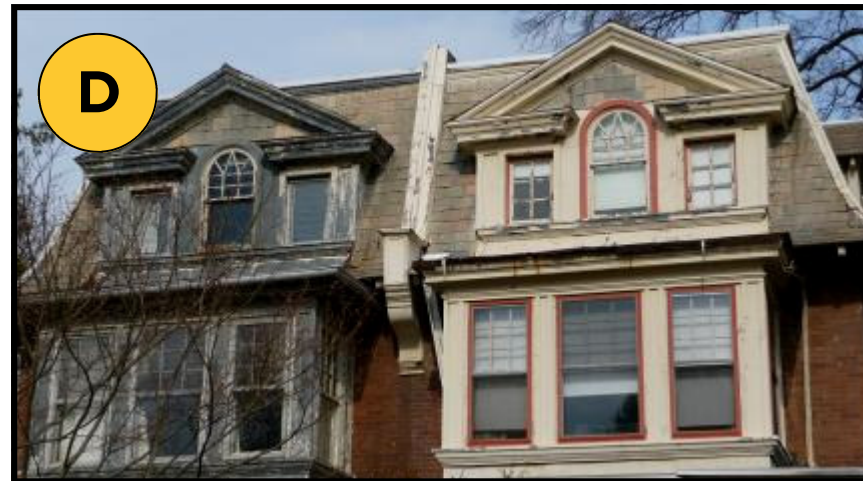
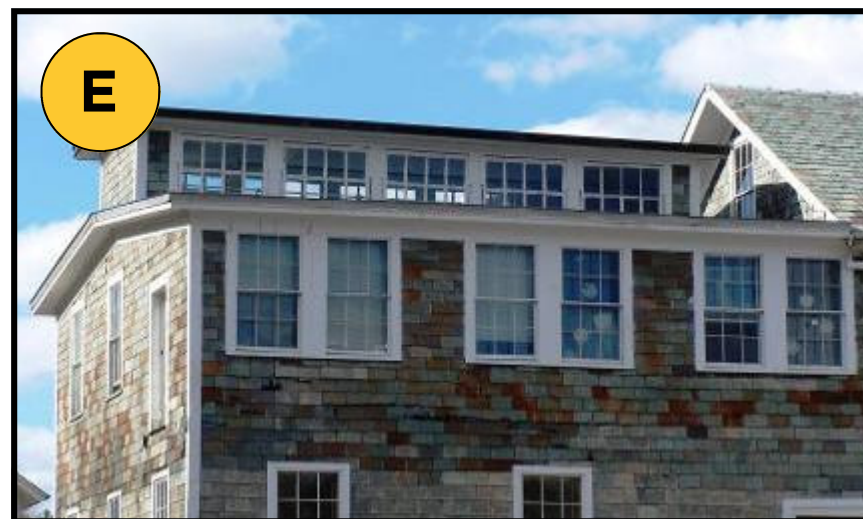
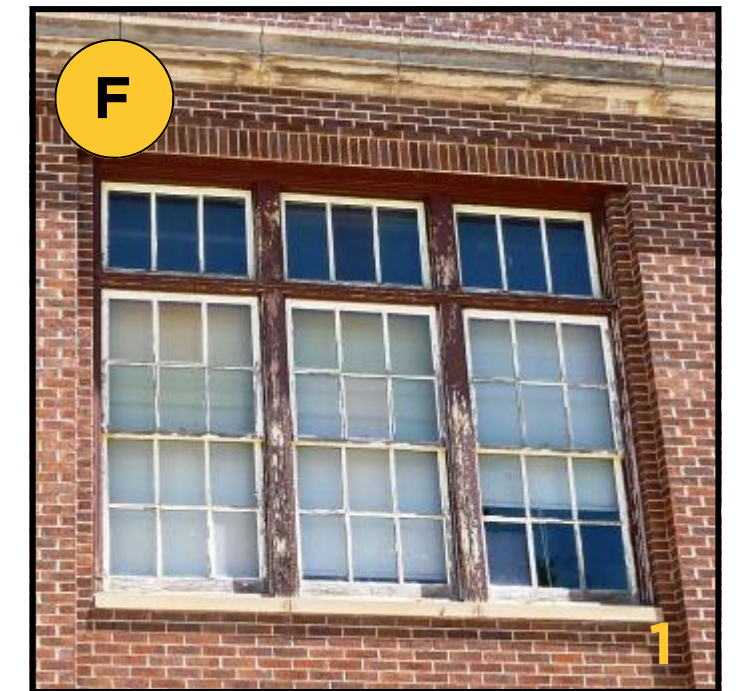
- A, B Two eight-over-eight double-hung sash dormer windows. Both are in disrepair; window A will need to be rebuilt or replaced to match window B.
- C Broken glass on these architecturally distinctive windows can be easily replaced and windows repaired.
- D A coat of paint and routine and preventive maintenance can restore windows to their original appearance.
- E Unique roof monitor with well-maintained and character defining six-over-six double-hung sash windows.
- F Group of six-over-six double-hung sash windows with transoms, only needing paint.

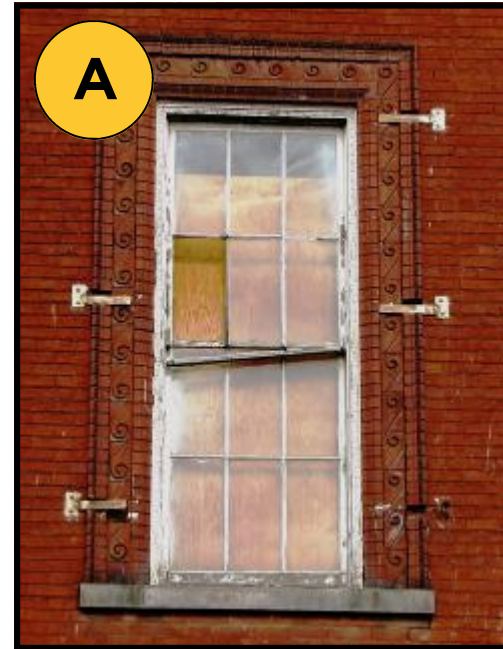
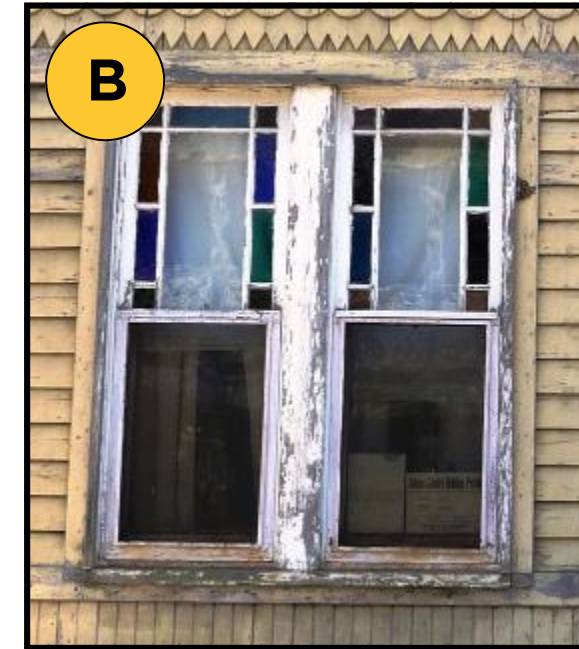
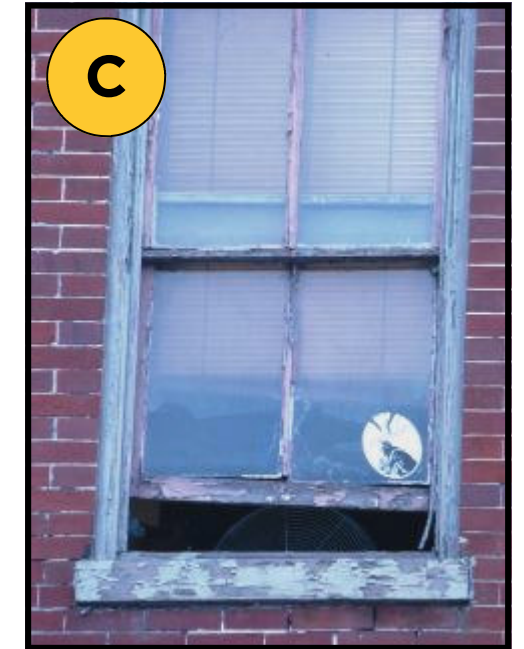
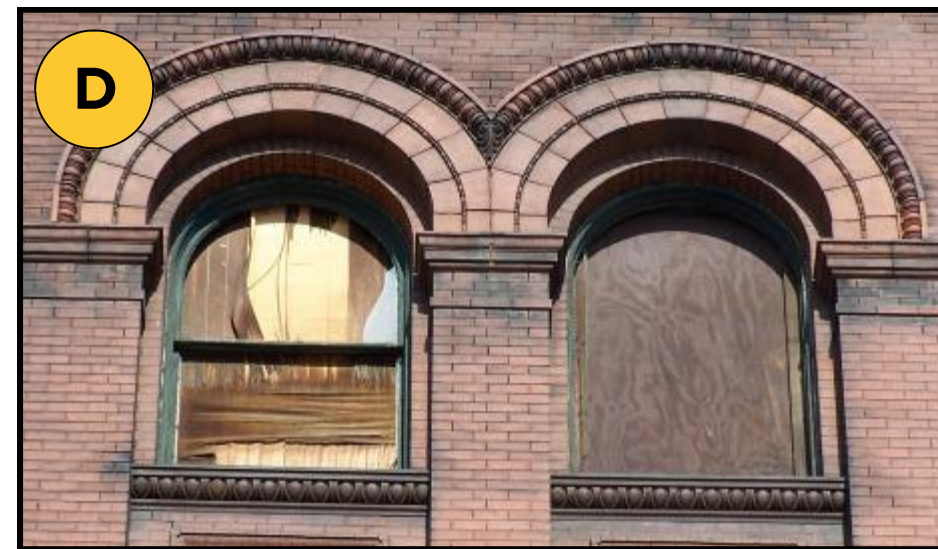
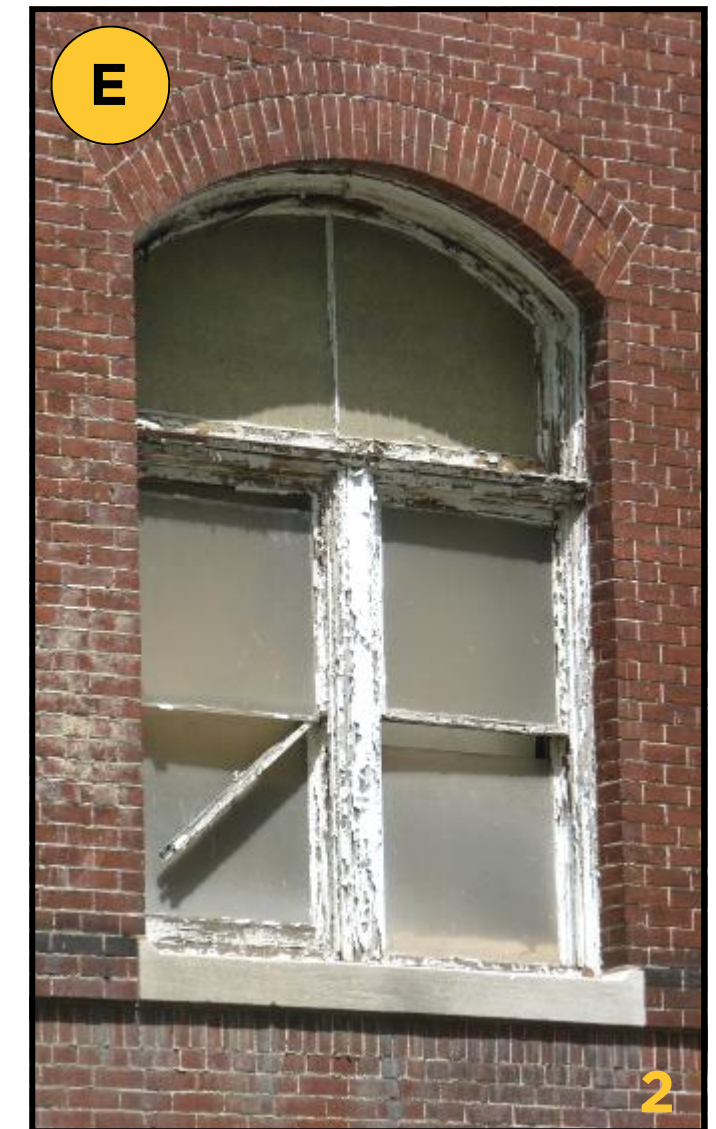
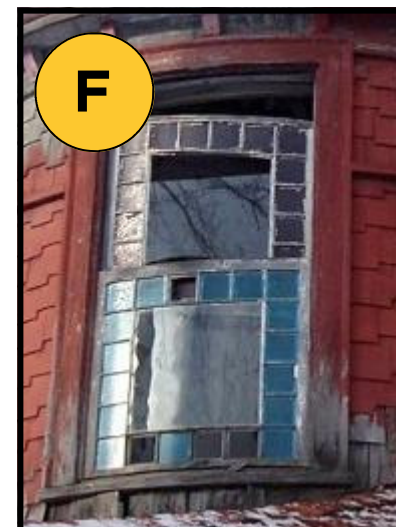
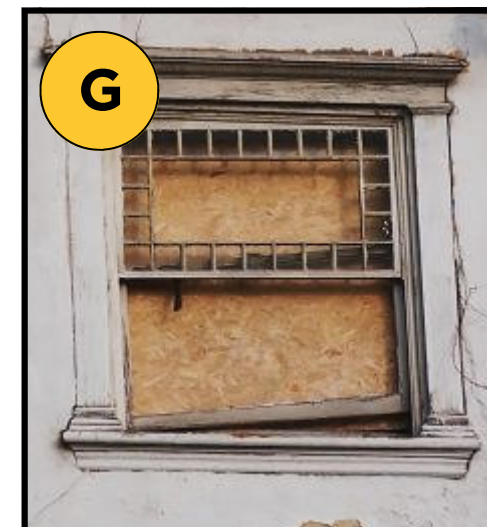
- A Six-over-six double-hung sash with loose meeting rail, missing glass — can be repaired.
- B Queen Anne windows needing paint, re-glazing — can be repaired.
- C Two-over-two double-hung sash with loose bottom rail, needing paint, re-glazing — can be repaired.
- D Arched double-hung sash windows missing glass and frames — replacement likely.
- E One-over-one double-hung sash windows and fixed transoms with detached meeting rail, needing paint and re-glazing — can be repaired.
- F Queen Anne window in poor condition, detached from frame and missing glass — borderline, requiring extensive repairs.
- G Queen Anne window missing glass and subject to structural settling of the building — borderline, requiring extensive repairs.

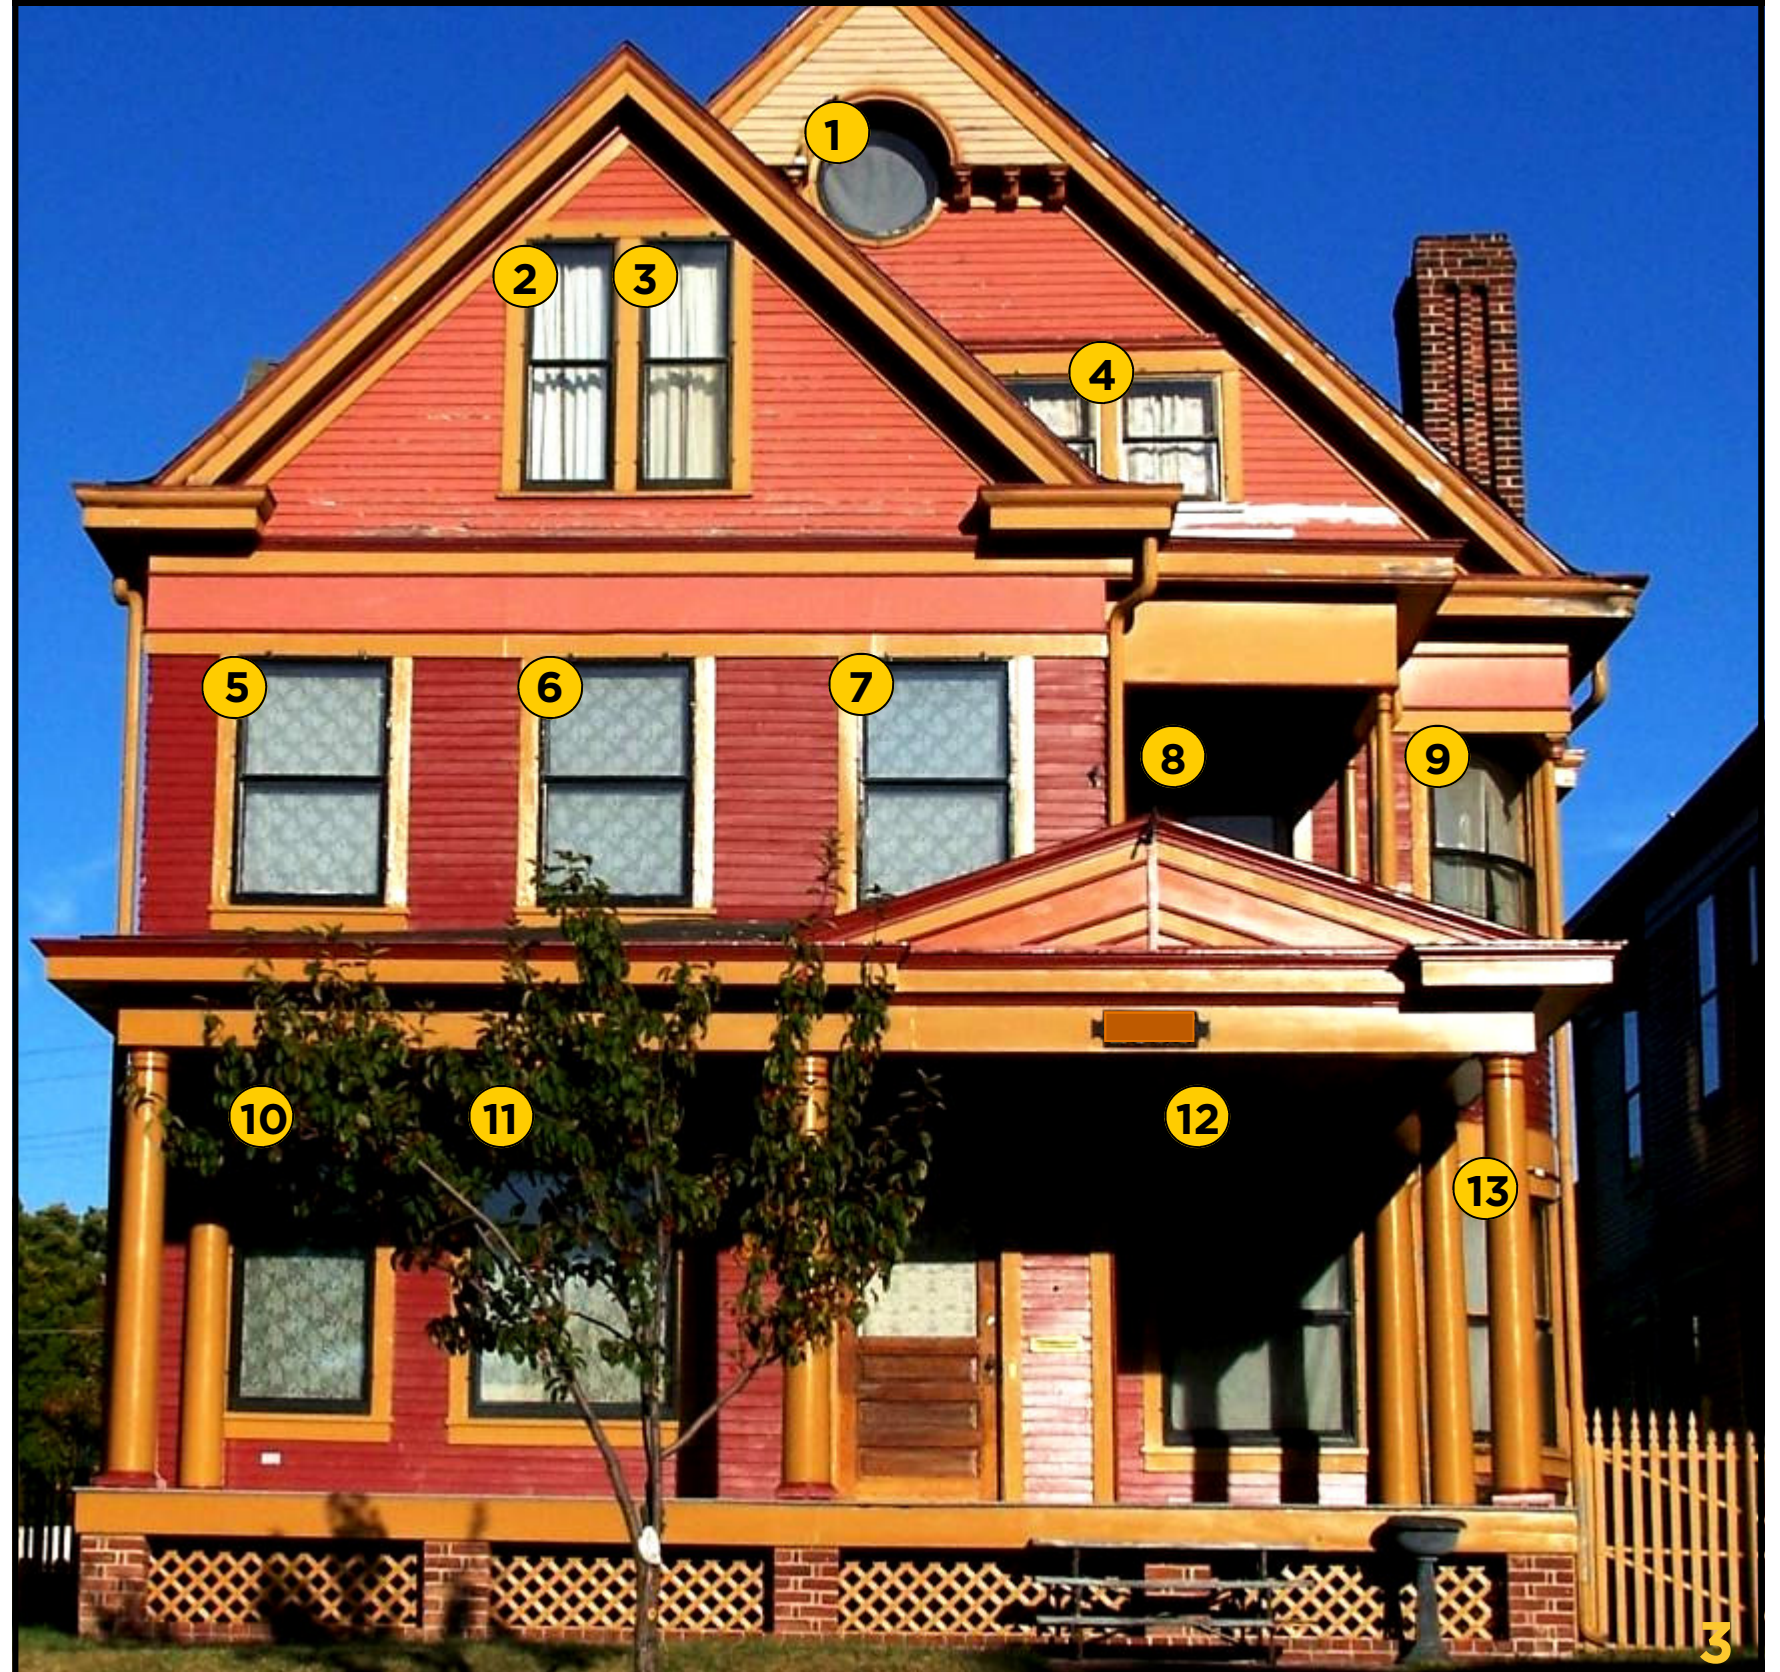
1890s Queen Anne style house
Original one-over-one double-hung sash windows with storm windows

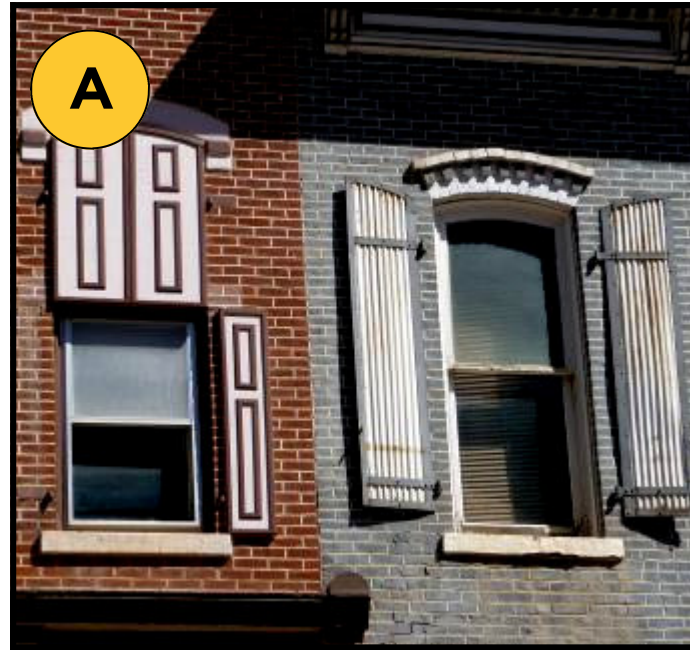
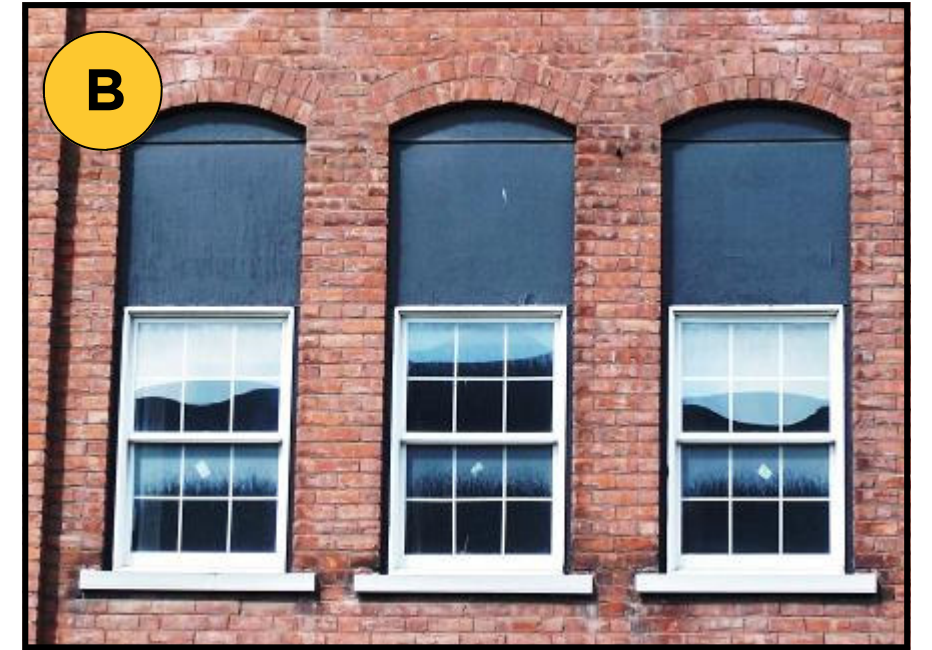
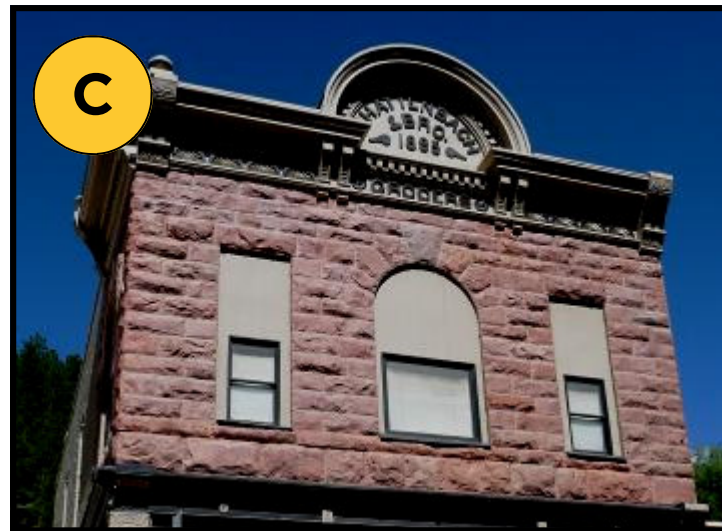
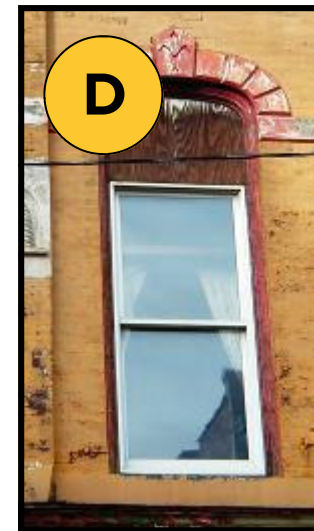
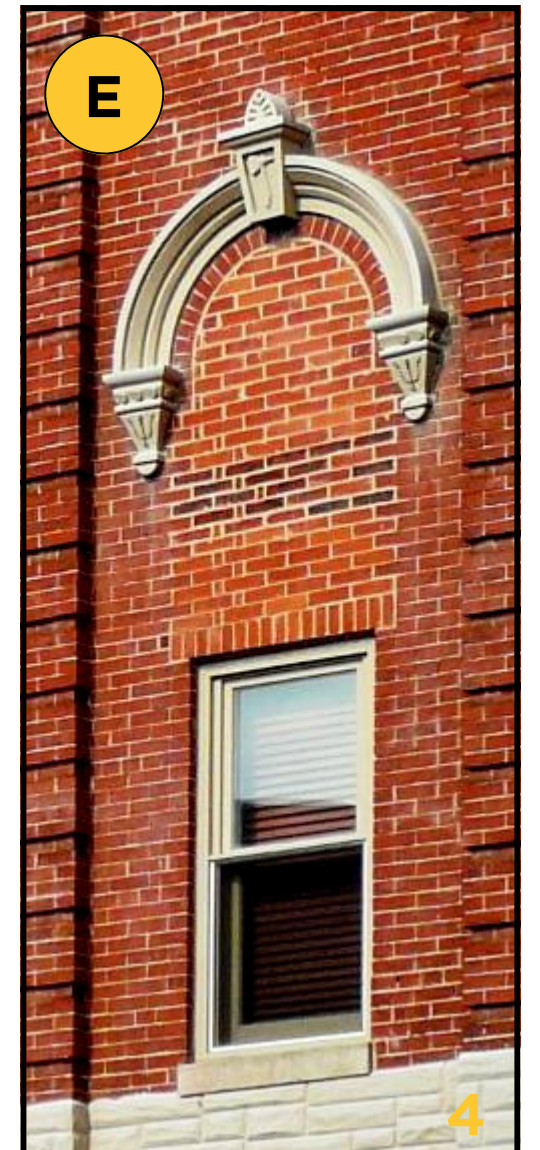
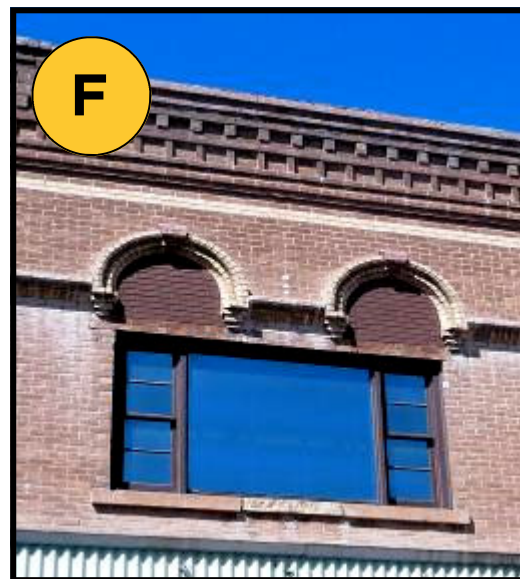
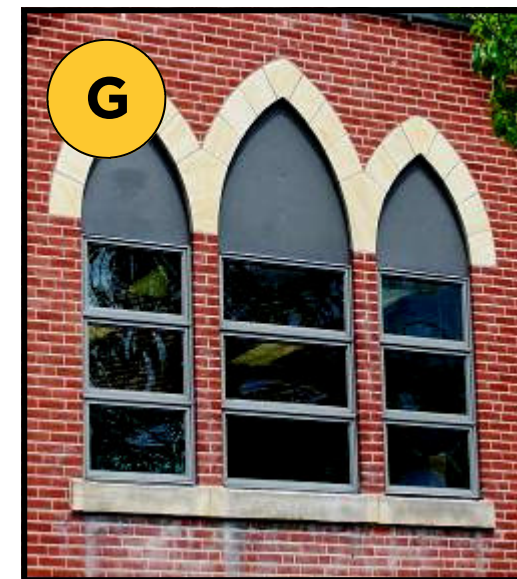
- A Italianate style row houses, side by side. Building to the right retains original arched one-over-one double-hung sash windows. Building to the left has smaller replacement windows and in-fill panels installed in the original opening.

- B Industrial building converted for housing with reduced windows and in-fill openings.
- C Main Street commercial building with upper floor windows removed, openings reduced down and much smaller replacement windows that do not match.

- D A stock, smaller window unit was used to replace a larger double-hung sash window.
- E Brick was used to in-fill the original opening of the round-arched window.

- F Two round arched windows were removed and replaced by one larger picture window, completely different in design and period to the historic Main Street building.

- G Three vertically-oriented Gothic style windows were reduced and replaced by horizontally-oriented hopper type windows.

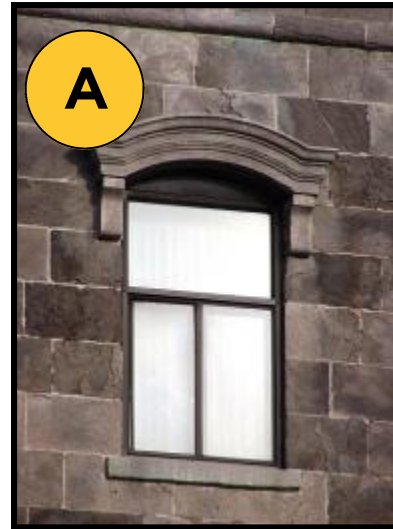
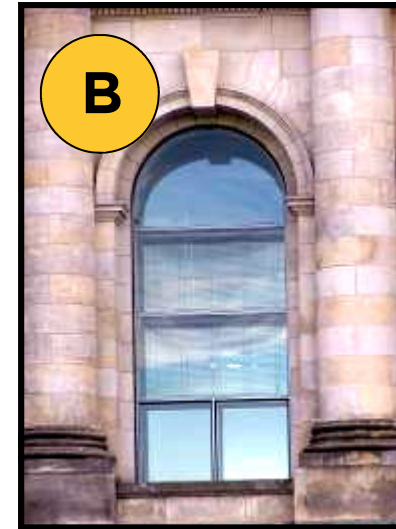
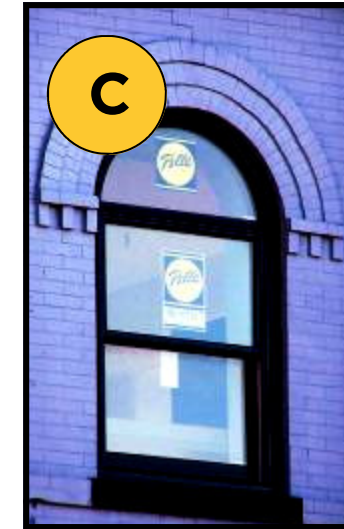
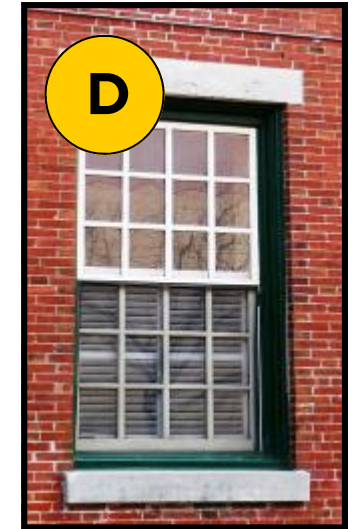
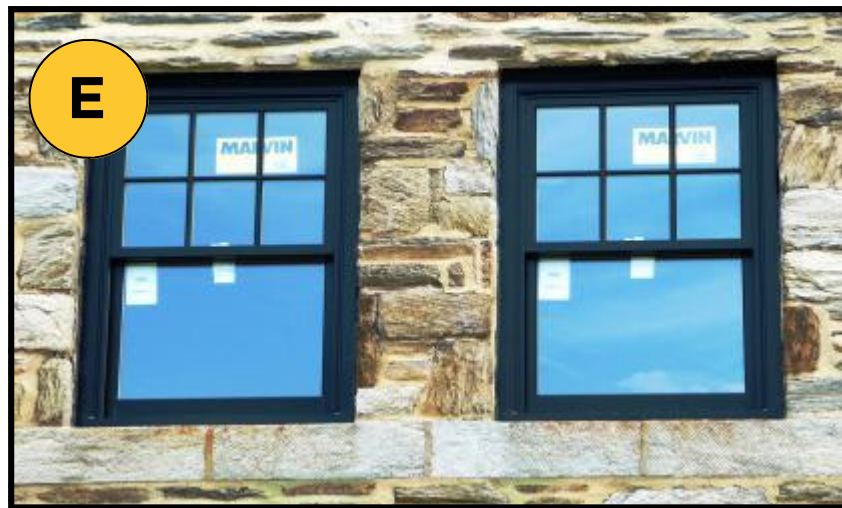
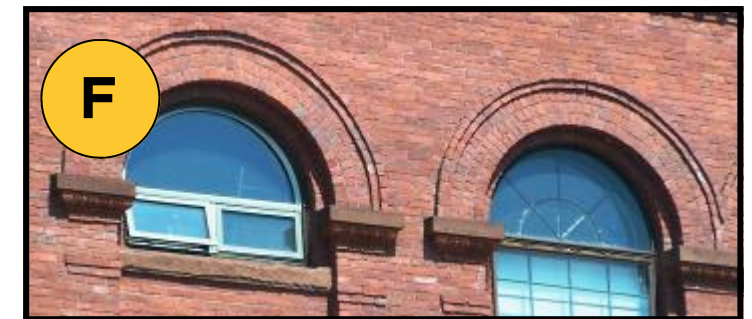
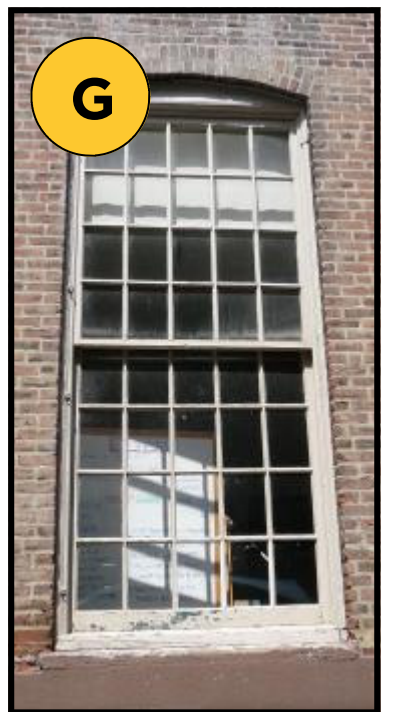
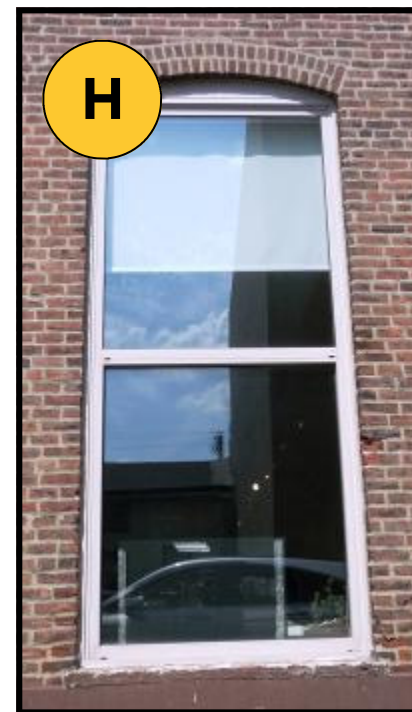
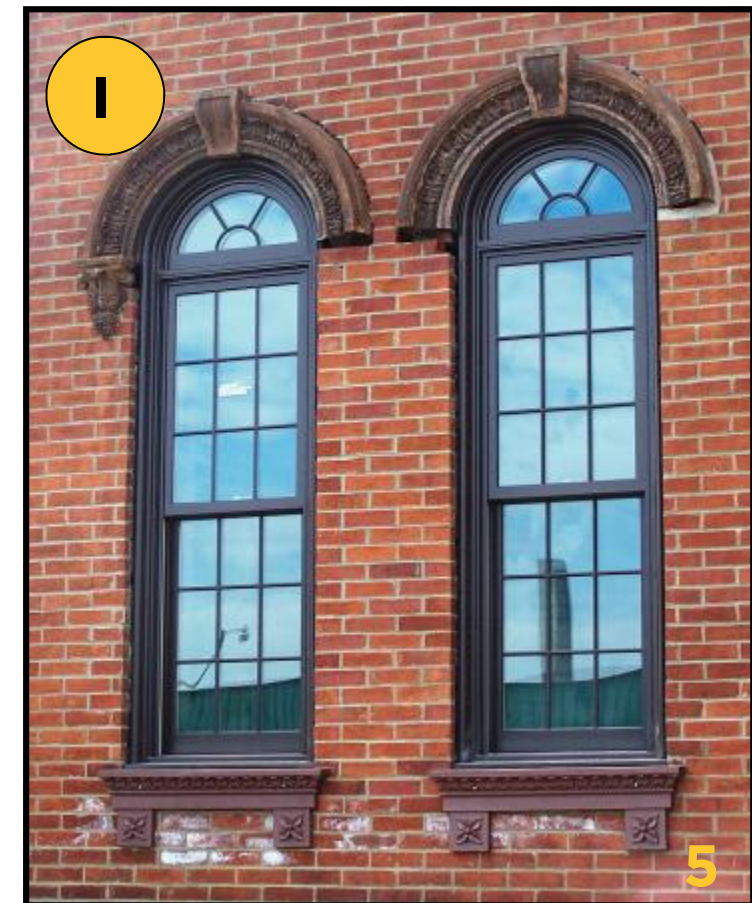
- A Replacing an original double-hung sash window with a casement and fixed transom dramatically changes the look and architectural character of this historic building.

- B Modern interpretation of an arched window alters the pattern and overall design on this monumental civic building. If original windows are no longer intact, this approach may be acceptable as windows clearly reflect their own era.

- C Replacing a round arched double-hung sash window is a one-over-one double-hung sash with fixed transom. This illustrates using stock windows to fit an opening that often requires a custom or more costly replacement window.

- D The thickness of muntins as well as their profile can make a difference. This window is not a true divided-light design, instead featuring applied, flat muntins.

- E New windows will often require 'building out' and enlarging the casing and surround to accommodate a stock replacement unit, effectively reducing the size of the window in comparison to the originals.

- F The introduction of a hopper window completely alters the look of this window.
- G, H Window G features the original twenty-over-twenty double-hung sash window. The replacement, window H, is a fixed one-over-one unit. The design, profile and depth are altered in the process.

- I New windows attempt to replicate originals, though the casing and surround is wider and the fixed fanlight does not match originals.

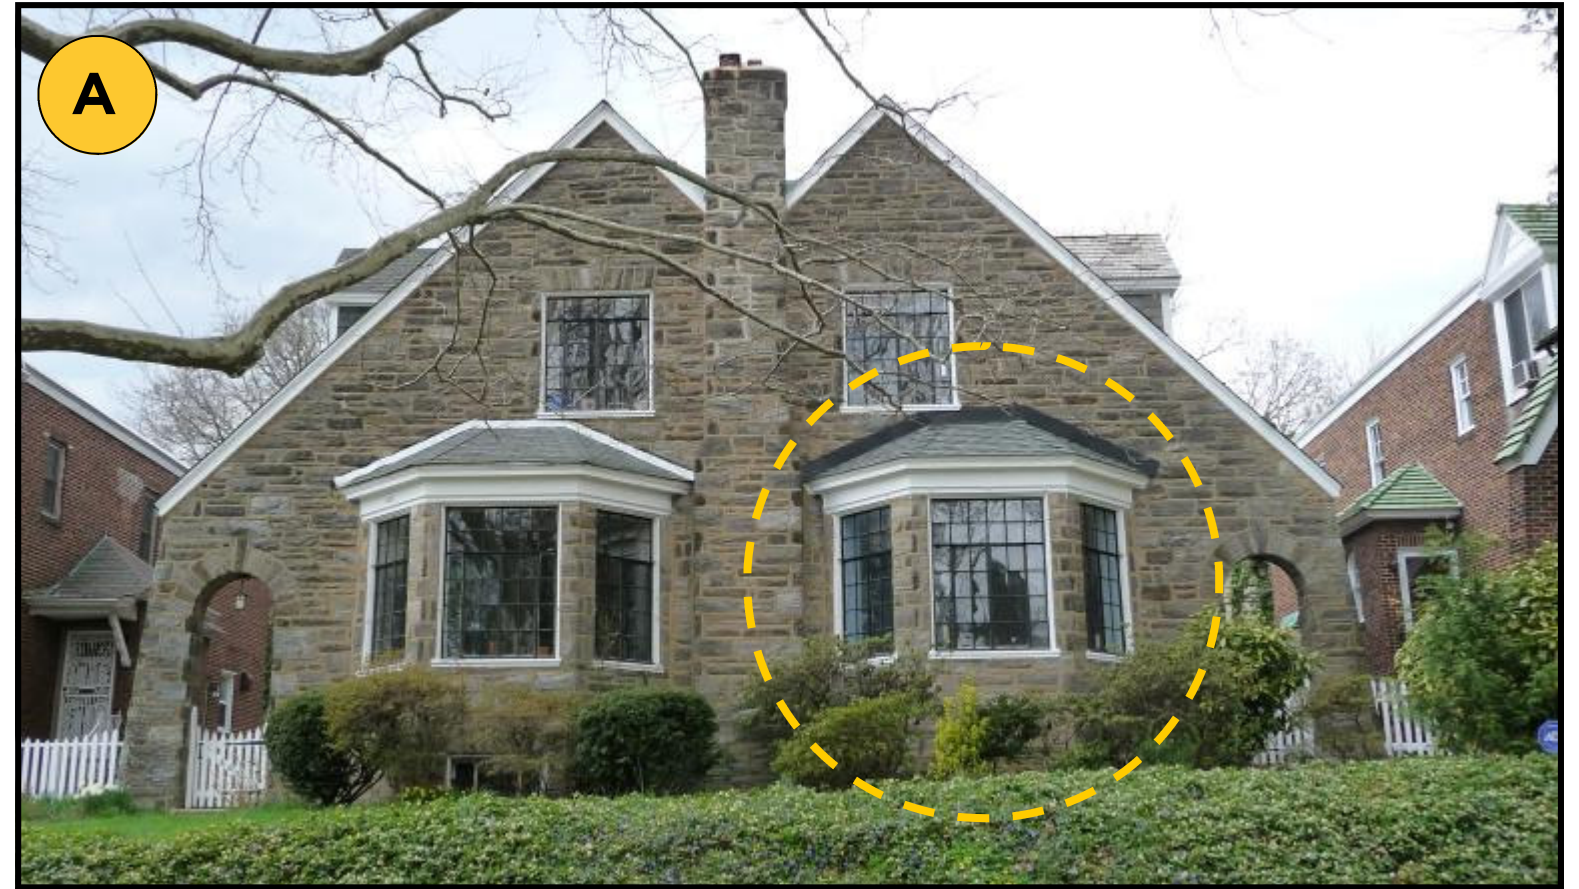
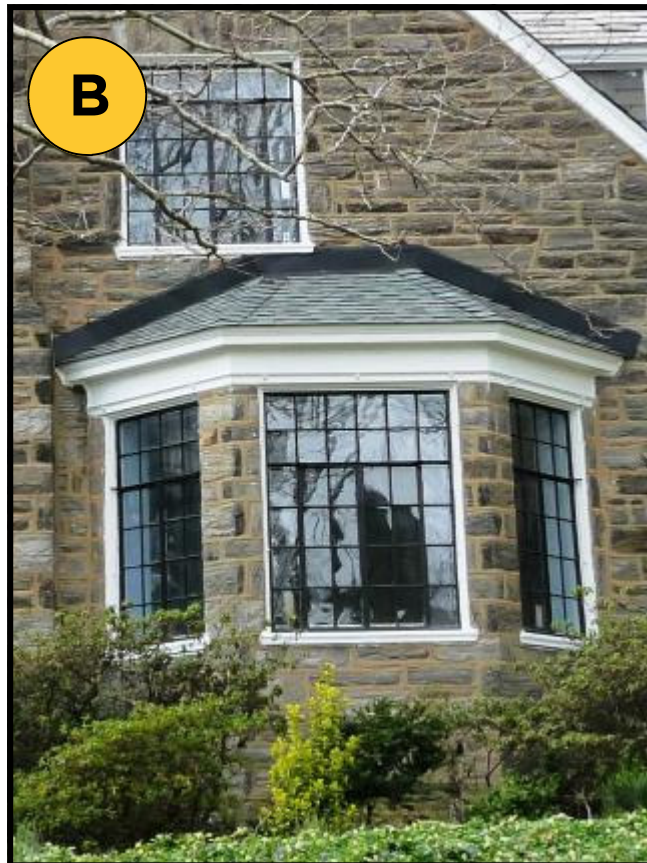
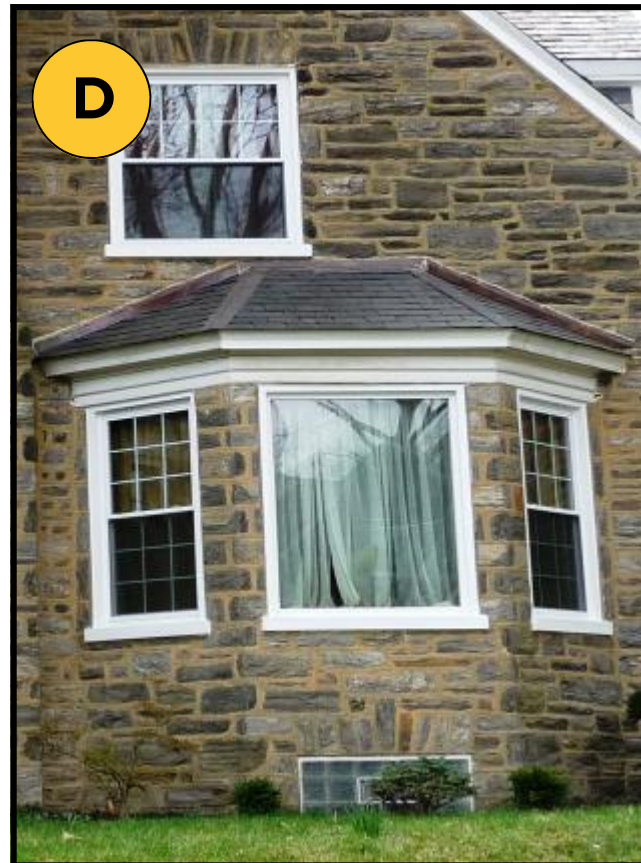
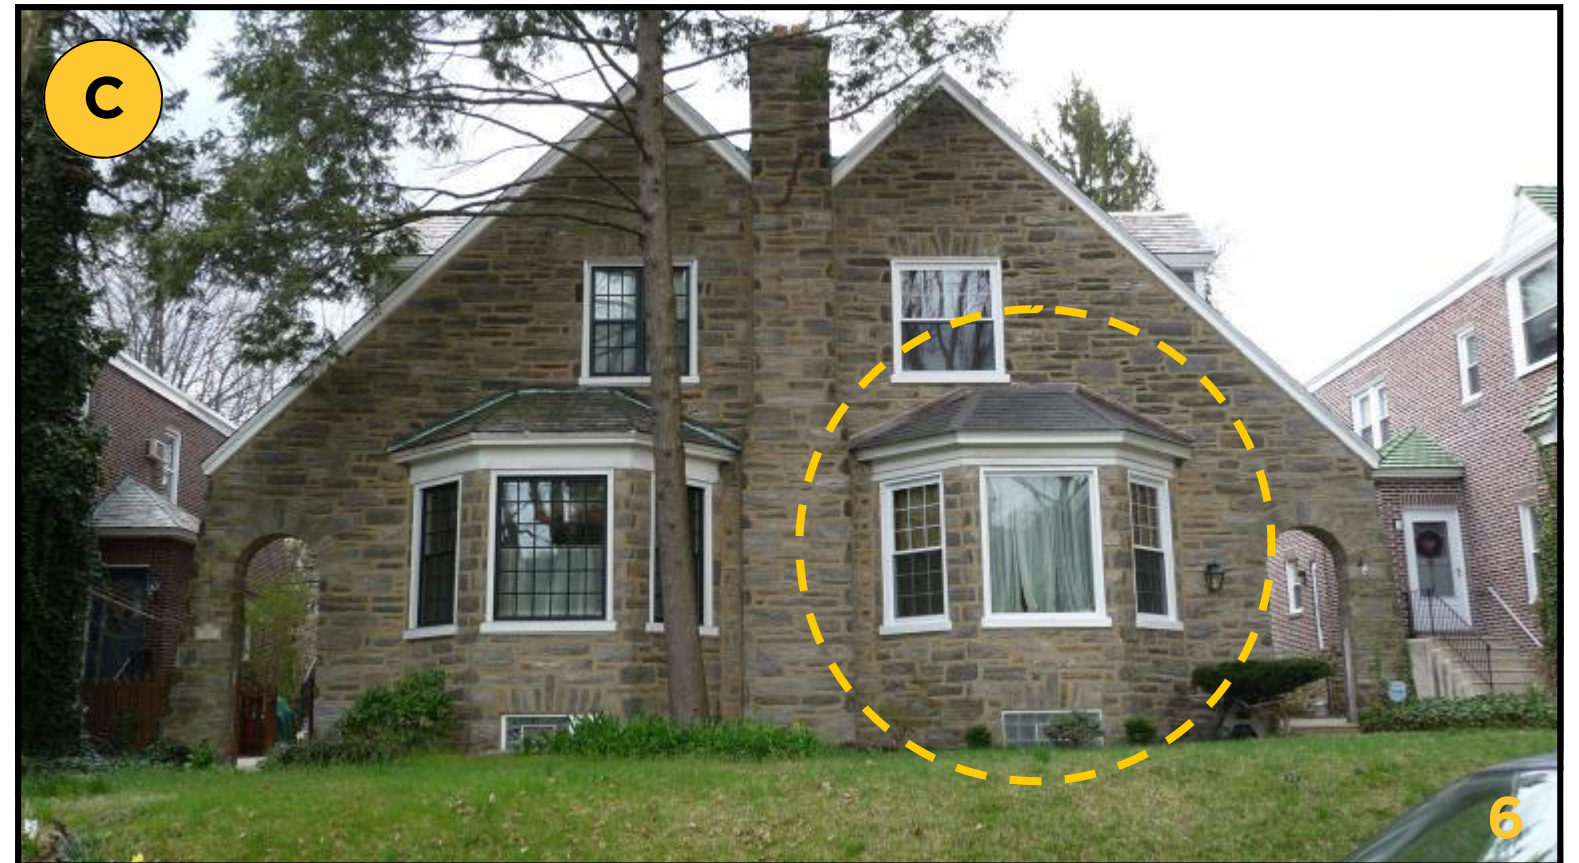
- A, B Both sides of this duplex feature original rolled steel casement windows with interior storm window inserts.
- C, D Both sides of this duplex have replacement windows. The one to the left more closely mimics the lines and details of the original steel casements, though the new windows are a mixture of fixed and double-hung sash units and the proportions are not an exact match. The unit to the right also features fixed and double-hung sash replacement windows. In this case, the result is less successful with white vinyl casing and a central picture window missing any muntin pattern.

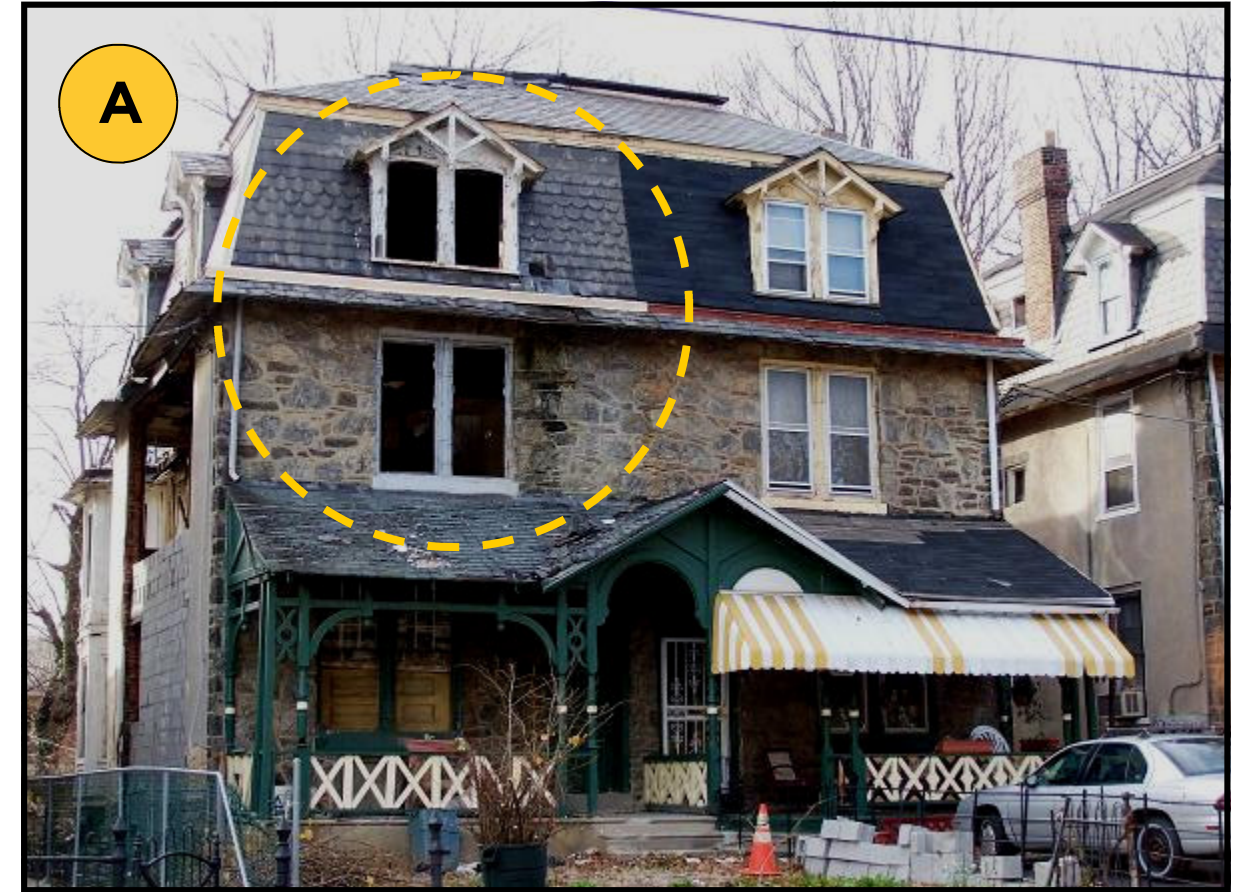
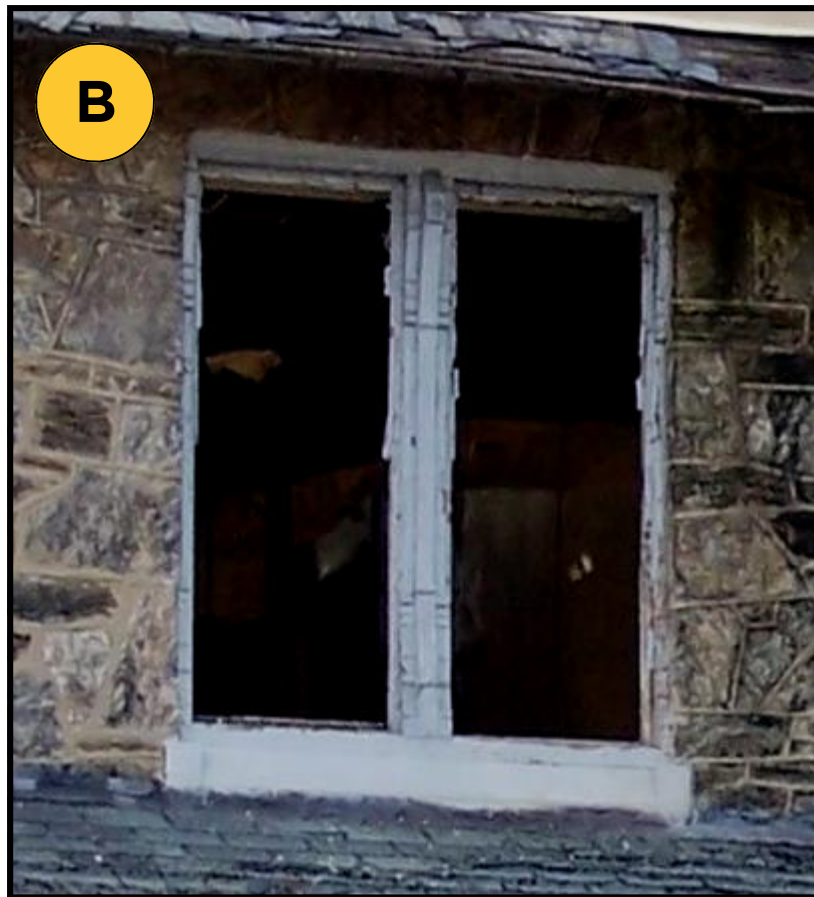
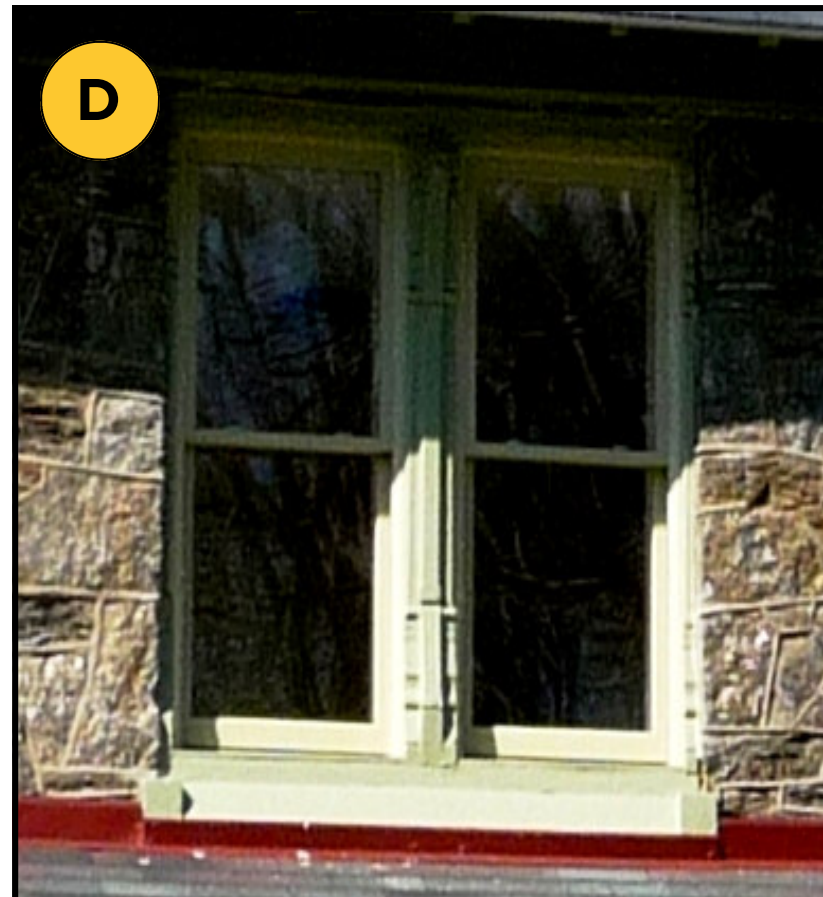
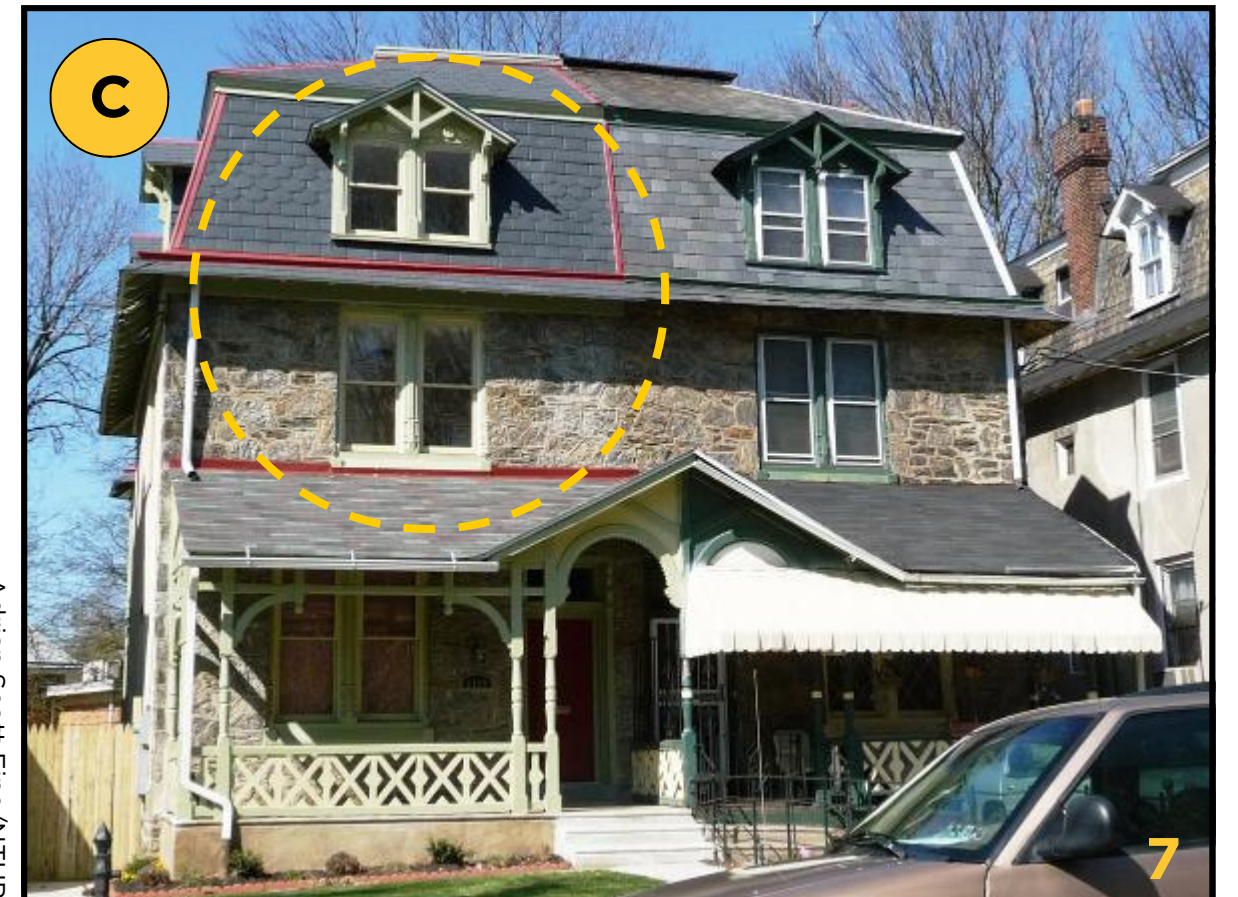
- A, B Original windows are missing but decorative casings and openings remain.
- C, D As part of the rehabilitation project, new wood double-hung sash windows were chosen to fit the original openings and the decorative casings were repaired and retained. New windows replicate the originals in terms of size, type, proportion and materials.
