NATIONAL
TRUST
FOR
HISTORIC
PRESERVATION®

Repair or Replace Old Windows

A Visual Look at the Impacts

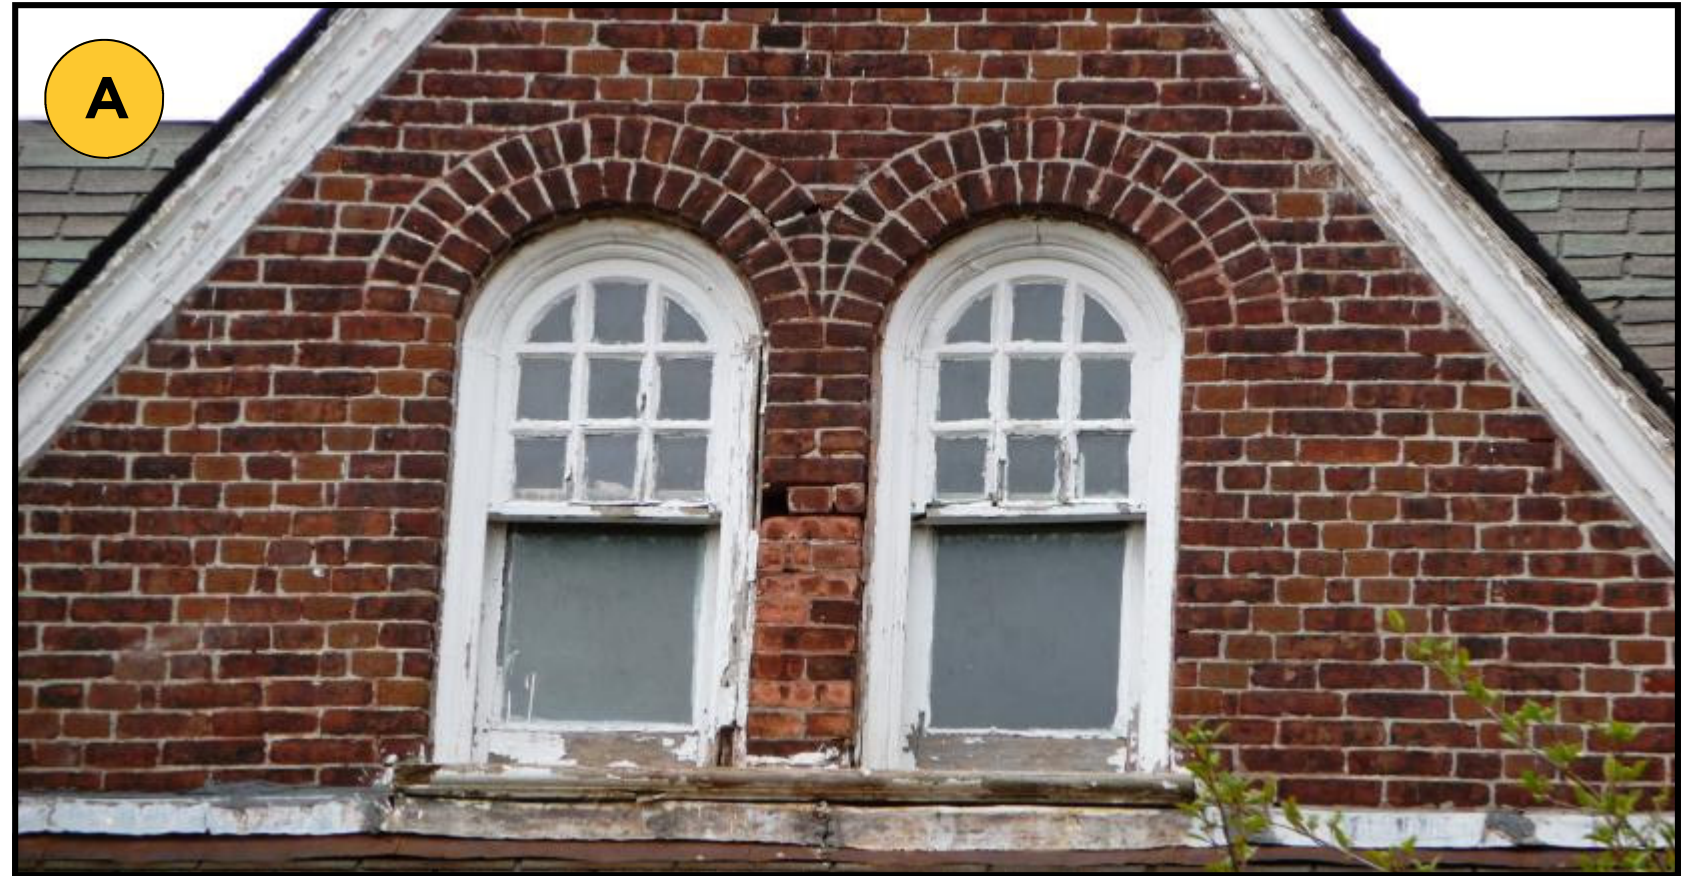
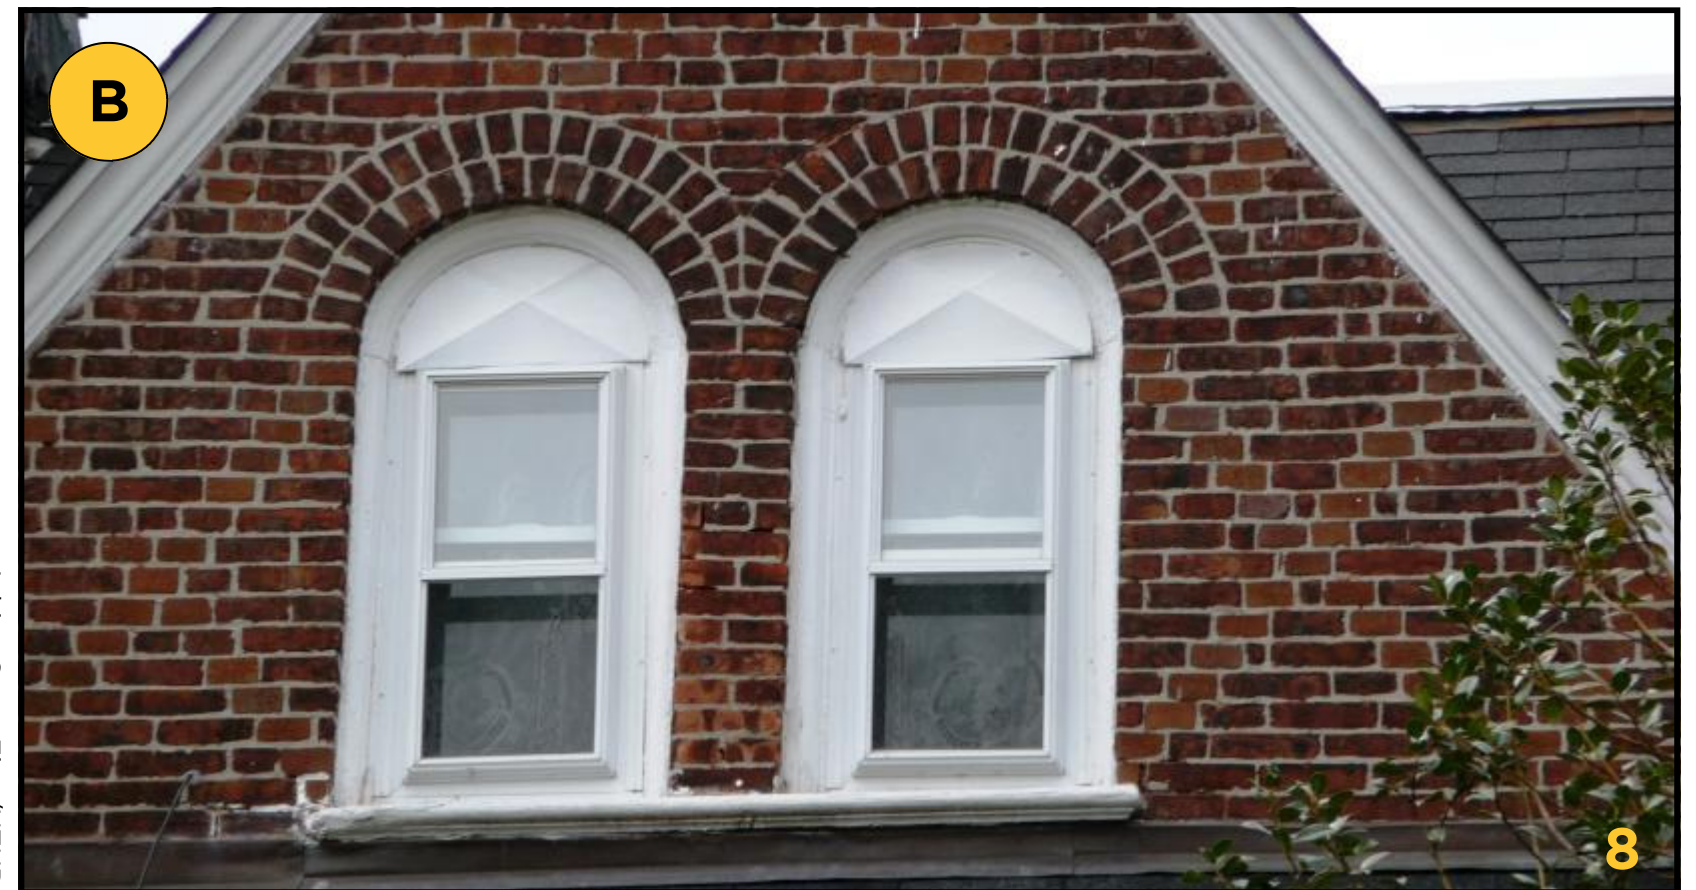
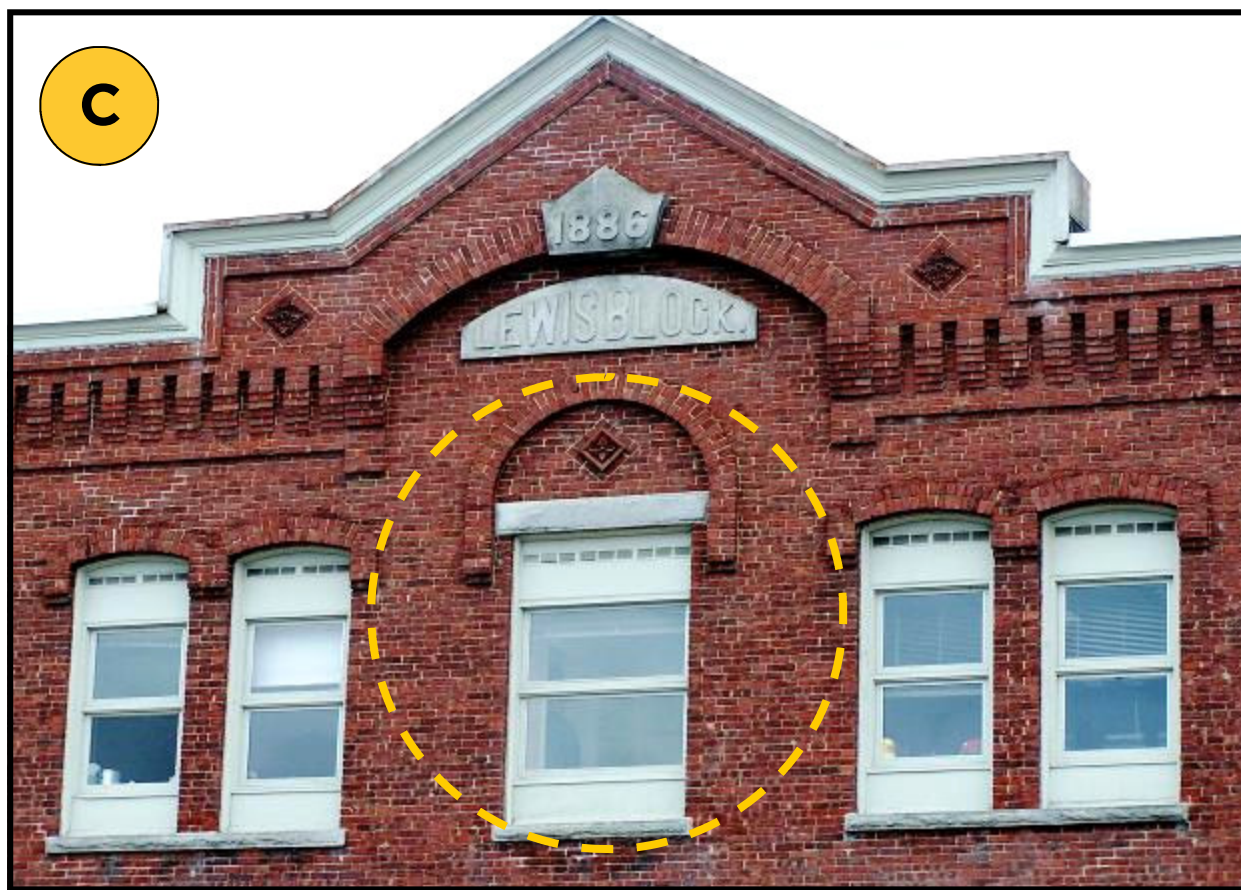
- A Two, arched nine-over-one double-hung sash windows are in disrepair with loose meeting rails and paint build up. They can be easily repaired and still maintain the character of the building.
- B An identical building with replacement windows. Stock units were used with aluminum in-fill around the opening. The difference in character between A and B is dramatic.
- C The upper story windows of this Main Street commercial structure were replaced with stock units with in-fill at the top and bottom.

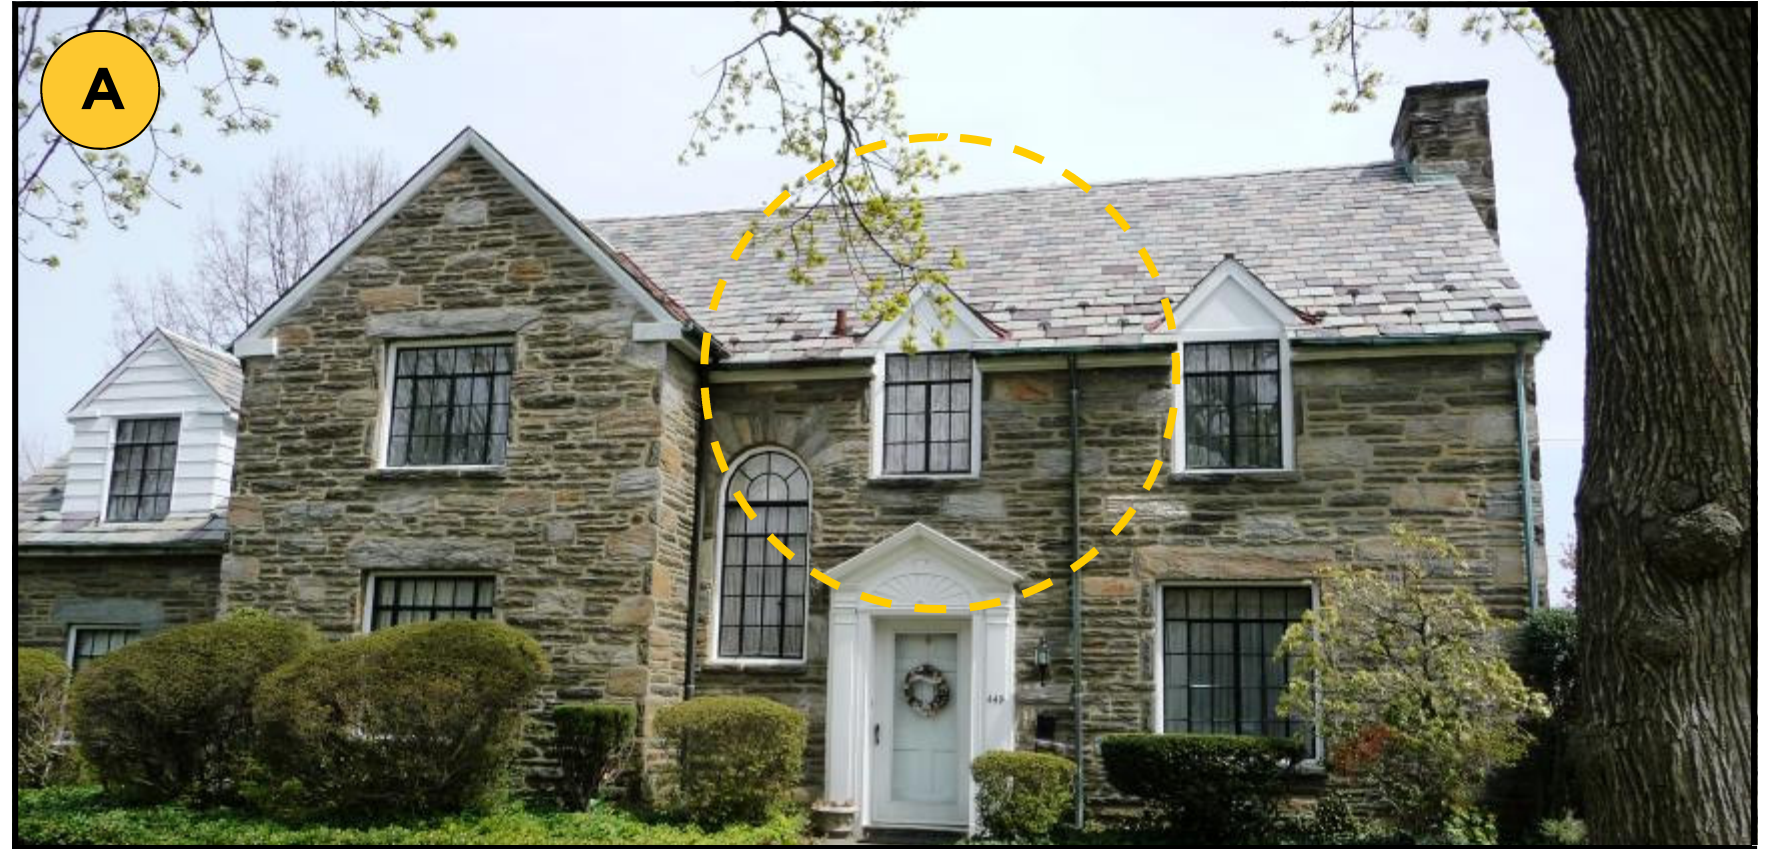
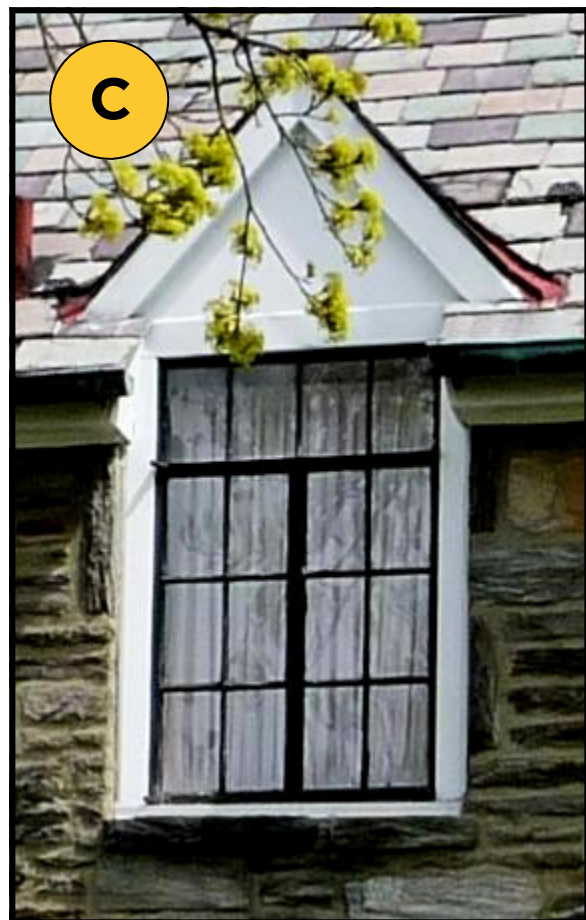
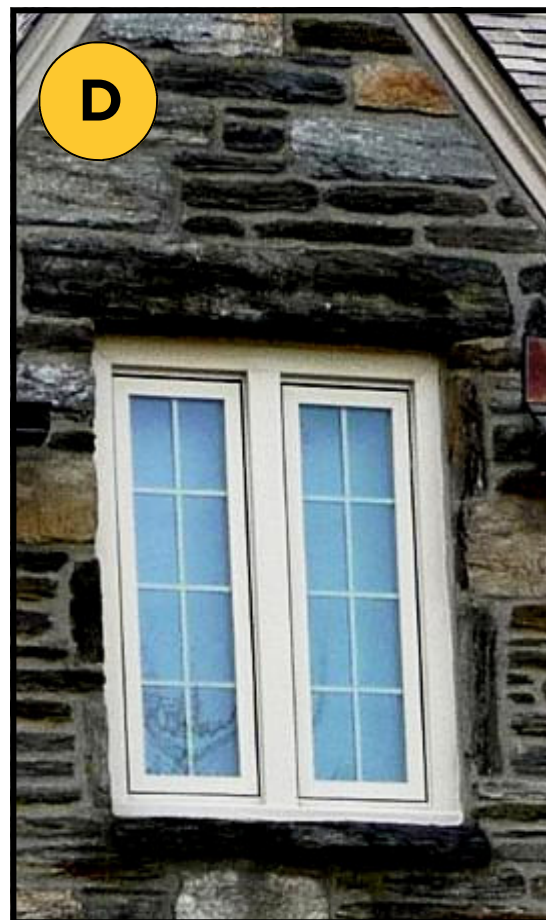
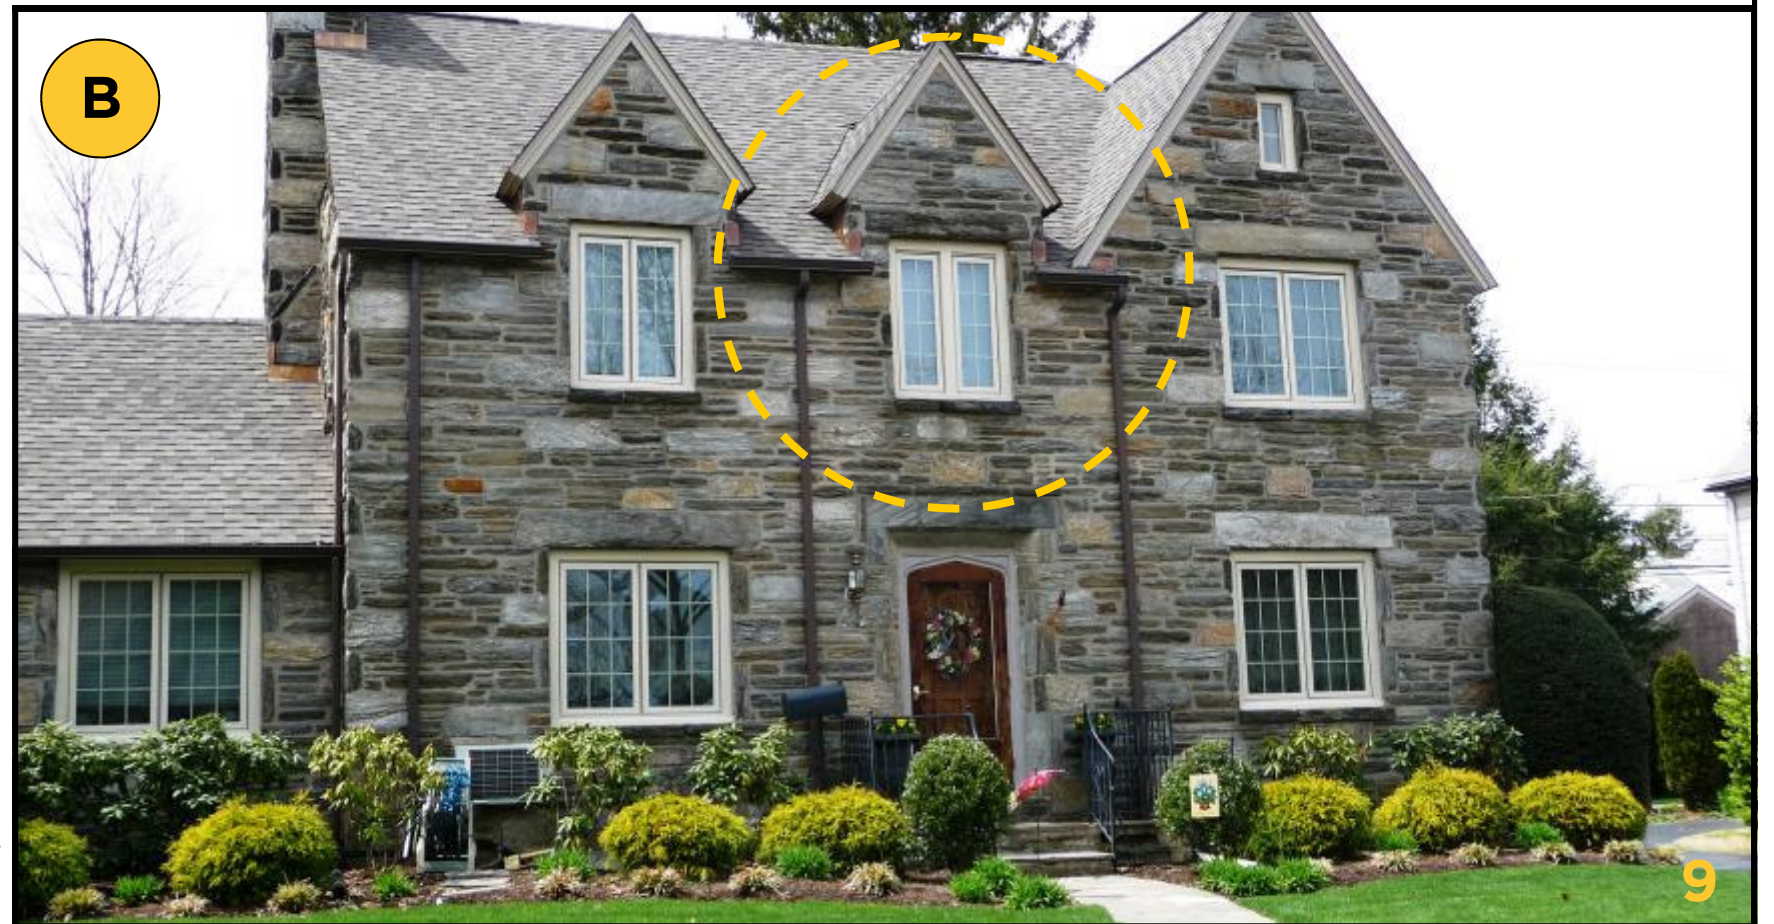
- A Steel casement windows with fixed transoms and side-lights, featuring interior storm windows. These windows are a character defining feature of the house.
- B Replacement windows attempt to match with casement style units yet the proportion, pattern, width and lack of a true divided-light miss the mark.
- C, D The differences between the original and replacement are readily seen, where the wider casing and surround are much prominent on the replacement windows.

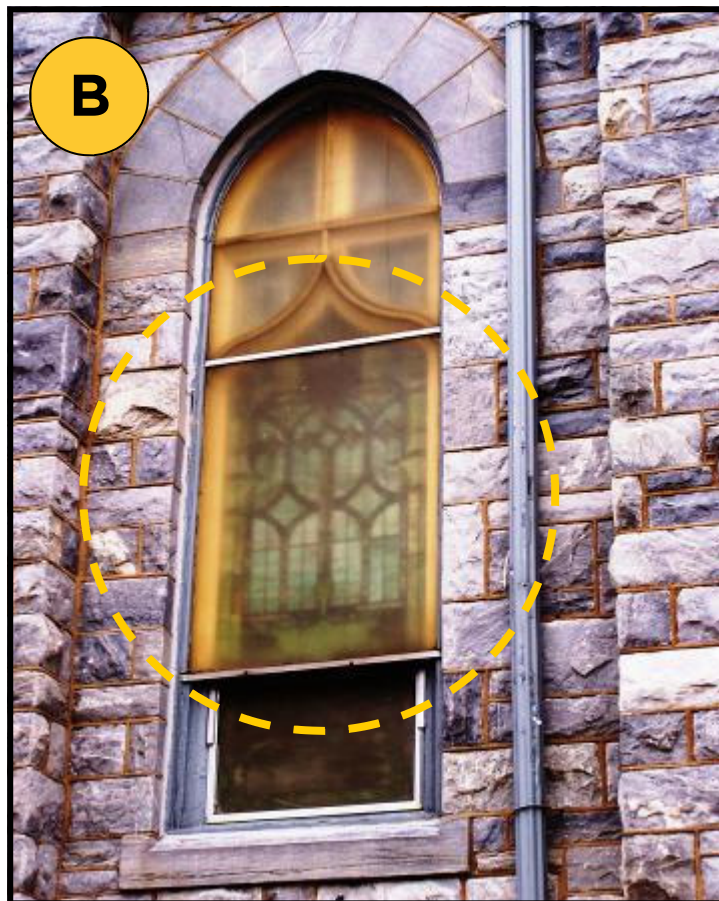
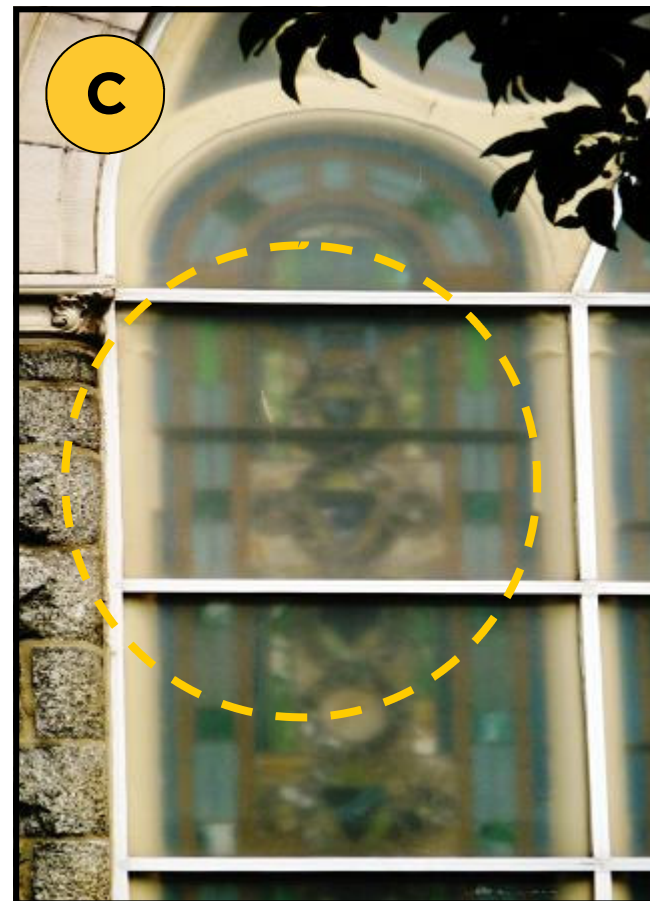
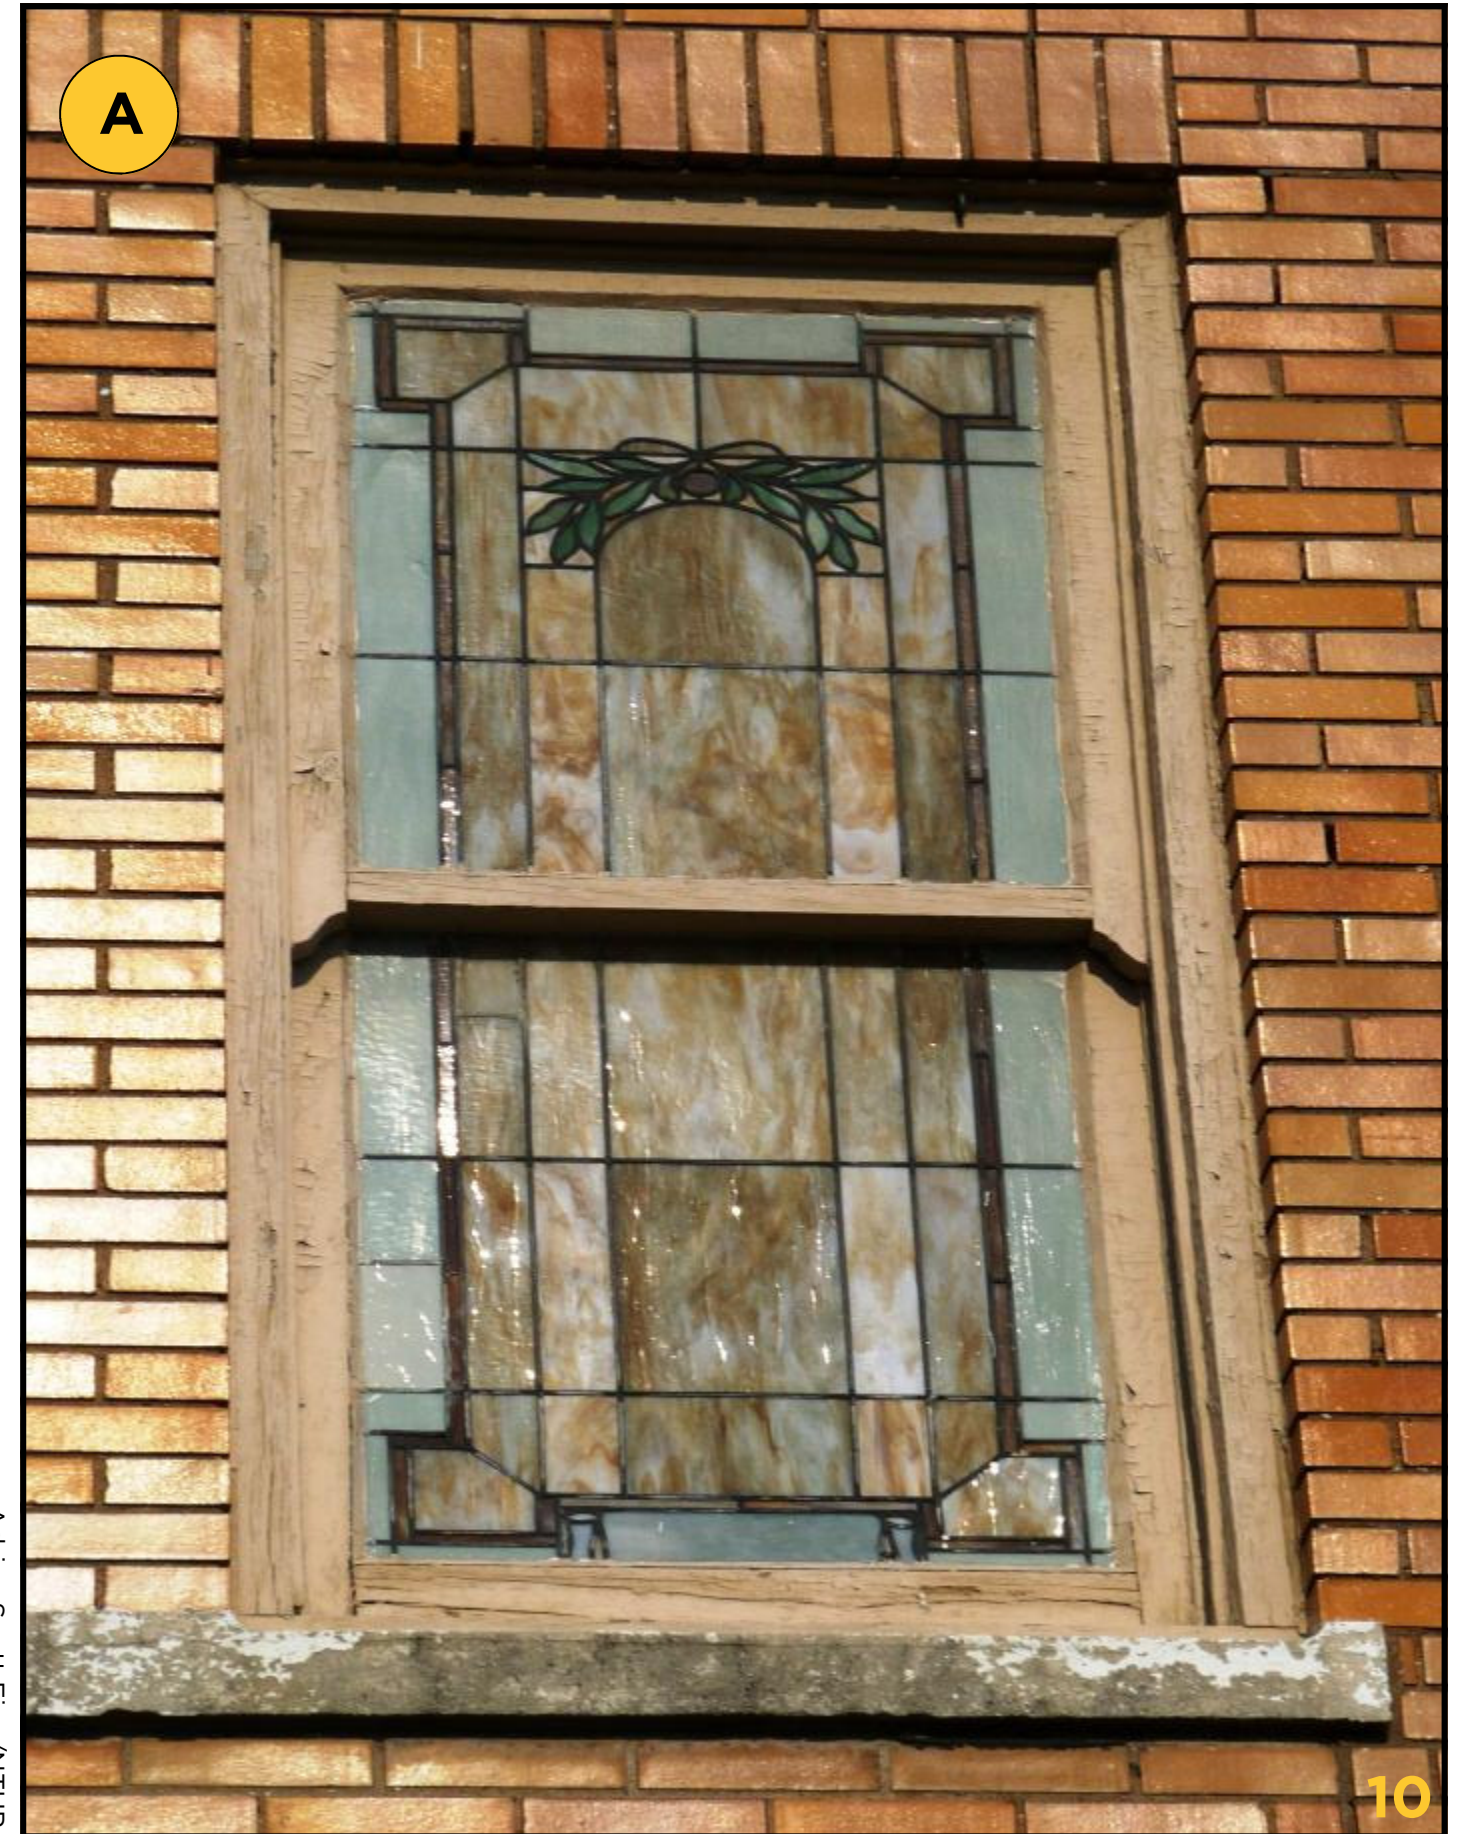
- A Exposed original one-over-one double-hung slag glass window .
- B Plastics (Lexan or Plexiglass) are impact-resistant and nearly shatter-proof but tend to yellow and get hazy over time.
- C Windows are obscured and the pattern is dramatically altered with new aluminum rails as part of this protective glazing system.

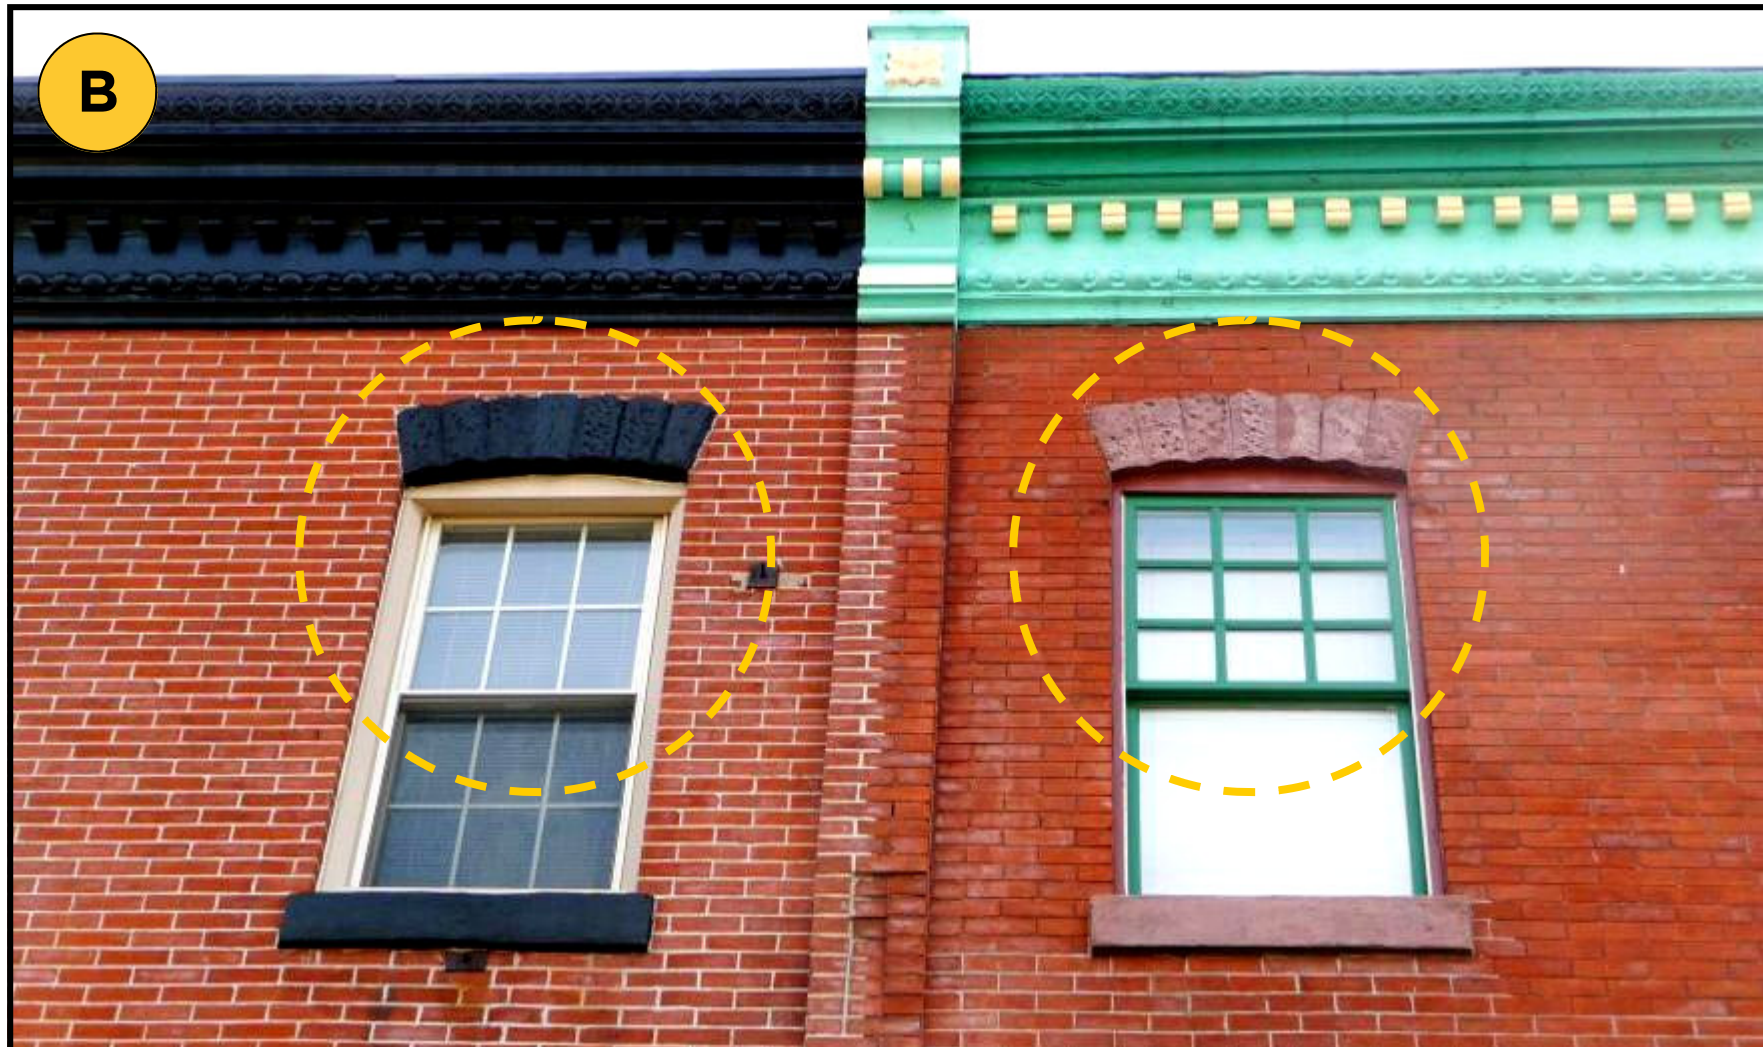
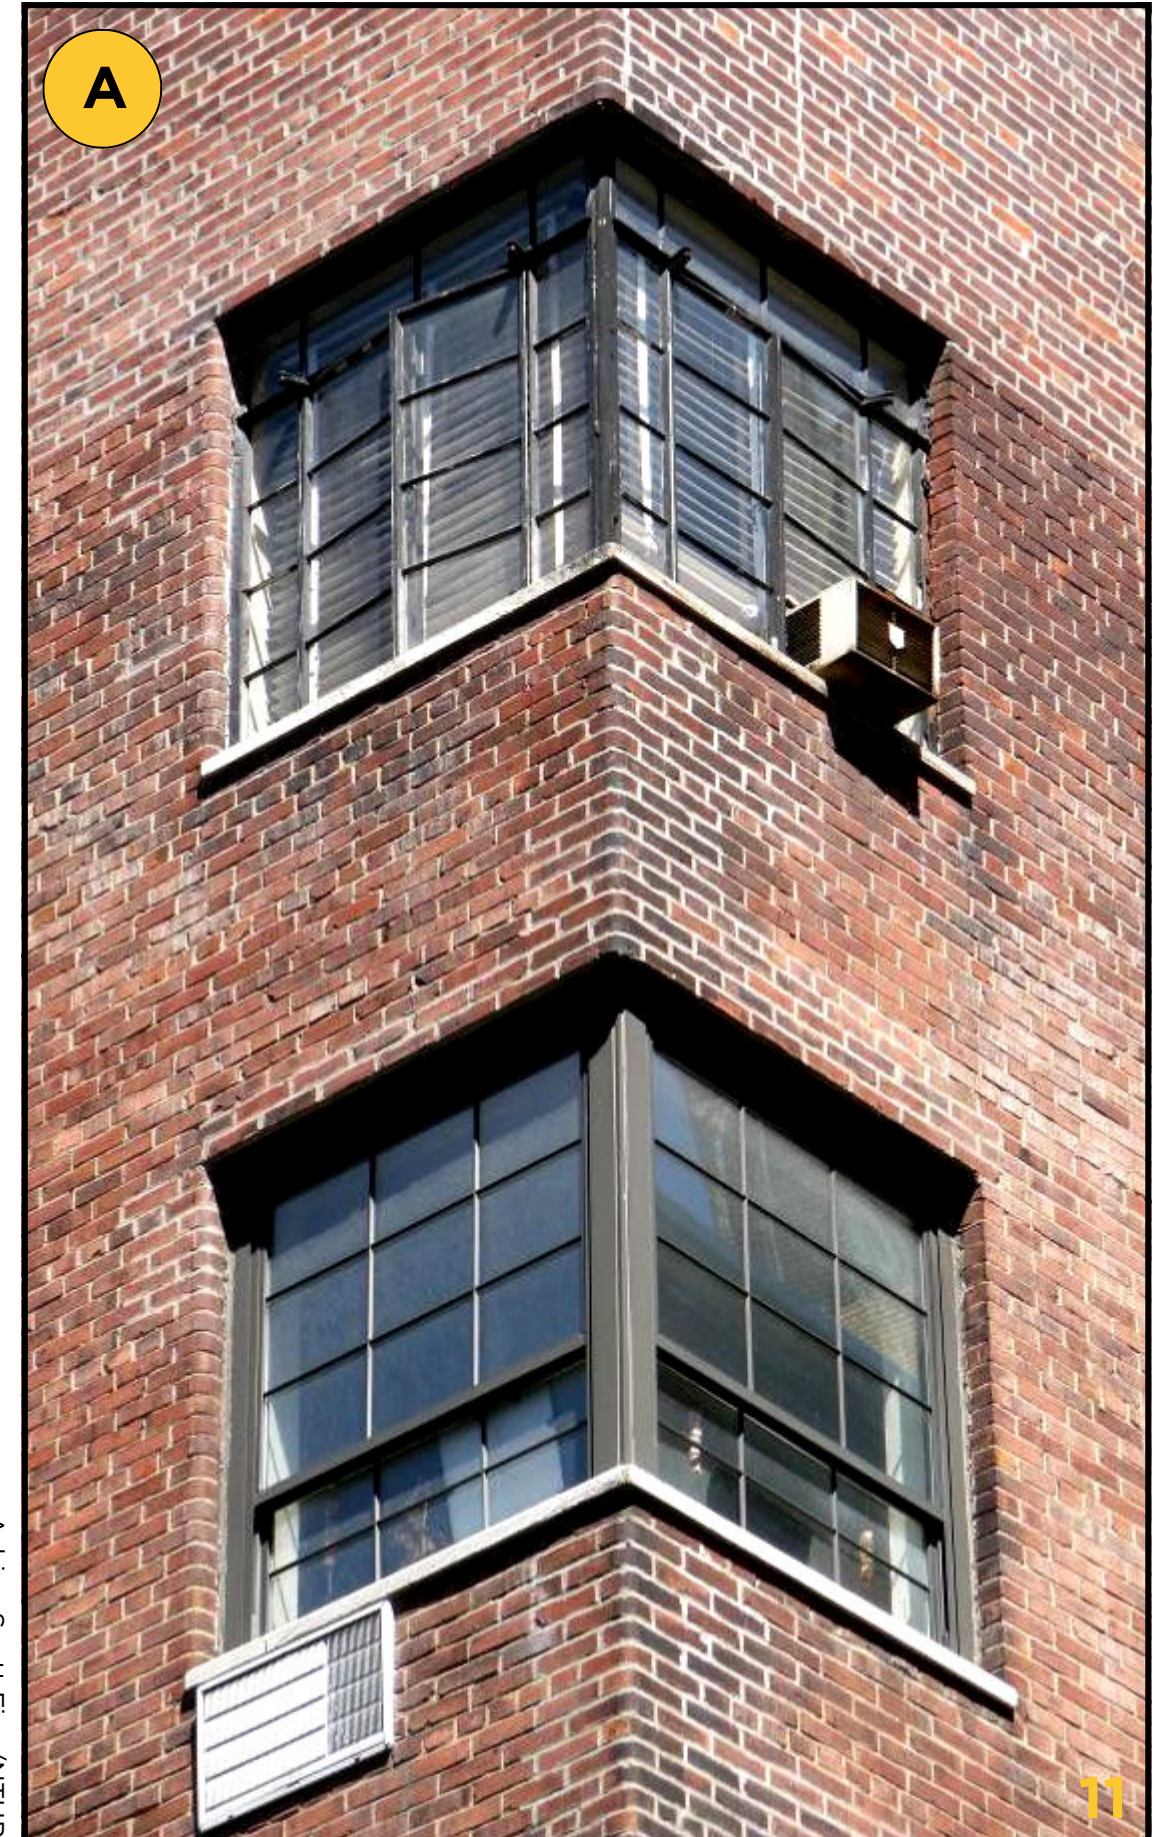
- A An early 1940s apartment building designed in the Art Deco style features corner, steel casement windows. The slender profile of the muntins and casing is a character defining feature. The replacement double-hung sash window, at the bottom, attempts to match the lines of the original, yet the muntin pattern and width of casing are much different.
- B Two double-hung sash replacement windows on side-by-side row houses demonstrate the subtle, but noticeable differences in design. While original windows were identical, these are different in terms of depth, muntin size and pattern and width of casing.

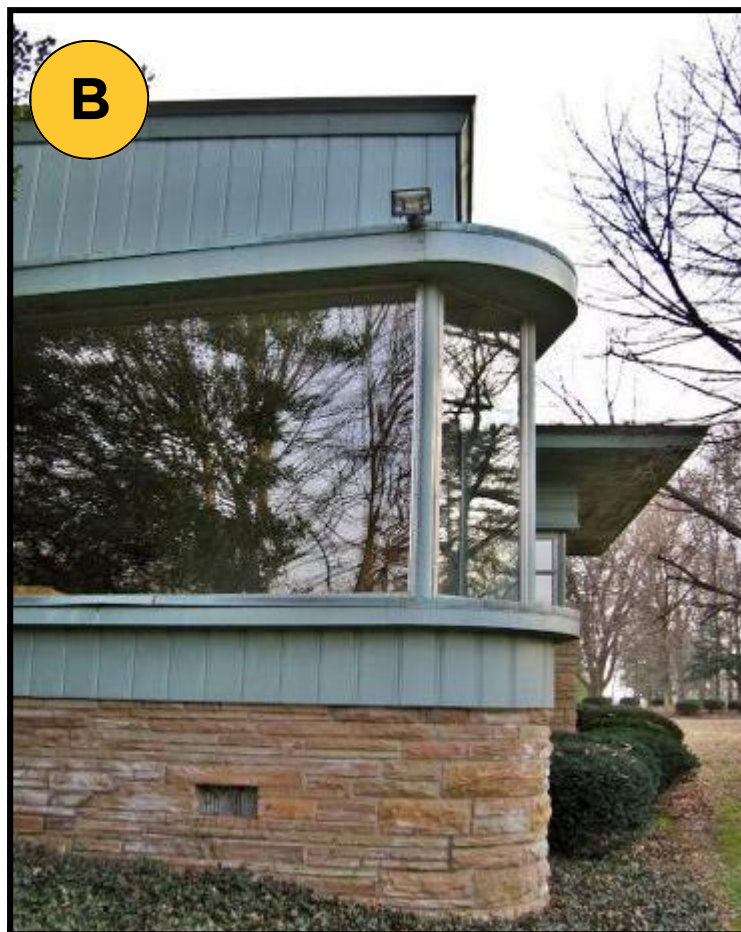
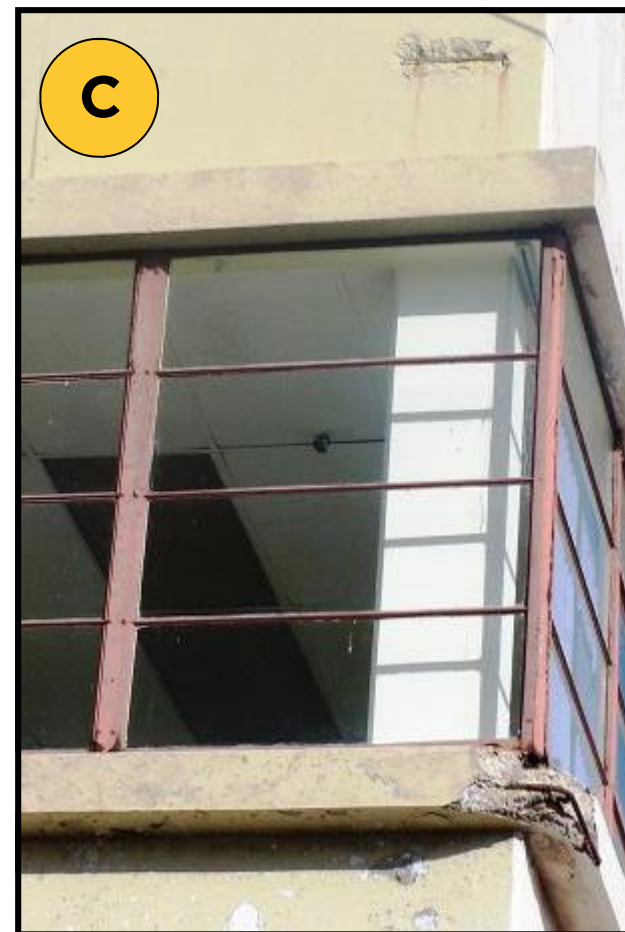
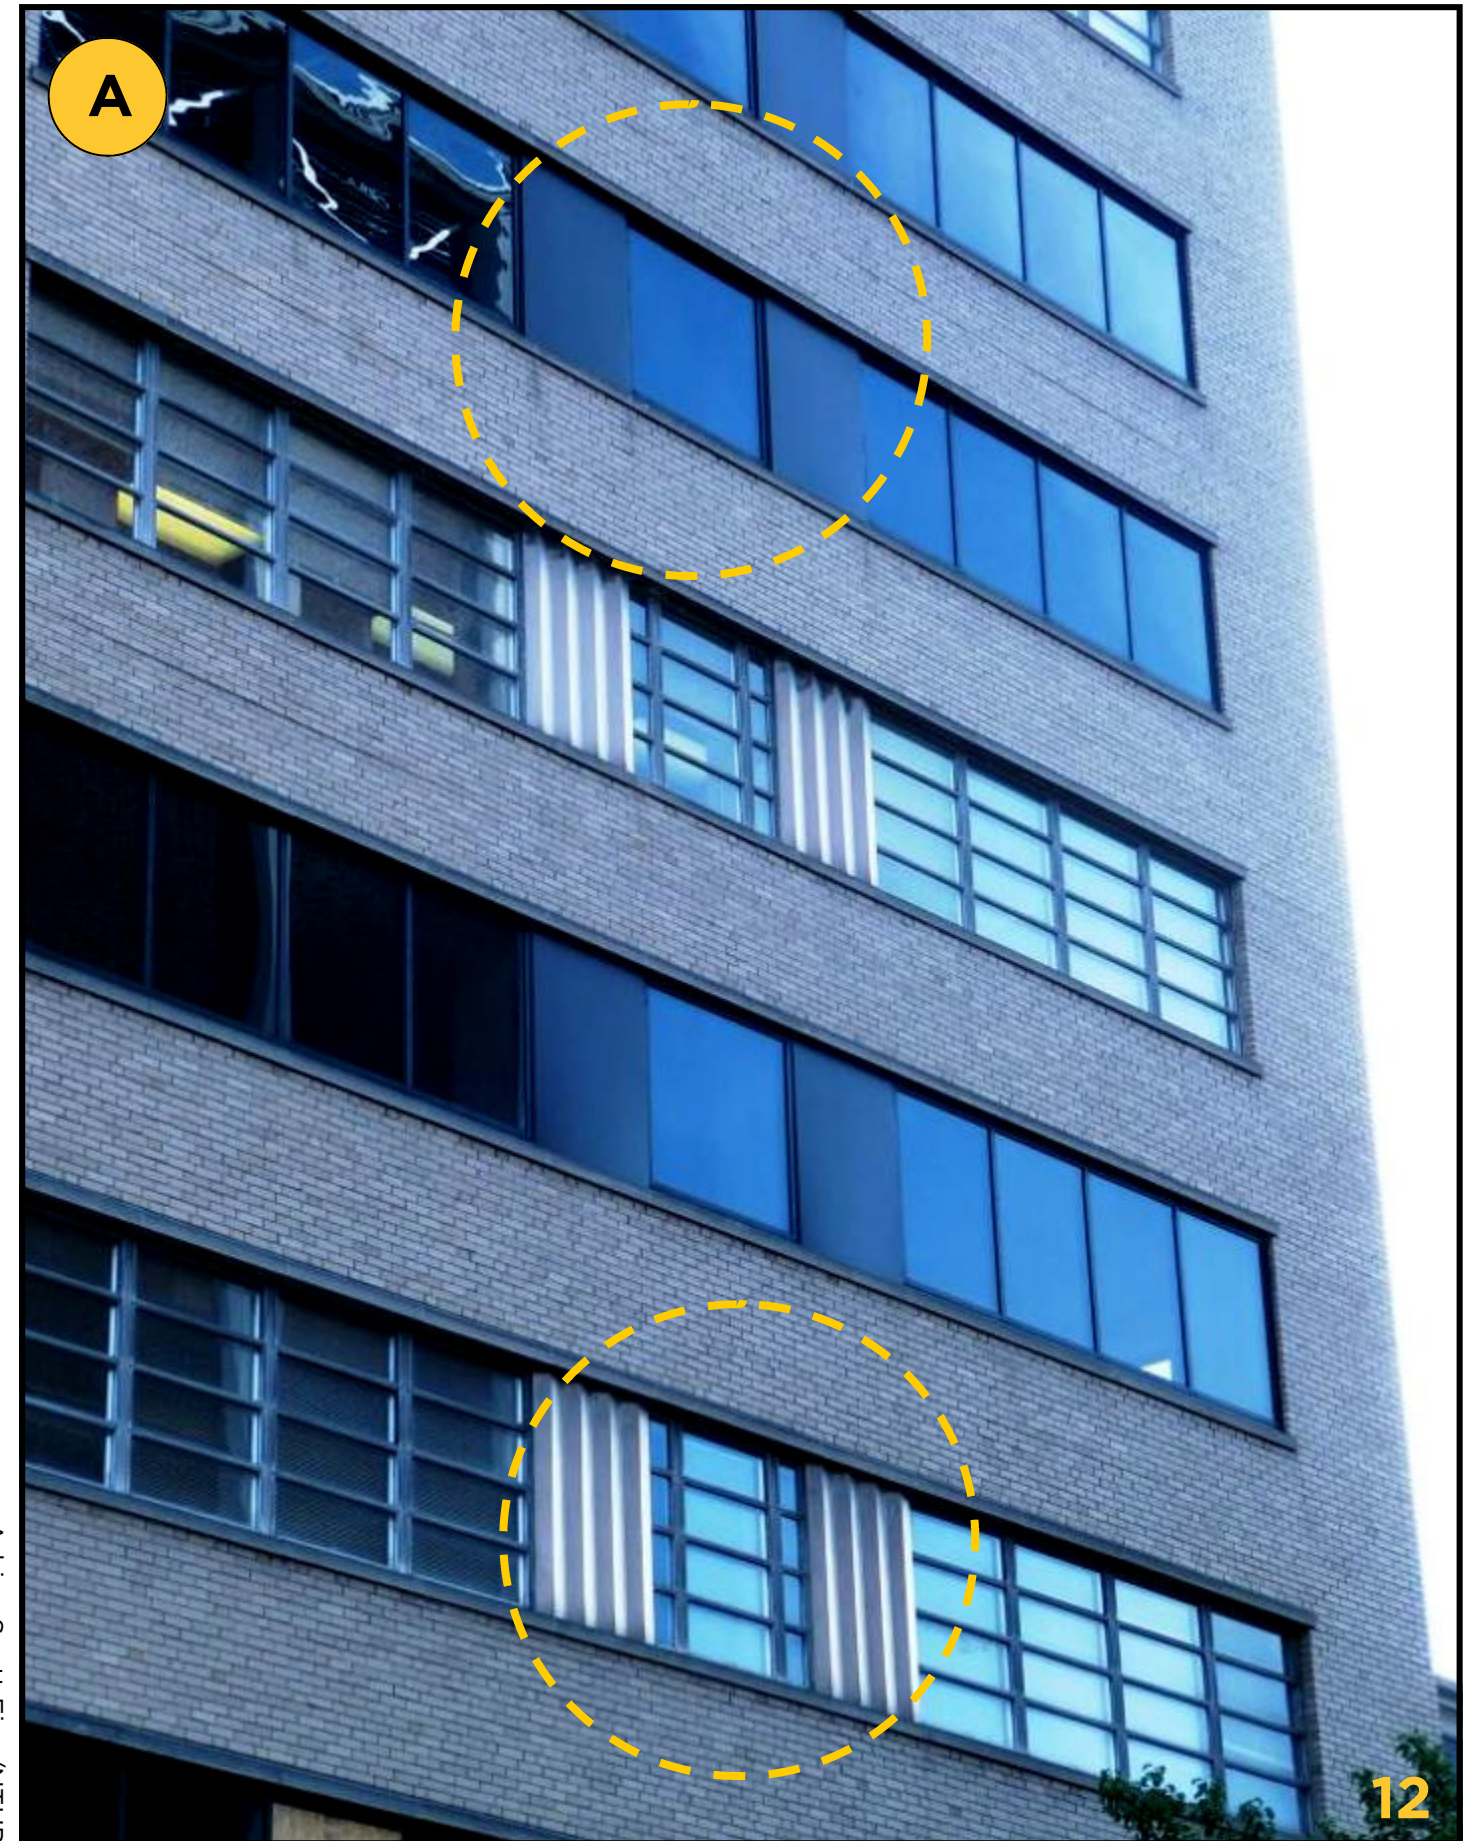
- A Original, character defining windows and corrugated stainless steel detail are being removed on this 1950s office building, replaced by dark tinted fixed windows that do not match.
- B, C Large spans of single pane and plate glass require innovative solutions, such as custom designed storm windows.
