NATIONAL
TRUST
FOR
HISTORIC
PRESERVATION®

Repair or Replace Old Windows

A Visual Look at the Impacts

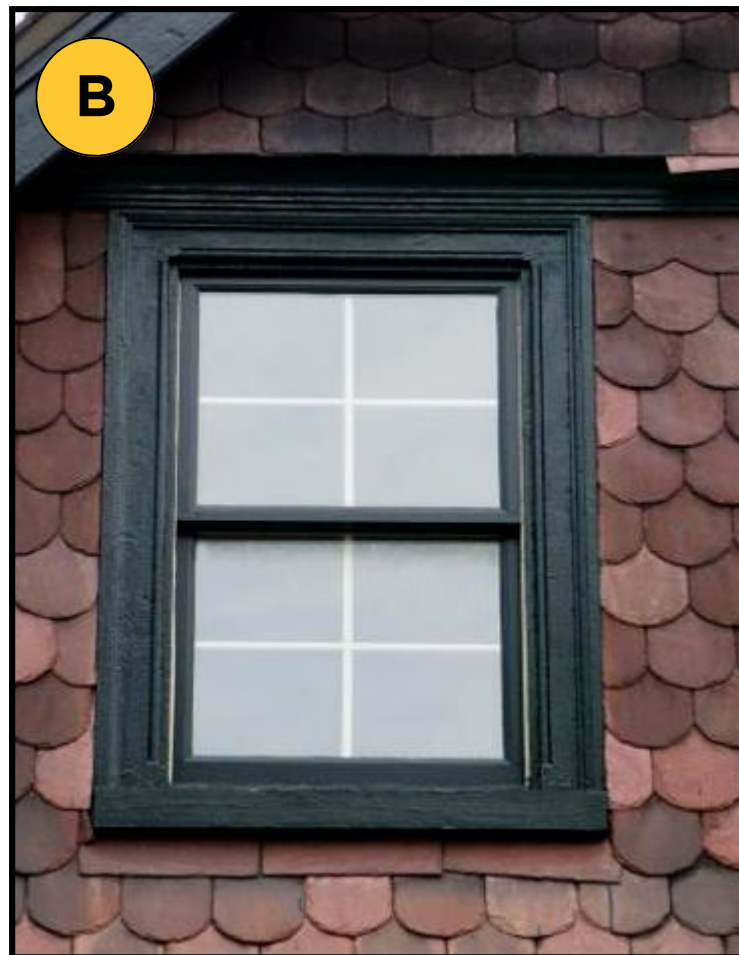
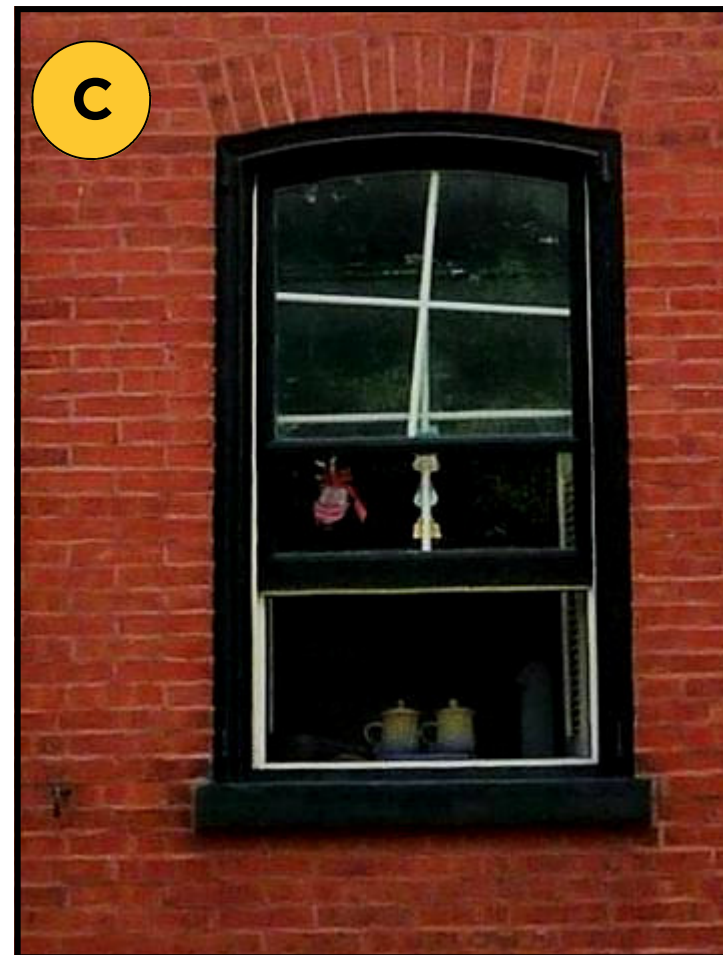
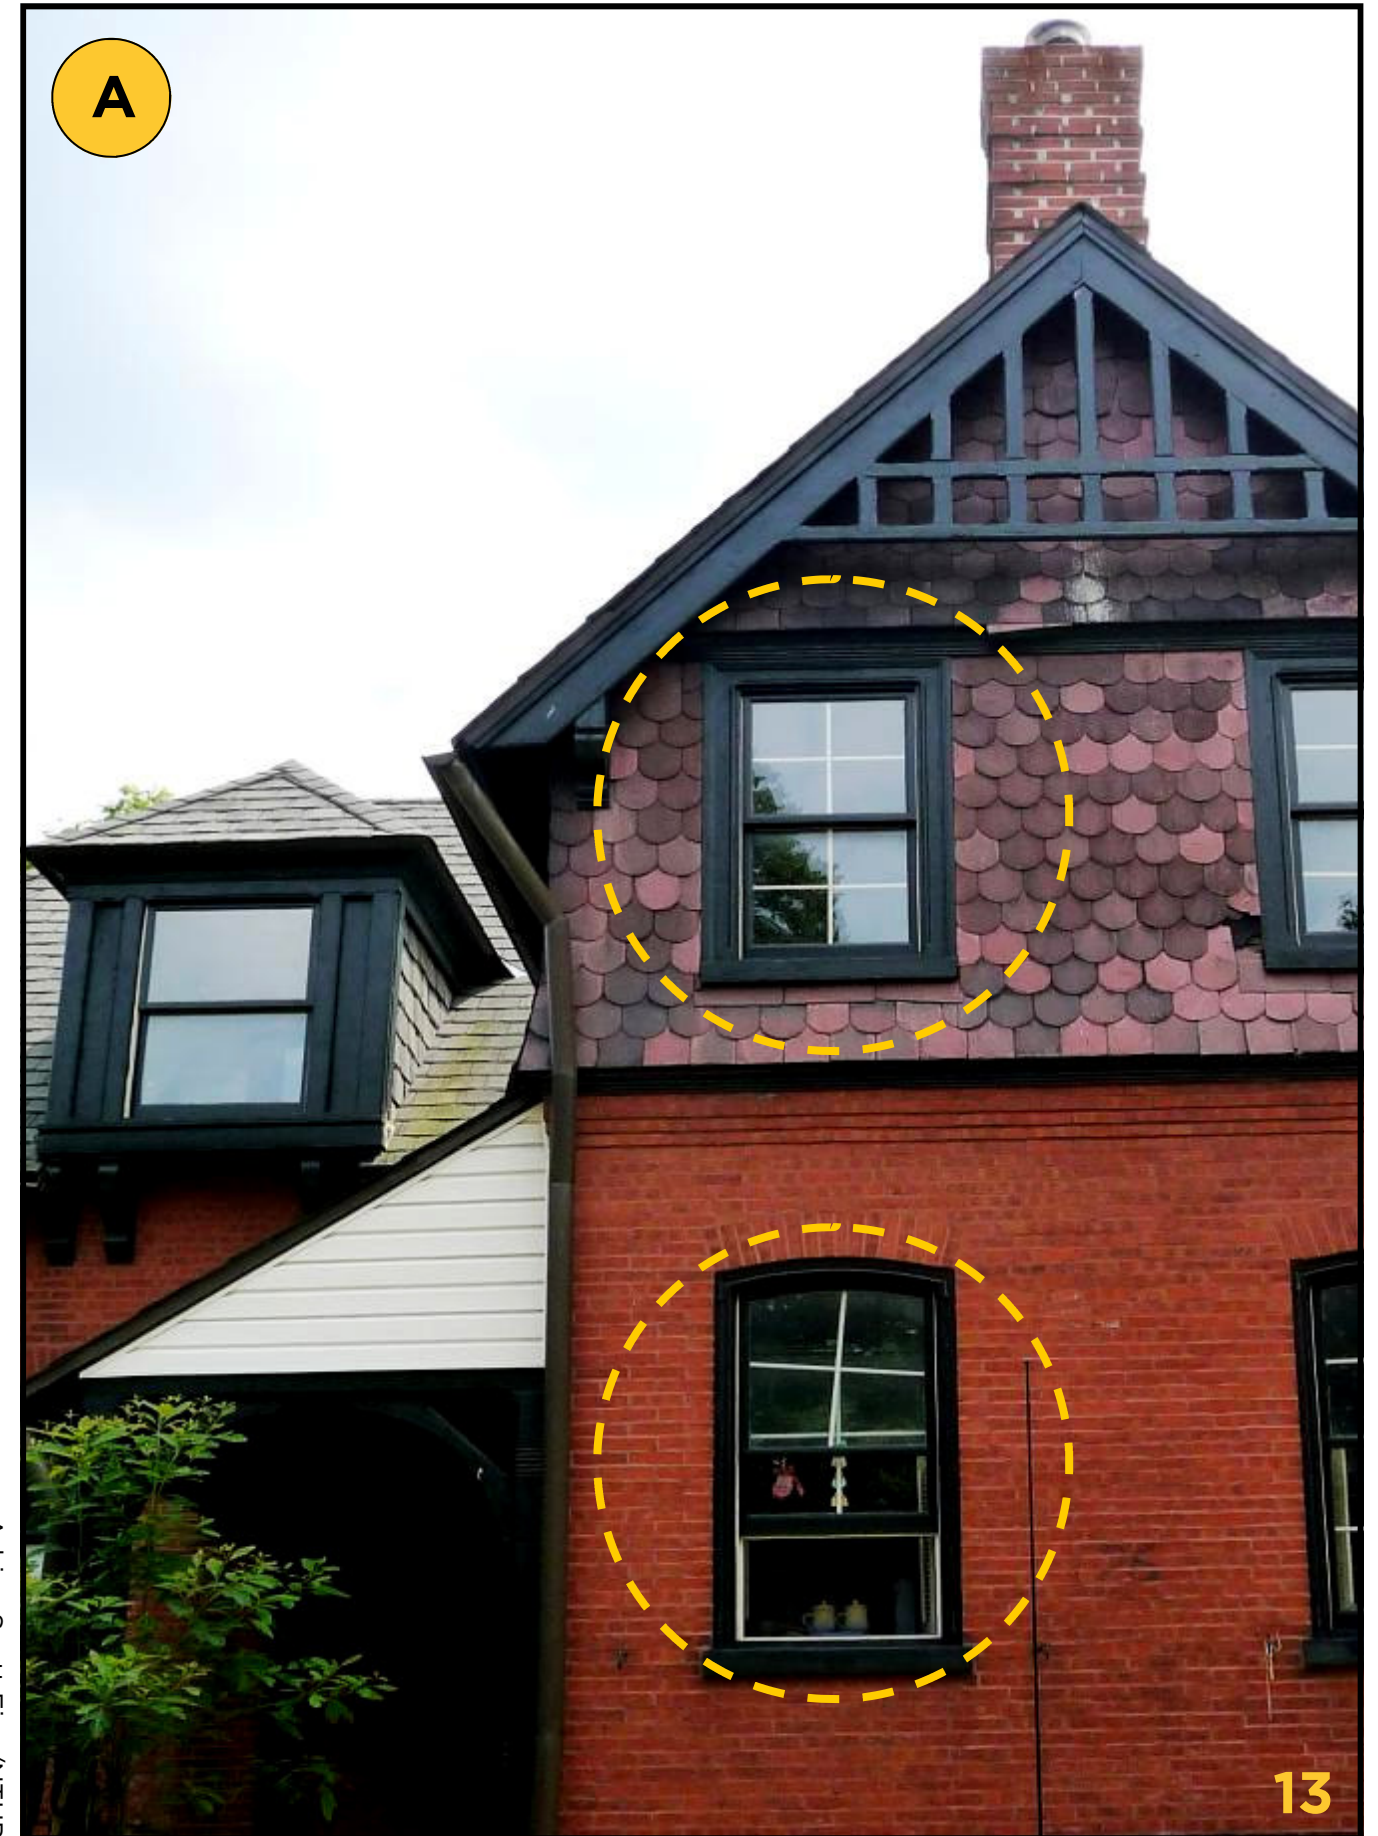
- A A former carriage house, rehabilitated and preserved for a new use, features replacement windows that attempt to look like true divided-light windows.
- B This four-over-four double-hung sash still has its original wood casing with a replacement window with clipped on interior muntins. There is little dimension or depth with this design and instead looks like a one-over-one sash.
- C This shows how clipped on interior muntins can loosen or fall off.

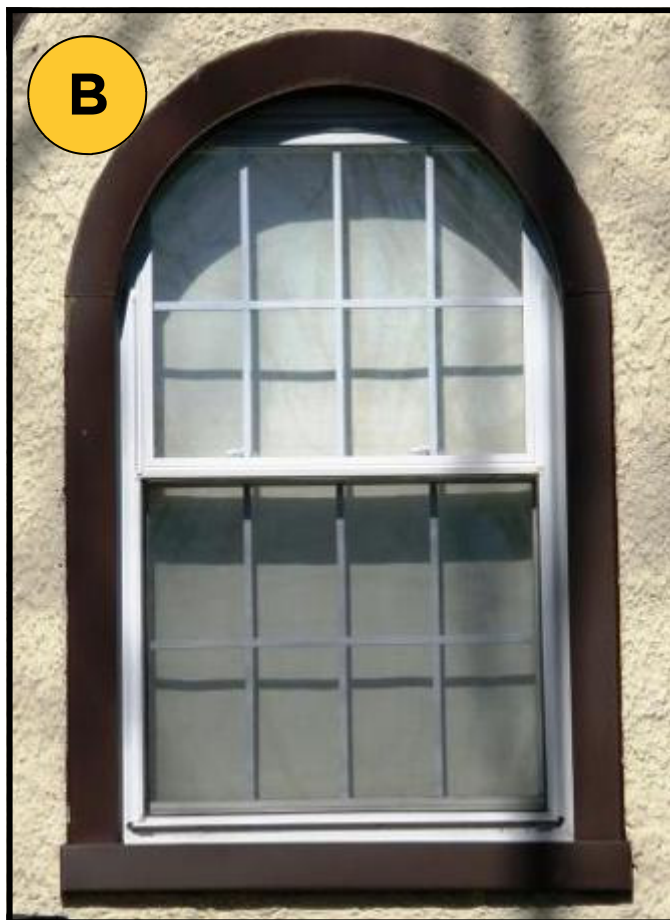
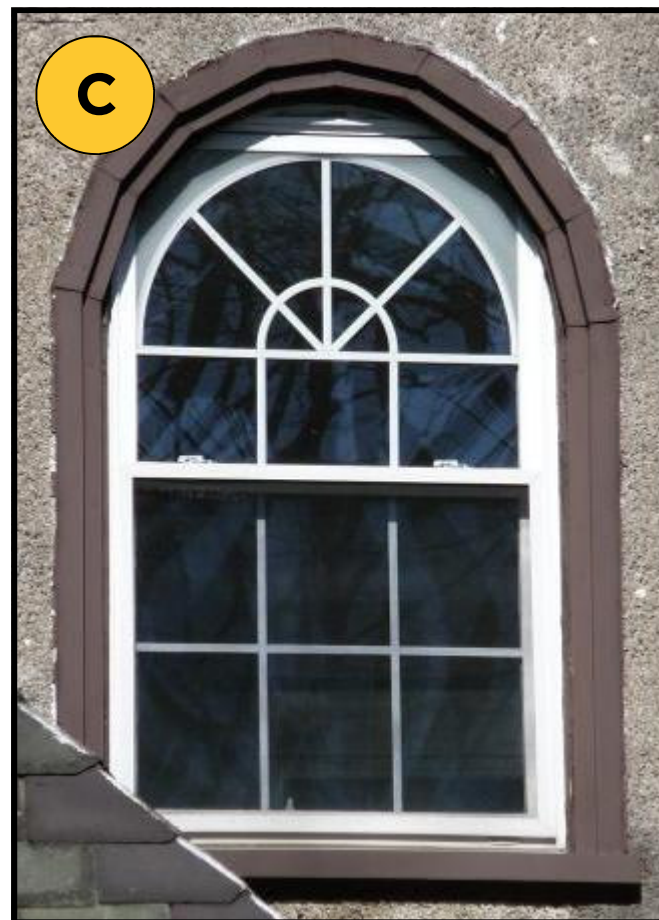
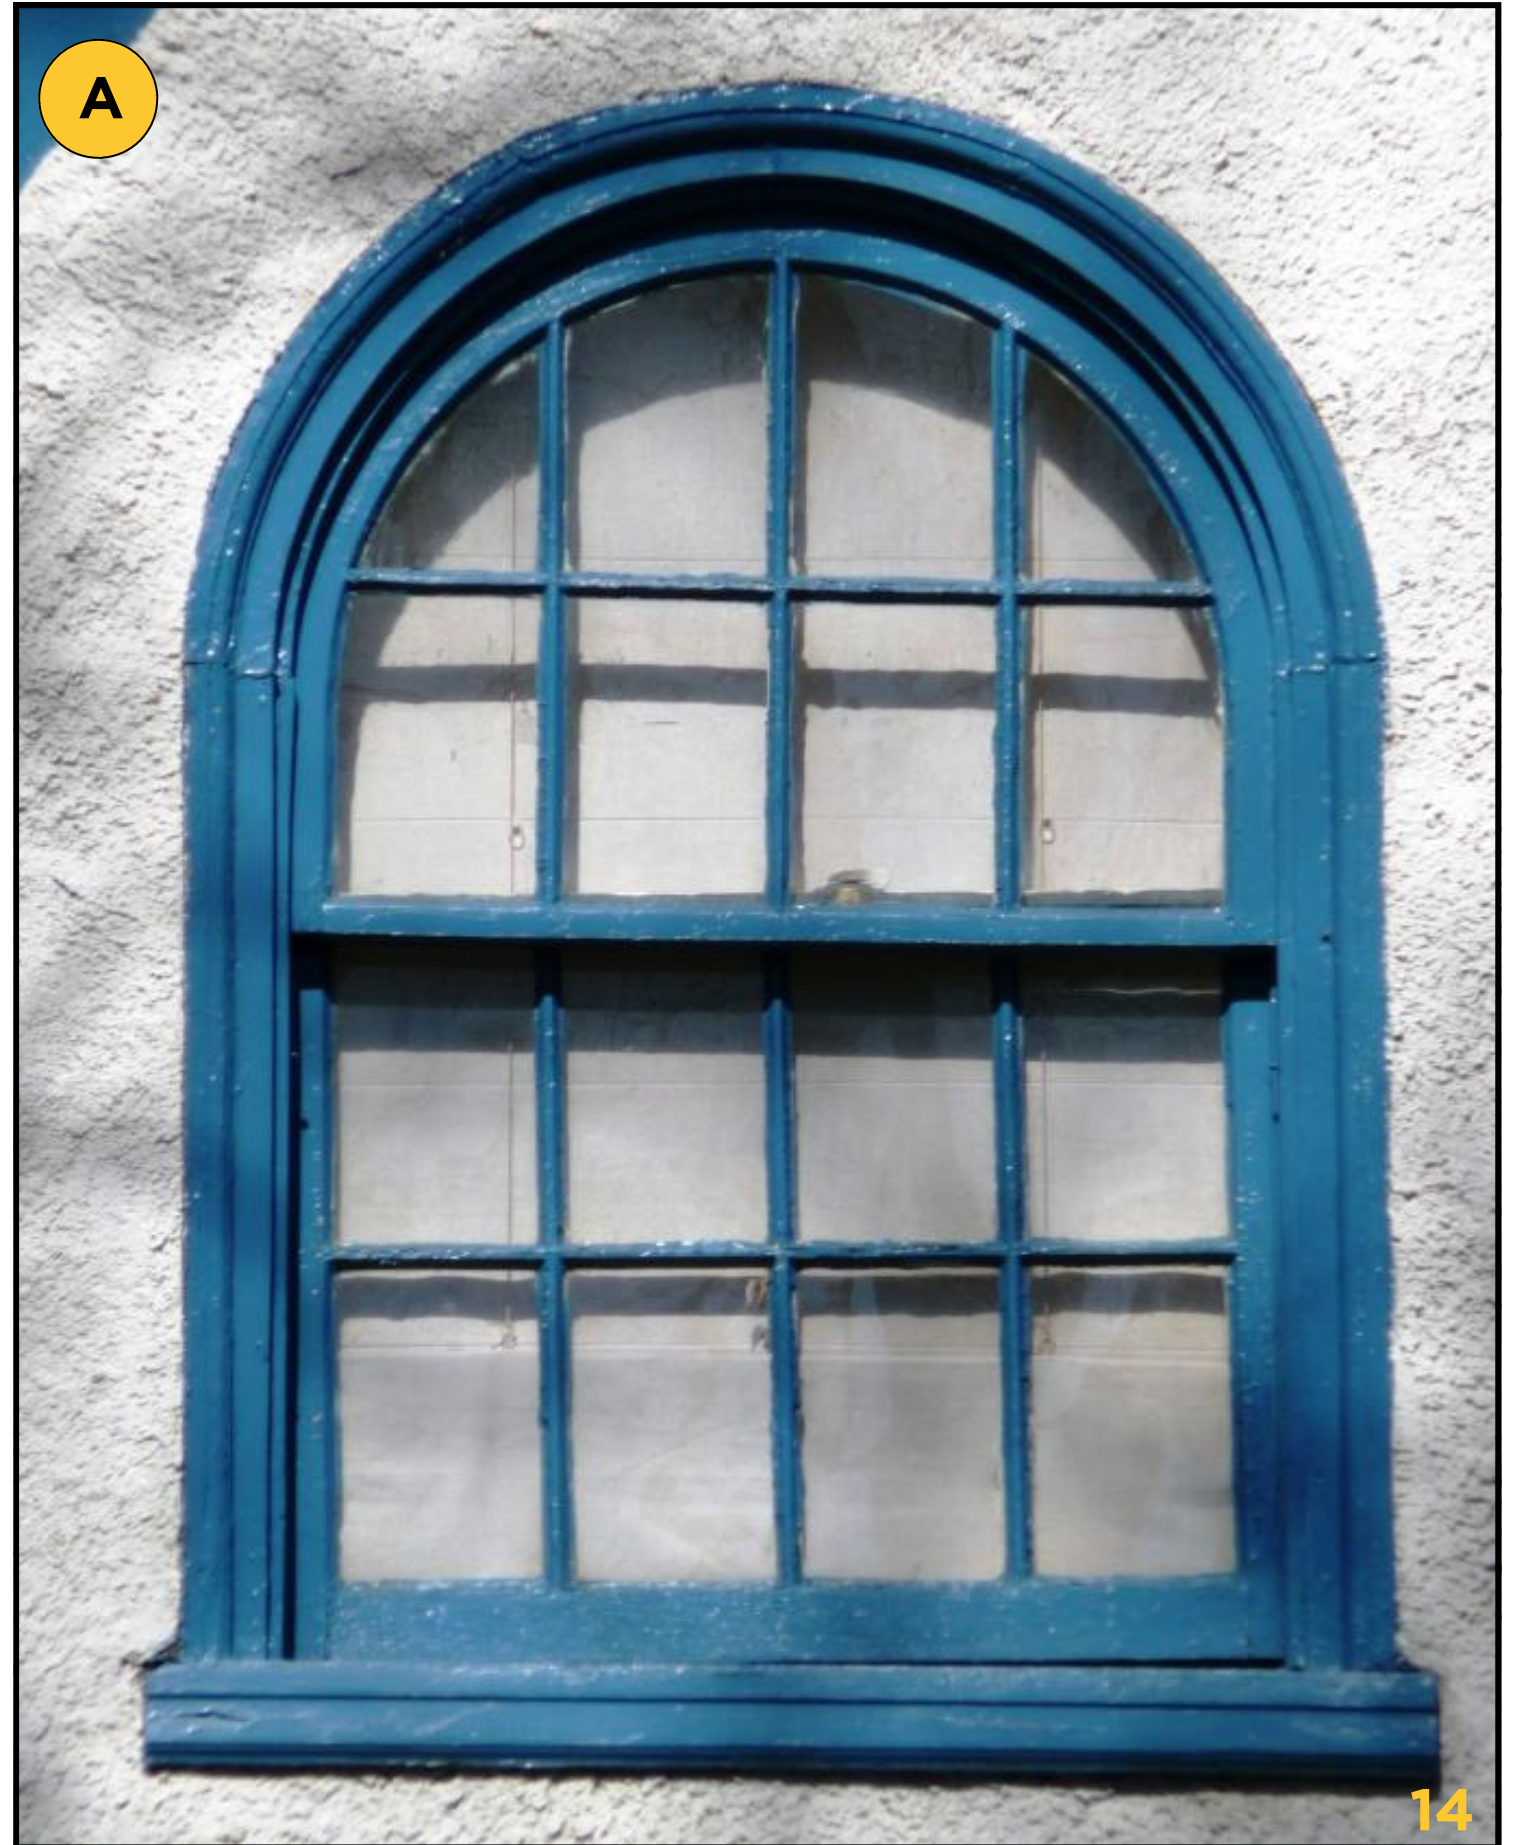
- A This eight-over-eight double-hung sash window with wood casing and sill is a common feature on houses in this neighborhood.
- B This replacement window attempts to replicate details of the original. However, it is not a true divided-light, the casing is wrapped in aluminum and the upper sash is flat and not round arched.
- C This replacement tries to look like a round arched window but is instead flat, features a completely different muntin pattern, has casing wrapped in aluminum and is not a true divided-light.

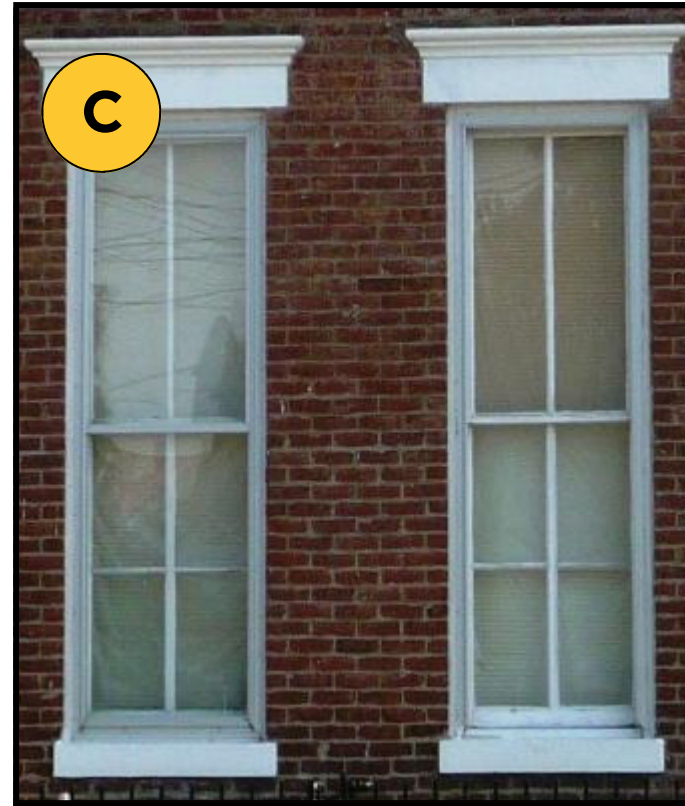
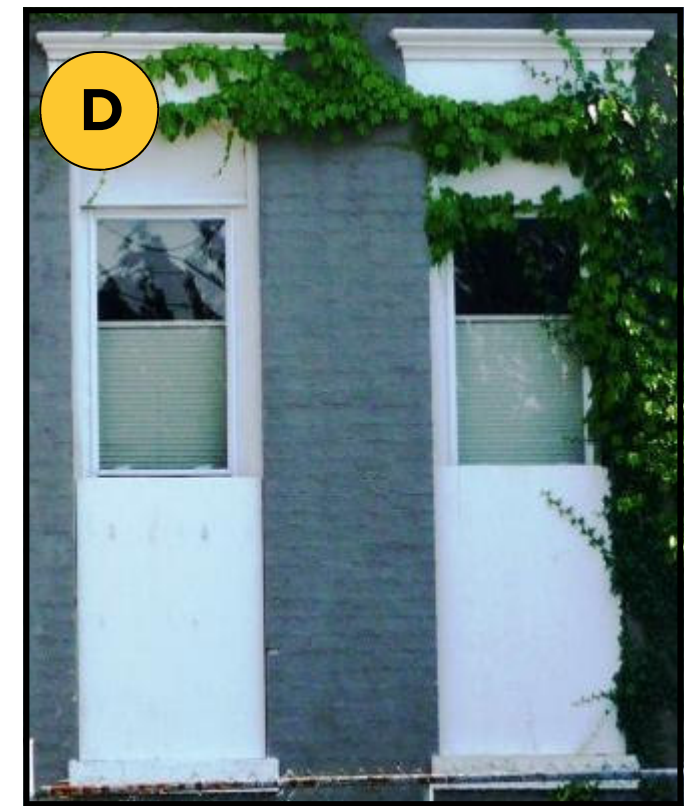
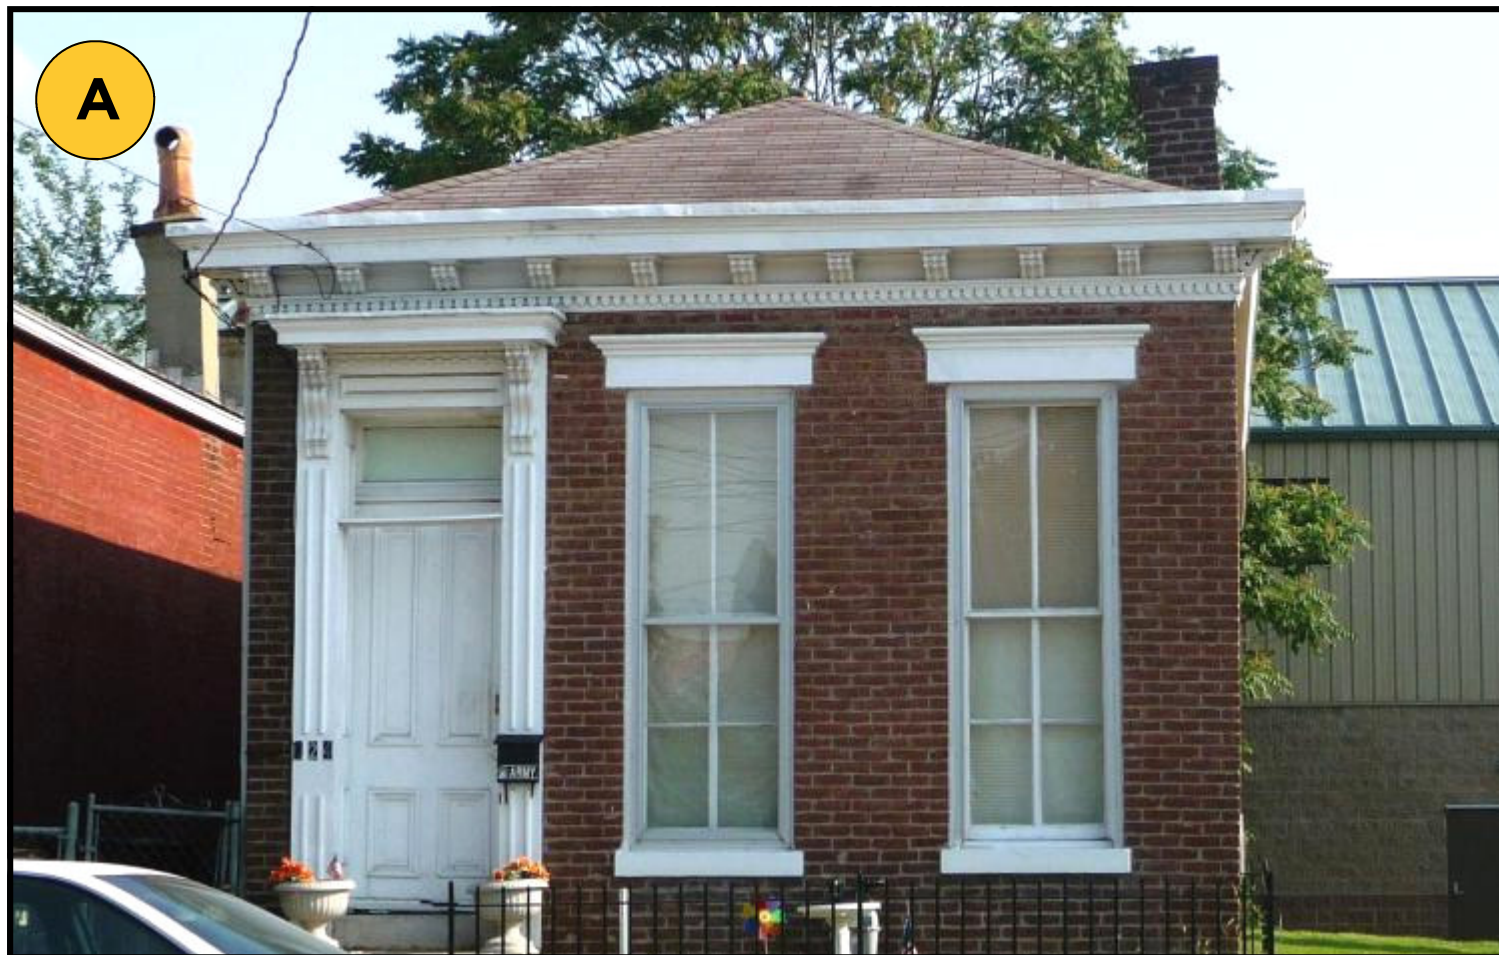
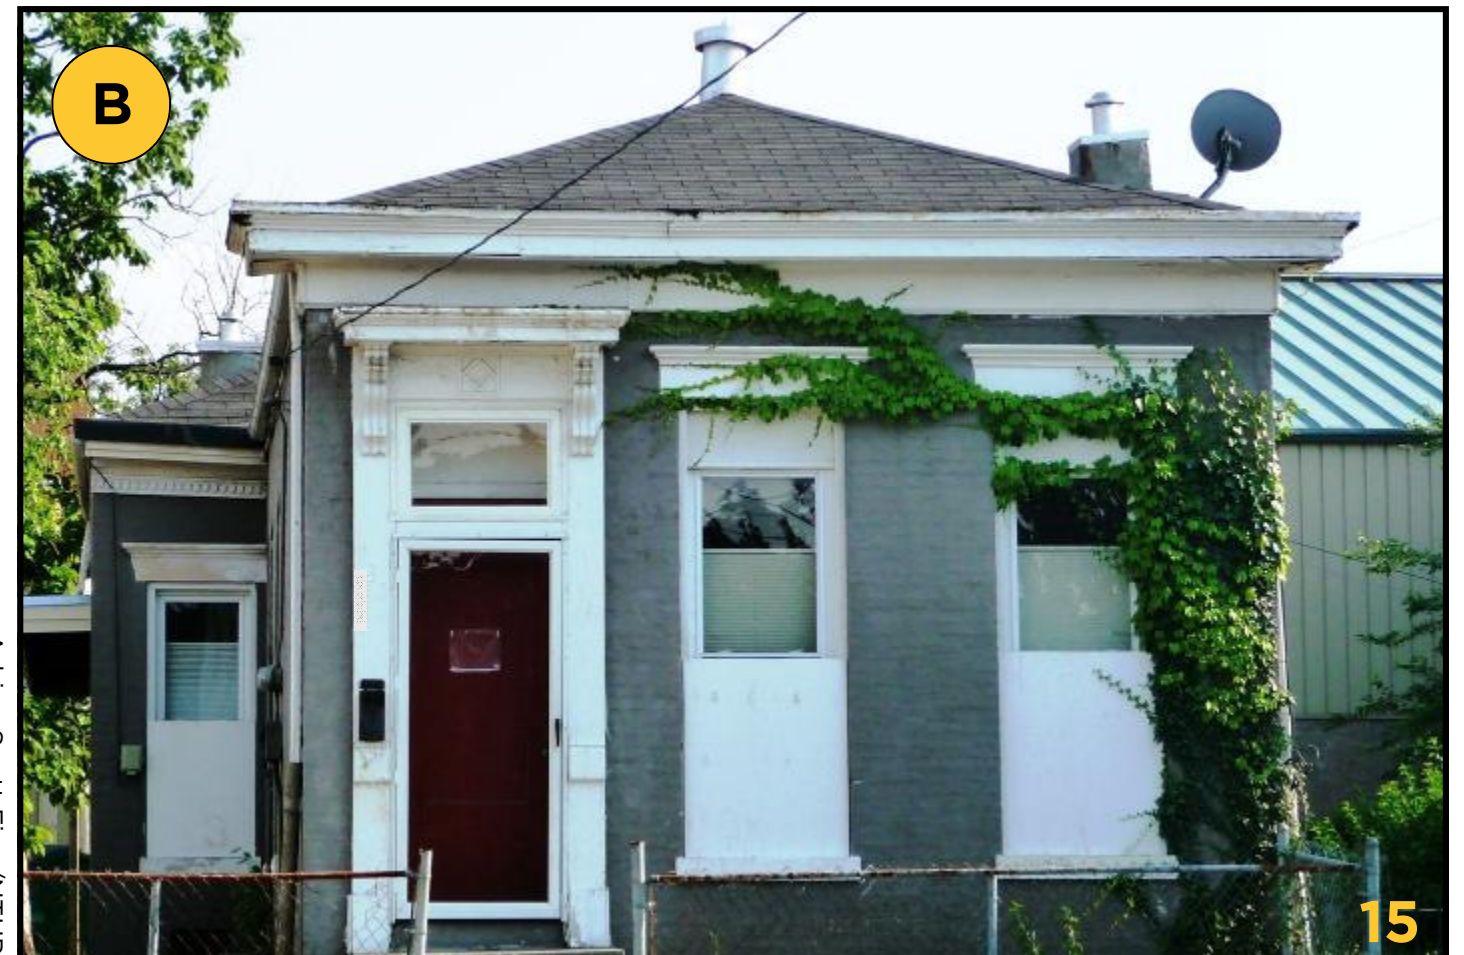
- A, B Two simple Shotgun style homes that were once nearly identical, to each other, and throughout the neighborhood.
- C Original two-over-two double-hung windows are a very prominent feature of these homes, directly relating to the size of the main entrance.
- D. The original windows were replaced, the openings reduced, and stock windows installed that are no longer in scale to the proportions of the house.

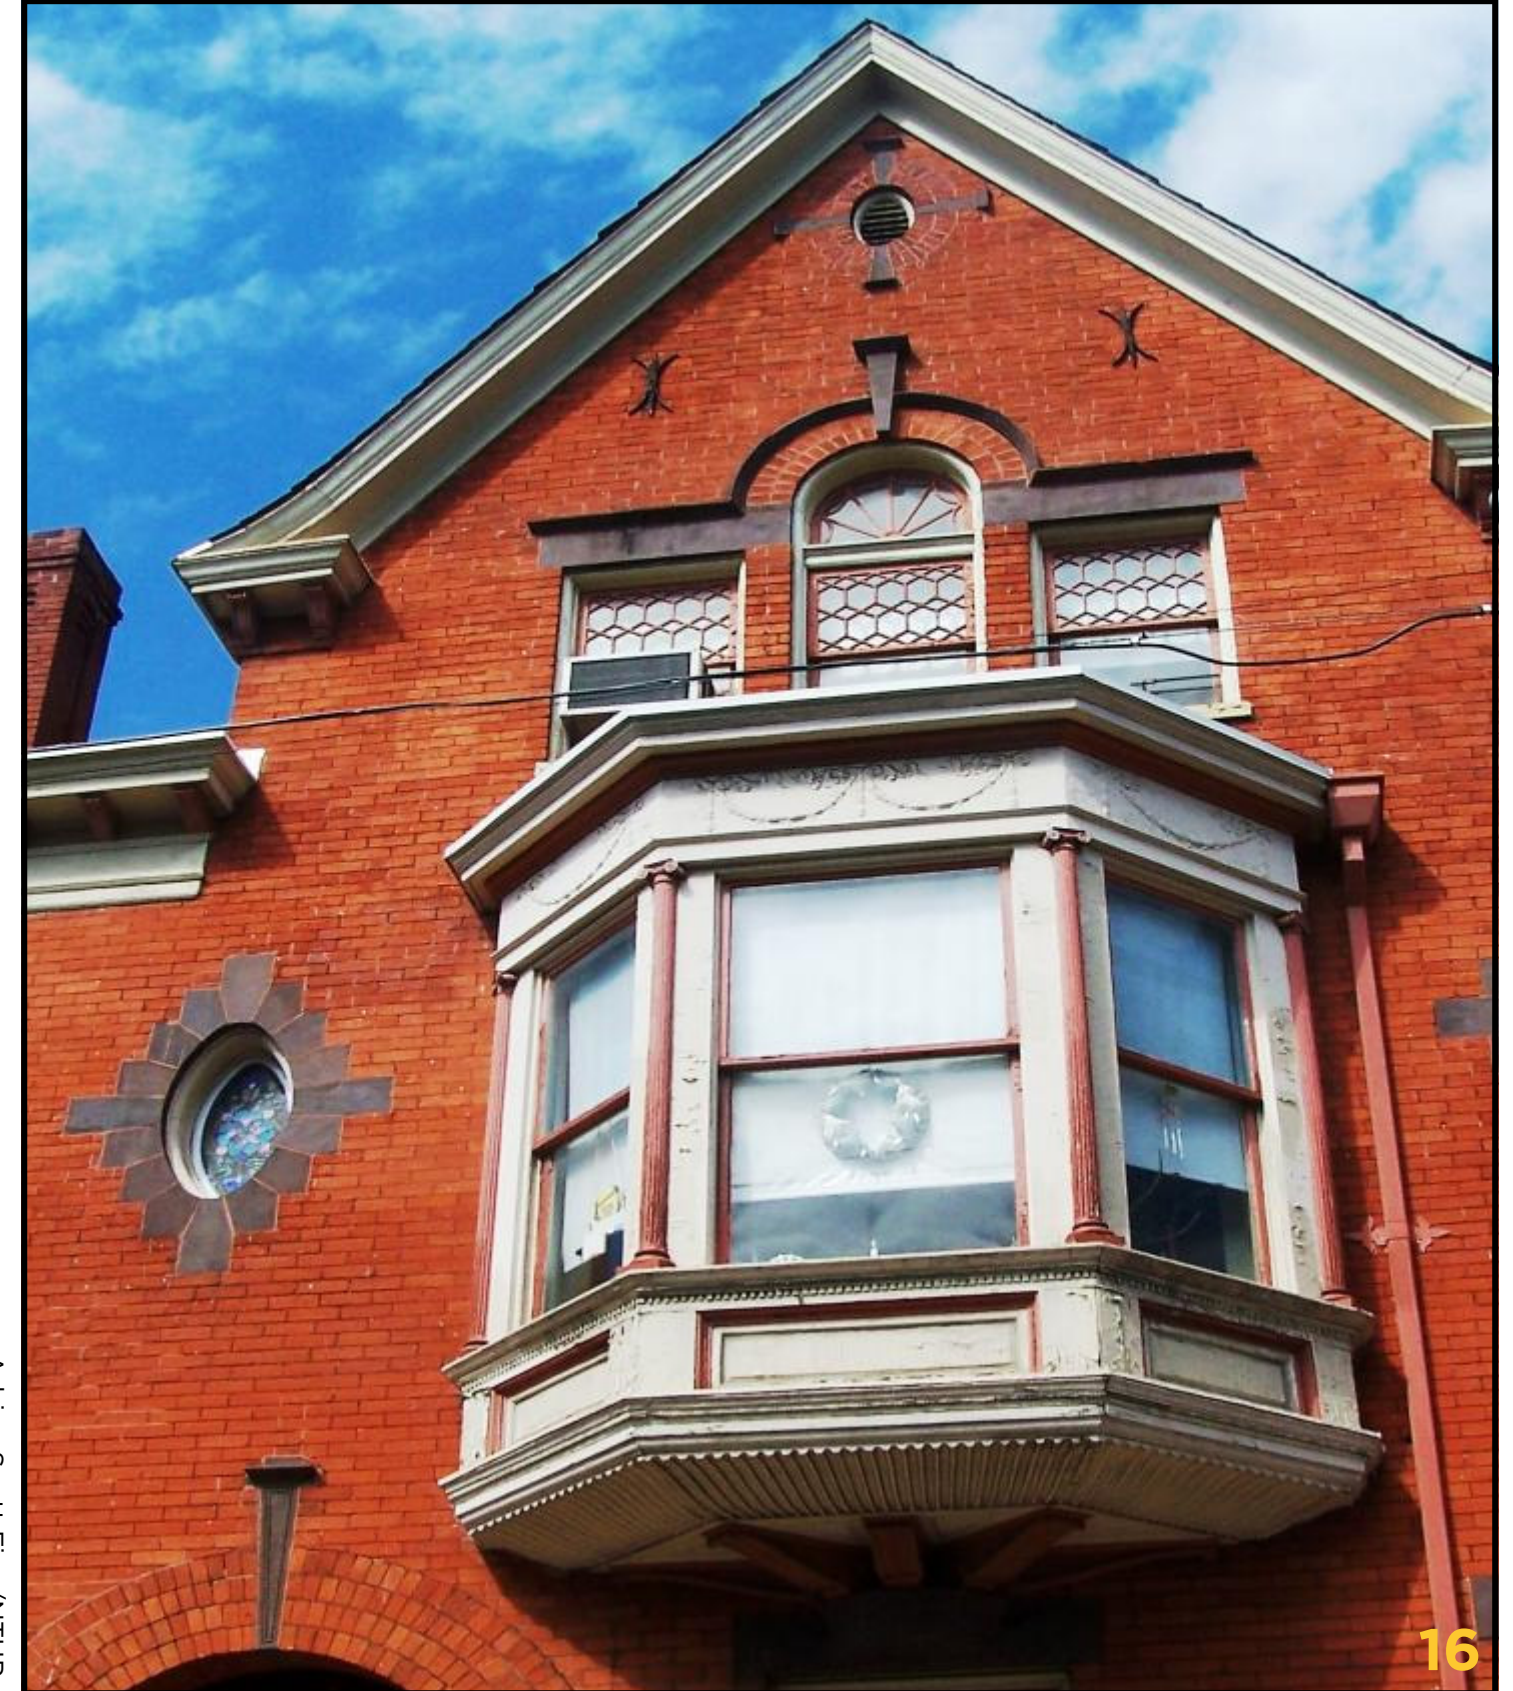
Early 20th century Queen Anne style house
Original windows help define the character of older buildings
