# Boulder Creek Restoration Master Plan

December 2015

Urban Drainage and Flood Control District  
Boulder County, City of Boulder, City of Longmont

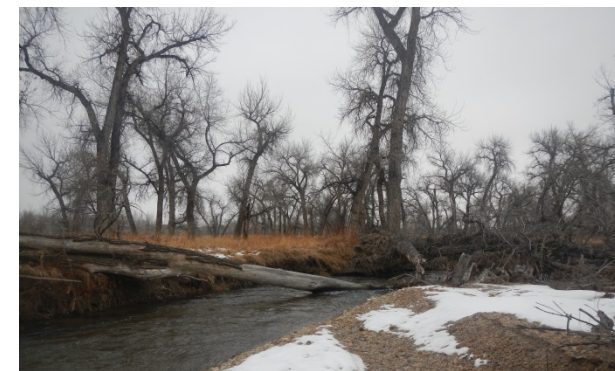
Photo 3: Flood debris along Boulder Creek (Reach 1)

Impacts within this corridor from the 2013 flood primarily reflect avulsions that developed from St. Vrain Creek. During the flood, St. Vrain Creek diverted from its standard path, flowed through adjacent aggregate ponds, and defined a new confluence location with Boulder Creek, approximately 1,600 feet upstream of the historic location. The new confluence location will be carried forward shortening the overall length of Boulder Creek. Although the Boulder Creek generally remained intact, flood debris in this reach still remains.

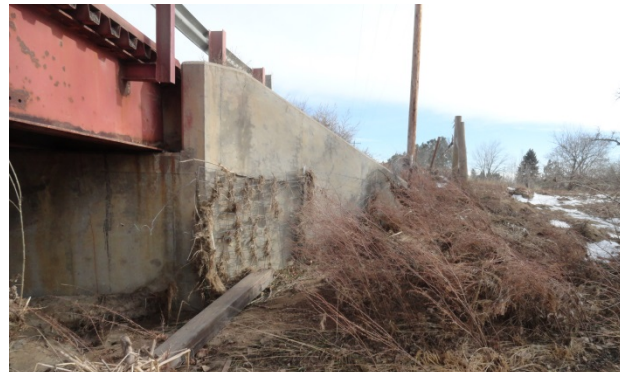
Photo 5: Flood debris at 20½ Road (Reach 2)

Impacts within this corridor from the 2013 flood primary reflect damage along the County’s roadway crossings with Boulder Creek, specifically at County Roads 20½ and 16½. At these locations, flooding resulted in scour around the bridge abutments and piers. The roadways were damaged where they overtopped.

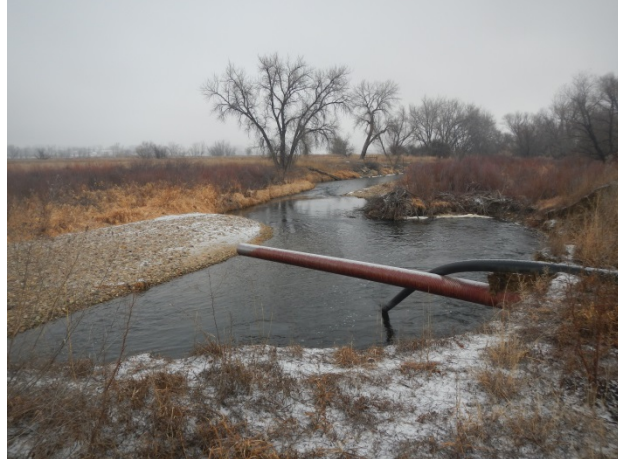
Photo 8: Failed bridge at Bailey-Kenosha Open Space (Reach 4)

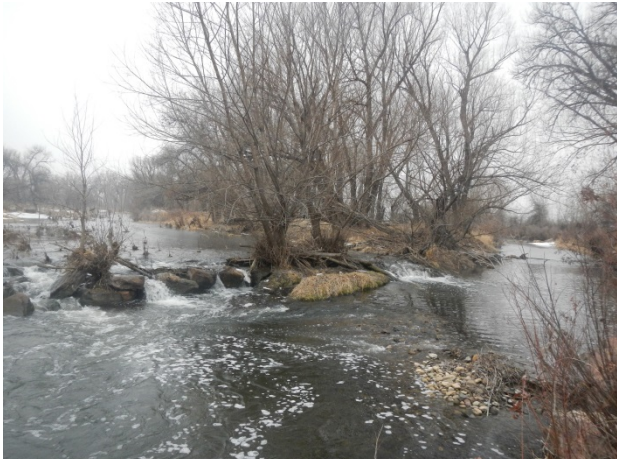
Photo 13: Braided flooding within the Alexander Dawson Open Space (Reach 5)

During the September 2013 flood, Boulder Creek diverted from its banks upstream of US 287 and within the Alexander Dawson Open Space property. The diversion short-cut the preexisting channel and recent restoration features installed by Boulder County and the Urban Drainage and Flood Control District. Overtopping of 95<sup>th</sup> Street caused by creek avulsion upstream of 95<sup>th</sup> Street was also significant, and the roadway failed approximately 1,000 feet north of the current bridge location. Significant damage was also noted to downstream ponds and property. This roadway has since been repaired by Boulder County.

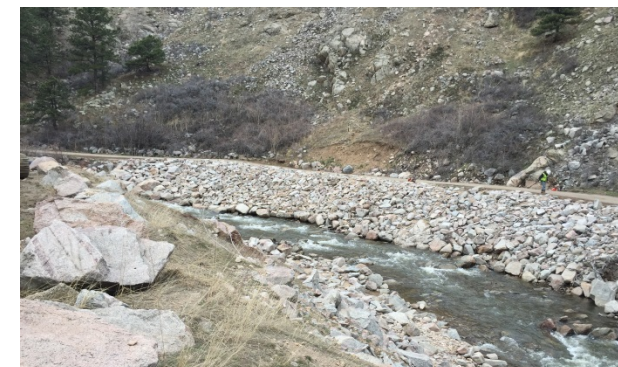
Photo 31: Bank armoring in Boulder Canyon (Reach 10)

Within Boulder Canyon, flood damage occurred to both Boulder Creek and State Highway 119. High velocities contributed to steam erosion, deposition and undermining of roadway infrastructure. Flows from inflow tributaries also overwhelmed infrastructure, resulting in damage to Highway 119. Much of the immediate damage has since been repaired by CDOT; however CDOT is currently planning for more permanent and flood resilient facilities in Boulder Canyon. Stream restoration needs are still prevalent, particularly along the Boulder Creek Path upstream of Settler's Park Trailhead.

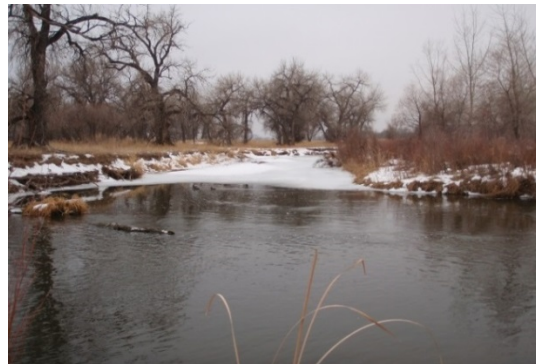
Photo 35. Confluence with St. Vrain Creek. Example of reference standard riparian habitat which includes dense vegetation community with three strata, stable stream banks, a wide floodplain and little human disturbance. Flood flows resulted in minimal damage to the riparian corridor.

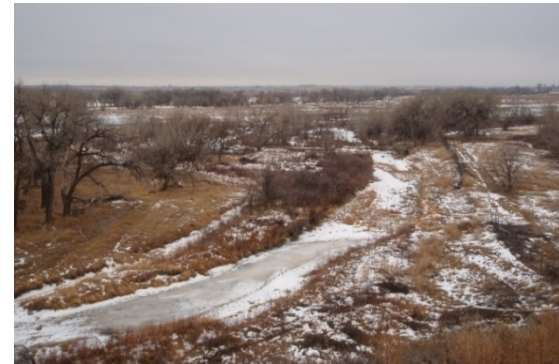
Photo 36. N 107th Street to St. Vrain Creek reach. Here flood flows resulted in abandonment of the pre-flood channel and riparian corridor. Herbaceous vegetation has begun to establish in the previous active channel bottom, indicative of an altered hydrologic regime.

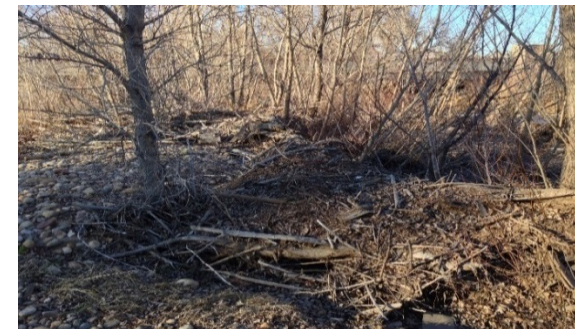
Photo 38. Boulder Creek near Valmont Road. Example of moderate post-flood disturbance to the riparian zone including: significant sediment deposition/vegetation burial, tree damage/loss and significant accumulation of debris from dead/downed trees. While moderate disturbance has occurred in this reach, a majority of the riparian vegetation remains intact and will continue to function.

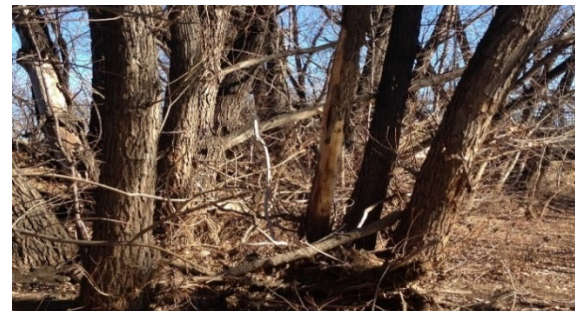
Photo 40. City of Boulder reach example of low-disturbance: debris accumulation and riparian zone tree damage (trunk damage and bark removal) as a result of the flood. For the most part, while damaged, a majority of the riparian vegetation community will persist and continue to function.

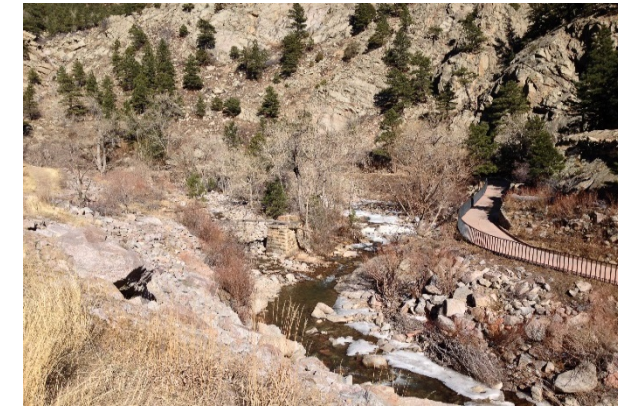
Photo 41. Boulder Canyon reach. The existing riparian zone is characterized by one vegetation strata including either trees or shrubs with no mid- or understory present. Flood damages to the riparian zone are low. Much of the riparian zone remains intact with little change the pre-flood condition.

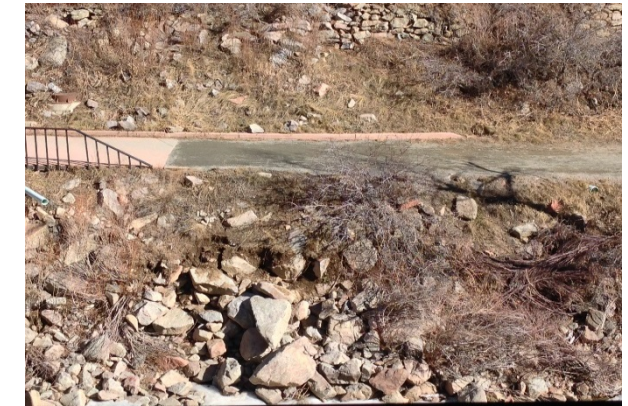
Photo 42. Boulder Canyon reach example of low post-flood disturbances which includes only minor bank erosion and shrub damage.

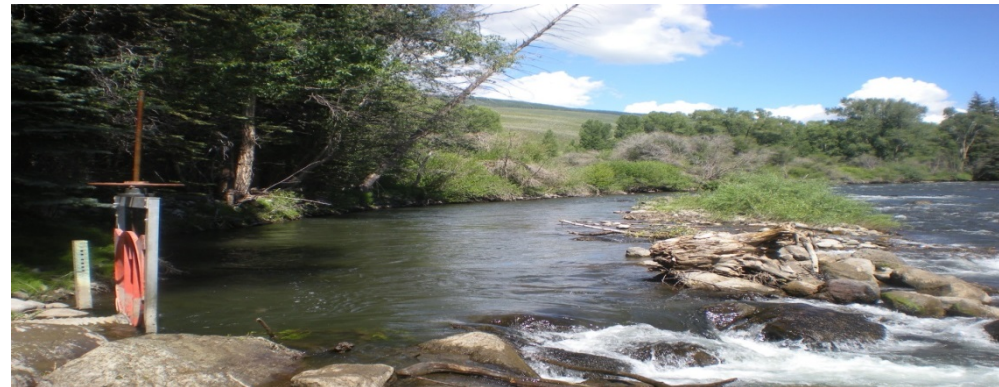
Photo 9.1 - Example of diversion structure and fish passage channel (ERC, East River)

- **Stream Stabilization and Ditch Diversions:** Numerous water diversion points exist in Boulder Creek. Currently very few of the existing diversions structures also accommodate fish passage or macro-invertebrates common to the region. Improvements are recommended to retro-fit or rebuild diversions to satisfy this multi-objective need. Specifically these systems are proposed to be replaced with sloped drop faces and fish passage measures. Each diversion point would still be required to also maintain adequate depth to satisfy the decreed discharge for water diversion. These conversions will allow the adjacent

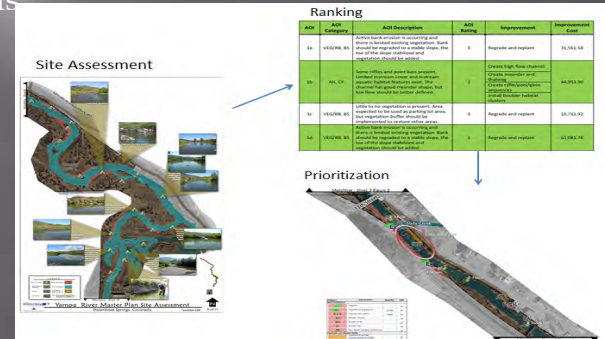
The diagram shows a 'Site Assessment' map of a stream reach with various features. An arrow points to a 'Ranking' table, which then points to a 'Prioritization' map showing the same reach with different colors indicating priority levels.

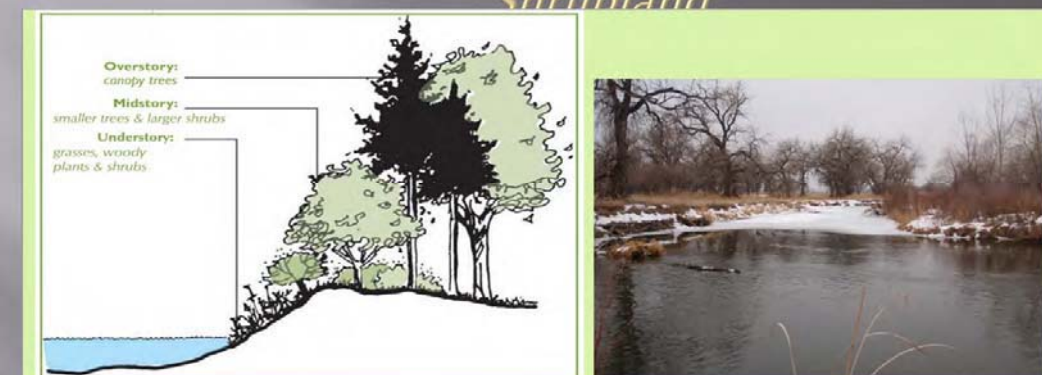
FIGURE 1. NATURAL RIPARIAN CORRIDORS OF HIGH ECOLOGICAL INTEGRITY TYPICALLY CONTAIN THREE DISTINCT LAYERS OF VEGETATION — OVERSTORY FOREST CANOPY OF TREES, MIDSTORY OF SHRUBS AND AN UNDERSTORY OF GRASSES. (MODIFIED FROM: MONTGOMERY COUNTY PLANNING COMMISSION 2006).

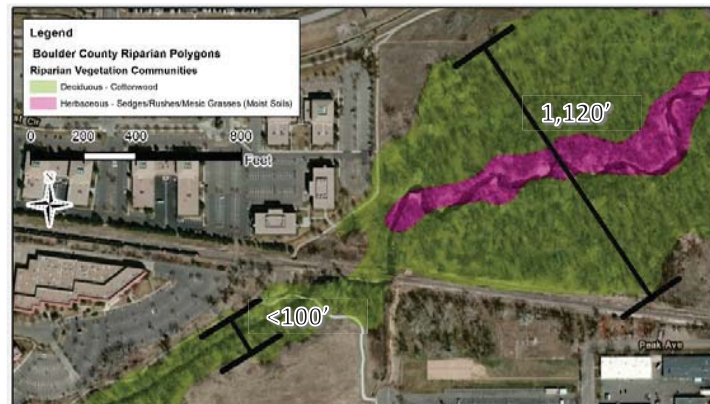
FIGURE 4. EXAMPLE OF VARYING RIPARIAN ZONE WIDTHS THROUGH THE PROJECT AREA. THE NARROW RIPARIAN ZONE (LEFT) IS LIMITED BY LAND USE AND BISECTED BY A RAILROAD; THE MORE NATURALIZED DOWNSTREAM SECTION (RIGHT) IS WIDE AND LESS CONFINED. (NOTE: EXAMPLE IS PROVIDED FOR RIPARIAN WIDTH CHARACTERISTICS ONLY - SITE SPECIFIC VEGETATION COMMUNITIES AND SPECIES MAY NOT REPRESENT AN APPROPRIATE RESTORATION TARGET.)

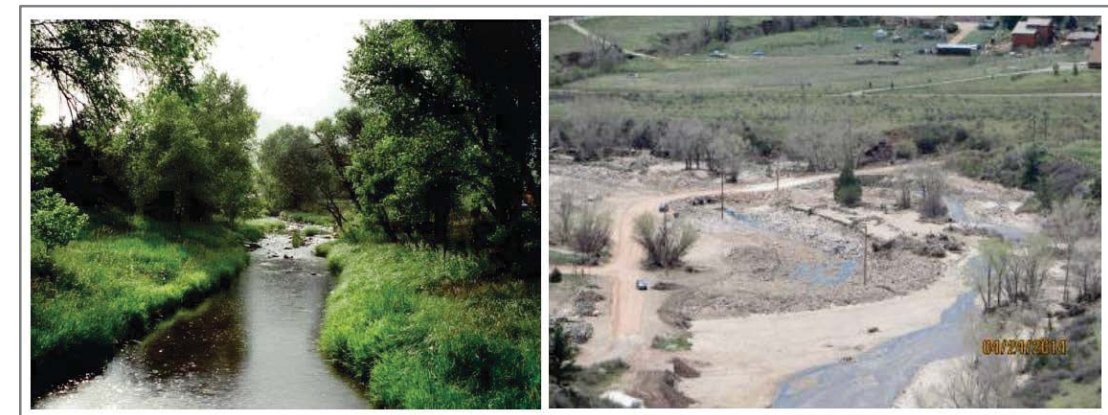
FIGURE 6. EXAMPLE OF NEARLY COMPLETE RIPARIAN ZONE LOSS: FROM LITTLE THOMPSON WATERSHED RESTORATION MASTER PLAN (DECEMBER 2014) [FIGURE 1.2 LITTLE THOMPSON RIVER AT BLUE MOUNTAIN NEIGHBORHOOD (FORMERLY X-BAR 7) BEFORE AND AFTER THE SEPTEMBER 2013 FLOOD.]

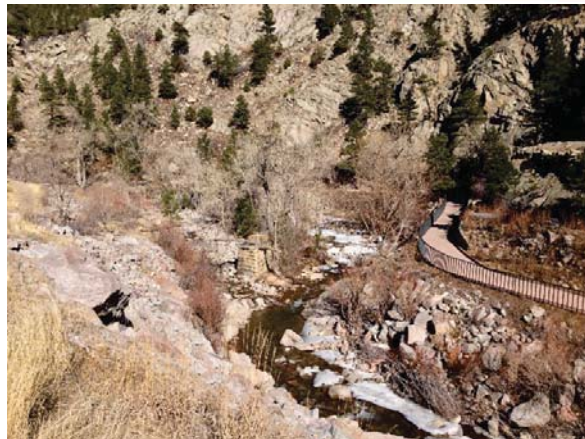
**Photo 1.** Boulder Canyon reach. The existing riparian zone is characterized by one vegetation strata including either trees or shrubs with no mid- or understory present. Flood damages to the riparian zone are low. Much of the riparian zone remains intact with little change the pre-flood condition.

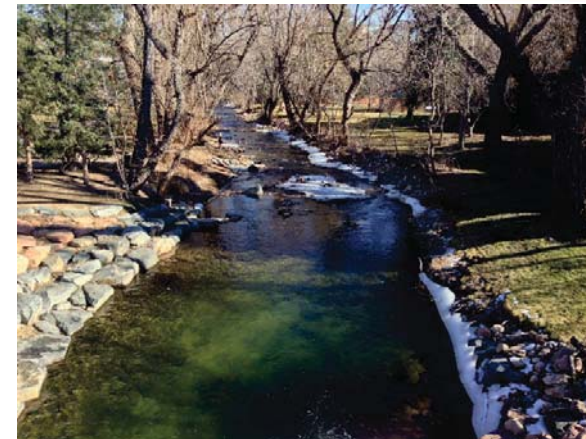
**Photo 3.** Highly urbanized area within City of Boulder reach characterized by overstory trees and armored stream banks. Through this reach, Boulder Creek overtopped its banks and inundated the existing riparian zone. After the flood event, the riparian zone remains relatively intact with little change from the pre-flood condition.

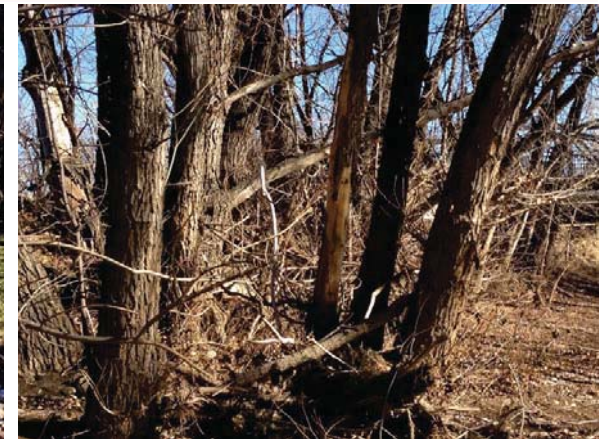
**Photo 4.** City of Boulder reach example of low-disturbance: debris accumulation and riparian zone tree damage (trunk damage and bark removal) as a result of the flood. For the most part, while damaged, a majority of the riparian vegetation community will persist and continue to function.

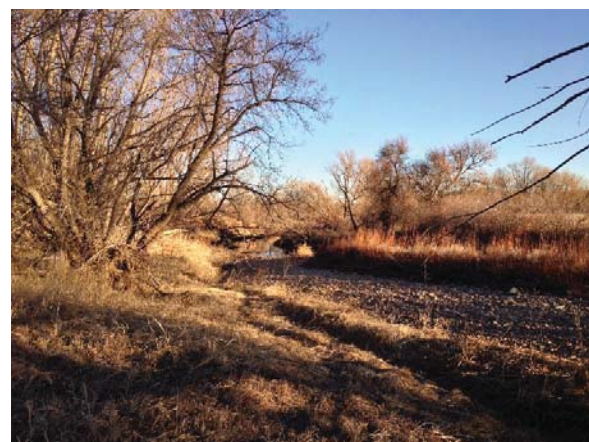
**Photo 5.** Boulder Creek east from 61<sup>st</sup> Street. Example of wide, well vegetated riparian zone with only moderate post-flood disturbance to the riparian zone. At this location, flood flows deposited significant amounts of cobble material within the existing overly wide stream channel which resulted in altered stream flow. The riparian zone is now disconnected from stream flow which can result in long-term habitat community shifts or complete loss of riparian species.

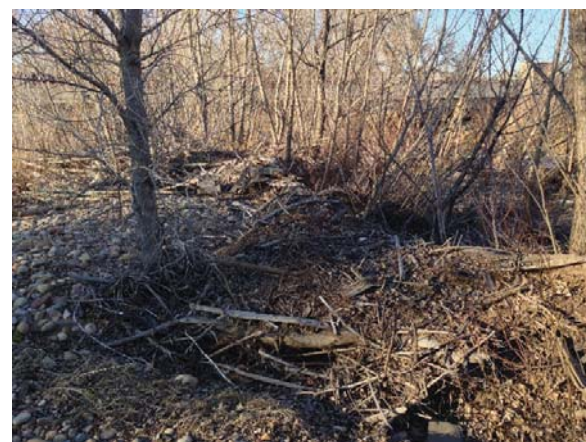
**Photo 6.** Boulder Creek near Valmont Road. Example of moderate post-flood disturbance to the riparian zone including: significant sediment deposition/vegetation burial, tree damage/loss and significant accumulation of debris from dead/downed trees. While moderate disturbance has occurred in this reach, a majority of the riparian vegetation remains intact and will continue to function.

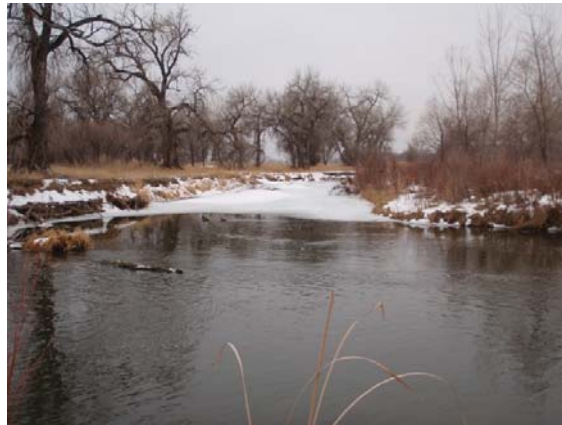
**Photo 7.** Confluence with St. Vrain Creek. Example of reference standard riparian habitat which includes dense vegetation community with three strata, stable stream banks, a wide floodplain and little human disturbance. Here flood flows resulted in minimal damage to the riparian corridor.

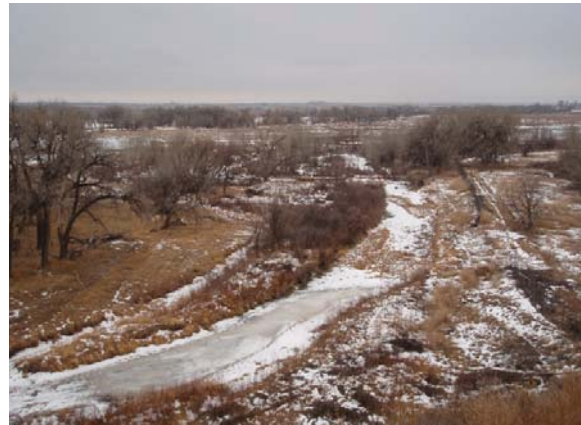
**Photo 8.** N 107th Street to St. Vrain Creek reach. Here flood flows resulted in abandonment of the pre-flood channel and riparian corridor. Herbaceous vegetation has begun to establish in the previous active channel bottom, indicative of an altered hydrologic regime.

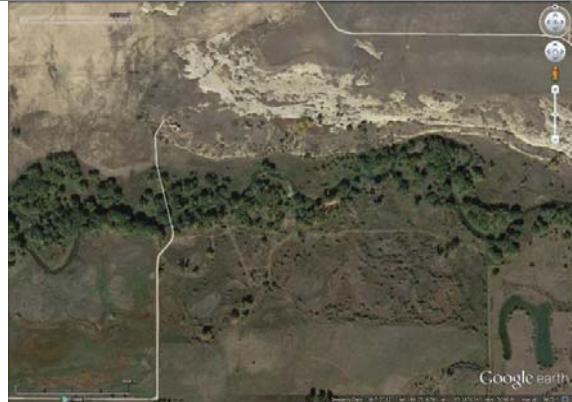
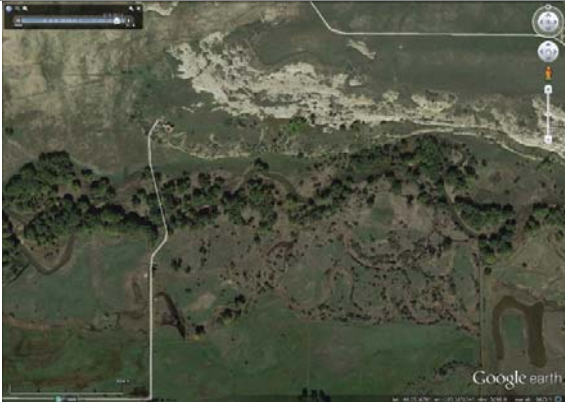
<p><b>Foothills to N 107th Street reach.</b> Pre-flood conditions east of 75th Street. In this less disturbed section of the reach, Boulder Creek is not confined, the riparian zone is well developed and able to access the active floodplain.</p>	<p>Example low post-flood disturbance, east of 75th Street. In this section, the riparian zone had functioned properly by allowing flood flows to dissipate on the floodplain; therefore, the post-flood disturbance to the riparian zone is low and includes only localized stream bank erosion/failure and/or tree damage/loss. In these low disturbance areas, the riparian zone remains intact and functioning.</p>

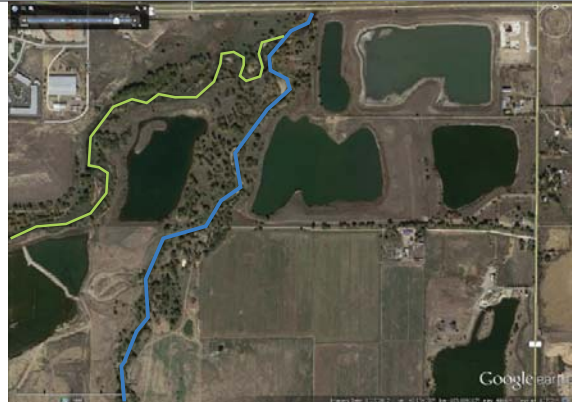
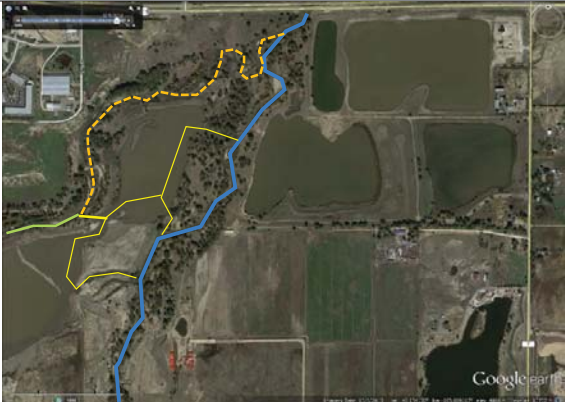
<p><b>N 107th Street to St. Vrain Creek reach.</b> Pre-flood conditions south of Hwy 119. Variable conditions along Boulder Creek (right, blue line). Saint Vrain Creek is shown on the left (green line). Portions of this reach are well vegetated and able to access the floodplain, while other areas are narrow and more confined as a result of historic gravel mining.</p>	<p>Example moderate post-flood disturbance, south of Hwy 119. Extreme flood flows through historically confined sections of Boulder Creek resulted in channel breach through existing gravel ponds (yellow line). A breach also occurred on Saint Vrain Creek (left, green line) which resulted in channel abandonment (orange line). As a result of the flood, the existing well vegetated riparian zone through this reach is threatened from altered stream flow which can result in long-term habitat community shifts or complete loss of riparian species.</p>
