2019-2020 Parking Study Report

Human Dimensions Work Group
City of Boulder Open Space & Mountain Parks

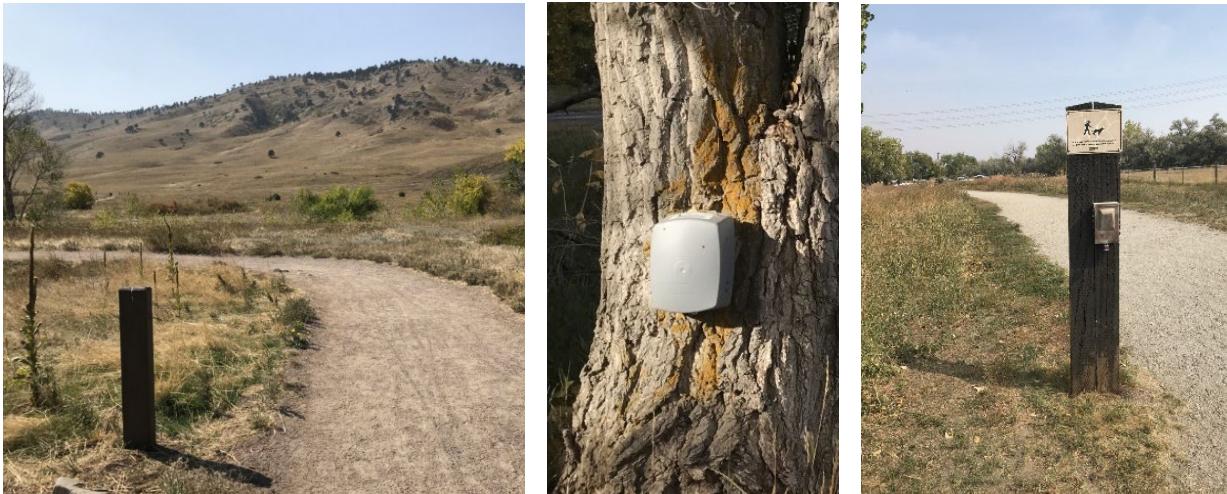
Figure 2. Types of passive infrared trail counters used in the study. From left to right: Eco-Counter PYRO, Eco-Counter PYRO-Box, TRAFx Generation III.

Trail counters were considered for locations where installing a vehicle counter was not feasible. Three passive infrared trail counter types were used for this study: Eco-Counter PYRO, Eco-Counter PYRO-Box, and TRAFx Generation III (Figure 2). Most of the Eco-Counter PYRO units were already installed for a separate long-term visitation monitoring effort. The Eco-Counter PYRO-Box and TRAFx units were installed for this study and are intended for shorter-term use. At these locations hourly trail counts can be paired with human observed vehicle counts. Where there are strong relationships between trail counts and vehicle counts, relative trail visits can provide an estimate for percent lot occupancy. This additional analysis is done on a site-by-site basis as feasible based on the strength of the correlation between trail and vehicle counts. Trail counters were in place through most of the study period with counts aggregated to hourly intervals.

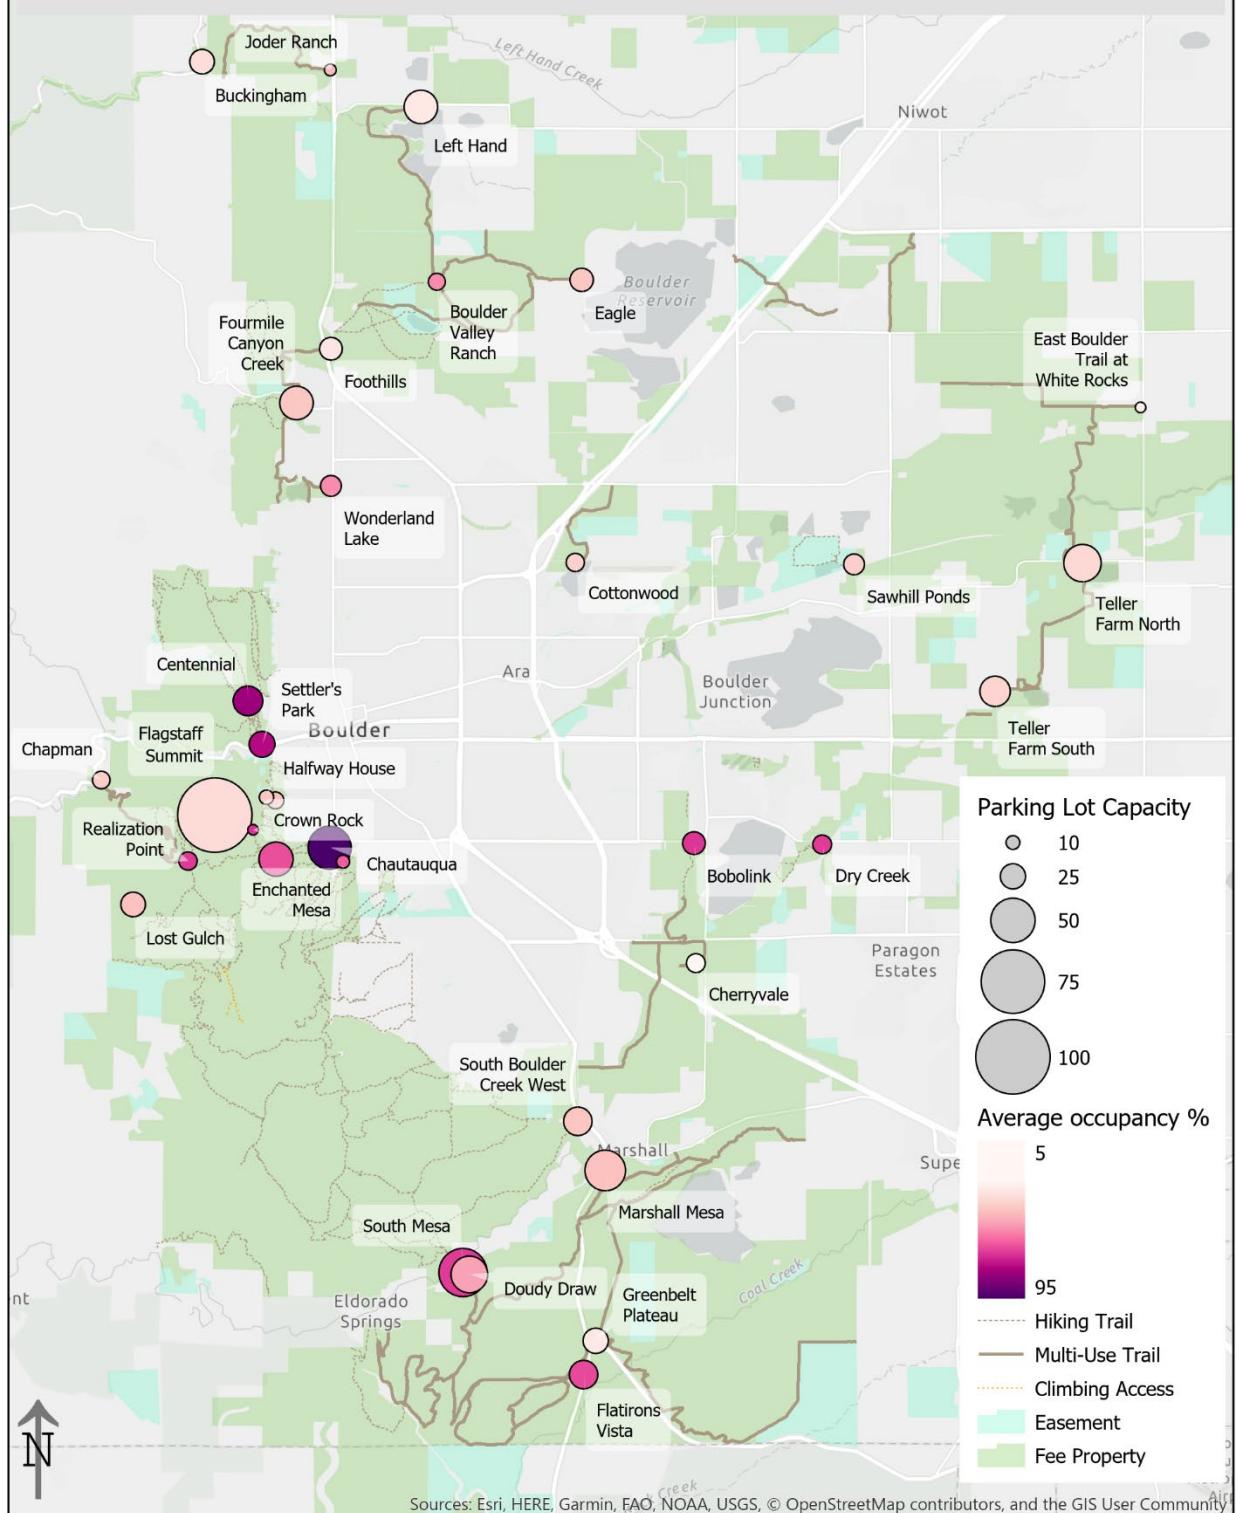
**OSMP parking lot capacity and average observed occupancy
2019 - 2020 Parking Study: Phase I**

Figure 4. Lot Size and Average Percent Occupancy from 9 a.m. to 5 p.m. Shows data collected from June 2019 through March 2020.

This relationship is further described in the Figure 4 map (below), which spatially shows average percent occupancy (color) and lot capacity (circle size). The largest circle on the map is Flagstaff Summit with 89 standard spaces. This represents all spaces, including pull-offs, that are past the gate at Realization Point. Examples of lots with relatively larger parking areas with lower average occupancy include Flagstaff Summit, Marshall Mesa, and Teller Farm North. Relatively smaller lots with higher average occupancy include Bobolink and Dry Creek.

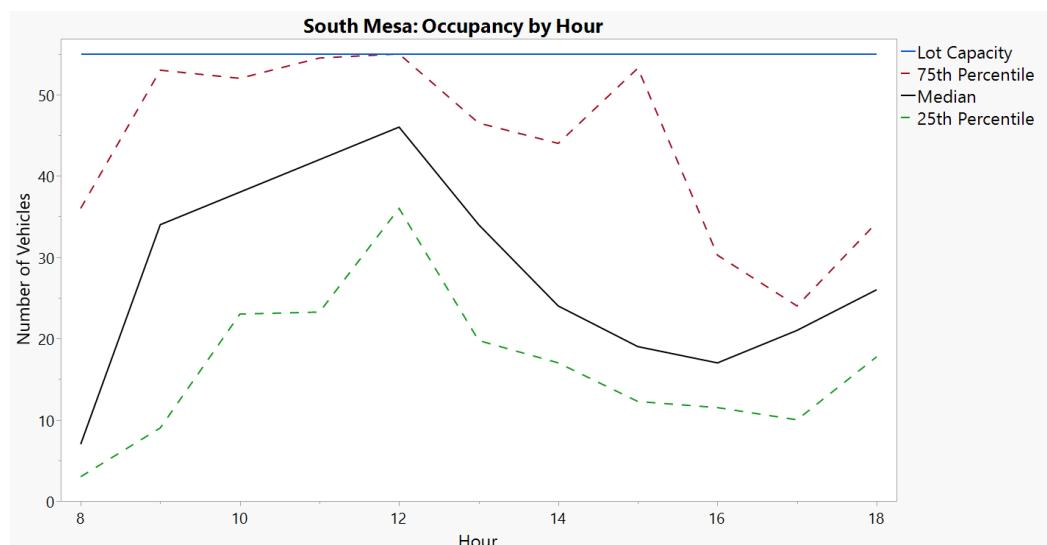
Figure 5. Hourly occupancy data for South Mesa for hours with at least two data points. Shows data collected from June 2019 through March 2020.

A higher level of detail can be obtained on a site-by-site basis. For example, Figure 5 below shows hourly occupancy data for South Mesa for hours with at least two data points. Based on these data, South Mesa was observed to be at 57% occupancy with 31 vehicles parked during the day on average. This slightly differs from the 61% listed in Table 3 above because it is based on data from 8 a.m. to 7 p.m. as opposed to 9 a.m. to 5 p.m. (the timeframe with which staff can most accurately compare sites to each other). For locations where cameras were installed, 24-hr data are provided, as well as weekday and weekend variations because sufficient datapoints were collected to provide that level of detail (e.g., Lost Gulch Overlook in Figure 6). Overall occupancy estimates for observations were restricted to 7 a.m. to 6 p.m., since these were the typical daylight hours during the study period (June through March).

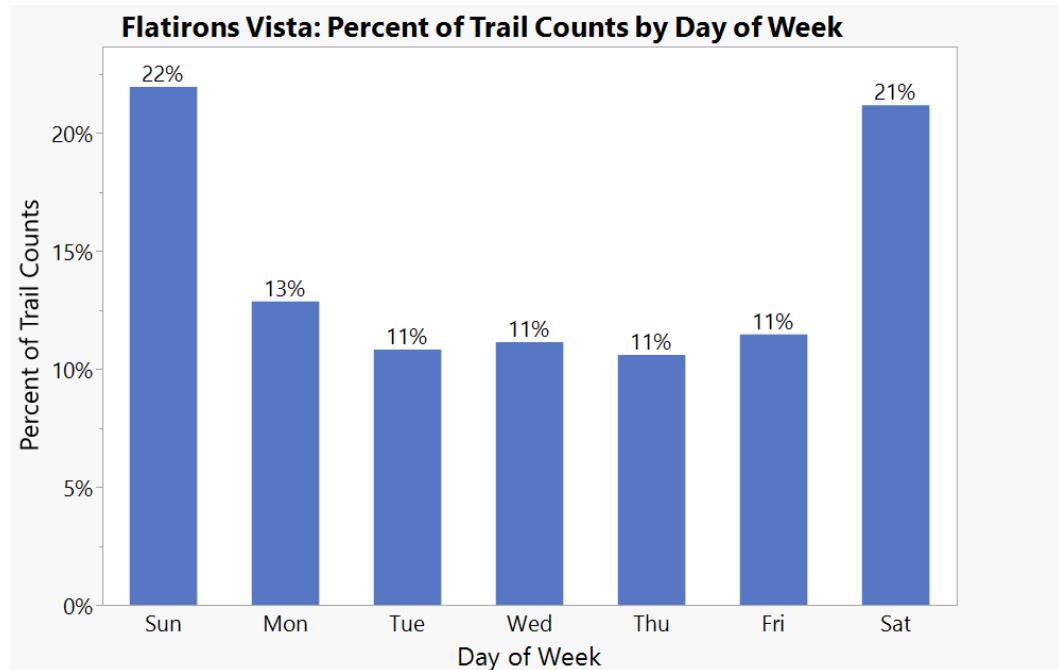
Figure 8. Percent of trail counts by day of week at Flatirons Vista. Shows data collected from June 2019 through March 2020.

At locations where vehicle and trail counters were installed, relative use can be estimated by day of the week in terms of the percent of vehicle and trail counts by day of the week (Figure 7 and Figure 8).

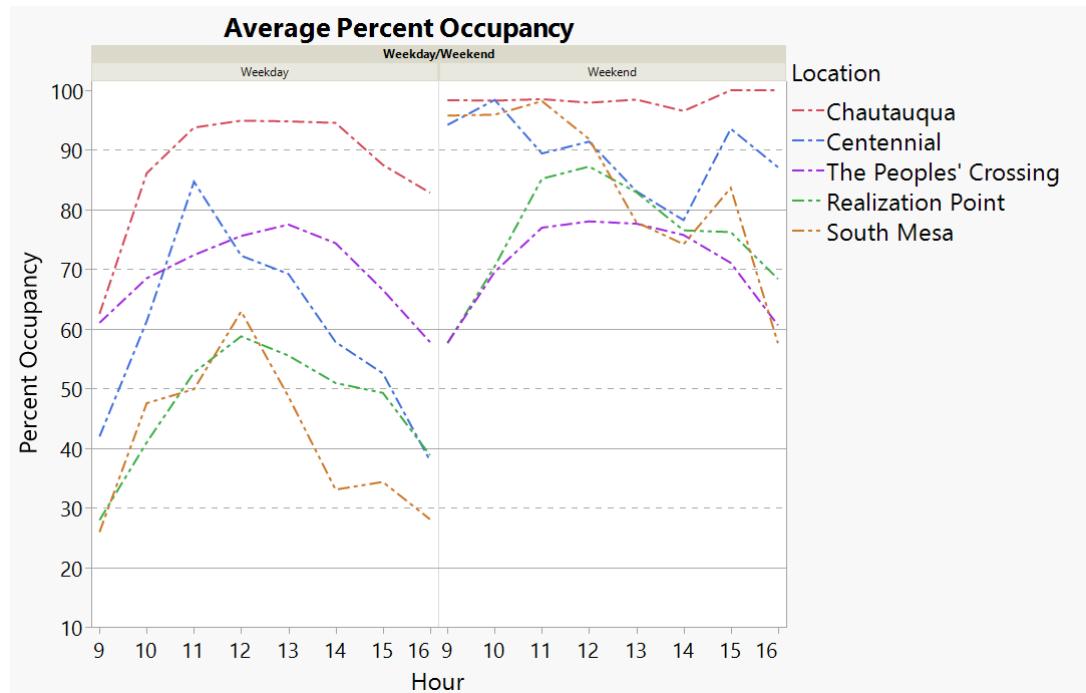
Figure 9. Hourly average percent occupancy by weekday and weekend. Shows data collected from June 2019 through March 2020.

An hourly comparison of the five highest percent occupancy lots is shown in Figure 9 below. Note how the distribution for The Peoples' Crossing looks very similar for weekdays and weekends, while the other locations show more variation. A site-specific summary of each location can be found in Appendix C: Results by Location.

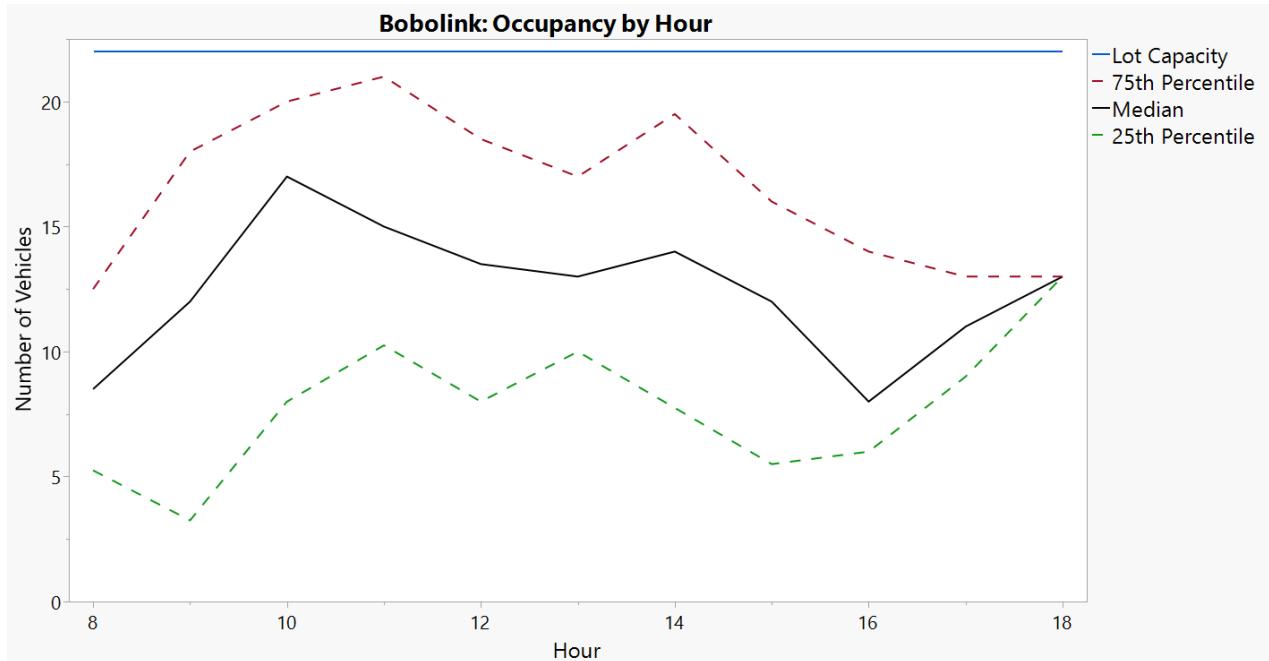
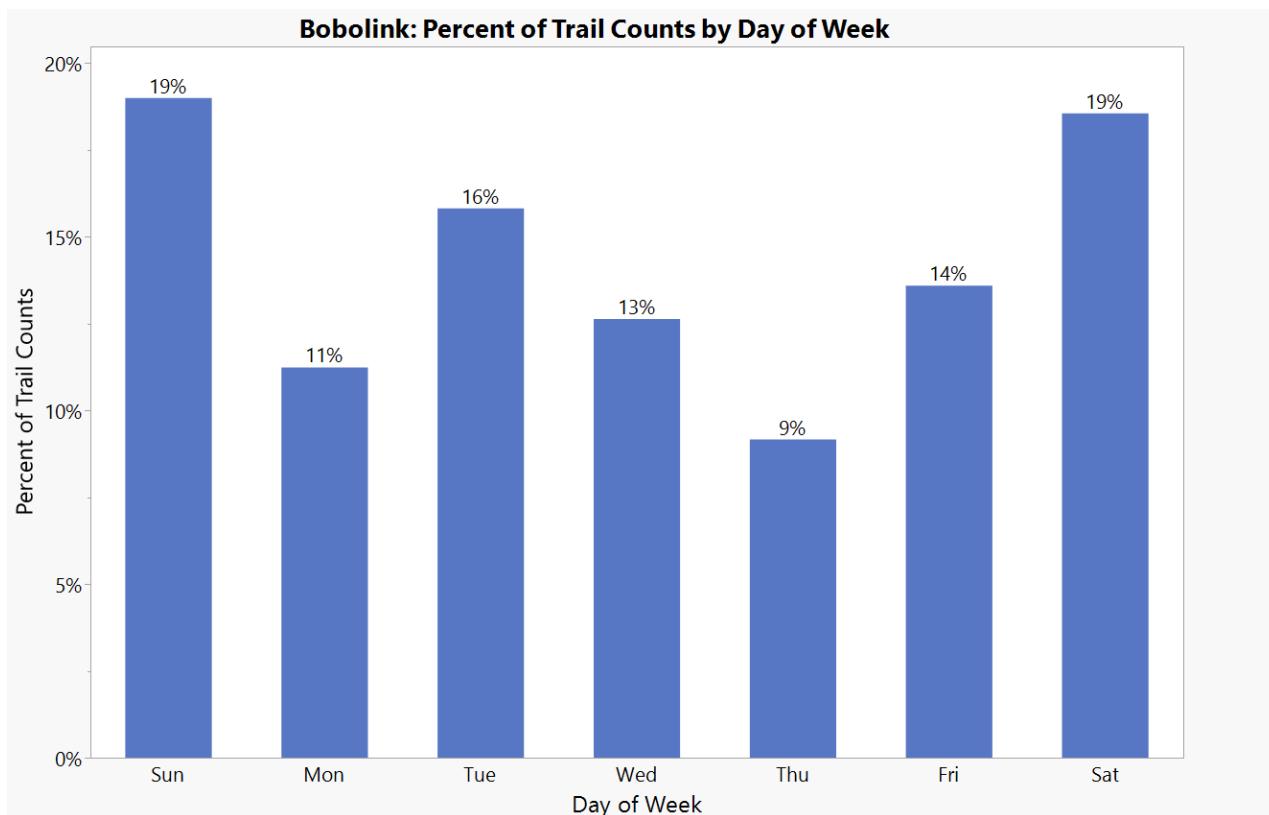
On average, Bobolink was observed to be at **58%** occupancy with 13 vehicles parked during the day (2019-2020). This ranged from 49% on weekdays (11 vehicles) to 75% on weekends (17 vehicles). The lot was observed to be completely full 8 out of 100 observations (8%).

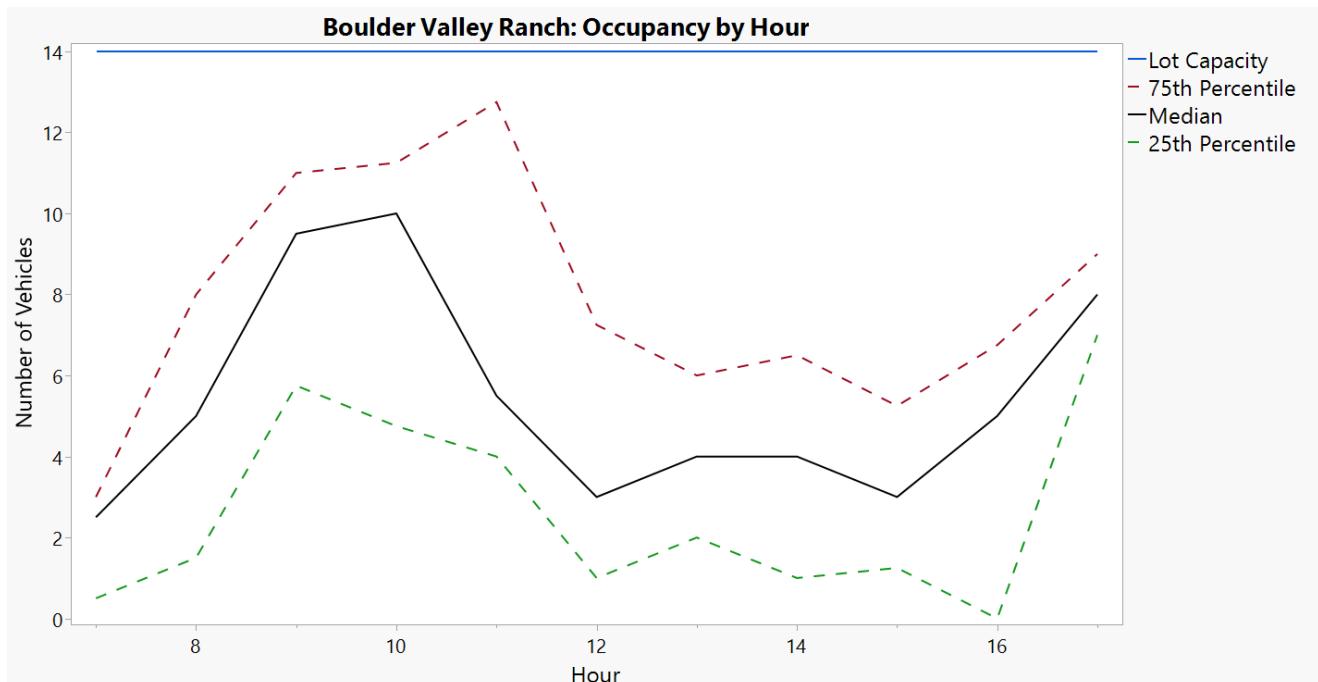
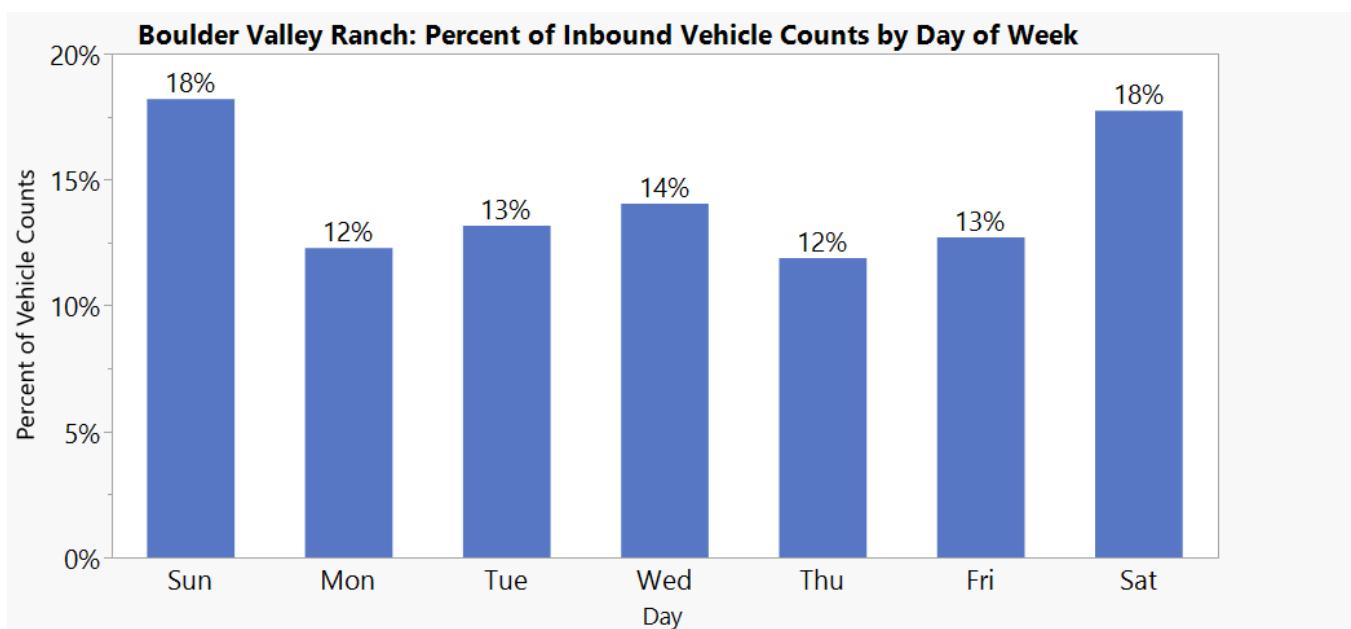
On average, Boulder Valley Ranch was observed to be at **41%** occupancy with 6 vehicles parked in the formal lot during the day (2019-2020). This ranged from 29% on weekdays (4 vehicles) to 58% on weekends (8 vehicles).

The lot was observed to be completely full 6 out of 100 observations (6%). Up to 20 vehicles were observed parked outside of the main parking lot, but these were excluded from the occupancy analysis. Note: The vehicle counter was installed on Longhorn Road, so average daily traffic counts include vehicles going to the ranch.

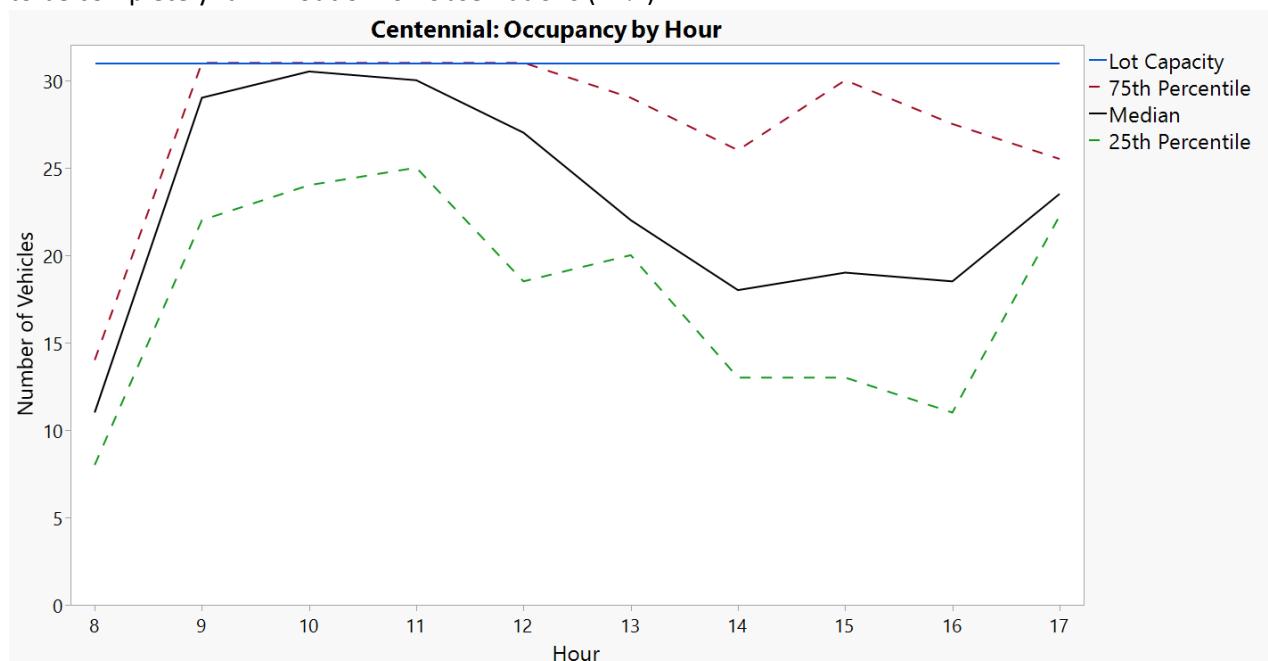
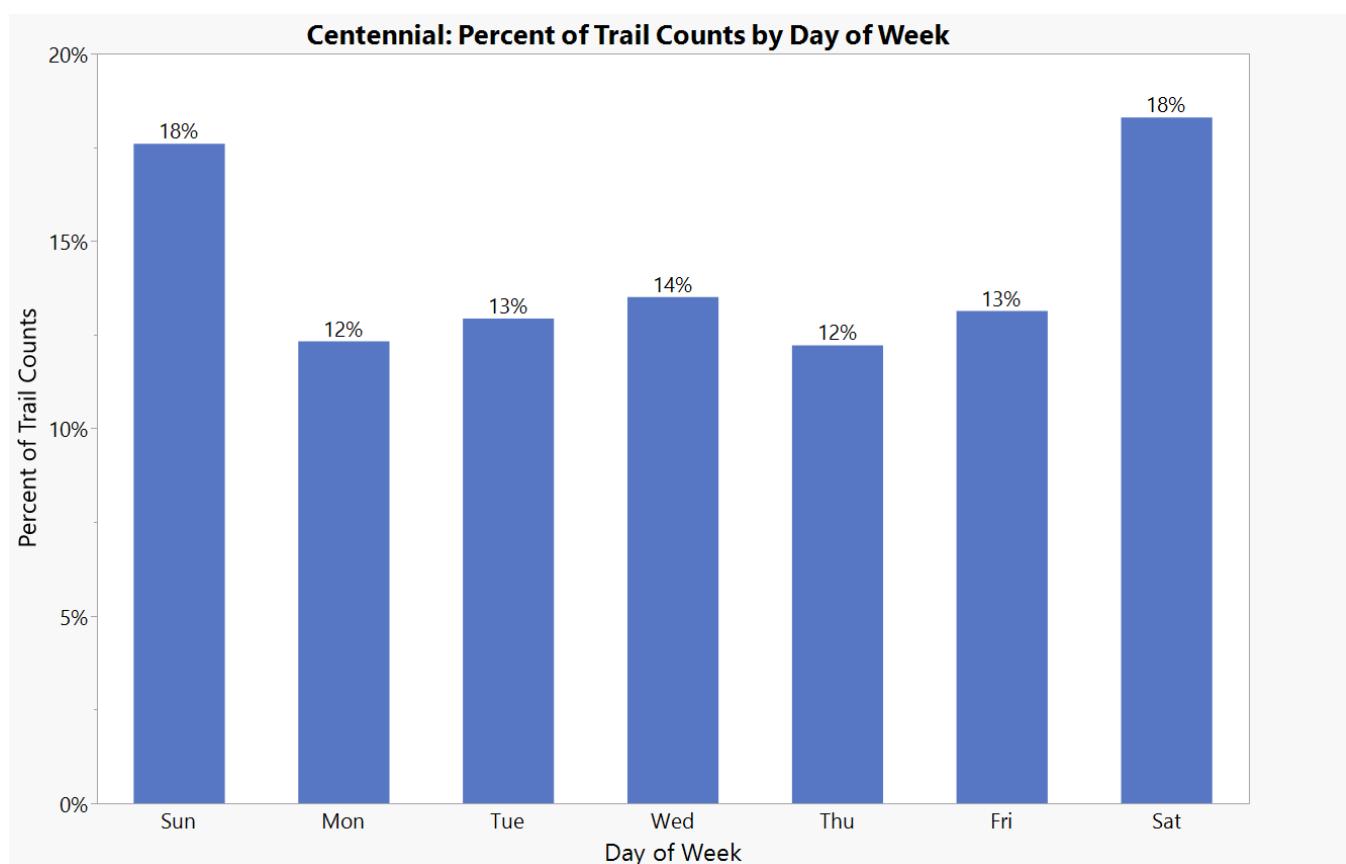
On average, Centennial was observed to be at **74%** occupancy with 23 vehicles parked during the day (2019-2020). This ranged from 64% on weekdays (20 vehicles) to 88% on weekends (27 vehicles). The lot was observed to be completely full 22 out of 104 observations (21%).

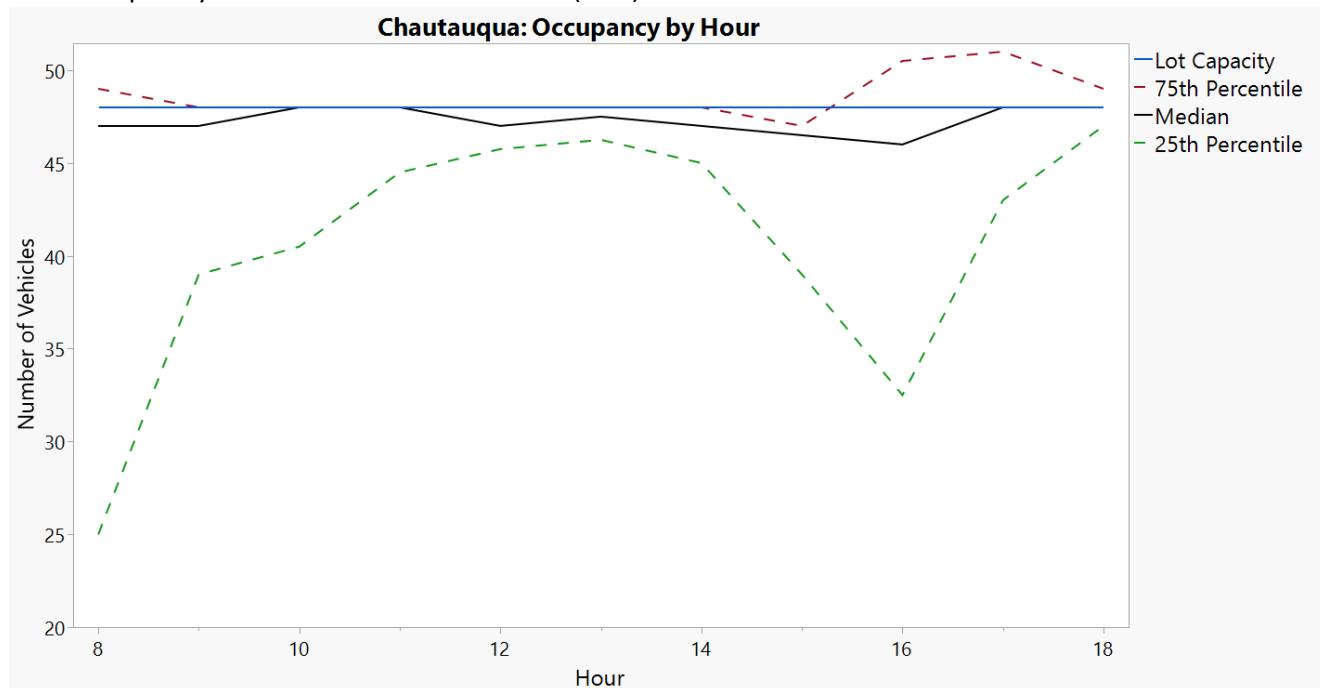
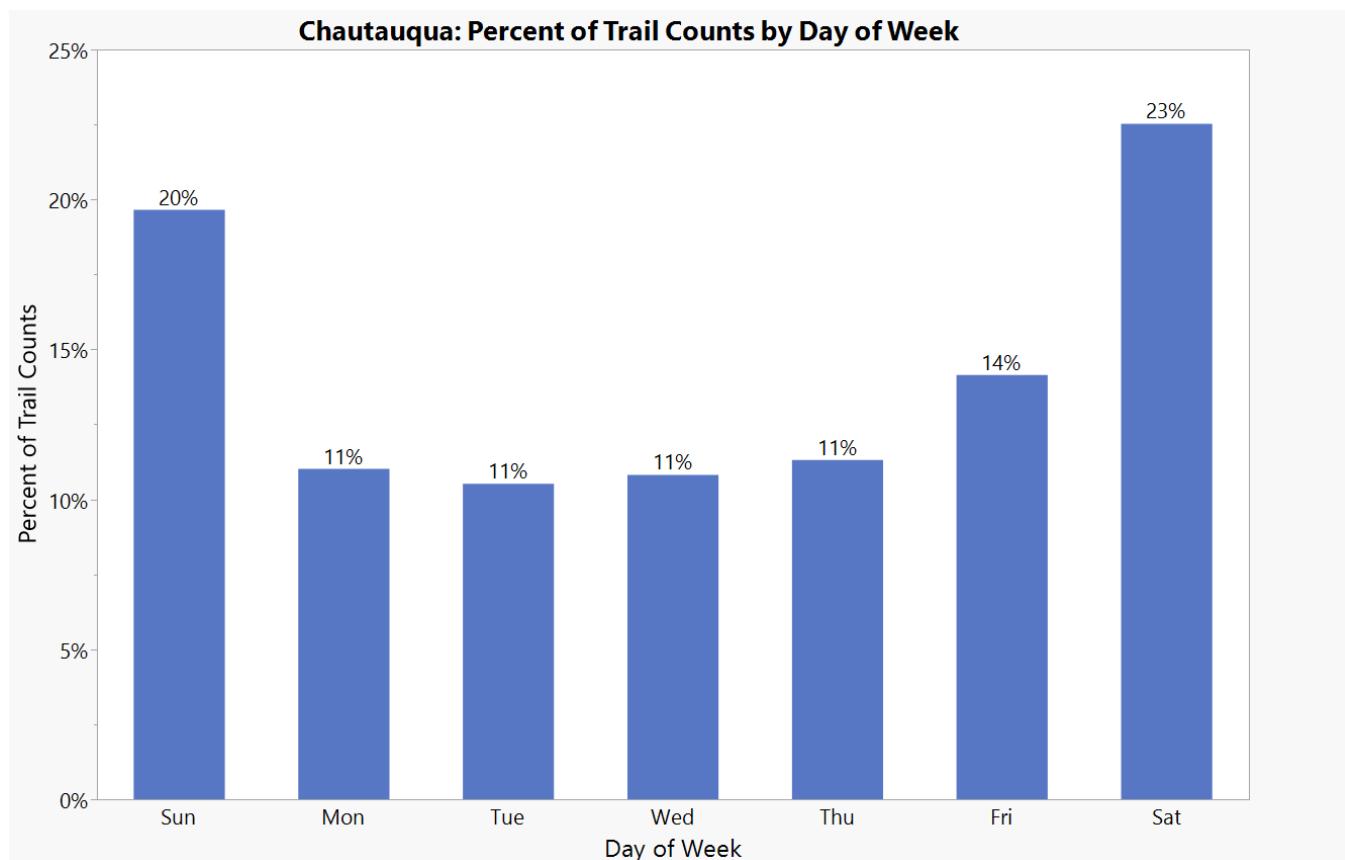
On average, Chautauqua was observed to be at **94%** occupancy with 45 vehicles parked during the day (2019-2020). This ranged from 91% on weekdays (44 vehicles) to 98% on weekends (47 vehicles). The lot was observed to be completely full 37 out of 88 observations (42%).

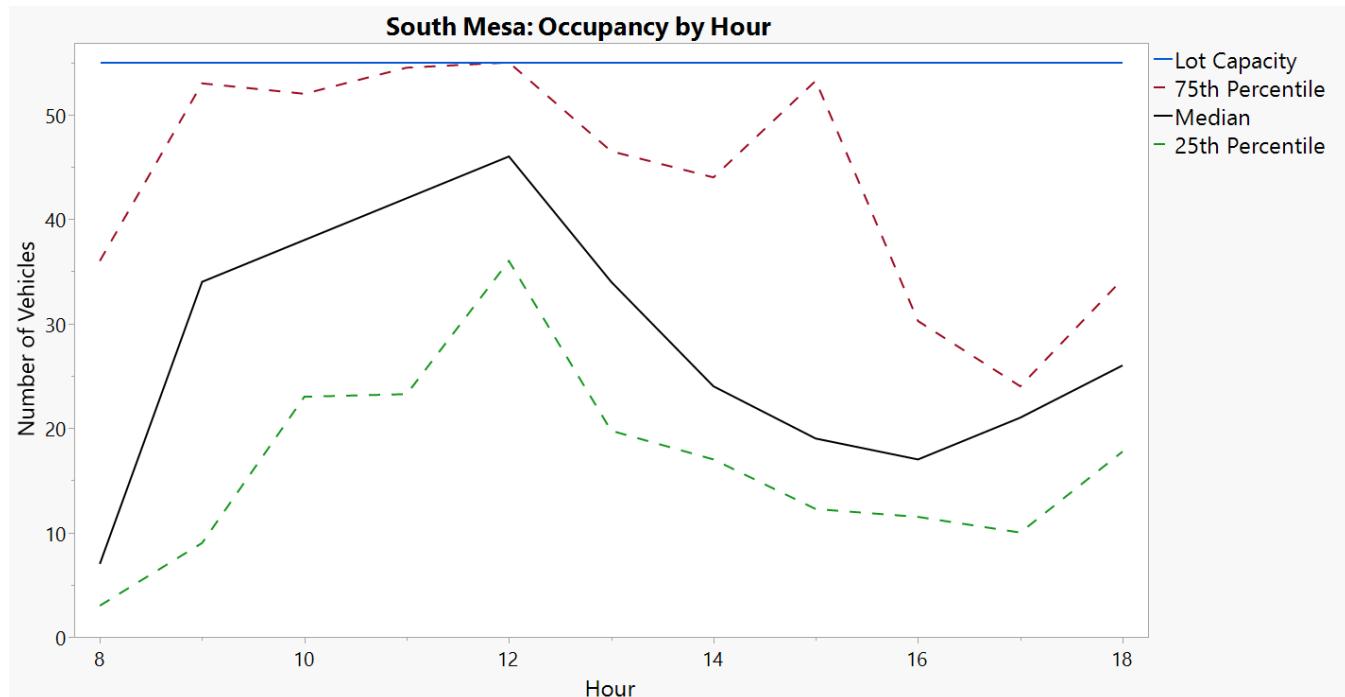
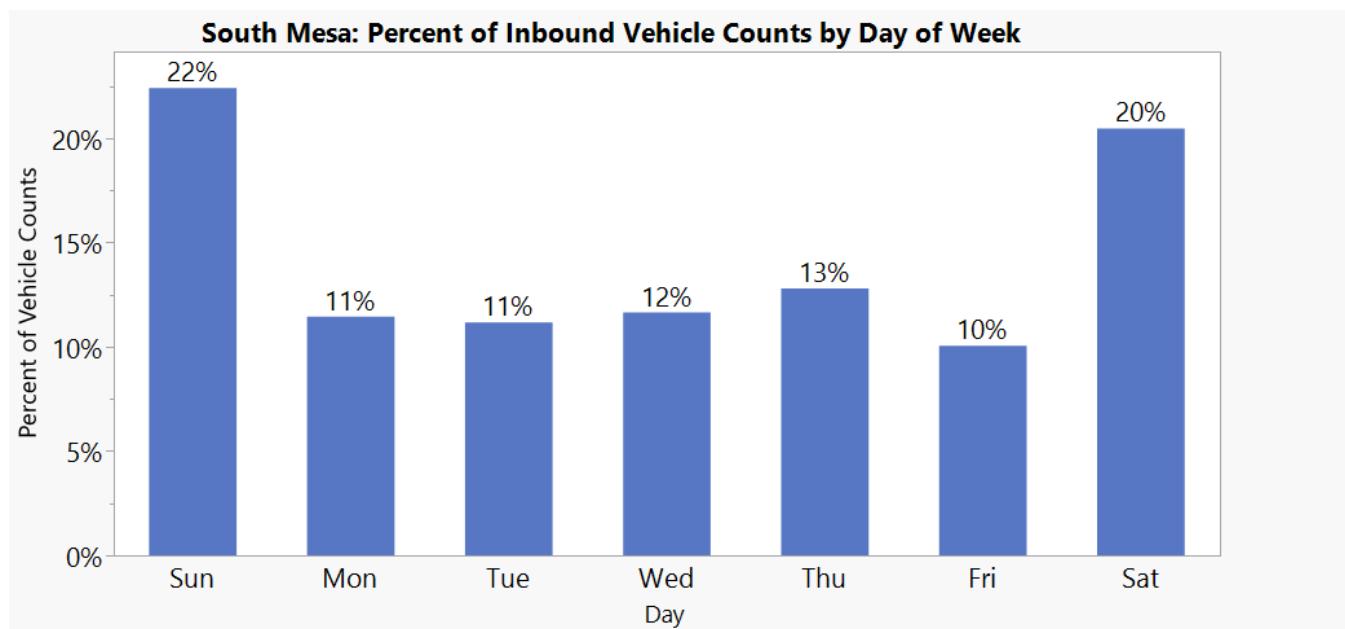
On average, South Mesa was observed to be at **57%** occupancy with 31 vehicles parked during the day (2019-2020). This ranged from 39% on weekdays (22 vehicles) to 85% on weekends (47 vehicles). The lot was observed to be completely full 25 out of 103 observations (24%).
