GENERAL DESIGN GUIDELINES

FOR BOULDER'S HISTORIC DISTRICTS AND INDIVIDUAL LANDMARKS

CITY OF BOULDER

LANDMARKS PRESERVATION ADVISORY BOARD

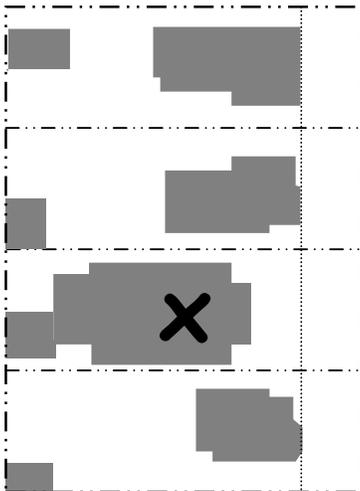
2.1.1 / 2.1.7

The marked building is built outside the range of typical setbacks and occupies a much larger percentage of the back yard area than typical.

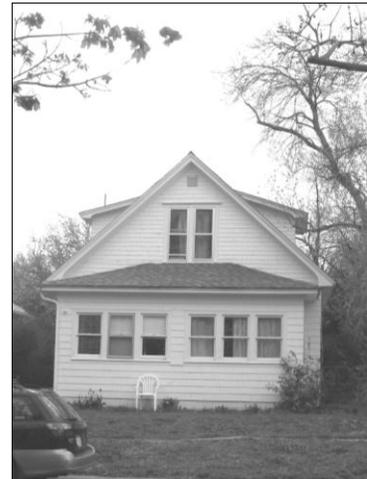
2.1.3

Traditionally, the primary building entrance faced the street. The lack of a front entrance on this home disrupts the character of the street.

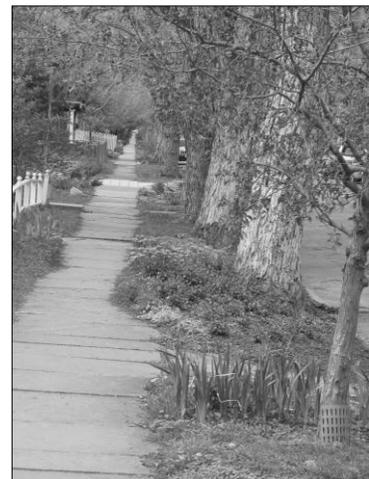
2.2.4

Grass, low ground cover, and evenly spaced street trees are appropriate for the area between the street and the sidewalk.

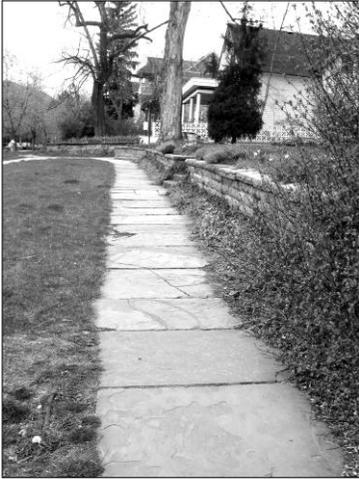
2.2.7
Retaining walls are typically stone or brick. Plain concrete is

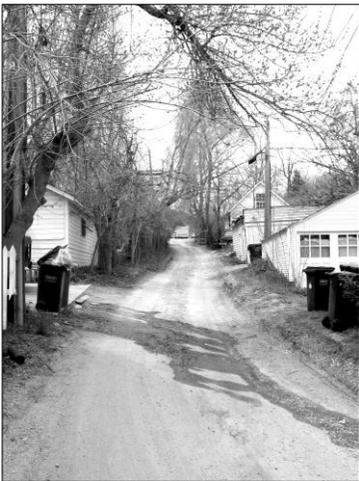
2.3.2
Typical alleys are unpaved and characterized by a variety of small-scale accessory structures and access to parking.

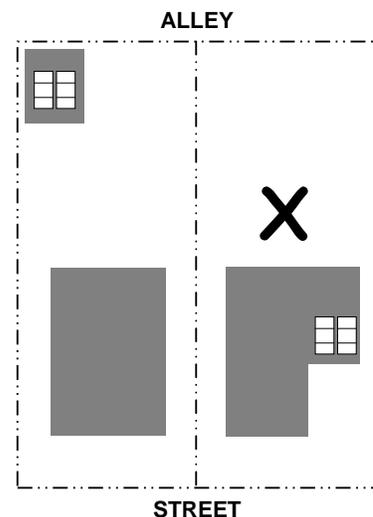
2.4.1 / 2.4.2

Parking should be provided at the rear of the lot and accessed by an alley whenever possible.

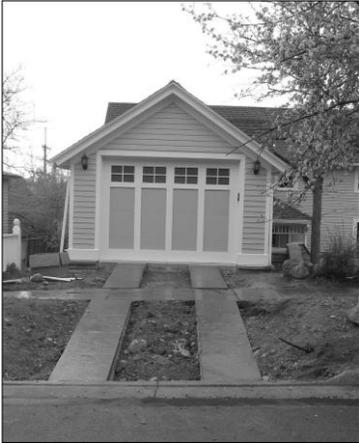
2.4.7
This new garage is accessed by flagstone wheel strips

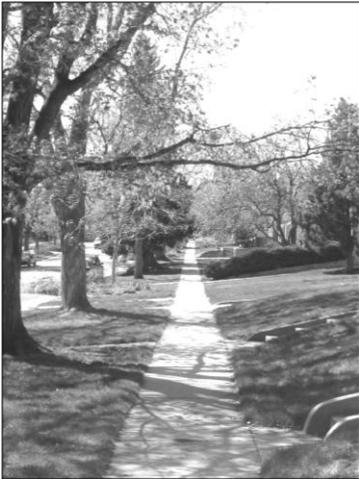
2.5.1
Typical sidewalks are concrete or flagstone and simple in design.

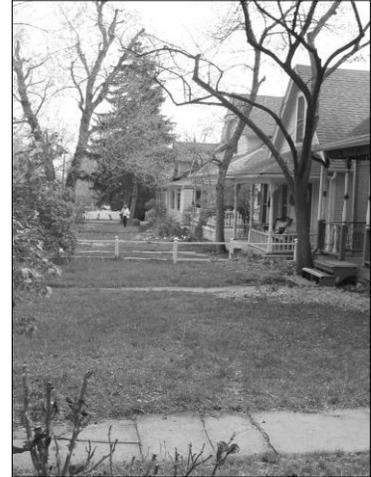
2.6.2

Many of the historic districts are characterized by open front yards. Adding new front yard fences in such areas is generally inappropriate.

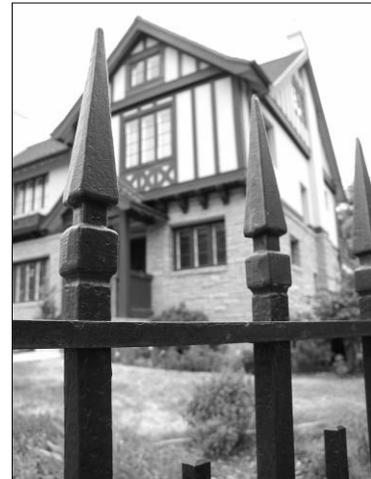
2.6.4

Wrought iron and cast iron fences were typically found only on lots with large or grand homes.

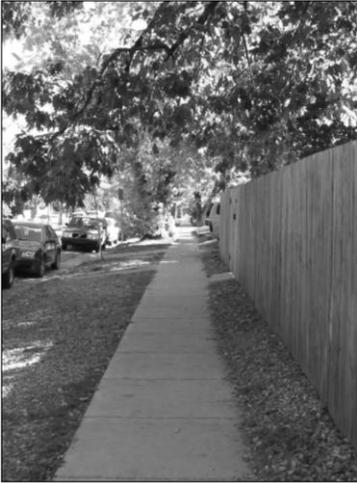
2.6.6
This front yard fence is inappropriate for both its height and lack of openness.

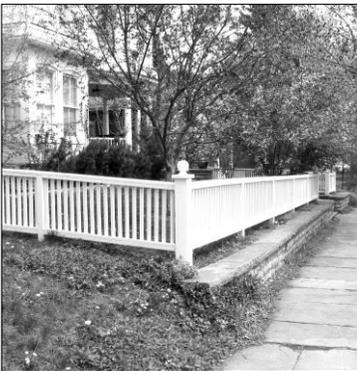
2.6.7
This is an appropriately open and low front yard fence.

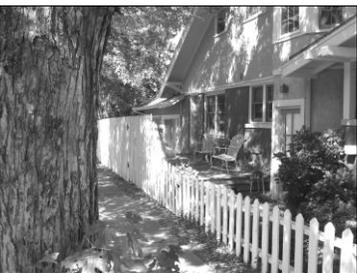
2.6.8
This side yard fence gradually transitions from the rear to the front.

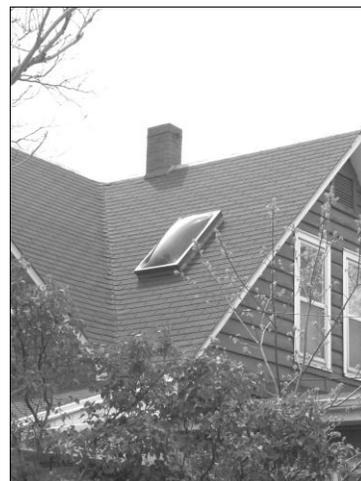
3.1.3
Bubble-type skylights are inappropriate, especially when visible from the street.

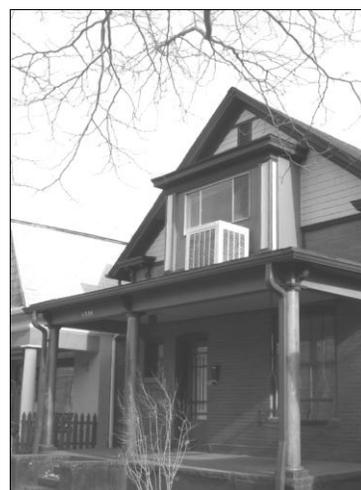
3.1.5
Mechanical equipment, such as coolers, should not be visible from the street.

.5 Roof appurtenances such as swamp coolers, TV antennas, and satellite dishes should be installed so that they are not visible from the street and do not damage or obscure historic features. Also see Guideline 8.3.4.

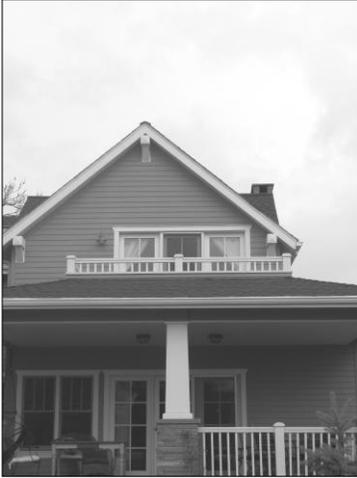
3.2.2
This rear roof deck is appropriately integrated into the roof.

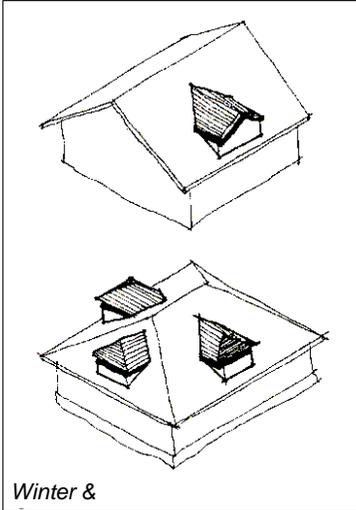
3.5.4

Dormer forms should match roof forms; e.g. gabled roofs should have gabled dormers and hipped roofs should have hipped dormers.

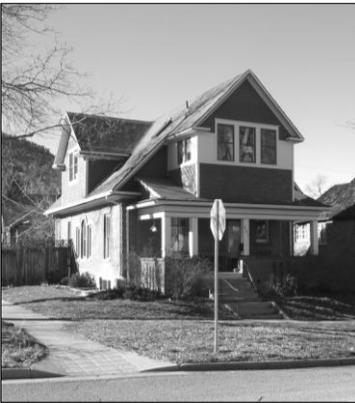
3.5.6 / 3.5.7

The size of these dormers overwhelms the main roof and the ridgelines are even with, rather than below, the main roof.

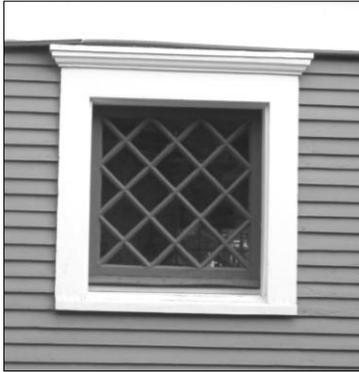
3.7.12
True-divided light windows have individual panes of glass separated by muntins. While some high-quality simulated-divided light windows may be acceptable as replacements in some cases, true-divided light windows are most appropriate.

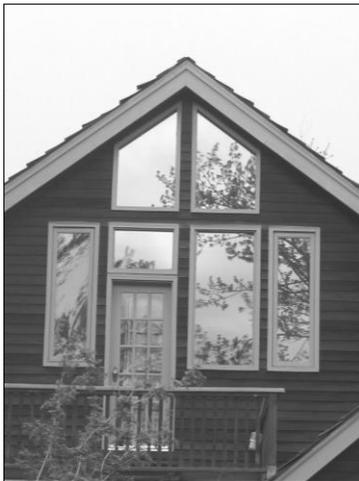
3.7.15 / 3.7.19
The relationship between the amount of window and wall in this home is out of proportion with traditional designs. The odd shaped windows at the roof peak are also incompatible with historic patterns.

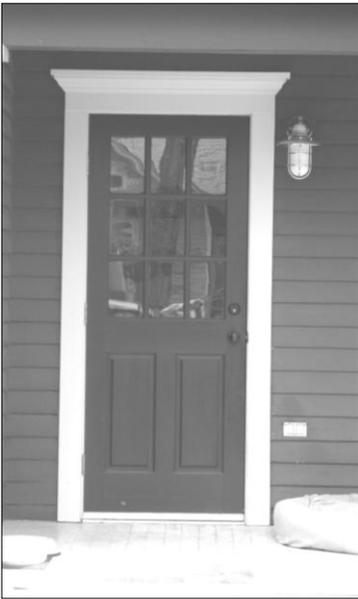
An appropriate door in terms of size, proportion and detailing.

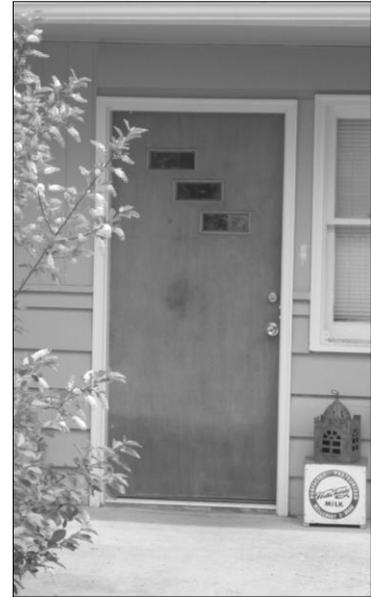
3.8.10
The modern detailing on this door would be inappropriate for most homes in Boulder's historic districts.

- .10 Doors in additions and new structures should reflect the proportions (height and width) of doors in the existing structure and/or the district.

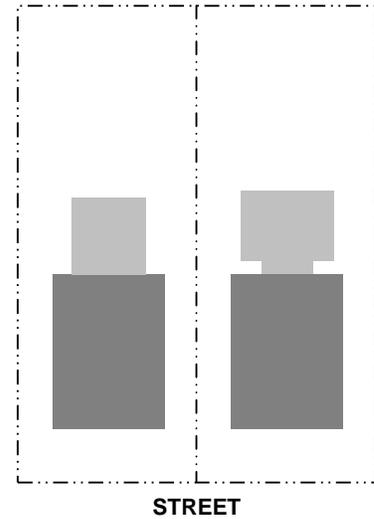
4.2.1

Additions can be distinguished from the original building by being set in, allowing the corners of the historic building to be visible.

- .1 Distinguish an addition from the historic structure, but maintain visual continuity between the two. One common method is to step the addition back and/or set it in slightly from the historic structure. Every project is different and successful designs may incorporate a variety of approaches.
- .2 Do not directly copy historic elements. Instead, interpret historic elements in simpler ways in the addition.
- .3 Additions should be simpler in detail than the original structure. An addition that exhibits a more ornate style or implies an earlier period of architecture than that of the original is inappropriate.
- .4 The architectural style of additions should not imitate the

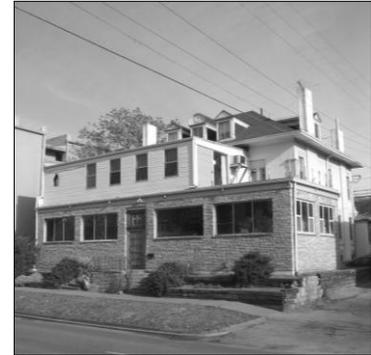
4.1.1 / 4.4.2

A series of inappropriate additions to this historic building have completely obscured the front façade and destroyed historic fabric.

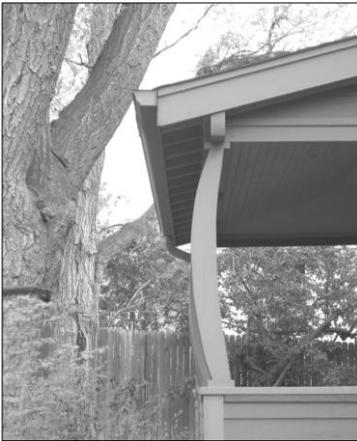
6.1.1
A contemporary interpretation of a historic element.

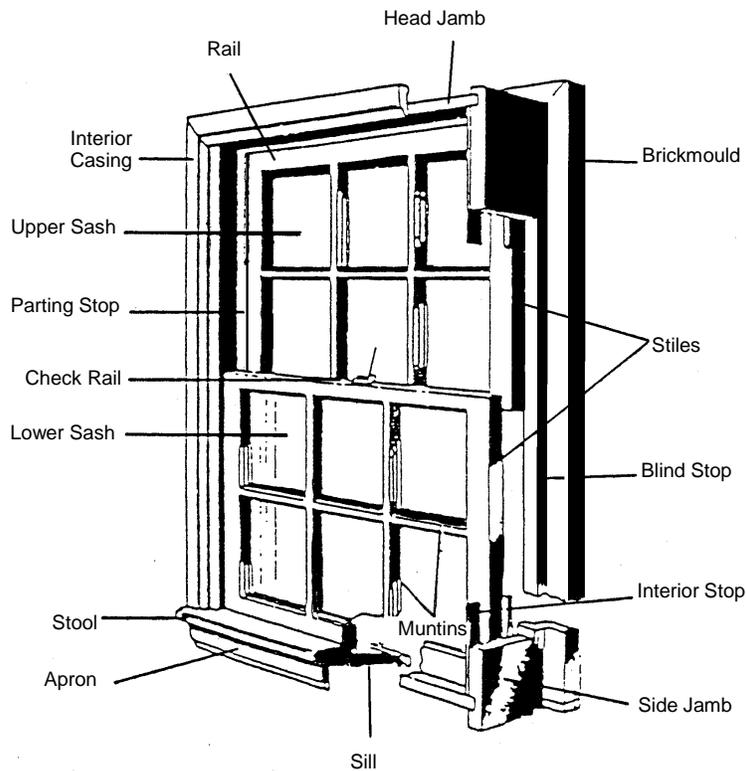
The moving units of a window are known as *Sashes* and move within the fixed *Frame*. The *Sash* may consist of one large *Pane* of glass or may be subdivided into smaller panes by thin members called *Muntins* or *Glazing Bars*. Sometimes in nineteenth-century houses windows were arranged side-by-side and divided by heavy vertical wood members called *Mullions*.
