HARBECK-BERGHEIM HOUSE

RESOURCE ASSESSMENT REPORT

DRAFT MARCH 2021

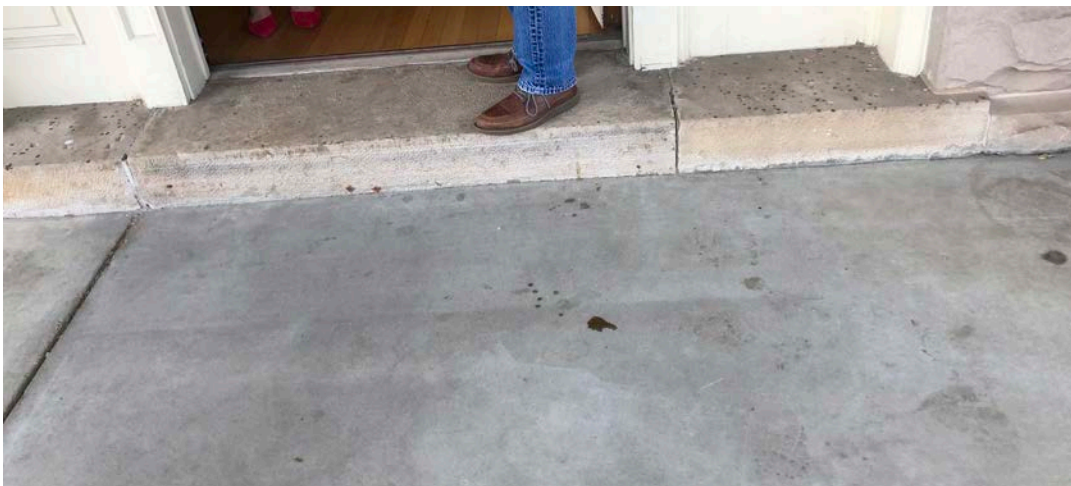
Front Porch: The walls surrounding the porch appear to be made of the same stone as the main building. Overall the stone is in fair shape, with a few areas that are in poor condition. The primary areas of concern are on the interior faces of the wall on the north side, and all around the main entry stair to the north. There is significant wear to the stone and mortar and large amounts of both have been weathered away, mostly likely from salts and chemical deicers. There has also been an issue with graffiti at the building, the removal of which has also caused damage to the stone at both the porch and the main building walls.

Figure 1-4. View of the porch transition at the main entry door, 2020 (source: Ratio)

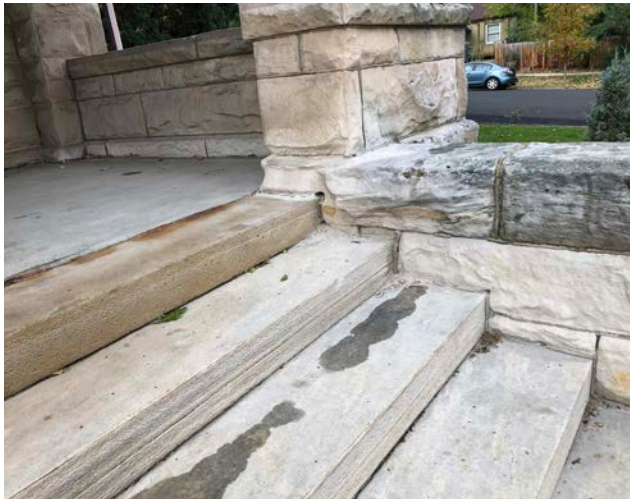
The caps of these walls appear to be a different type of stone which is in fair condition. A large amount of the cap stones are covered with lichens growing on them. The entry steps to the porch were noted as Lyons sandstone in previous building evaluations, and appear to be in good condition, with some uneven gaps due to ground settling. Supporting the porch roof are four large stone columns. The stone appears to be in good condition, though the mortar is in fair to poor condition and appears in need of repointing.

Figure 1-7. View of the main entry steps, 2020 (source: Ratio)

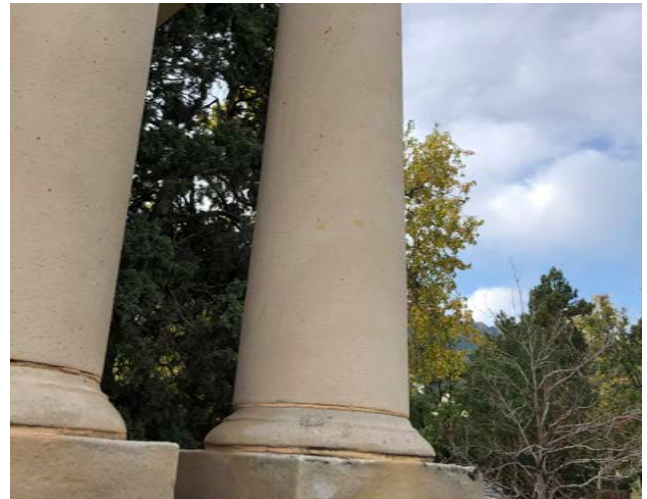
Figure 1-8. View of the porch columns, 2020 (source: Ratio)

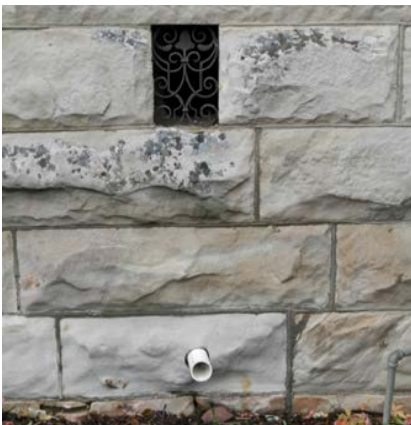
West Facade: Like the other sides of the building, the stone overall appears to be in good condition on the west face. The stone detailing below one of the windows shows some evidence of water damage. Another area toward the bottom of the wall exhibits significant amounts of lichen growing on the stone. There are also a few stones where the face of the stone is damaged or weathered away.

Figure 1-16. View of lichen and weathered stone, 2020 (source: Ratio)

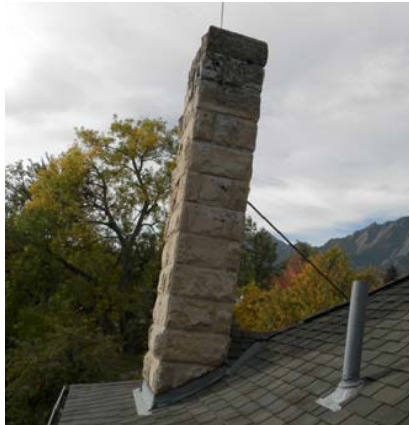
Chimneys: The stonework on the chimneys appears to be in fair to poor condition. Many of the stones are very worn and weathered, with portions of the stones missing, and significant mortar missing. Of the three chimneys, the one in the north east corner appears to be in the worst condition.

Figure 1-17. View of the south east chimney, 2020 (source: Ratio)

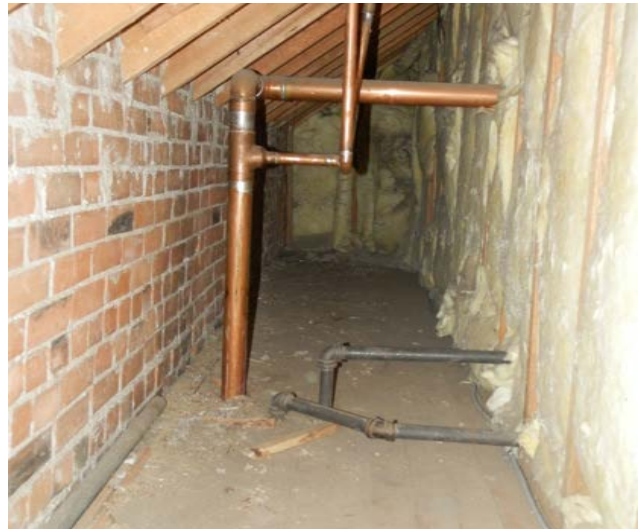
The exposed brick in the building is in the basement and the attic. The brick overall appears to be in fair condition. The primary areas of damage to the brick masonry are those where ductwork or other penetrations have been made through the brick walls. The resulting openings left holes in the brickwork, and the attempted sealing material between the ducts and the brick has not functioned properly causing more damage to the surrounding bricks and the integrity of the walls in those areas.

Figure 1-20. View of eave attic masonry, 2020 (source: Ratio)

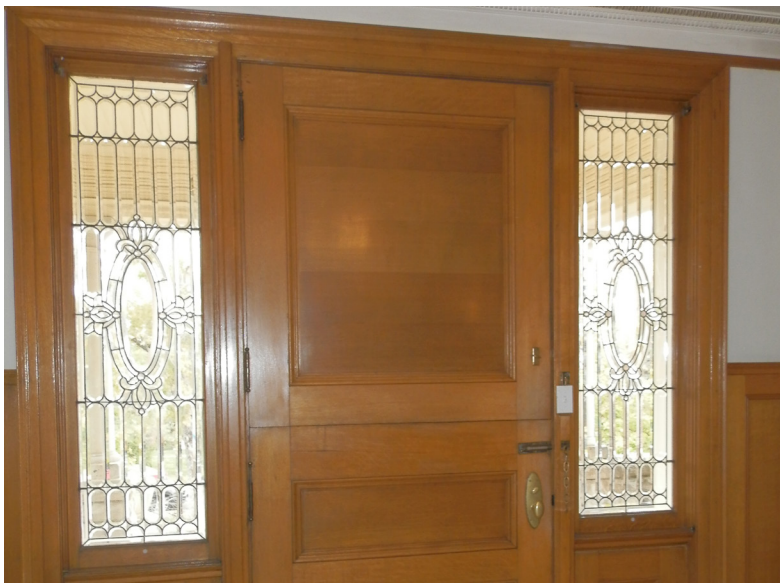
The exterior window glazing is in good condition overall with no major cracks or missing panes. A few of the basement windows have had the glazing removed for ventilation of interior appliances. The stained glass throughout the building has been rehabilitated and appears to be in good condition

Figure 1-21. View of stained glass at main north entry, 2020 (source: Ratio)

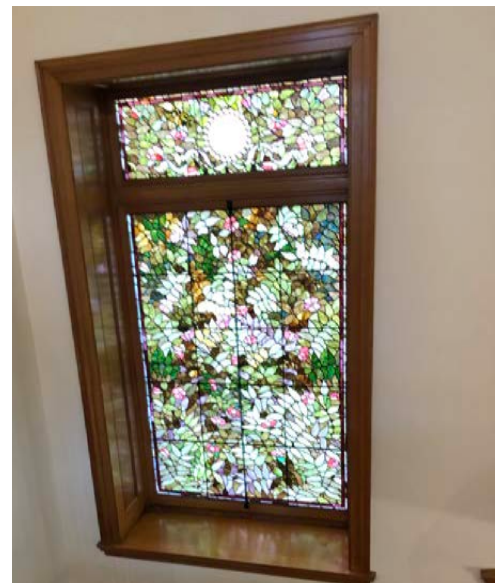
Figure 1-22. View of stained glass at interior stairway, 2020 (source: Ratio)

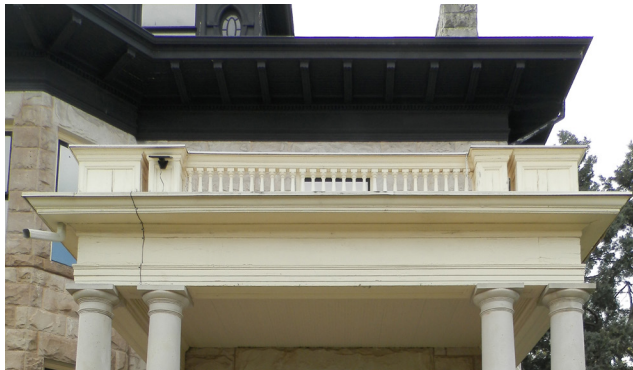
Exterior Porch: As viewed from ground level, the wood porch appears to be in fair condition. There is minor evidence of cracking and paint peeling. Below the porch, the wood soffit shows evidence of cracking and warping. During the site visit, it was evident that a substantial yellowjacket nest was located behind the soffit. The wood railing that wraps around the top of the porch is in poor condition. There are areas of major splintering, and multiple areas where the bare wood is exposed. An attempt at protecting the top of this wood was made at some point in the past, with the addition of metal caps that cover the tops of the rails. It is unclear the condition of the wood beneath

Figure 1-23. View of porch roof, 2020 (source: Ratio)

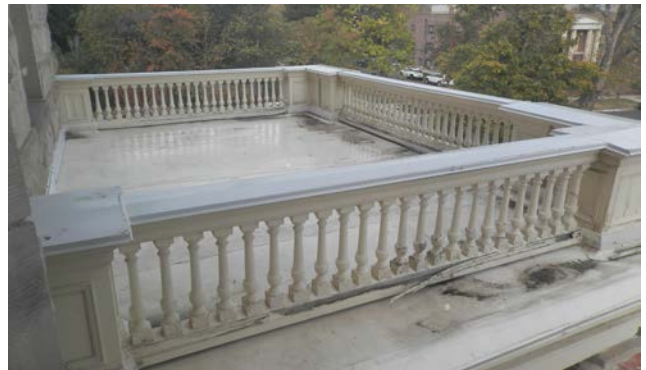
Figure 1-24. View of railing above entry porch, 2020 (source: Ratio)

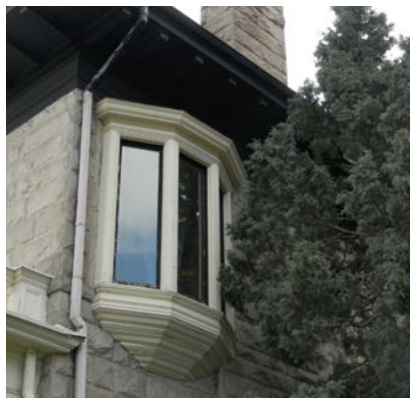
Exterior Windows and Doors: The wood windows and doors vary in condition based upon their locations, however many of the exterior frames and sashes show peeling and cracking paint over most of the exterior surfaces.

Figure 1-26. View of wood window, 2020 (source: Ratio)

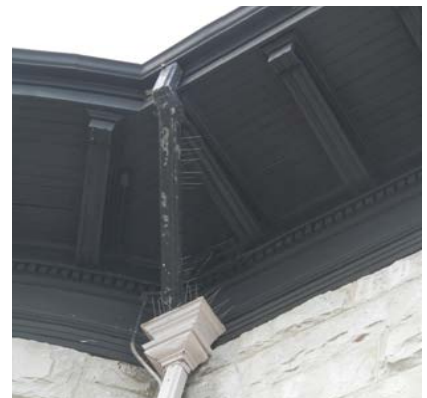
Exterior Roof: In general, the roof eaves and soffits appear to be in good condition. The brackets and additional wood detailing appears intact and with little evidence of rot or damage. However, the metal gutters and downspouts around the building are in poor to fair condition. The exterior wall finish around the attic appears to be in fair condition. There are a few areas with paint missing, and some weathering, but most of the finishes show little to no damage.

Figure 1-27. View of roof soffits, 2020 (source: Ratio)

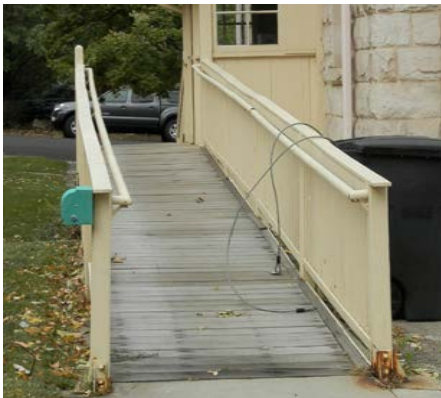
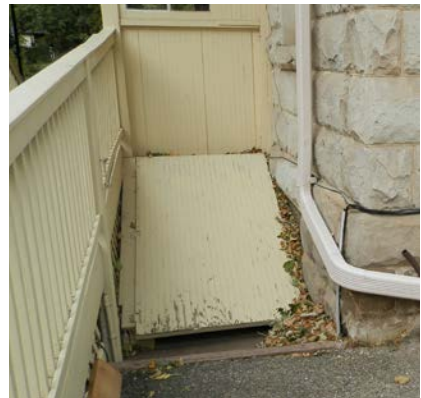
Exterior South Porch: The final exterior wood element is the south porch. This enclosed porch is currently used as the main entrance for the building users, and with the attached ramp, provides an accessible entry to the building. The porch walls are made of bead board and appear to be in fair shape with some warping and cracking. The flooring has been painted and is worn with signs of weathering, primarily near the exterior door. An entry ramp and stair have been added to access the south porch that are not original to the building. These additions appear to be in fair condition and have significant rust on the metal elements that connect the ramp to the concrete slab below. Just east of this porch area is a staircase leading to the basement, which runs below the porch. The cellar door type entry to the stair has additional plywood coverings and is kept closed due to vagrancy concerns.

Figure 1-28. View of south porch entry ramp, 2020 (source: Ratio)

Figure 1-30. View of south porch entry ramp, 2020 (source: Ratio)

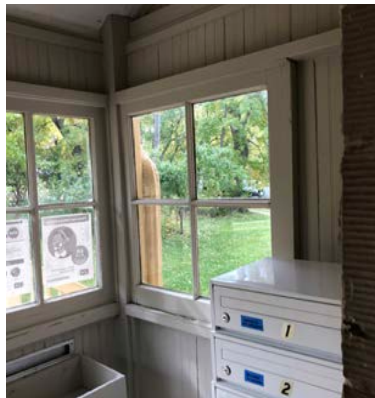
Figure 1-29. View of south porch interior, 2020 (source: Ratio)

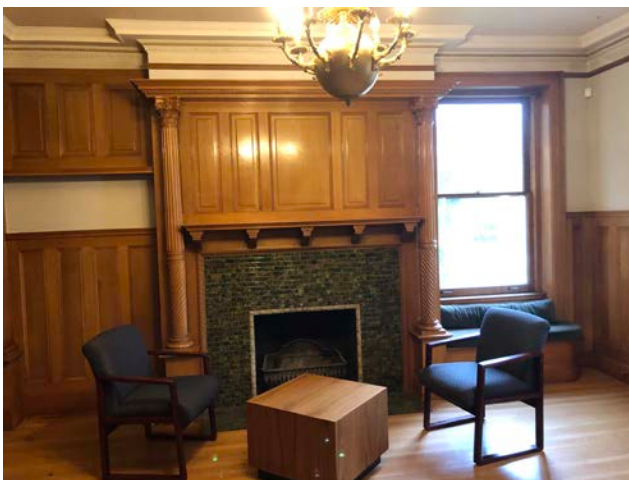
Interior Lobby: Just inside the front door, the lobby area has wood wall paneling, a wood fireplace surround, and wood detailing leading up to the main staircase. The majority of these decorative wood elements are in good condition. The front door itself is a Dutch door, which is fully functioning. The detailing appears to be intact and showing minimal wear. The two primary areas of wear are around the window seat, and at the exposed treads of the staircase.

Figure 1-31. View of lobby wood paneling, 2020 (source: Ratio)

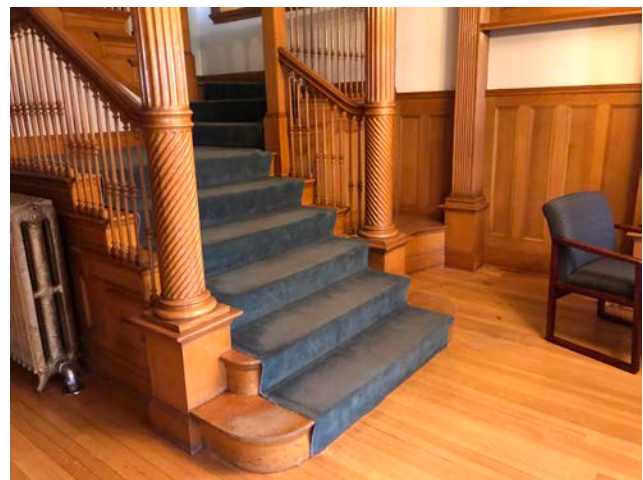
Figure 1-32. View of main staircase Ratio, 2020 (source: Ratio)

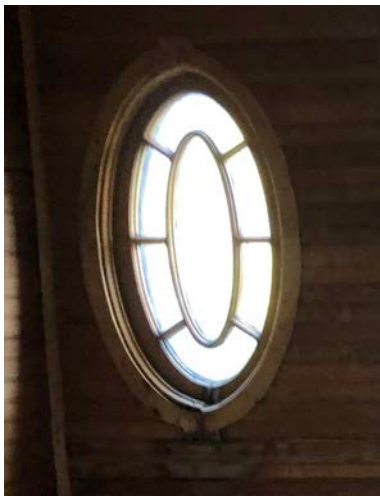
Interior Windows and Doors: The larger window interiors appear to be in good condition overall, however many of the interior windowsills show significant wear, weathering, or water damage. Also, many of the smaller and curved windows have significant cracking in their frames and sashes. In general, the doors appear to be in fair condition. The door construction and materials have maintained their integrity, but around the hardware and other areas of use the finish has become worn, scratched, or scuffed over time. At some of the locations where the doors have been painted, the painted finish is scratched or peeling.

Figure 1-33. View of oval attic window, 2020 (source: Ratio)

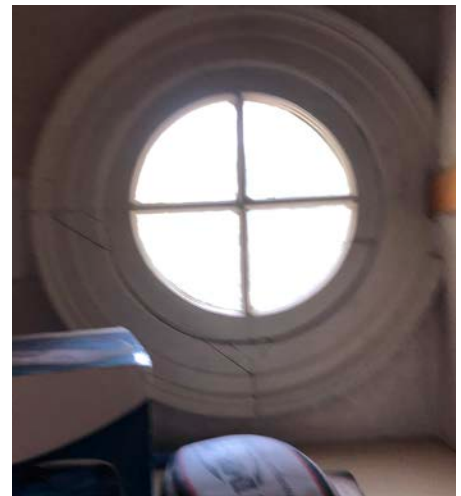
Figure 1-35. View of circular window, 2020 (source: Ratio)

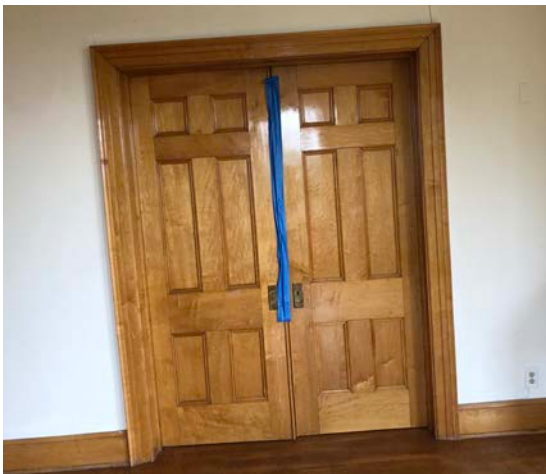
Figure 1-36. View of interior wood pocket doors, 2020 (source: Ratio)

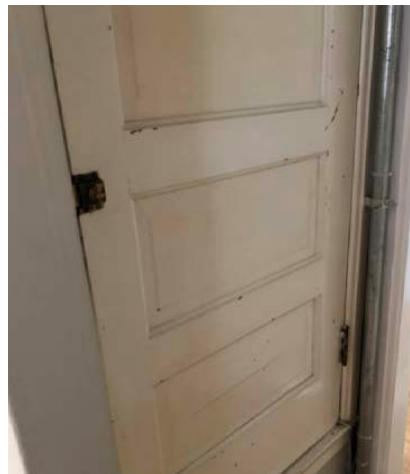
Figure 1-37. View of painted interior door Ratio, 2020 (source: Ratio)

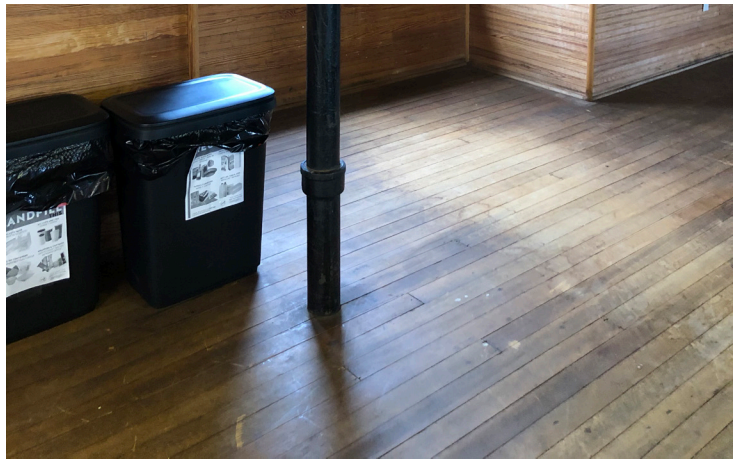
Wood Flooring: The wood flooring throughout the building appears to be in fair condition. There are a few larger areas of concern showing burn marks or water damage, however most of the flooring just has general wear and scratching showing the areas of use. In the attic, the wood flooring appears to be in worse condition than the rest of the building. There is gapping between boards, noticeable scratching, and the flooring does not appear to be of the quality or finish level as the rest of the building.

Figure 1-40. View of attic flooring, 2020 (source: Ratio)

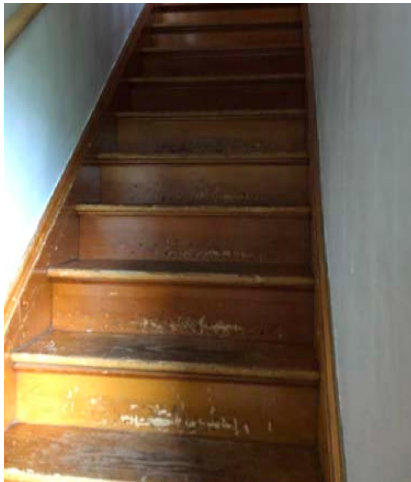
Figure 1-42. View of attic staircase, Ratio, 2020 (source: Ratio)

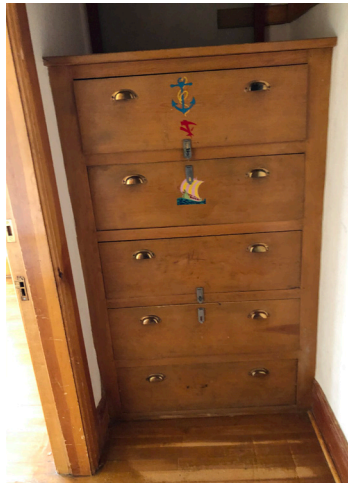
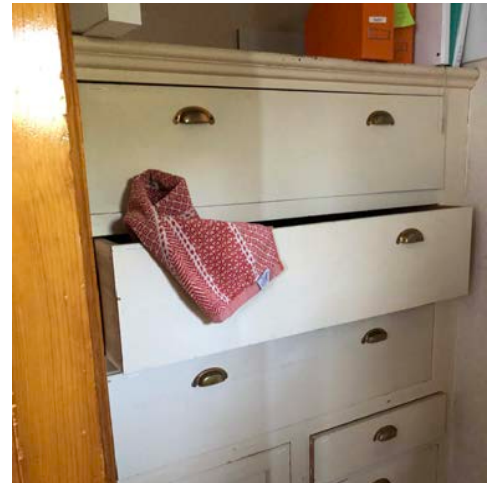
Miscellaneous Interior Wood Components: On both the first and second floors, there are wood fireplace surrounds which appear to be in good condition. Also, on the first floor, there is a large built-in cabinet with stained glass doors and a mirrored back wall. This cabinet appears to be in good condition. Many of the second-floor closets contain built-in cabinetry. These cabinets are in fair condition. One cabinet has a missing drawer, and most have small scratches and dents on the top surfaces.

Figure 1-43. View of closet built-in cabinets, 2020 (source: Ratio)

Figure 1-44. View of closet built-in cabinets, 2020 (source: Ratio)

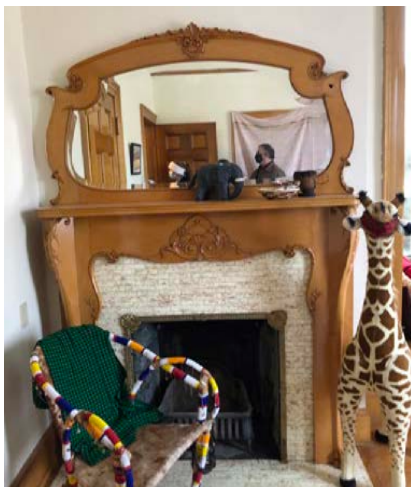
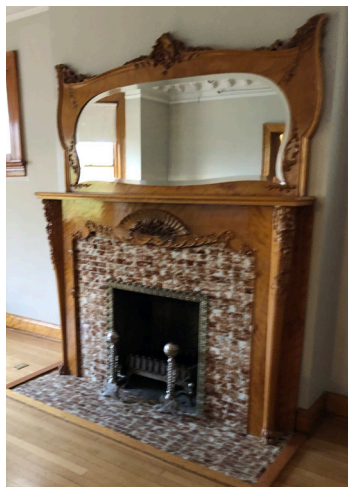
Figure 1-45. View of fireplace, 2020 (source: Ratio)

Figure 1-46. View of fireplace, 2020 (source: Ratio)

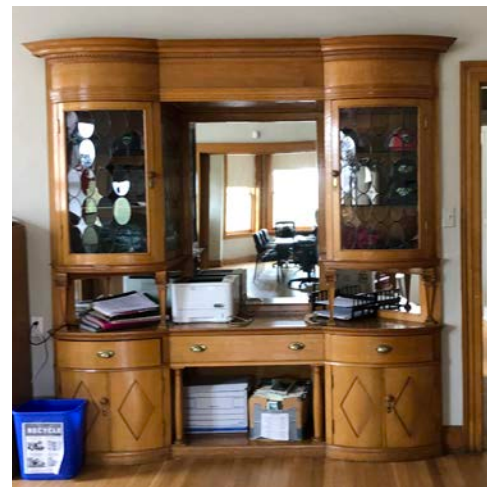
Figure 1-47. View of built-in cabinet, 2020 (source: Ratio)

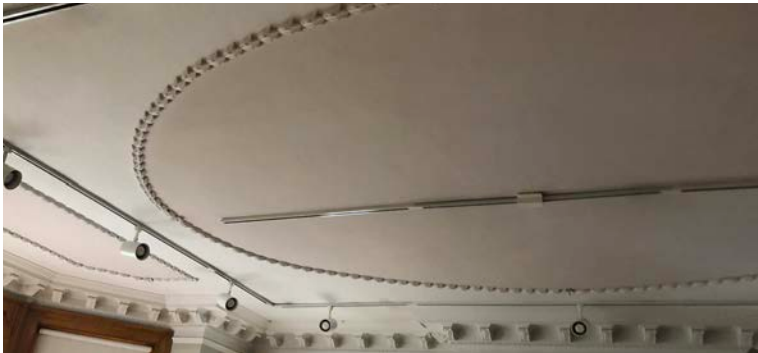
Apart from some detailing on the one of the first-floor ceilings, the interior wall and ceiling finishes are a mix of painted and unpainted wallpaper. Previous attempts to remove the wallpaper were unsuccessful, therefore the wallpaper was painted over. Most of the finished surfaces are in good condition. There are a few areas where the wallpaper is peeling. In a second-floor hall closet, a portion of the plaster finish has come off the wall.

Figure 1-48. View of ceiling detailing, 2020 (source: Ratio)

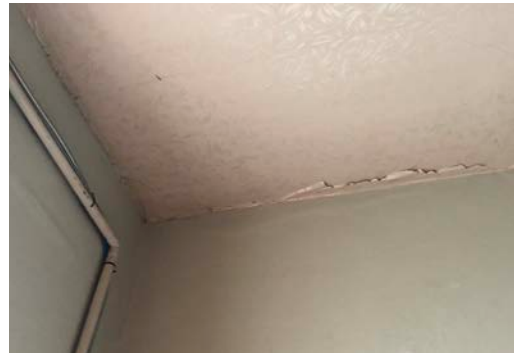
Figure 1-49. View of peeling wallpaper, 2020 (source: Ratio)

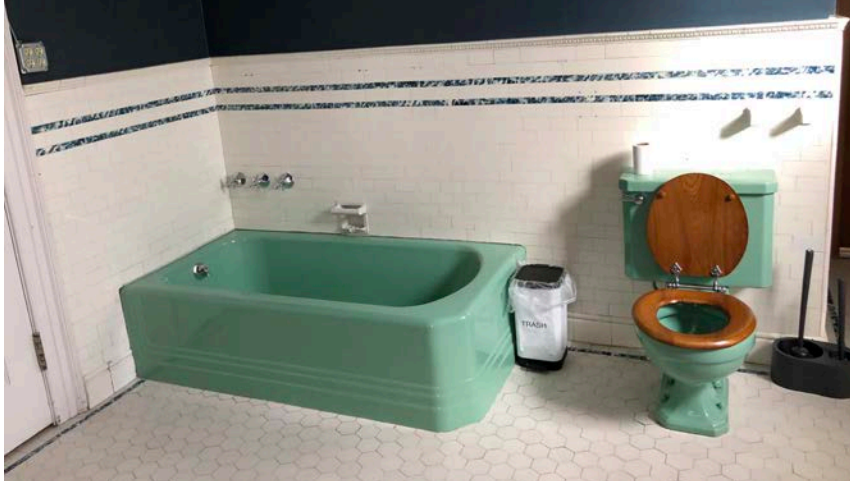
Figure 1-50. View of second floor restroom, 2020 (source: Ratio)

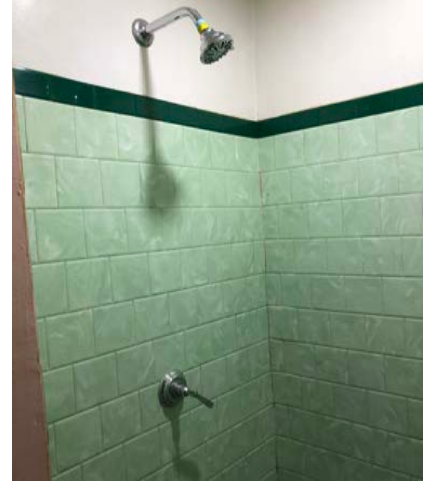
Figure 1-51. View of shower tile, 2020 (source: Ratio)

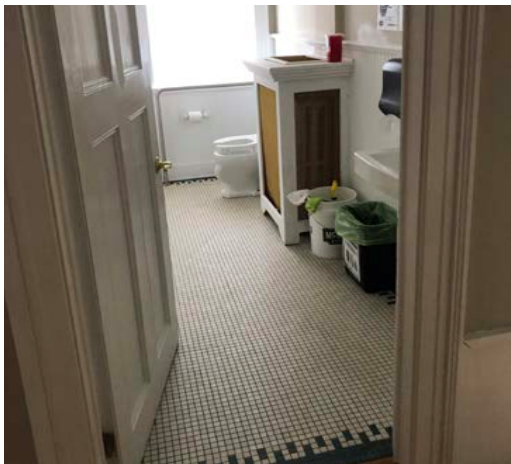
Figure 1-52. View of first floor restroom, 2020 (source: Ratio)

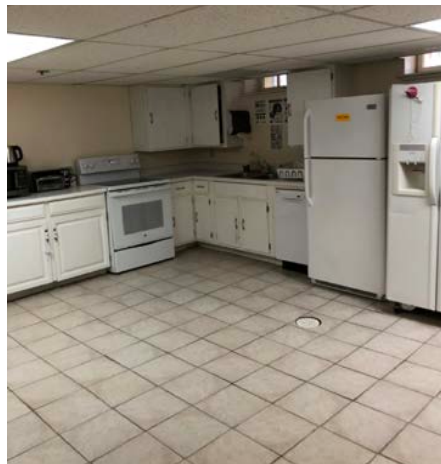
Figure 1-53. View of basement kitchen, 2020 (source: Ratio)

Basement Finishes: The basement kitchen has an acoustical tile ceiling that is in fair condition. Most of the basement flooring is concrete, which appears to be in good condition other than a rough transition between two slabs at one of the doorways. The finished rooms of the basement, other than the kitchen and restroom, have carpet floors which are in good condition, but not original to the building. These same rooms have doors that are not original to the building and appear to be of hollow core construction. Additionally, the exterior windows in the basement appear to be in fair to poor condition. A few locations have missing or broken hardware, and some windows have been nailed shut.

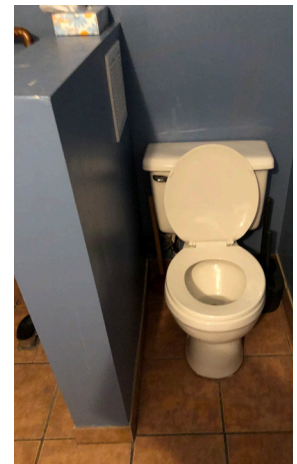
Figure 1-54. View of basement restroom, 2020 (source: Ratio)

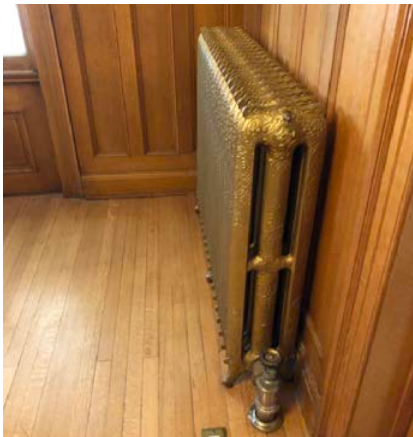
Most of the building is conditioned with radiators for heating and no method for cooling other than natural ventilation through the exterior windows. The attic has its own air conditioning system for heating and cooling. At the time of the site visit, all heating and cooling systems appeared to be in working order.

Figure 1-55. View of radiator, 2020
(source: Ratio)

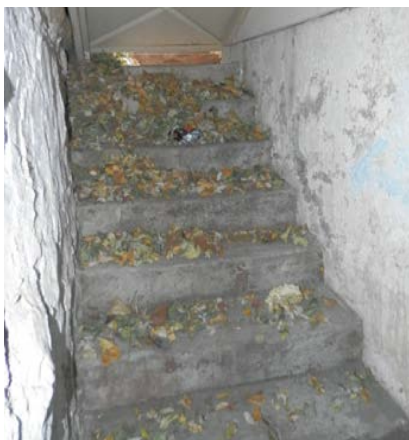
Exterior Basement Staircase: The exterior stairs are currently covered and inaccessible. The steps are concrete. They appear to be in fair condition, though they do not appear to meet current code requirements regarding tread and riser dimensions.

Figure 1-57. View of exterior basement stair, 2020 (source: Ratio)

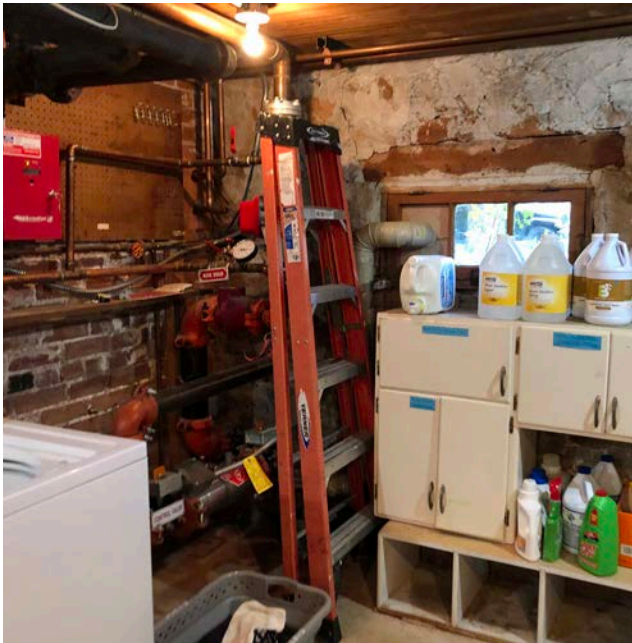
Figure 1-70. View of basement window, 2020 (source: Ratio)

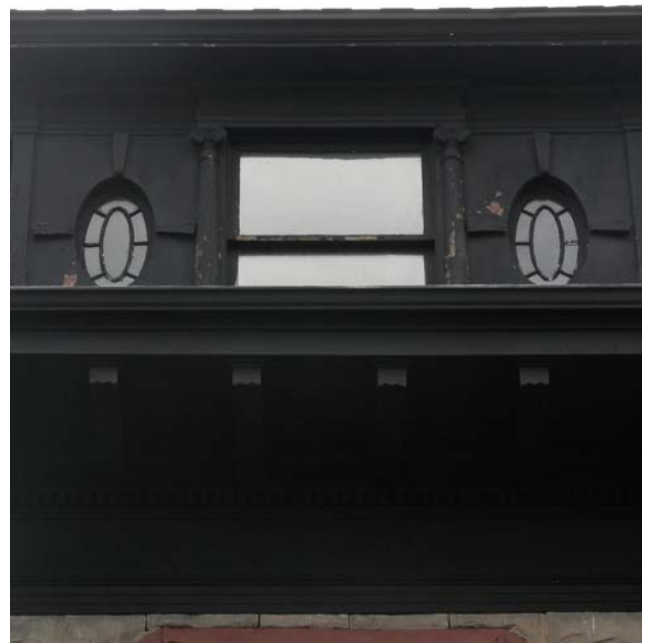
Figure 1-71. View of attic exterior, 2020 (source: Ratio)
